| PHOTOGRAPHIC LOG | |
| Site Location: Land at West End Nursery, Angmering | |

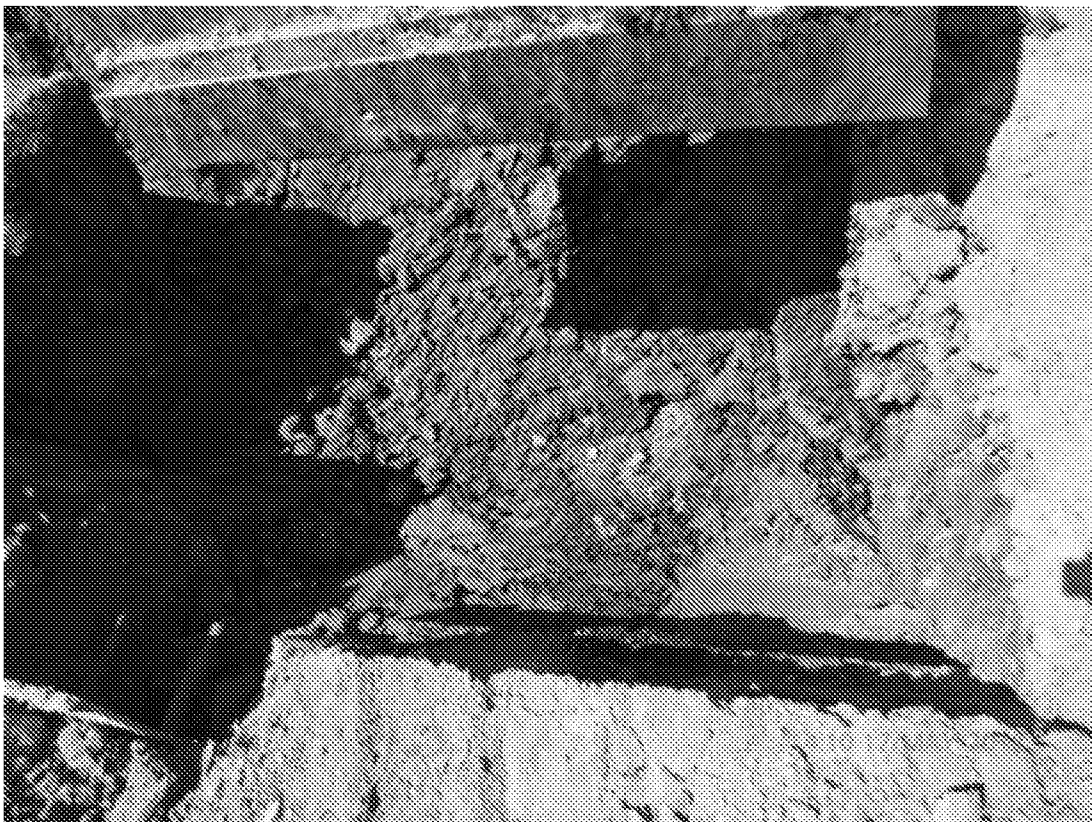
| PHOTOGRAPHIC LOG | |
|---|---|
| <b>Photo No.</b><br>7 | |

| PHOTOGRAPHIC LOG | |
|---|---|
| <p><u>Phase 2A:</u> Facing east: hydrocarbon hotspot excavation works in progress.</p> | |

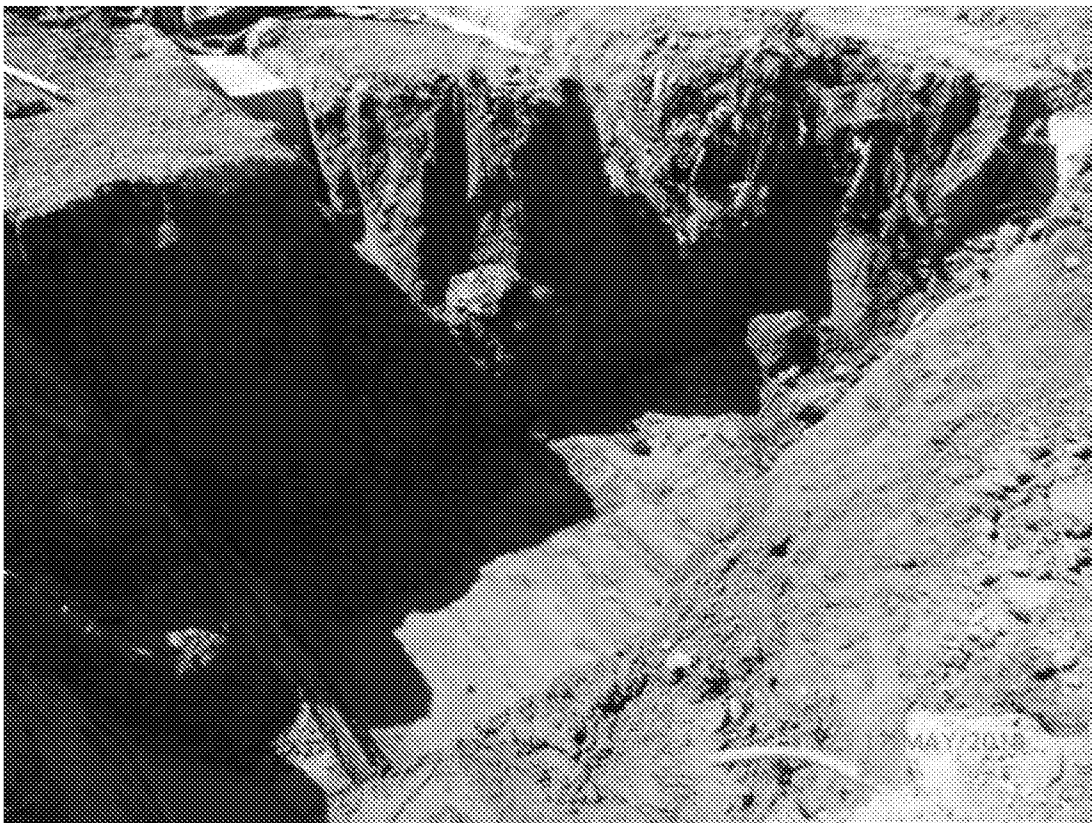
| PHOTOGRAPHIC LOG | |
|---|---|
| <b>Photo No.</b><br>8 | |

| PHOTOGRAPHIC LOG | |
|---|---|
| <p><u>Phase 2A:</u> Facing east: View of final excavation following removal of hydrocarbon impact in the vicinity of Plot 325 (east-central foundations).</p> | |

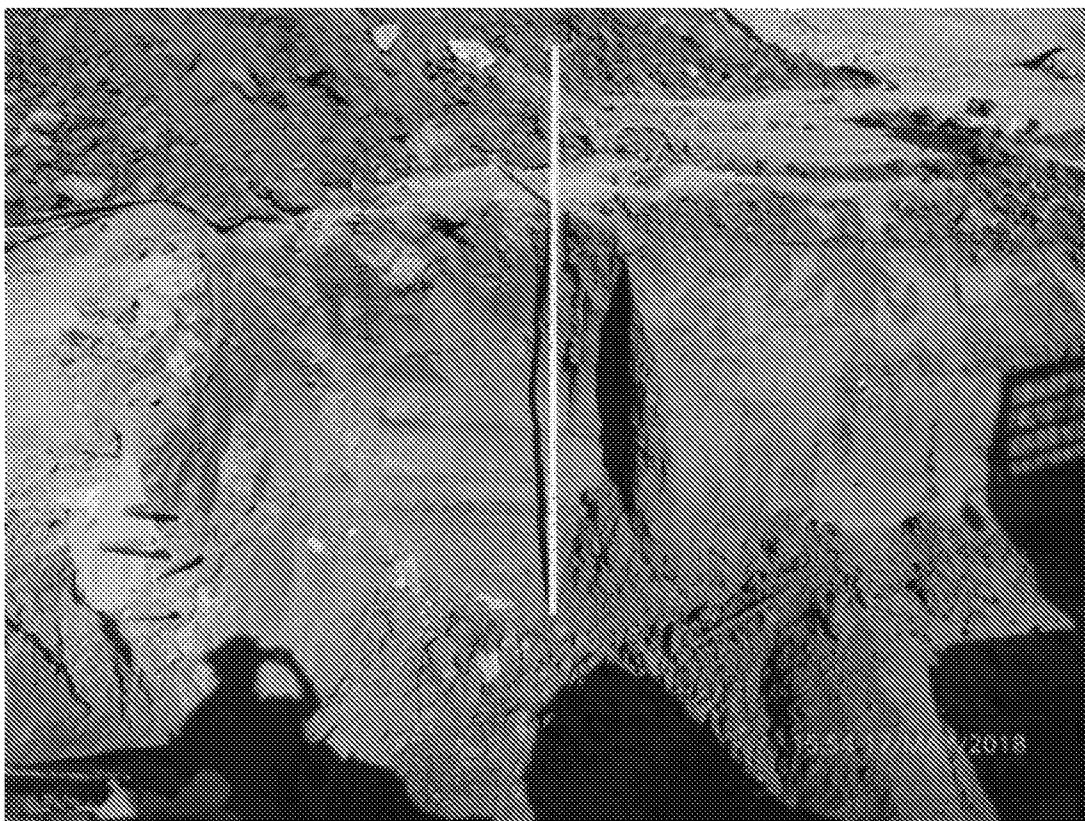
Photo No.  
9

Phase 2A: Eastern face of resulting excavation following removal of hydrocarbon impacts (Plot 325) with the resulting temporary stockpile TSP02-P3 behind.

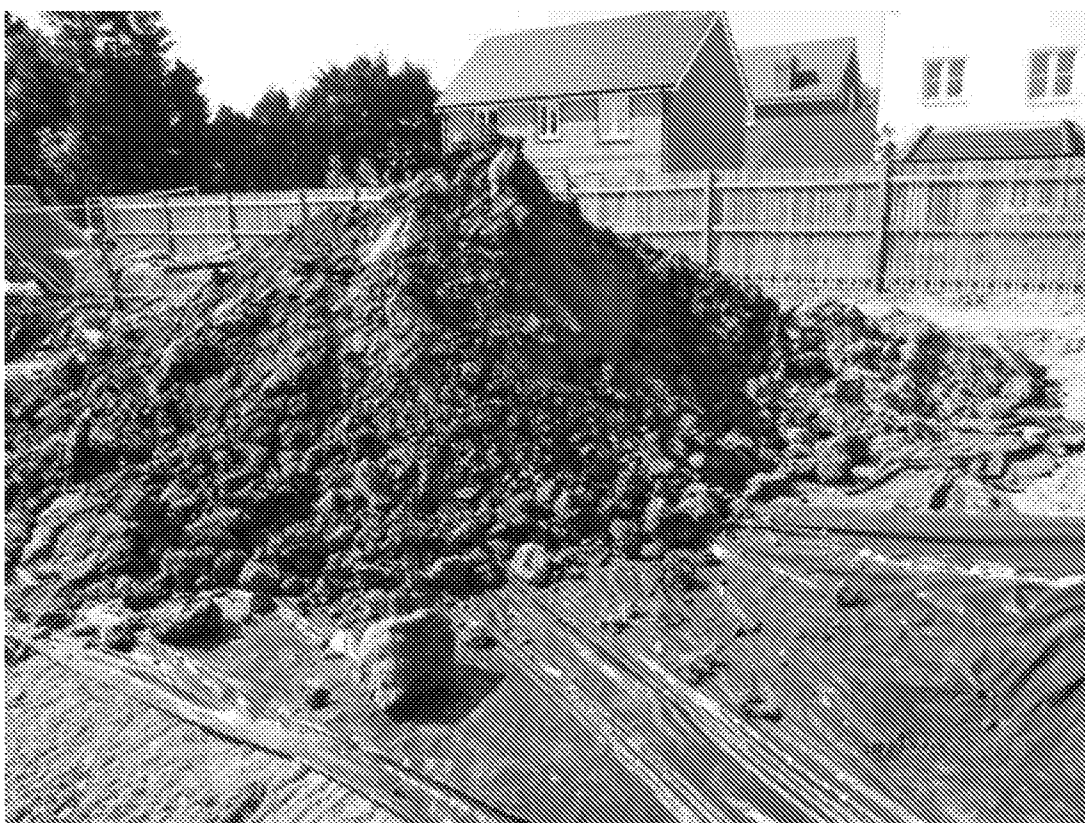
Photo No.  
10

Phase 2A: Facing north west: hydrocarbon-impacted soils placed on polythene sheeting to prohibit leaching of contaminants to ground. Temporary stockpile ID TSP02-P3.

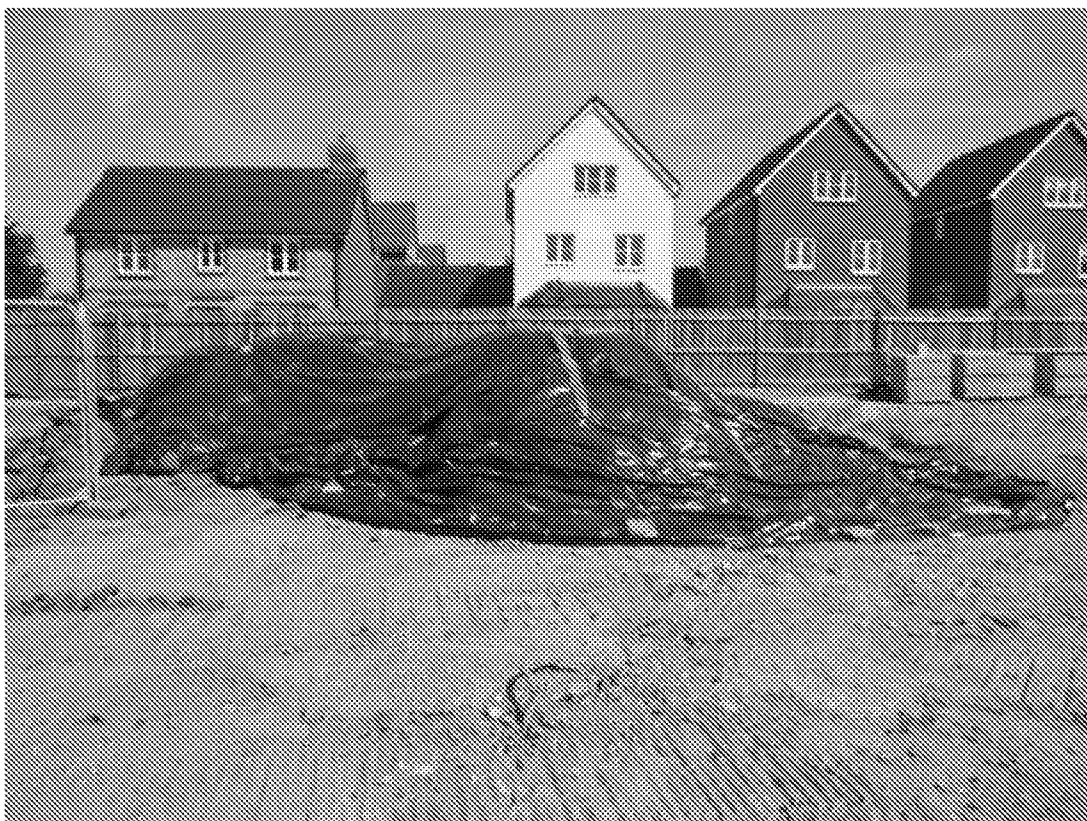
Photo No.  
11

Phase 2A: Facing north: polythene sheeting covering TSP02-P3 to prohibit rainwater infiltrating the hydrocarbon-impacted soil.

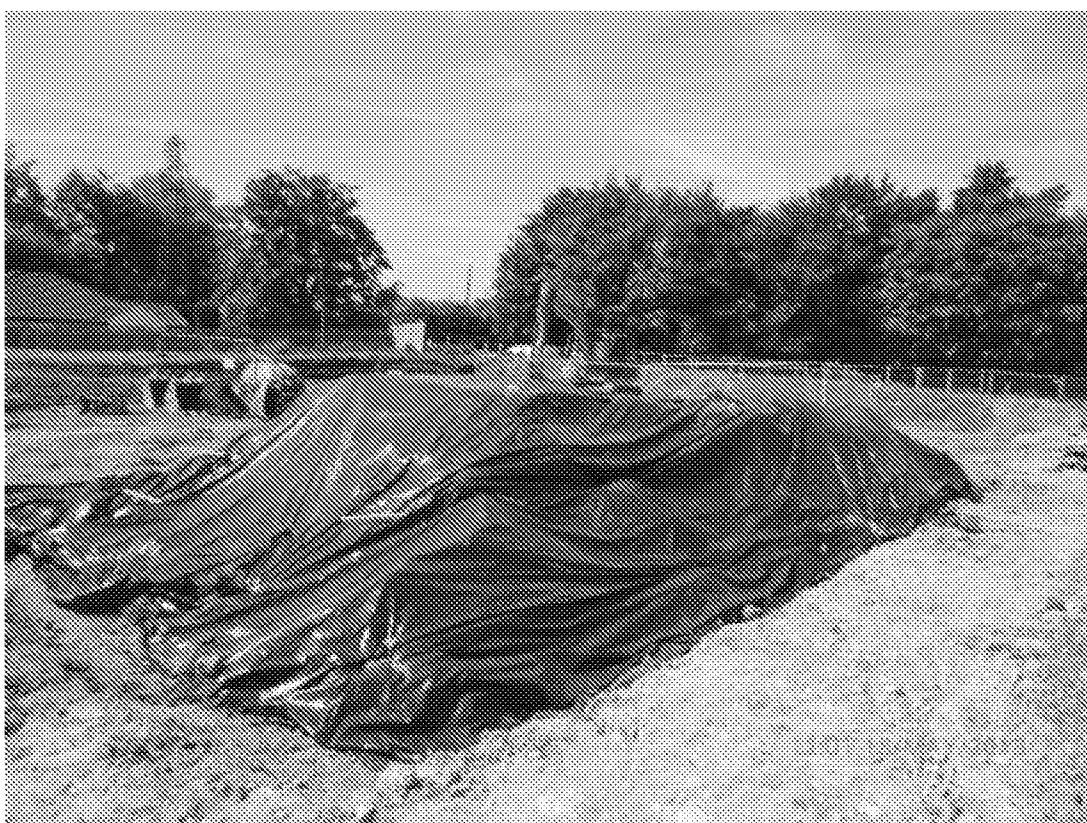
Photo No.  
12

Phase 2A: Facing southwest: polythene sheeting covering TSP02-P3 to prohibit rainwater infiltrating the hydrocarbon-impacted soil, potentially result in hydrocarbons leaching from the soil.

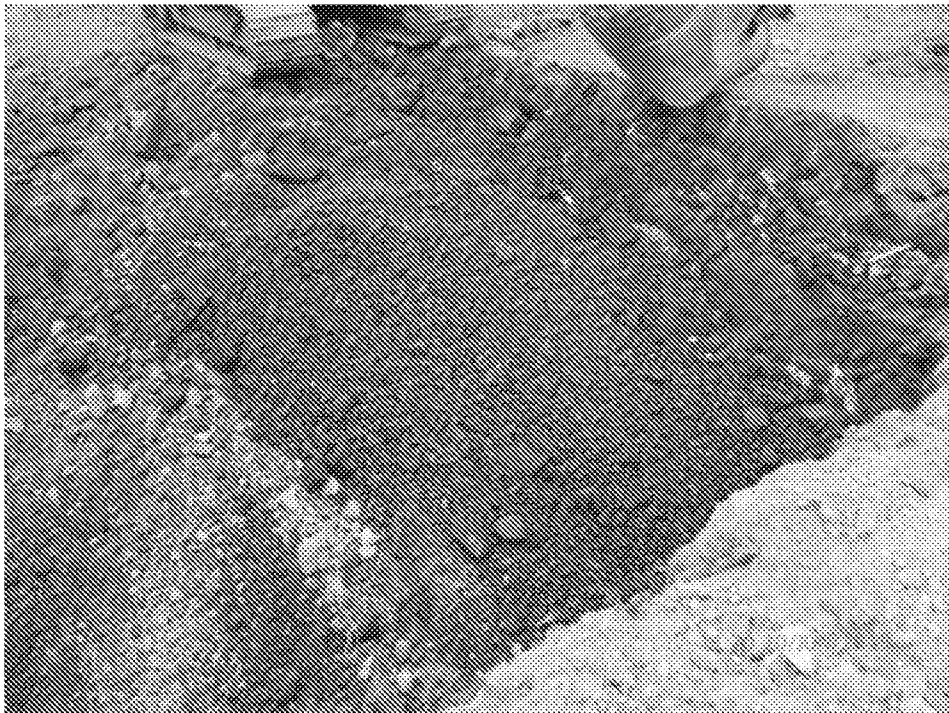
| PHOTOGRAPHIC LOG | |
|---|---|
| <b>Photo No.</b><br>13 | |

| PHOTOGRAPHIC LOG | |
|---|---|
| <u>Phase 2A:</u><br>View showing visual signs of septic tank impacts (stained flint gravel) from the soakaway feature underlying Plot 319 removed during hotspot excavation works. | |

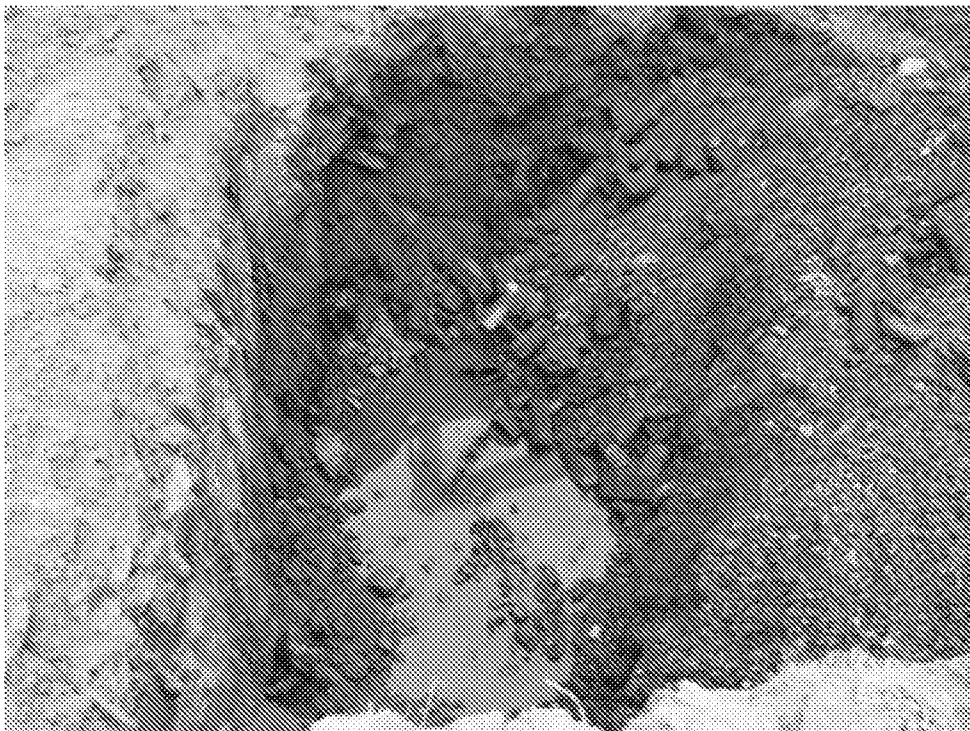
| PHOTOGRAPHIC LOG | |
|---|---|
| <b>Photo No.</b><br>14 | |

| PHOTOGRAPHIC LOG | |
|---|---|
| <u>Phase 2A:</u><br>View showing the remains of a concrete structure. Perched water with visual signs of localised septic tank impacts (sheen) noted to seep out from beneath the stained flint gravel. By the following day all perched groundwater observed to have evaporated. | |

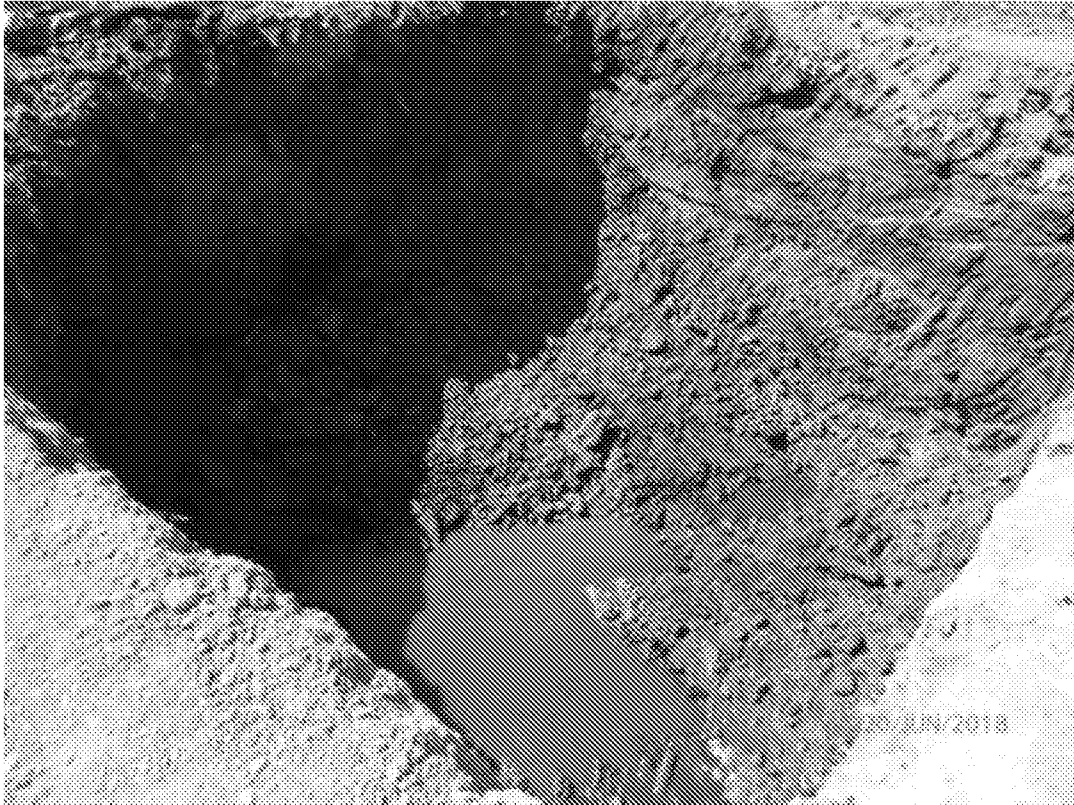
| <p><b>Photo No.</b><br/>15</p> | |

| <p><u>Phase 2A:</u><br/>View showing the Plot 319 excavation. Further visual signs of septic tanks impacts (stained concrete and flint gravels) were present underlying the perched water. By the following day all perched groundwater observed to have evaporated.</p> | |

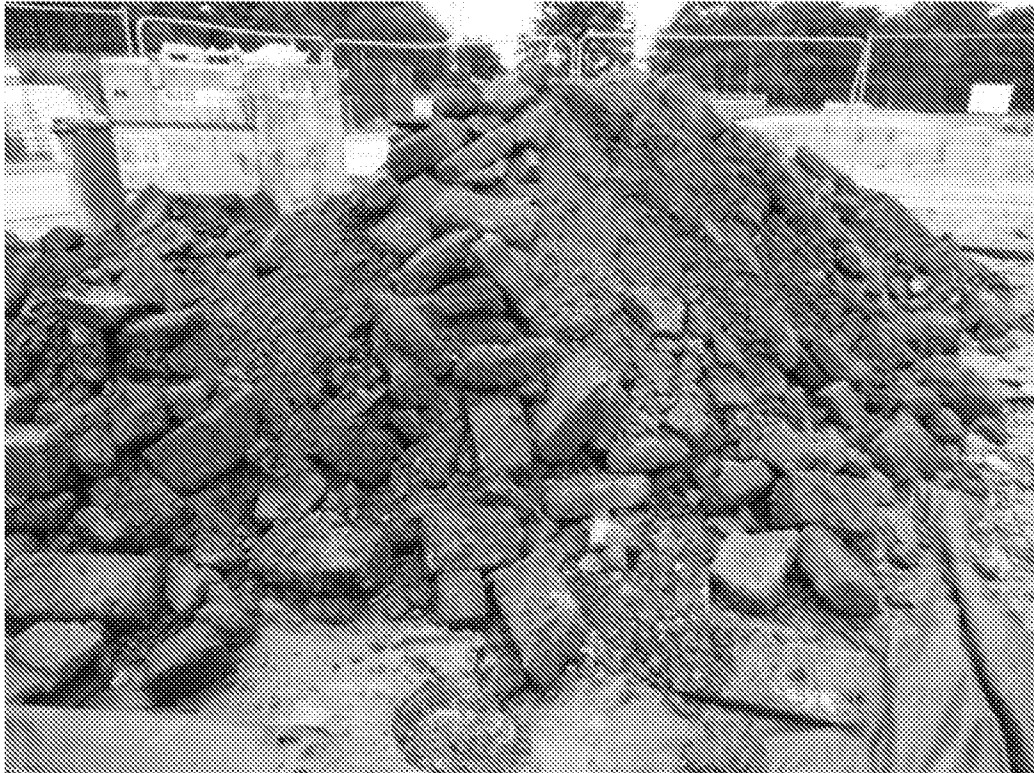
| <p><b>Photo No.</b><br/>16</p> | |

| <p><u>Phase 2A:</u><br/>View showing excavation arisings removed from the Plot 319 hotspot, placed on geo-marker membrane.</p> | |

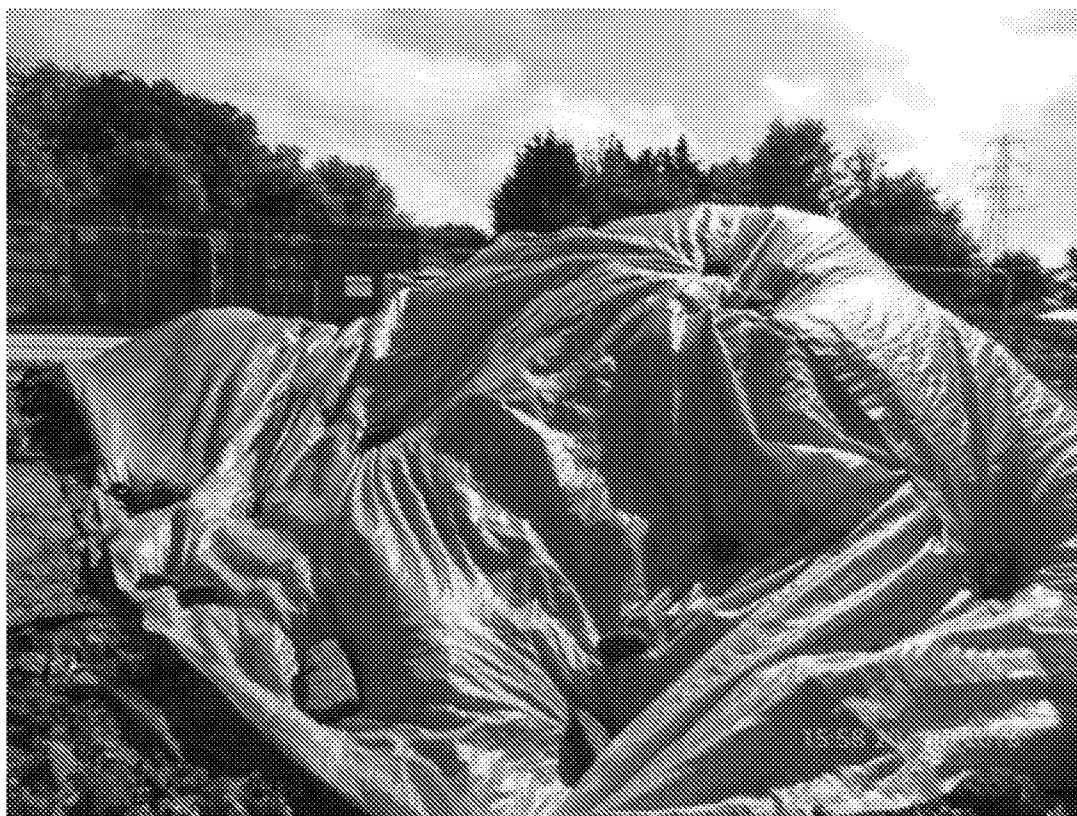
Photo No.  
17

Phase 2A:  
View showing  
the Plot 319  
excavation  
arising  
covered by  
geo-marker  
membrane.

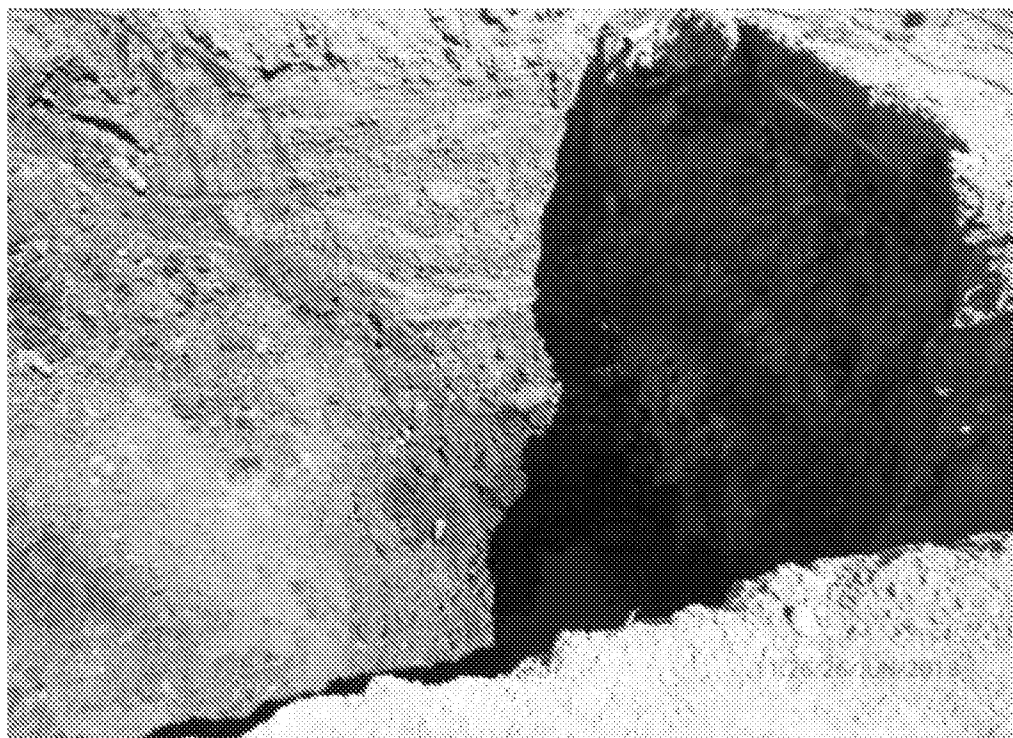
Photo No.  
18

Phase 2A:  
View of the  
Plot 319  
excavation,  
from the  
south during  
hotspot  
removal  
works.  
Exposed  
services can  
be seen in  
the east wall  
following its  
collapse.

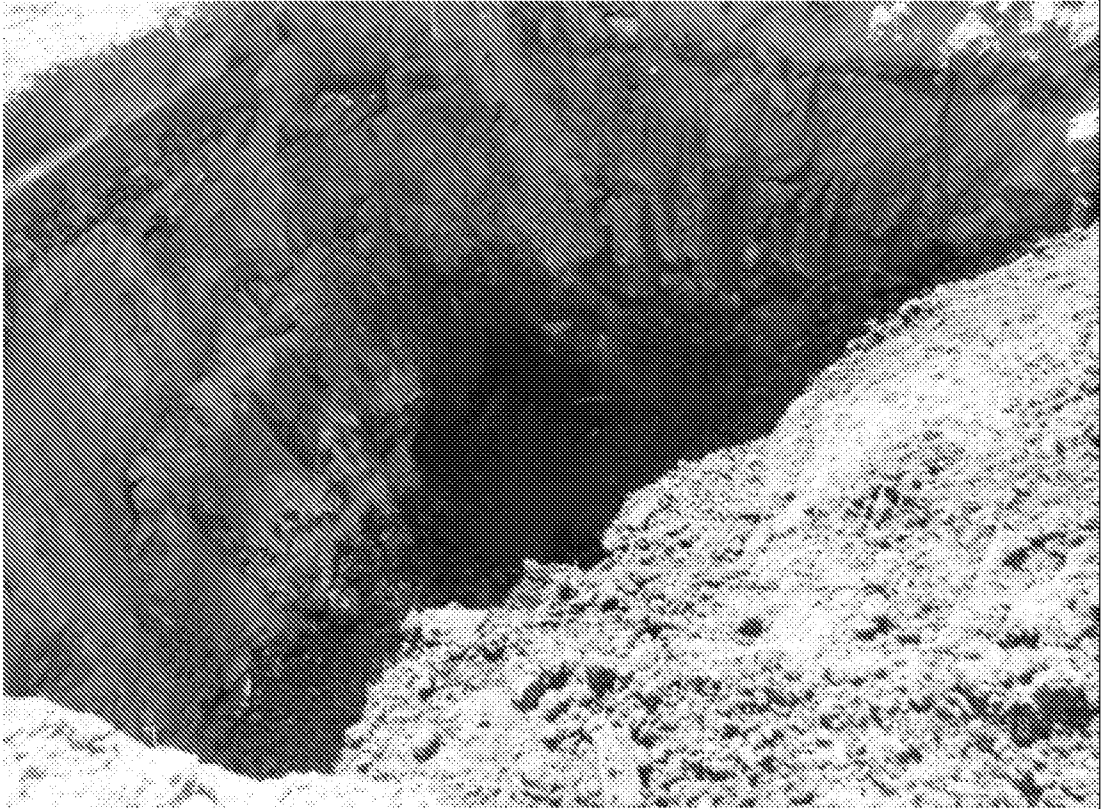
| PHOTOGRAPHIC LOG | |
|---|---|
| <b>Photo No.</b><br>19 | |

| PHOTOGRAPHIC LOG | |
|---|---|
| <p><u>Phase 2A:</u><br/>View of the Plot 319 excavation from the north during hotspot removal works. Perched groundwater observed in the south eastern corner. By the following day all perched groundwater observed to have evaporated.</p> | |

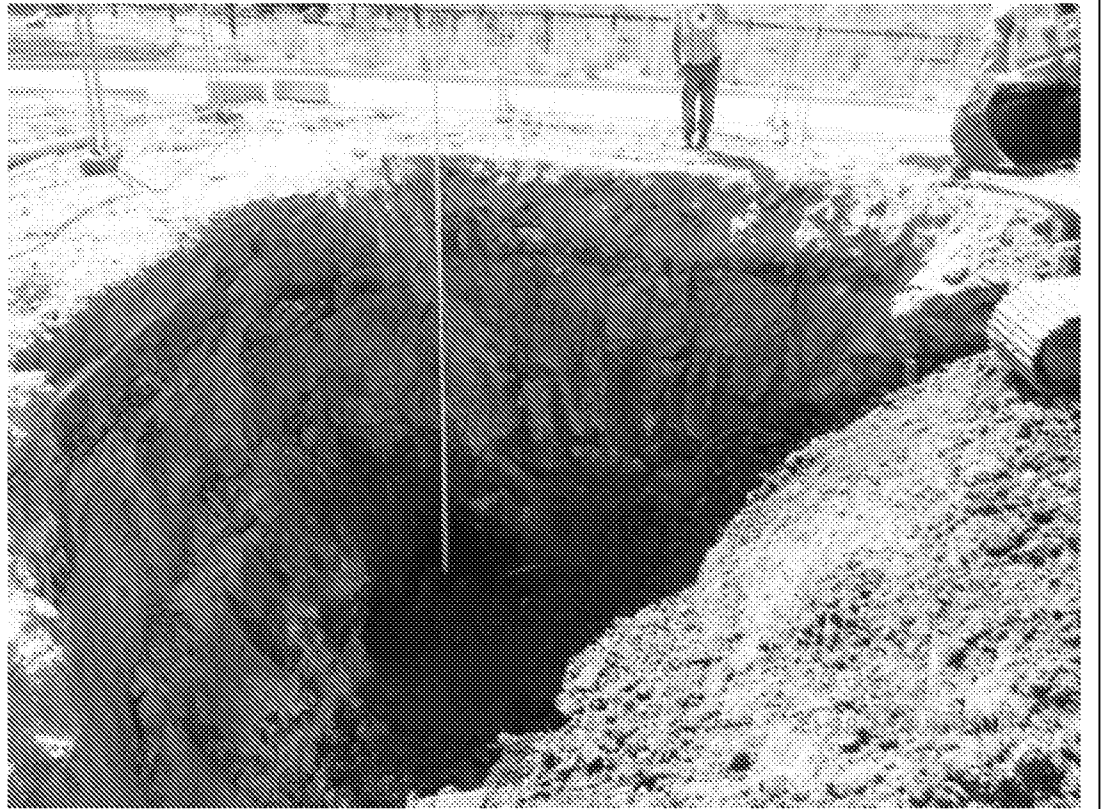
| PHOTOGRAPHIC LOG | |
|---|---|
| <b>Photo No.</b><br>20 | |

| PHOTOGRAPHIC LOG | |
|---|---|
| <p><u>Phase 2A:</u><br/>View of the Plot 319 excavation from the north, during hotspot removal works. The depth of excavation at this point observed to be approximately 4.9 m bgl in the south eastern corner.</p> | |

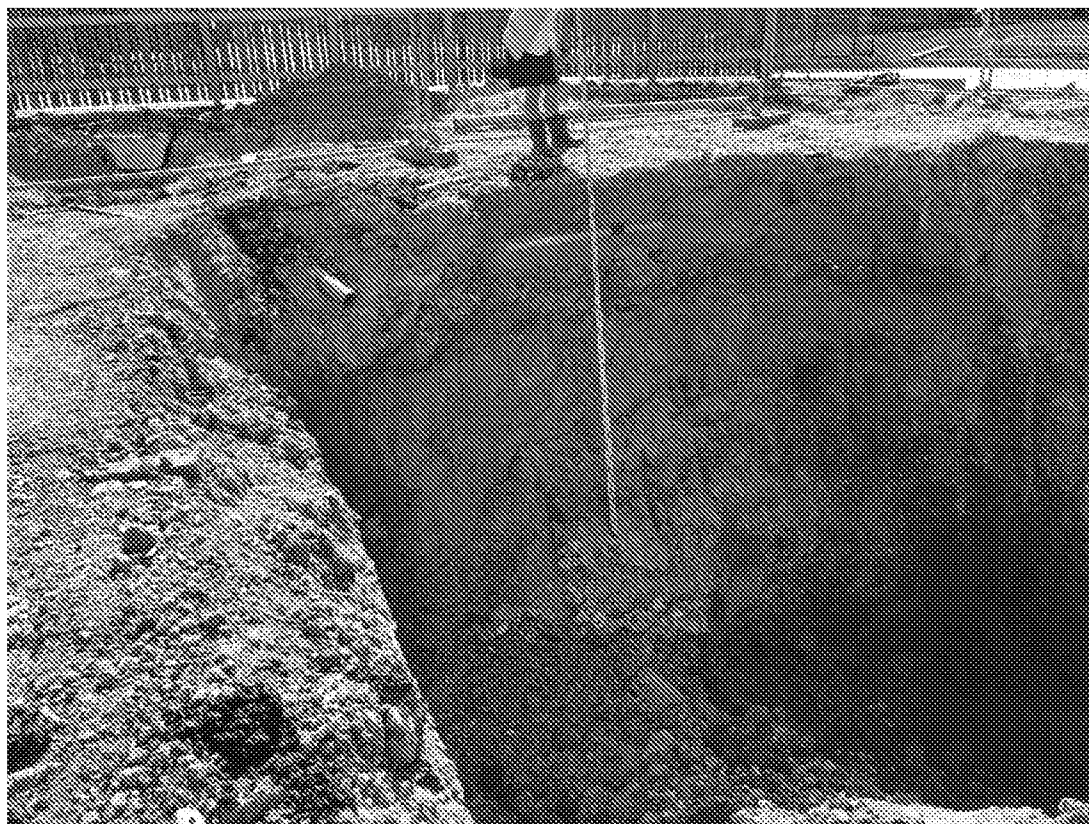
Photo No.  
21

Phase 2A:  
View of the eastern wall of the Plot 319 excavation following hotspot removal works. Validation sample collected from 3.00 m bgl.

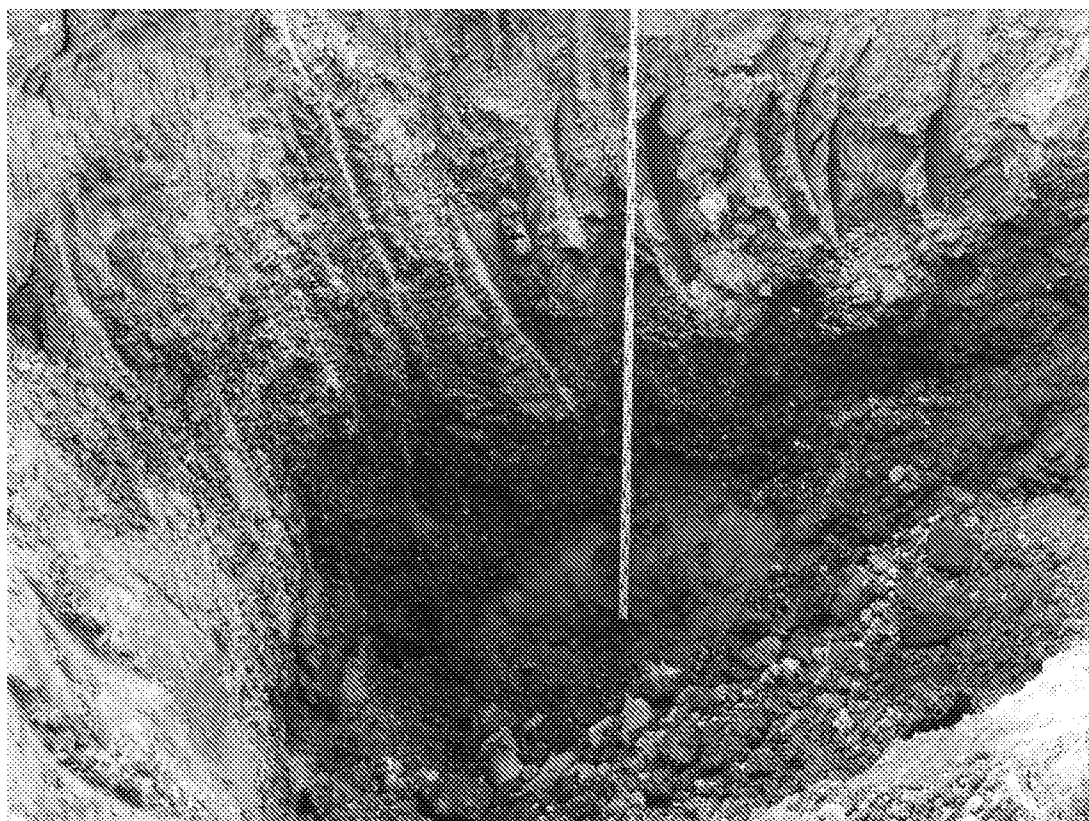
Photo No.  
22

Phase 2A:  
View of the base of the Plot 319 excavation showing the validation sampling location at the base of the excavation within the chalk (~6.00 m bgl).

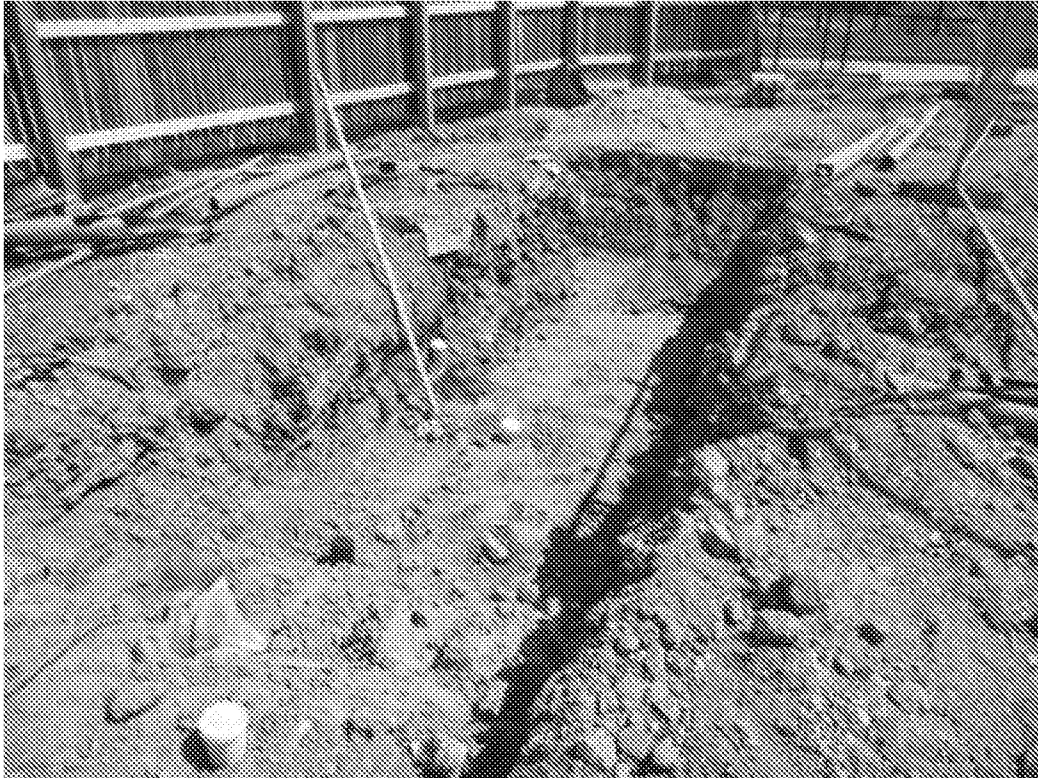
| PHOTOGRAPHIC LOG | |
|---|---|
| <p><b>Photo No.</b><br/>25</p> <p><b>Date:</b><br/>02/07/2018</p> <p><u>Phase 2A:</u><br/>View of the Plot 317 parking bay hydrocarbon hotspot validation excavation from the north.</p> | |

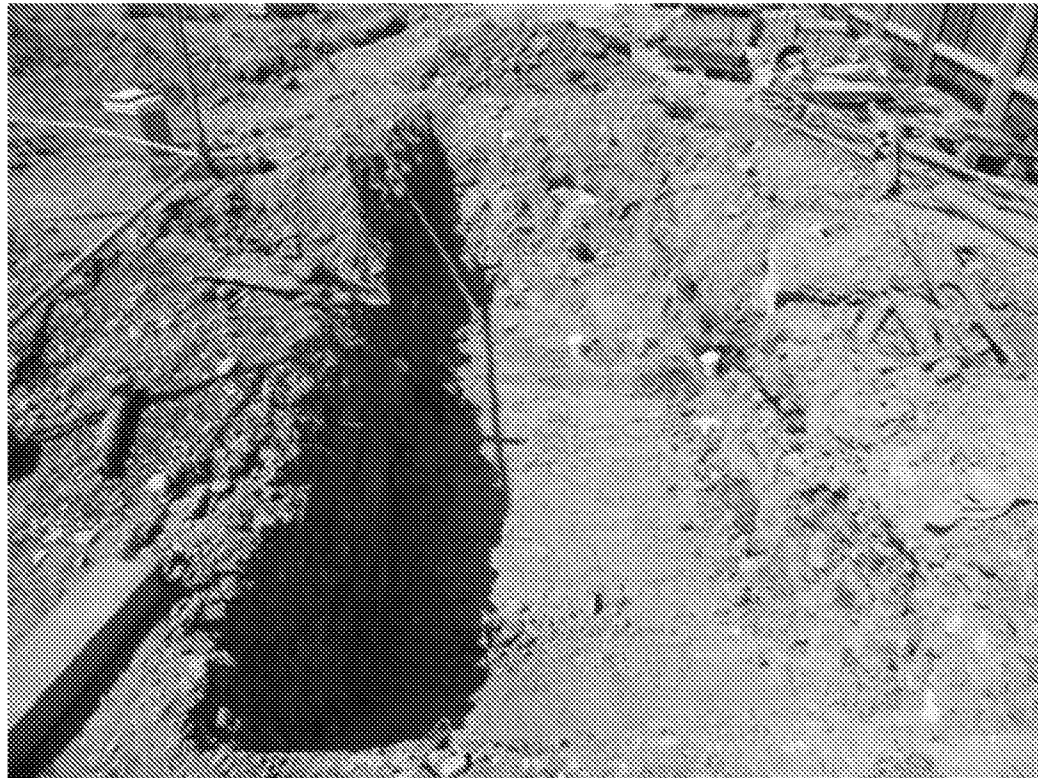
| PHOTOGRAPHIC LOG | |
|---|---|
| <p><b>Photo No.</b><br/>26</p> <p><b>Date:</b><br/>02/07/2018</p> <p><u>Phase 2A:</u><br/>View of the Plot 317 parking bay hydrocarbon hotspot validation excavation from the south. Showing the location of the sample taken from the base of the excavation.</p> | |

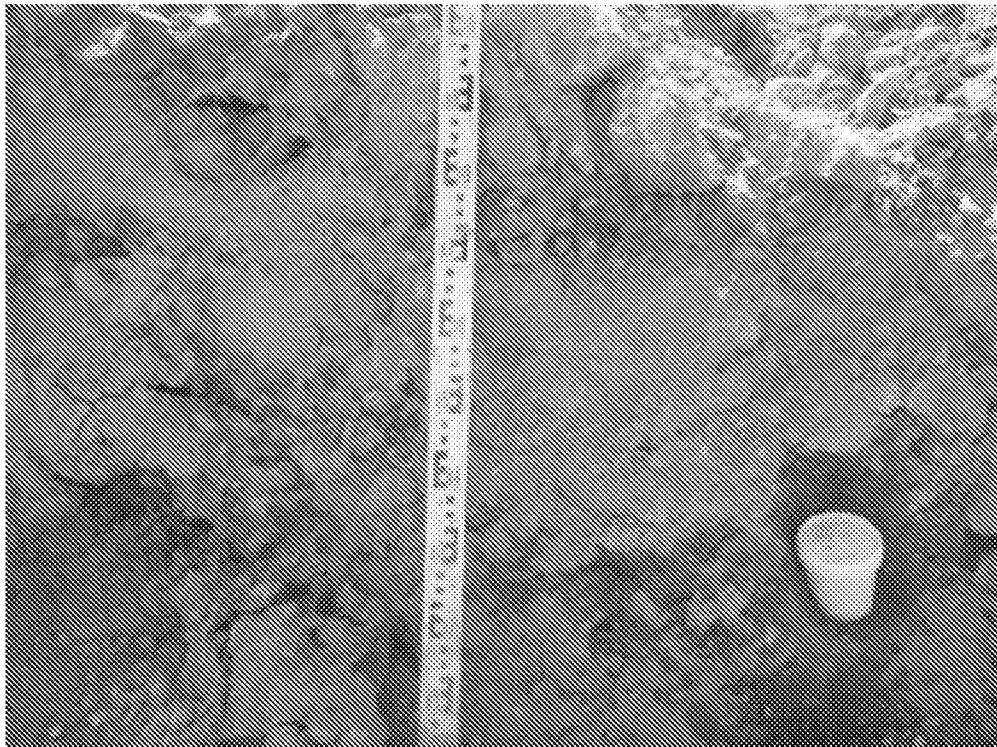
| PHOTOGRAPHIC LOG | |
|---|---|
| <b>Photo No.</b><br>29 | |

| PHOTOGRAPHIC LOG | |
|---|---|
| <u>Phase 2A:</u><br>Location of the western wall validation sampling location from the Plot 317 parking bay hydrocarbon hotspot validation. | |

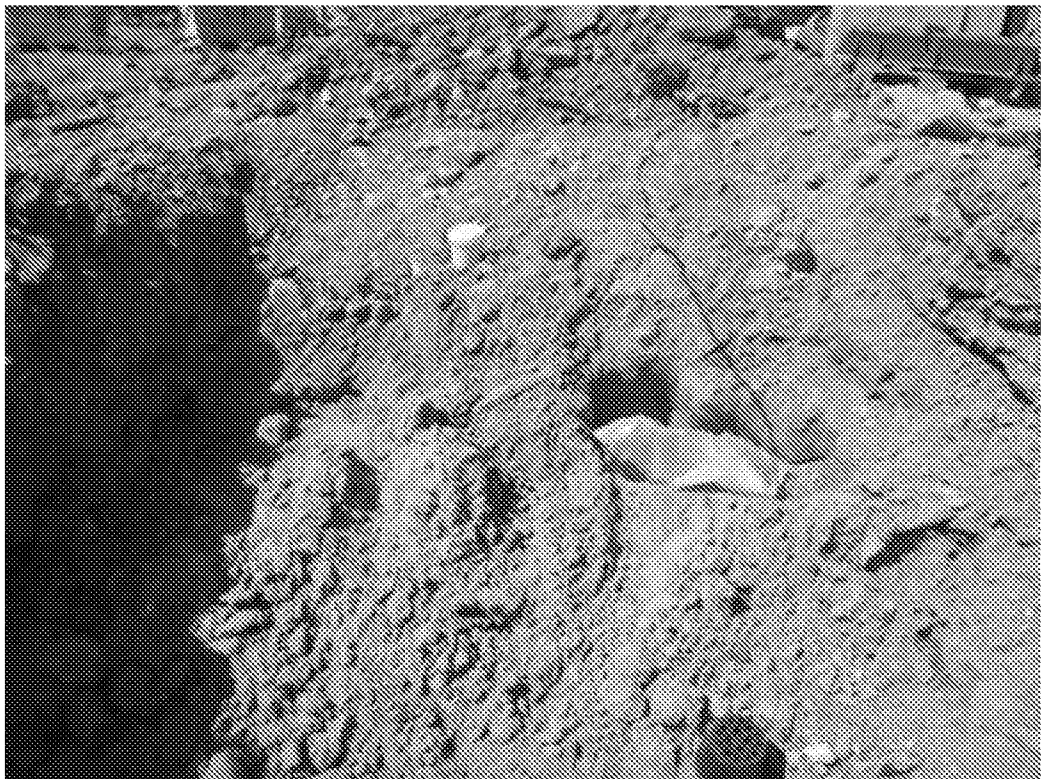
| PHOTOGRAPHIC LOG | |
|---|---|
| <b>Photo No.</b><br>30 | |

| PHOTOGRAPHIC LOG | |
|---|---|
| <u>Phase 2A:</u><br>Location of the northern wall validation sampling location from the Plot 317 parking bay hydrocarbon hotspot validation. | |

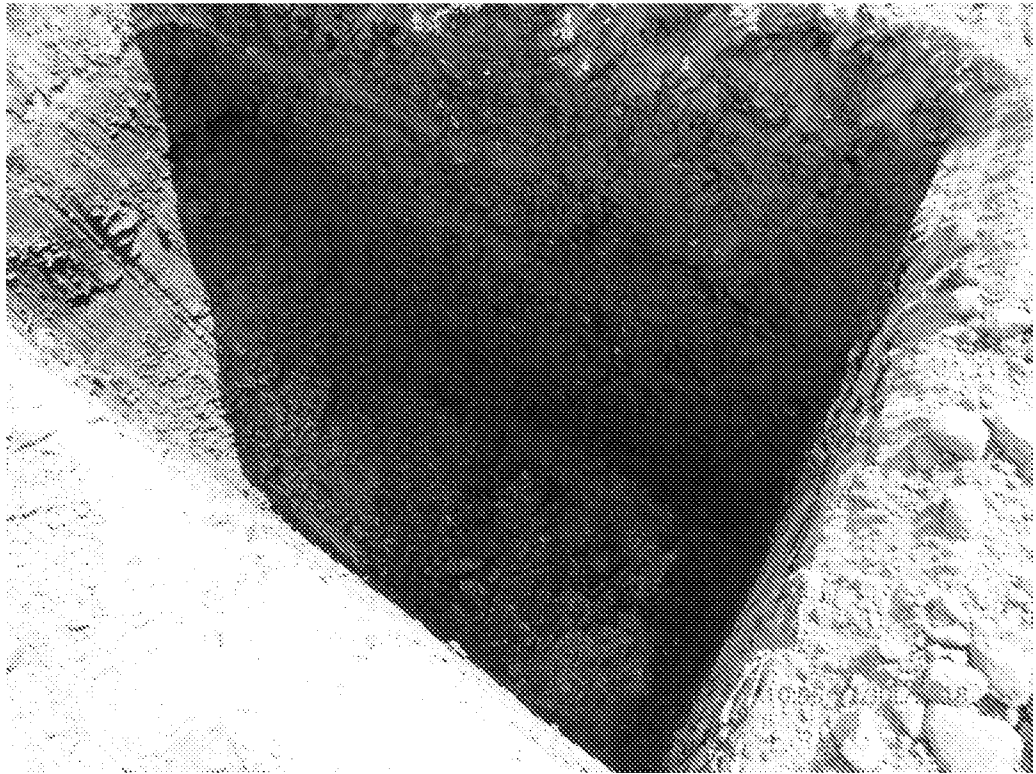
| PHOTOGRAPHIC LOG | |
|---|---|
| <b>Photo No.</b><br>31 | |

| PHOTOGRAPHIC LOG | |
|---|---|
| <u>Phase 2A:</u><br>View of Plot 320-323 parking bay septic tank hotspot during validation. excavation from the south west. | |

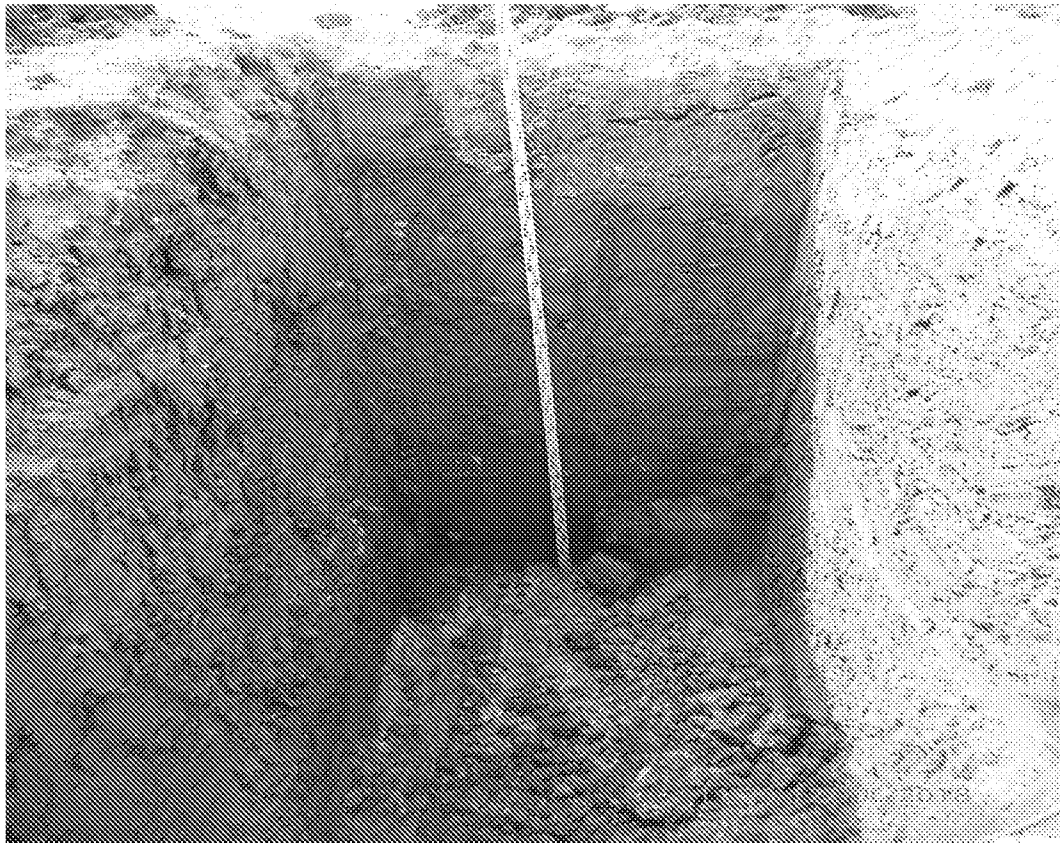
| PHOTOGRAPHIC LOG | |
|---|---|
| <b>Photo No.</b><br>32 | |

| PHOTOGRAPHIC LOG | |
|---|---|
| <u>Phase 2A:</u><br>View of Plot 320-323 parking bay septic tank hotspot during validation. Sampling location on the southern wall. Sample was collected from 1.7 m bgl. Photo shows the full depth of excavation to 3.7 m bgl. | |

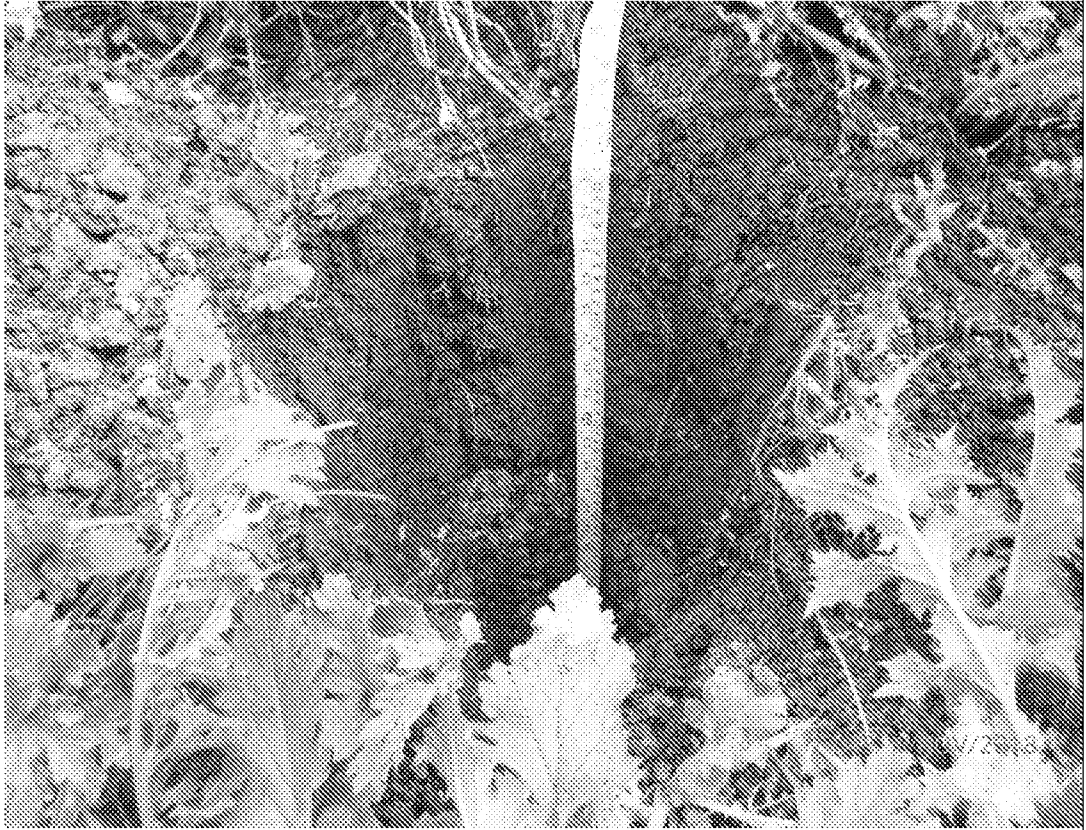
| PHOTOGRAPHIC LOG | |
|---|---|
| <b>Photo No.</b><br>37 | |

| PHOTOGRAPHIC LOG | |
|---|---|
| South West Bund A validation pit 1 overview. Capping layer thickness observed to be >600 mm thick. | |

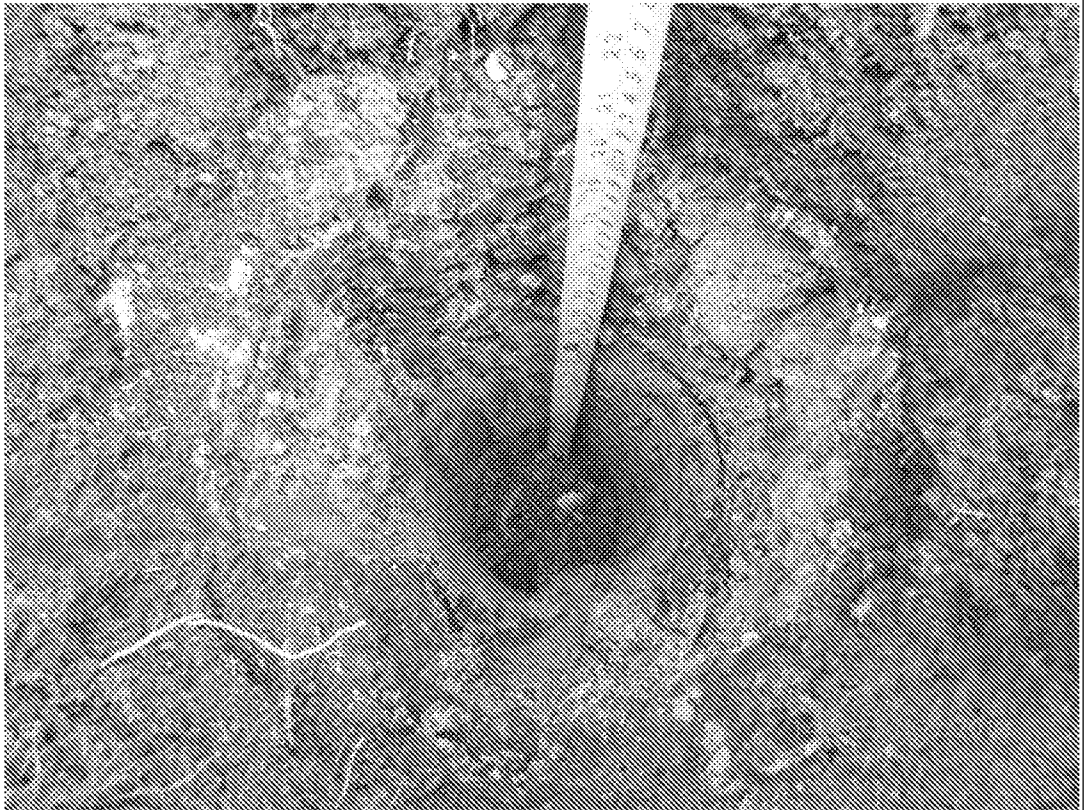
| PHOTOGRAPHIC LOG | |
|---|---|
| <b>Photo No.</b><br>38 | |

| PHOTOGRAPHIC LOG | |
|---|---|
| South West Bund A validation pit 1, detailed view showing orange marker membrane at the base. | |
