**LAND AT WEST END NURSERY, ANGMERING**

**LOCATIONS WHERE SUSPECTED ASBESTOS CONTAINING MATERIALS (ACM) ENCOUNTERED IN PHASE 3**

## **PHOTOGRAPHIC LOG**

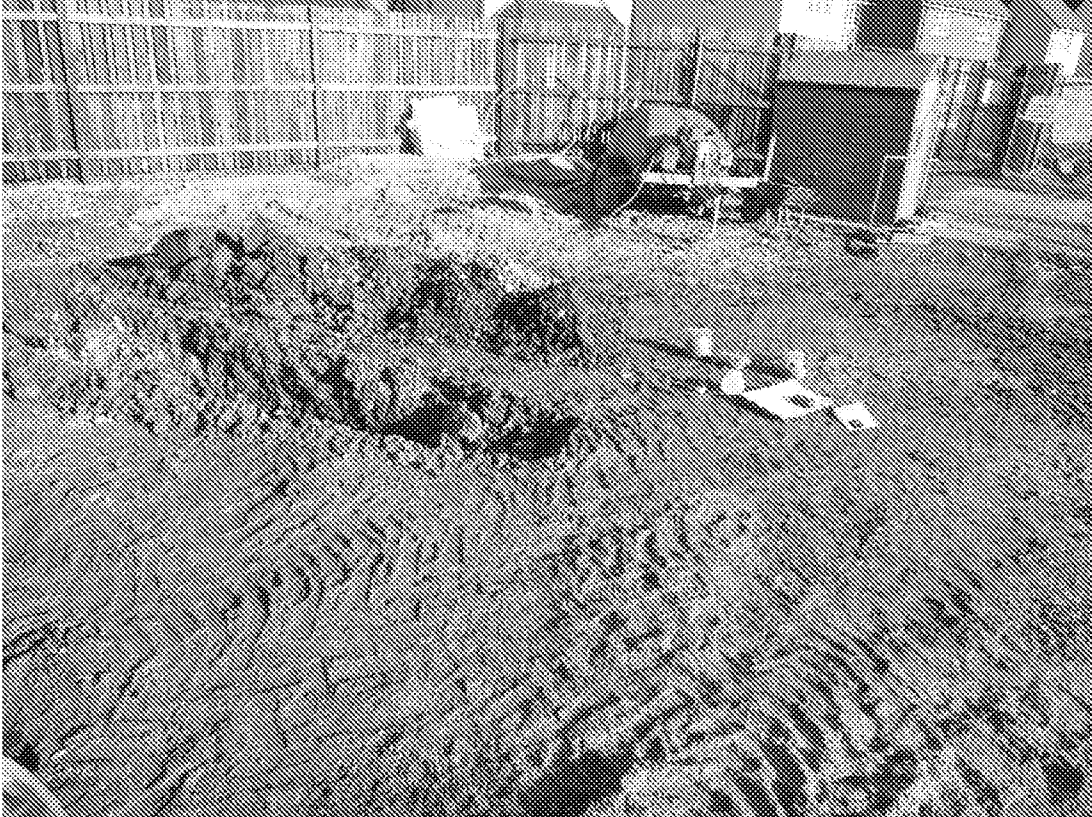
| Photo No.<br>1 | |

| Facing<br>northeast,<br>overview of<br>area around<br>TP301 | |

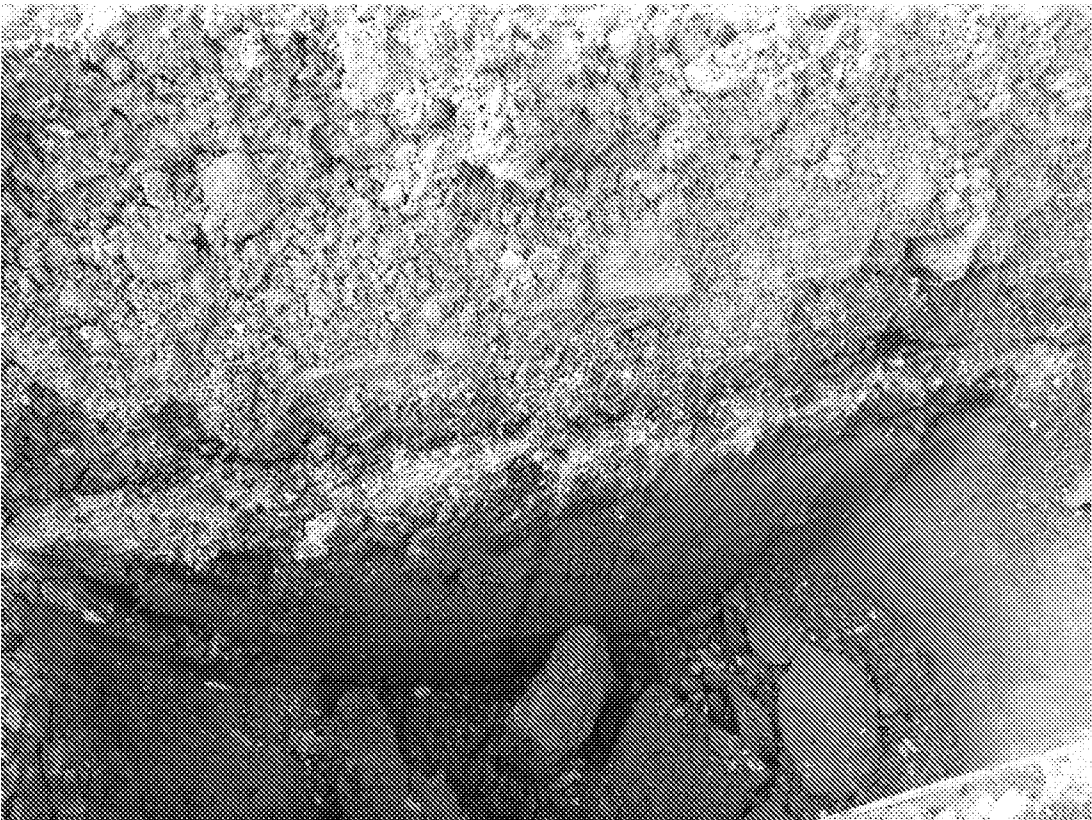
| Photo No.<br>2 | |

| West wall of<br>TP301, 1.1 m<br>from top to<br>base of pit | |

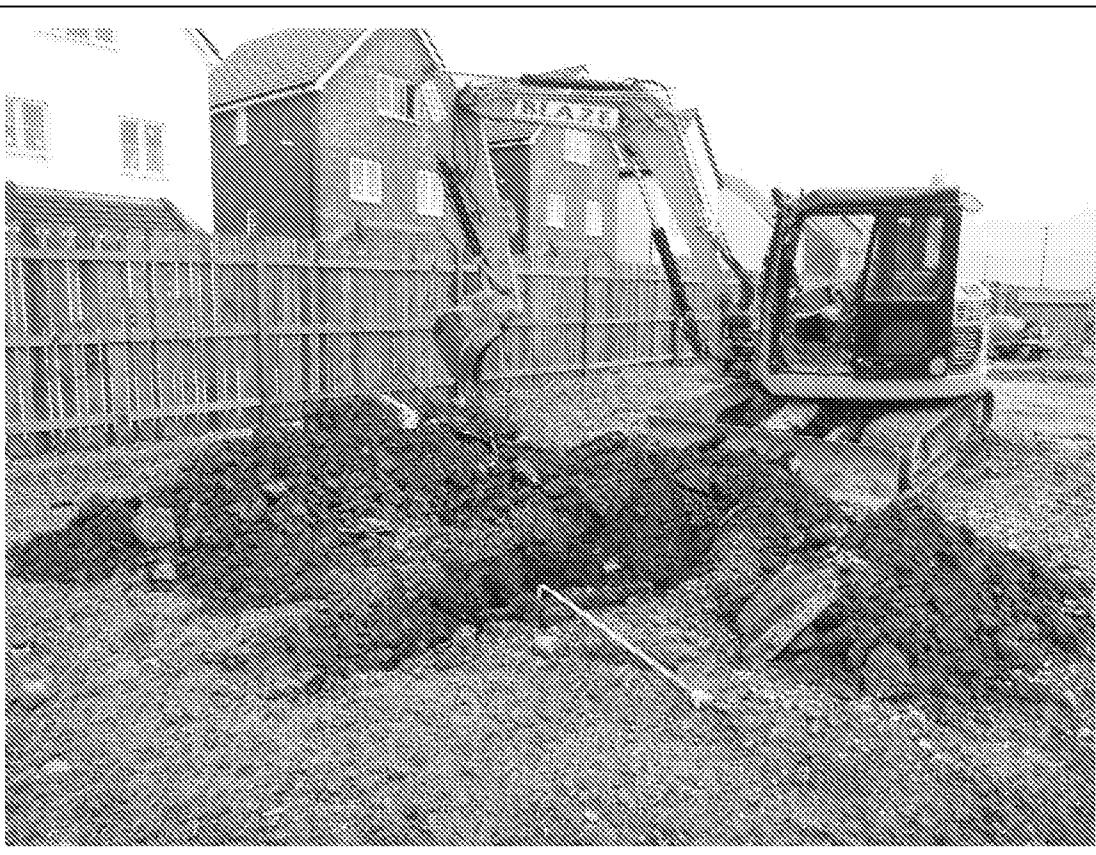
| Photo No.<br>3 | |

| Facing<br>northeast,<br>overview of<br>area around<br>TP302 | |

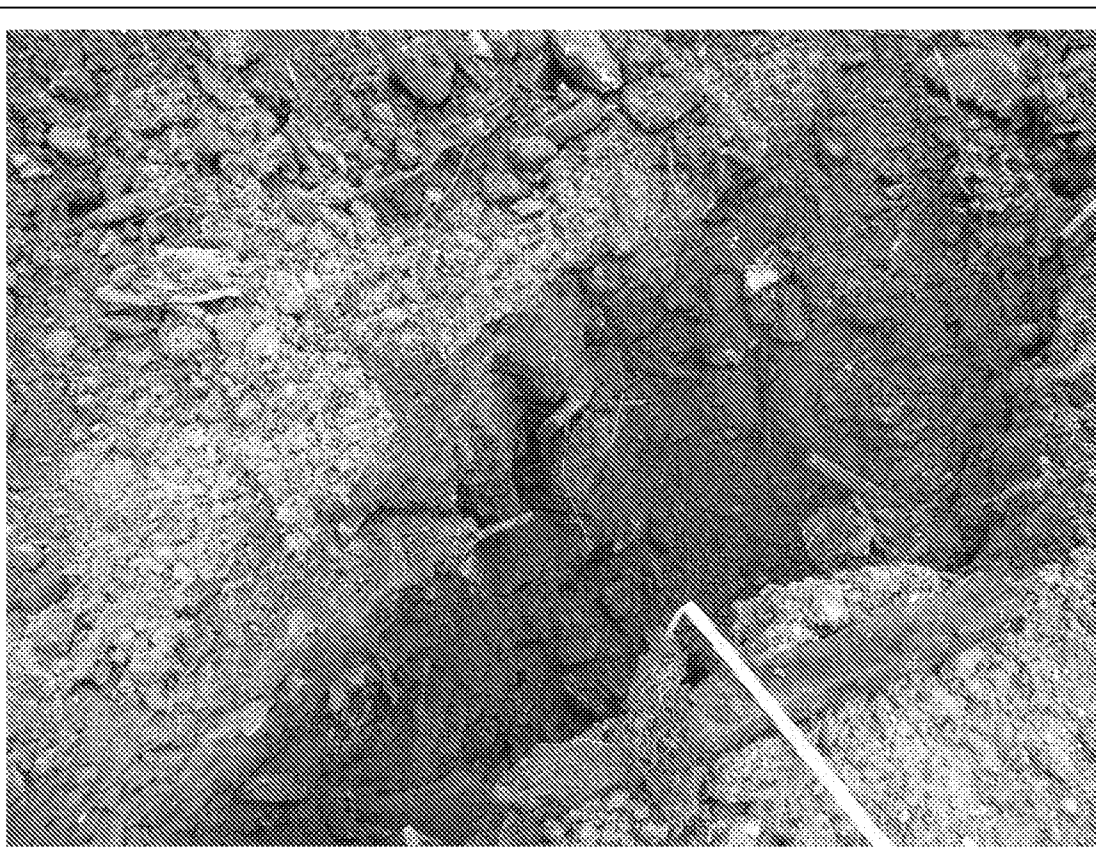
| Photo No.<br>4 | |

| Downhole<br>view of<br>TP302,<br>showing<br>instability of<br>made ground<br>and large<br>proportion of<br>anthropogenic<br>materials | |

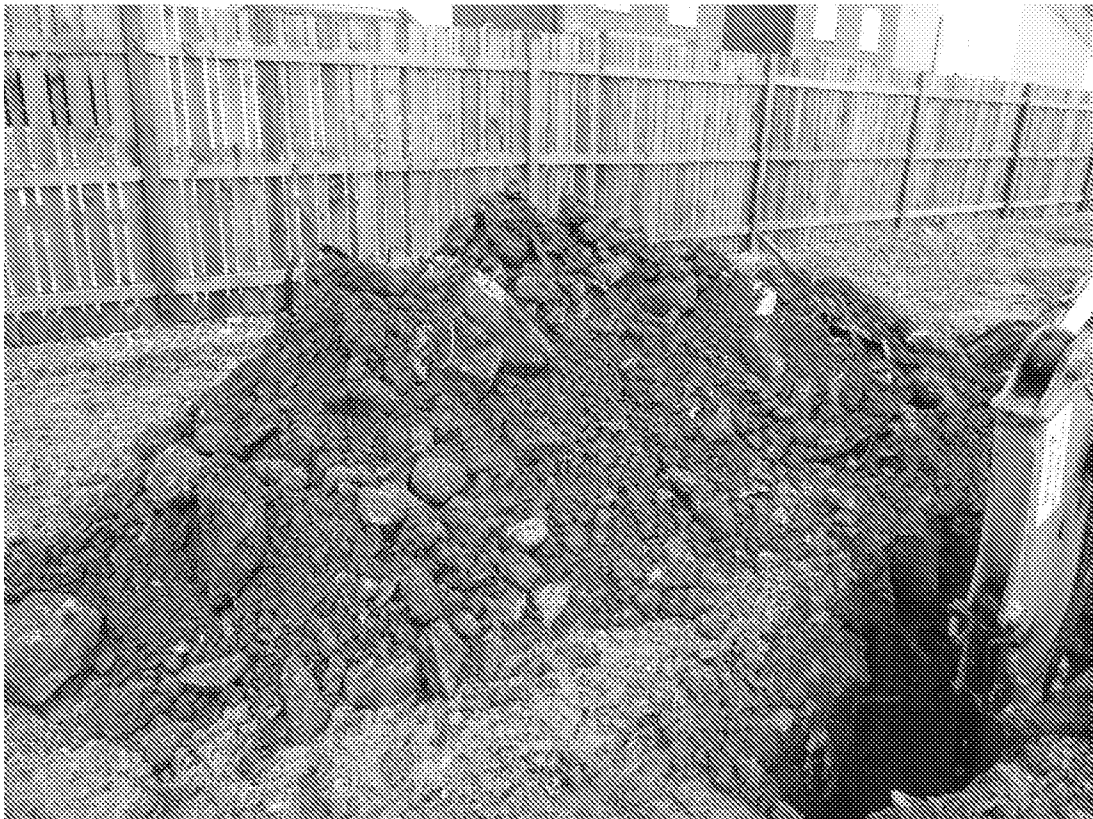
| Photo No.<br>5 | |

| TP302 arisings, large proportion of anthropogenic materials visible | |

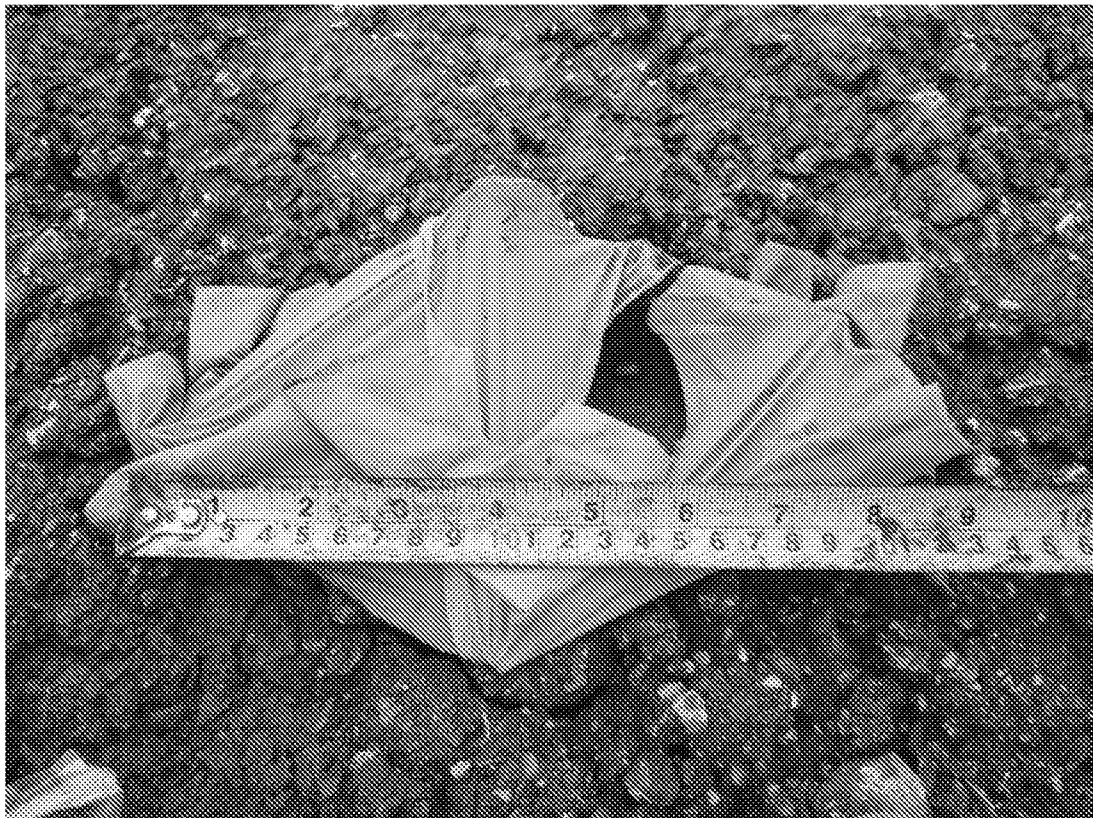
| Photo No.<br>6 | |

| Fragment of suspected asbestos cement found in TP302 arisings (wrapped in nitrile gloves used during identification) | |

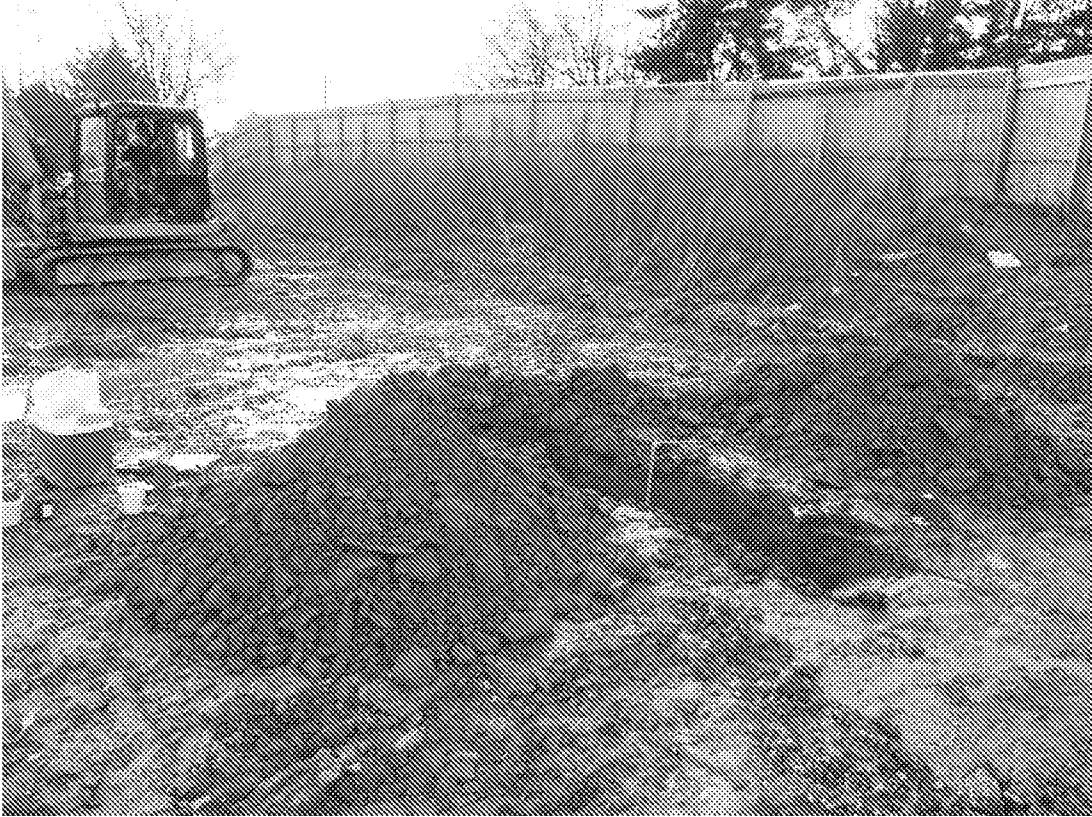
| PHOTOGRAPHIC LOG | |
|---|---|
| <b>Photo No.</b><br>7 | |

| PHOTOGRAPHIC LOG | |
|---|---|
| Facing southwest, overview of area around TP303 | |

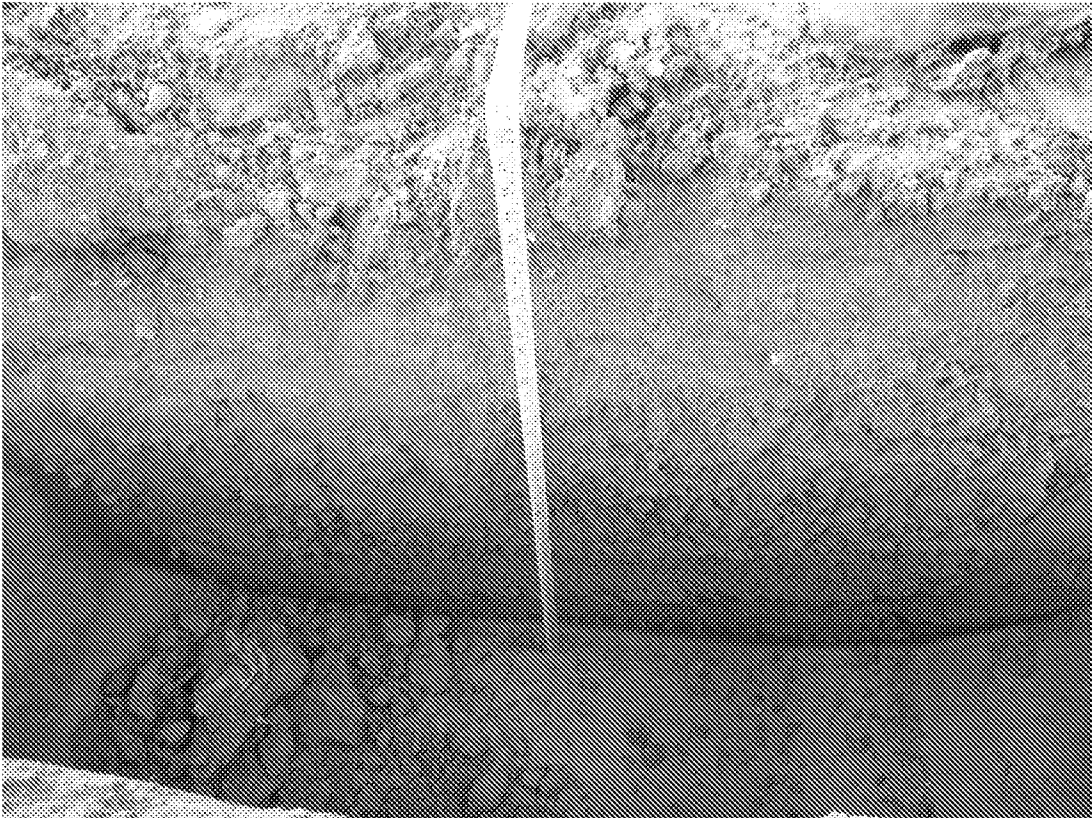
| PHOTOGRAPHIC LOG | |
|---|---|
| <b>Photo No.</b><br>8 | |

| PHOTOGRAPHIC LOG | |
|---|---|
| West wall of TP303, 1.25 m from top to base | |

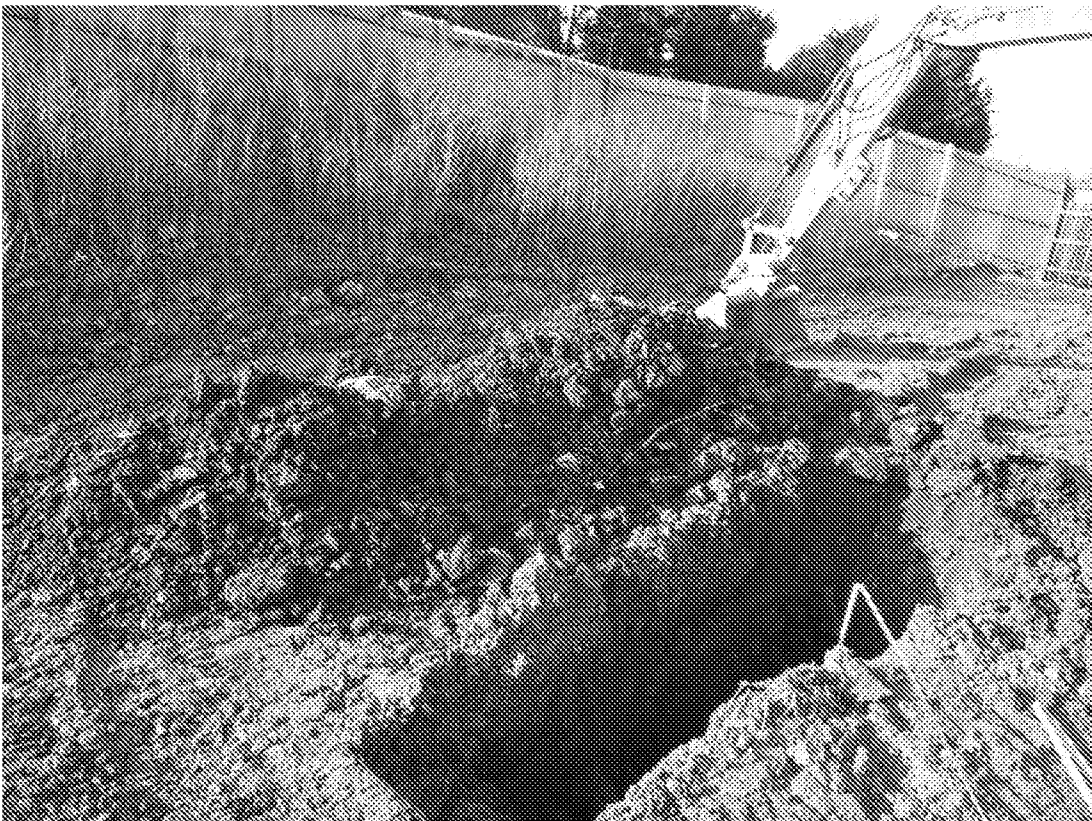
| Photo No.<br>9 | |

| Facing northwest, overview of area around TP304 | |

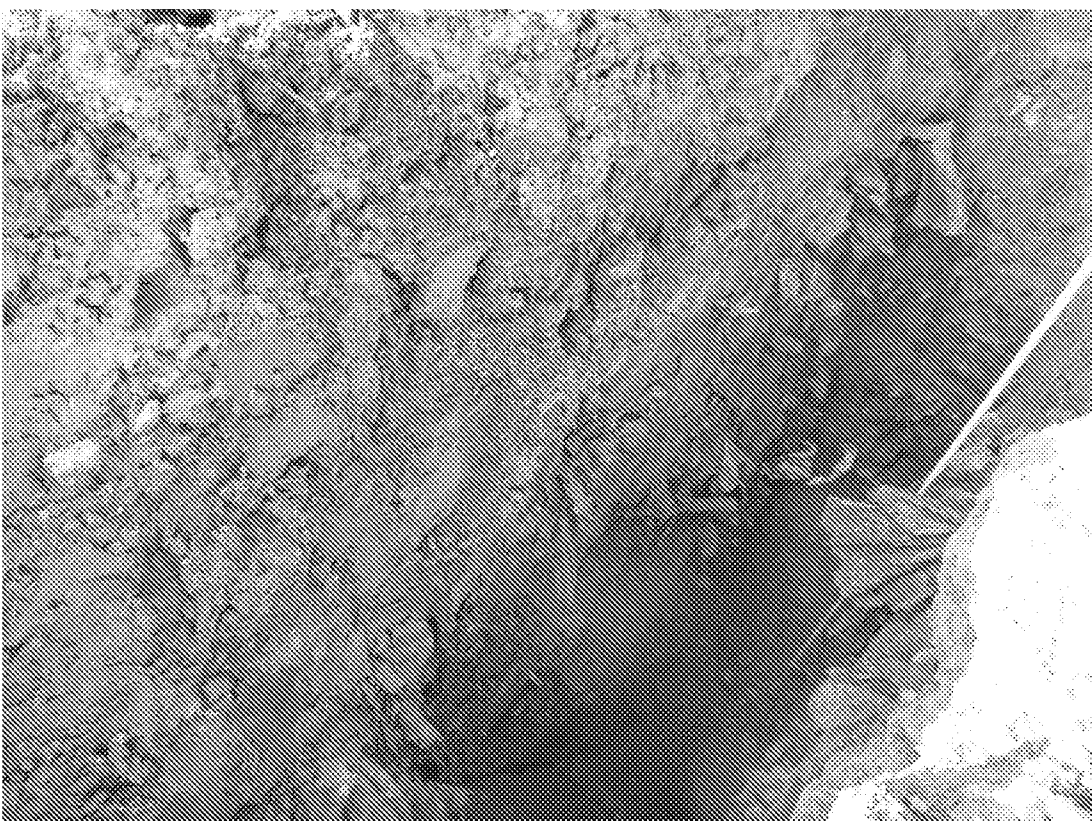
| Photo No.<br>10 | |

| West wall of TP304, 2.55 m from top to base, shows high proportion of anthropogenic materials | |

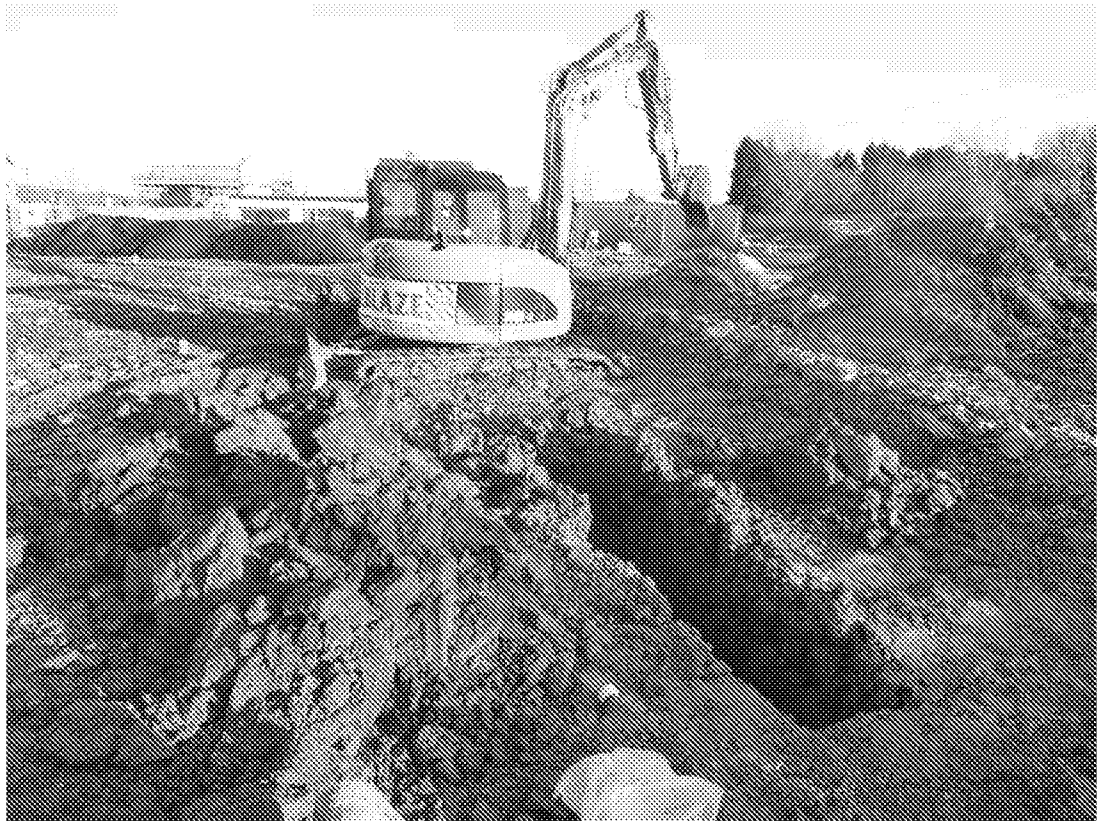
**Photo No.**  
11

Facing east,  
area around  
TP305

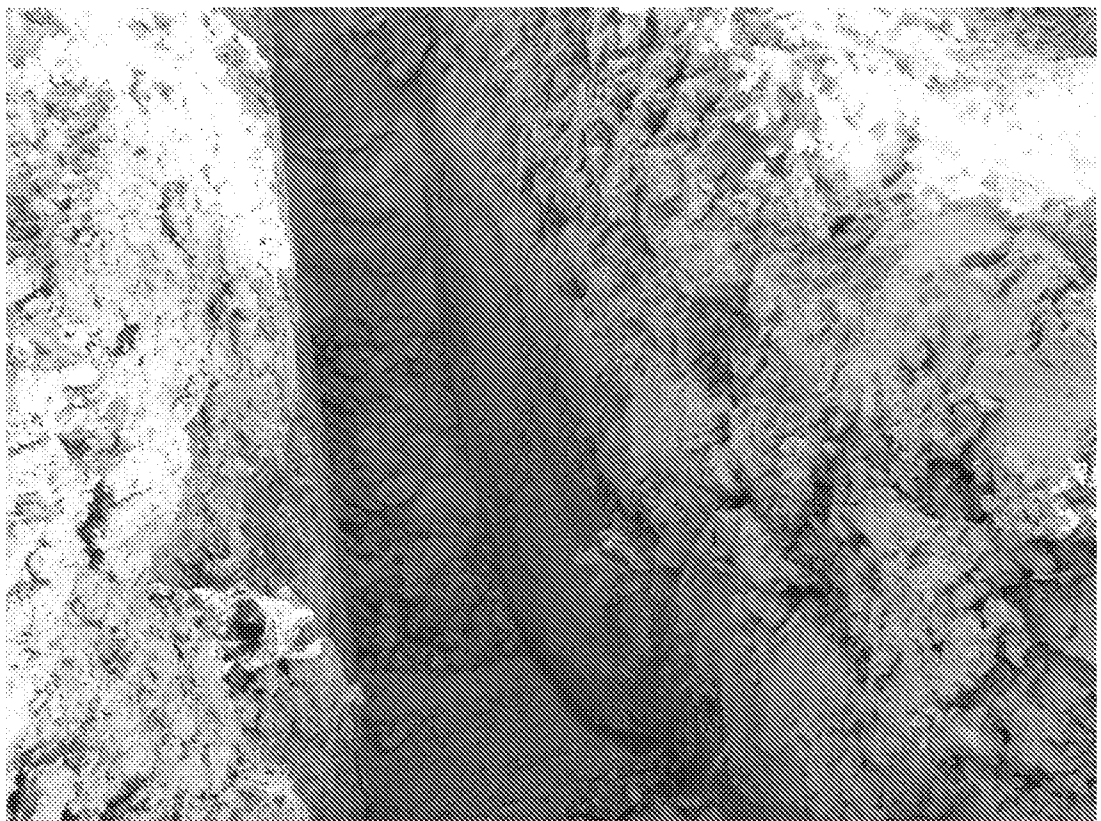
**Photo No.**  
12

View east of  
south wall of  
TP305,  
showing  
shallow  
thickness of  
made ground

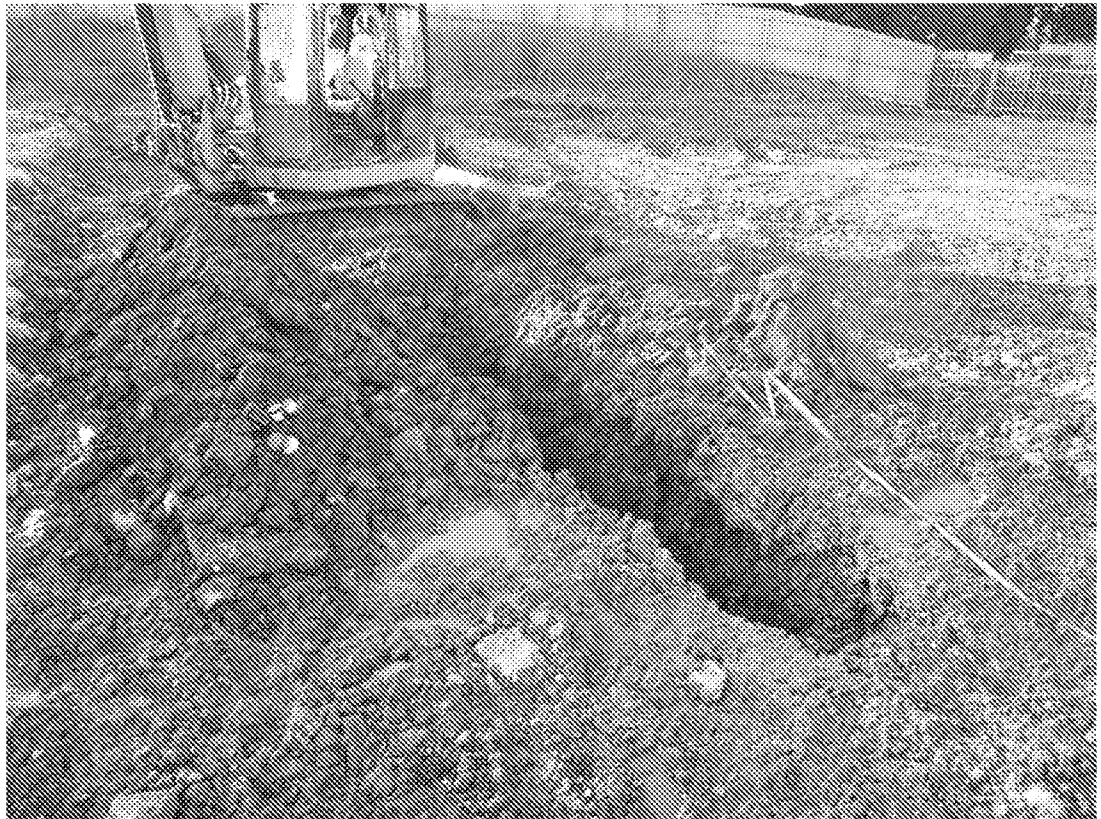
**Photo No.**  
13

Facing west,  
view of TP306  
and arisings

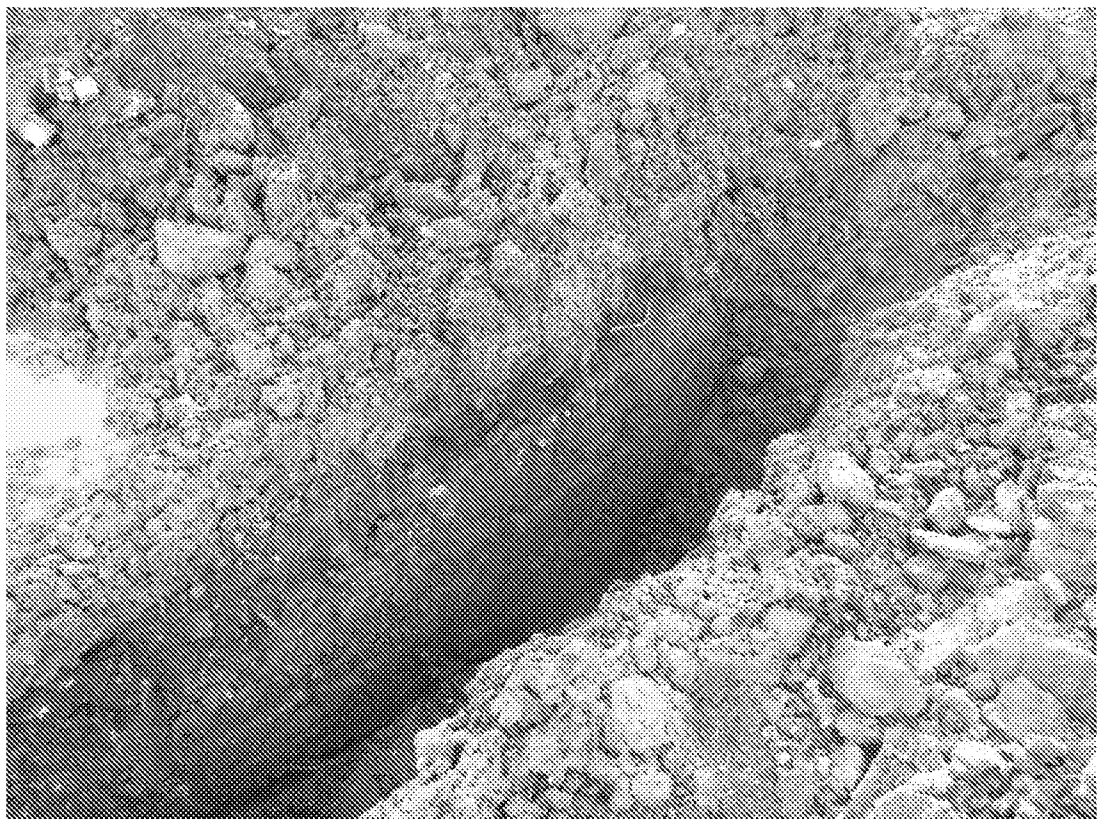
**Photo No.**  
14

View  
southwest of  
south wall of  
TP306,  
showing  
shallow  
thickness of  
made ground

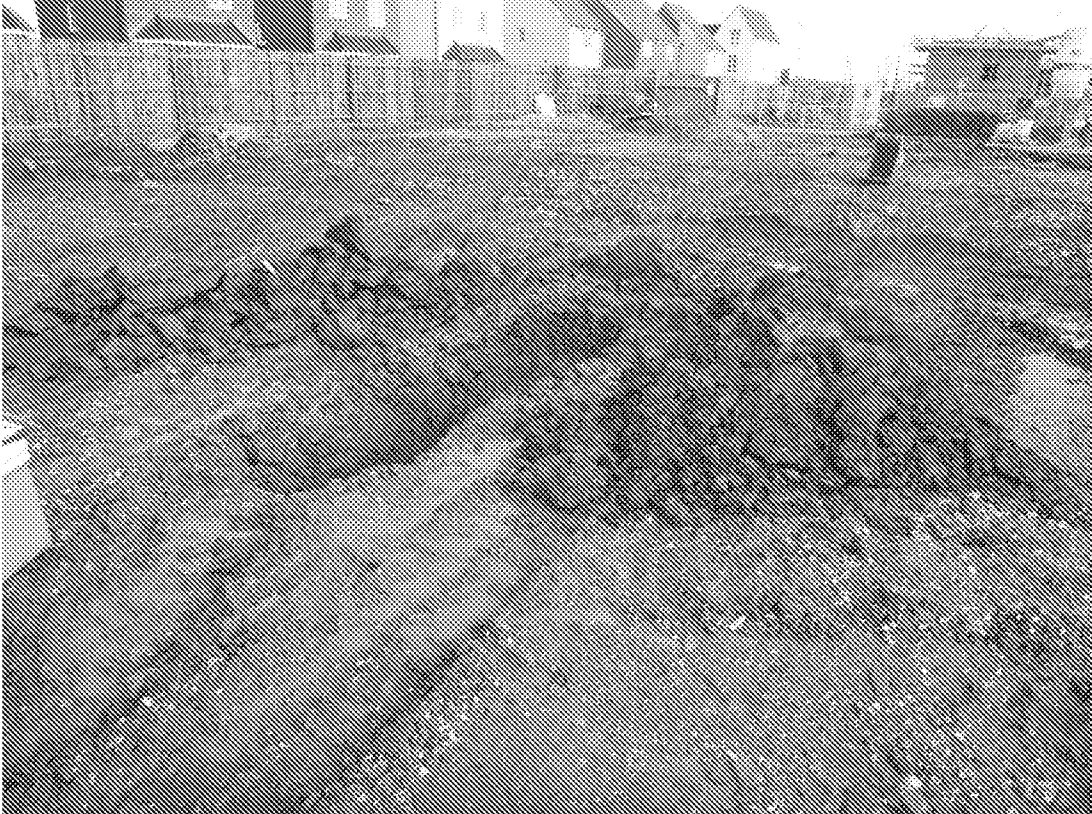
| Photo No.<br>15 | |

| View east of<br>TP307 | |

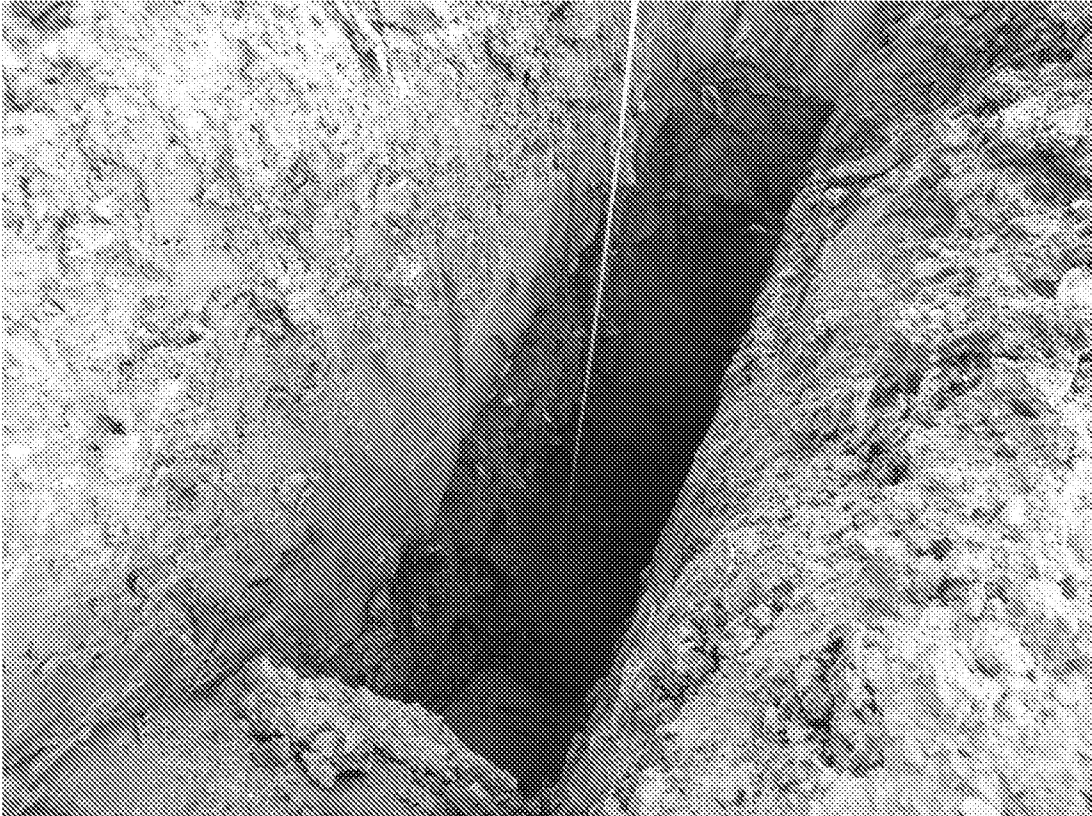
| Photo No.<br>16 | |

| View<br>downhole of<br>TP307 | |

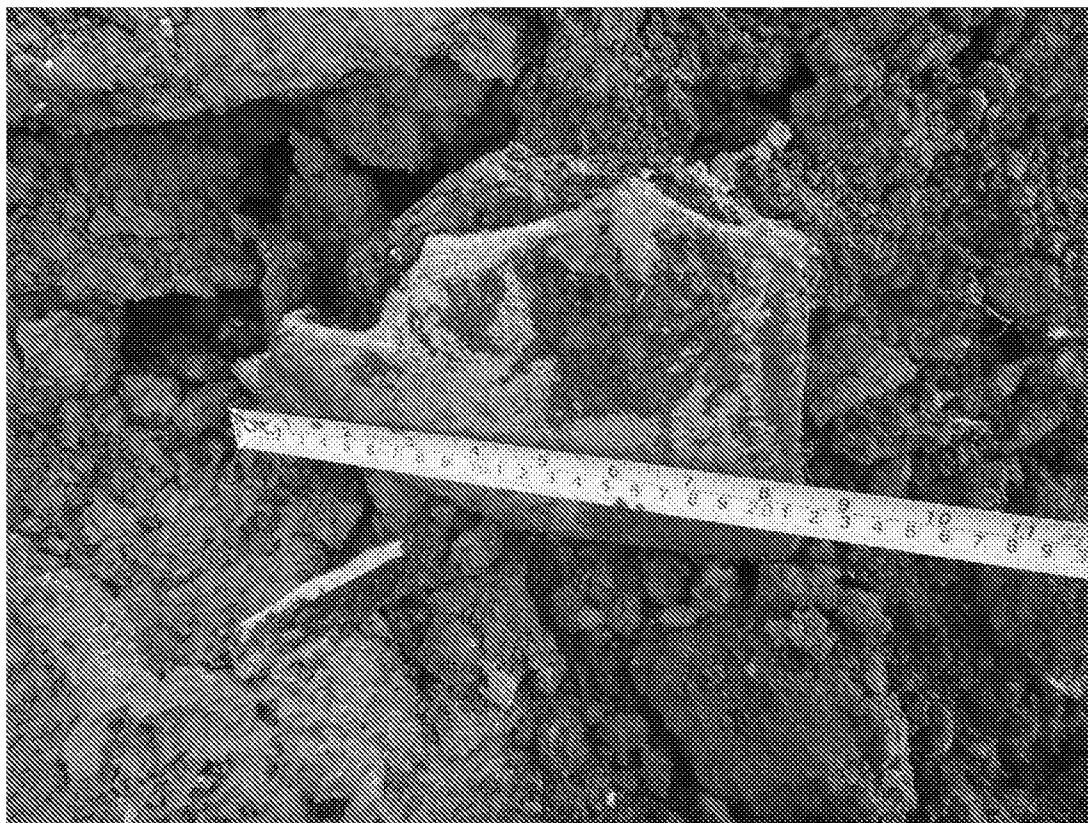
**Photo No.**  
17

Fragments of suspected asbestos cement found in TP307 made ground

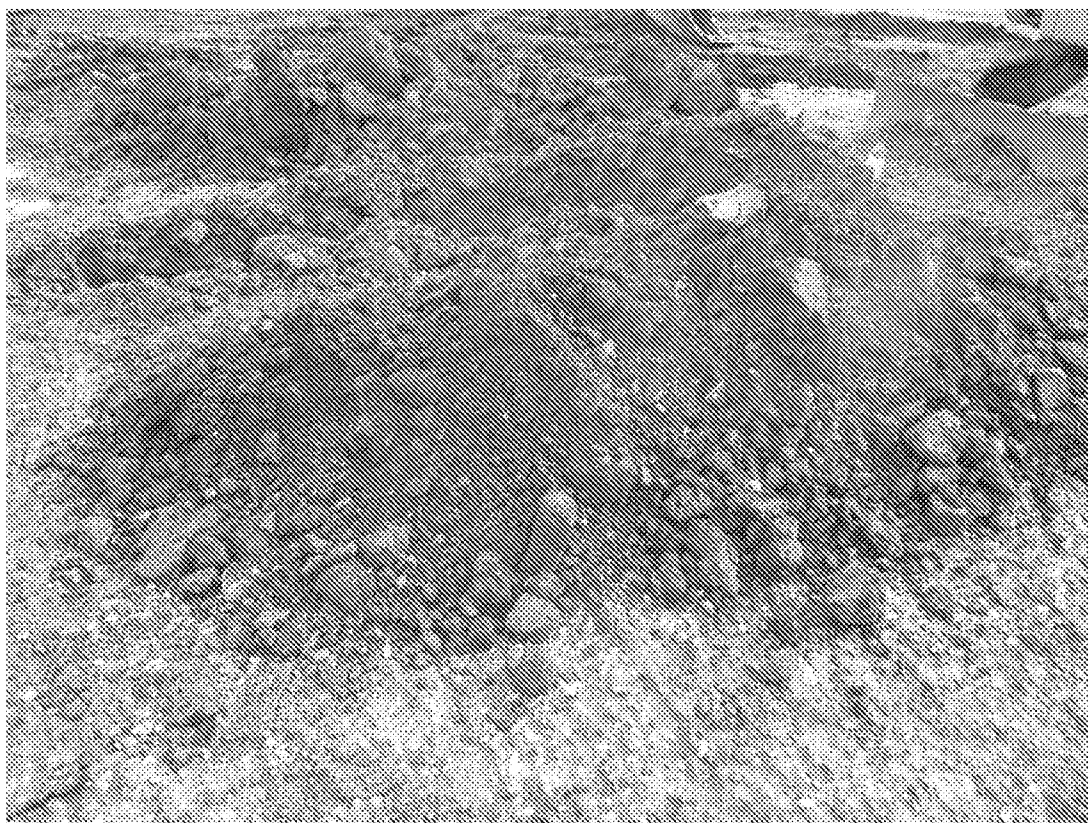
**Photo No.**  
18

Arisings from TP308

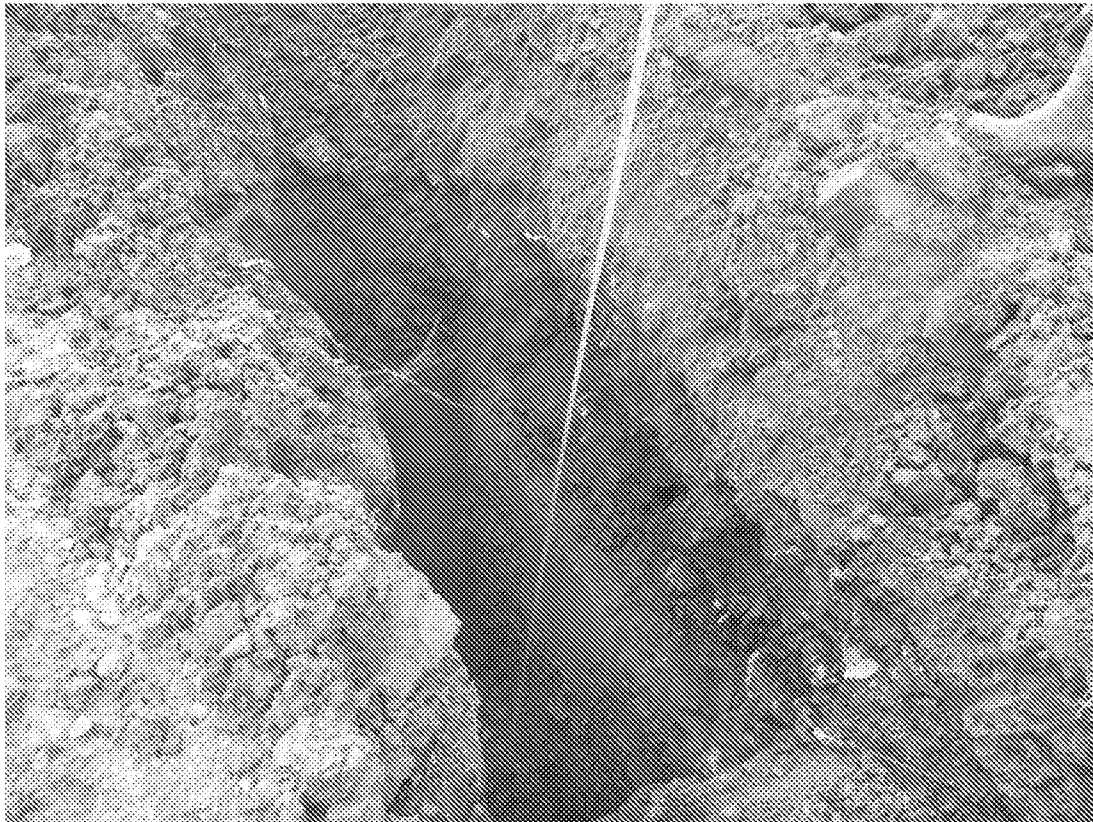
| Photo No.<br>19 | |

| Downhole<br>view of TP308 | |

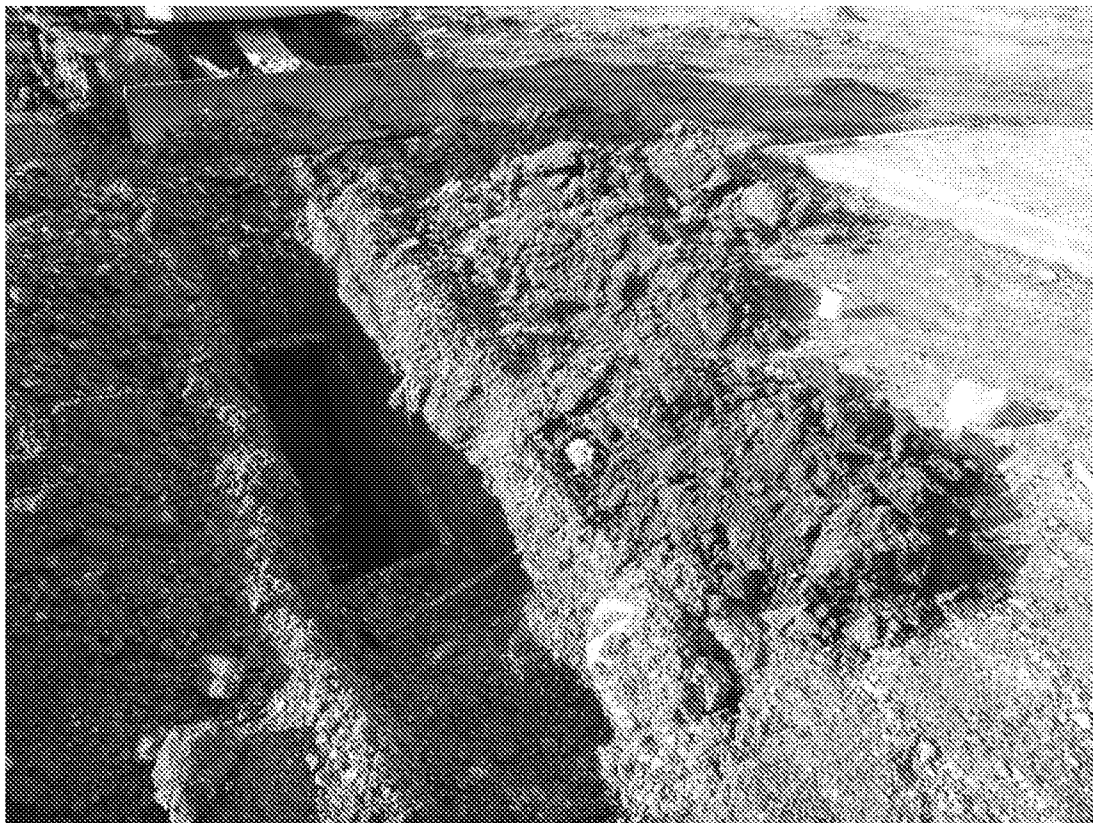
| Photo No.<br>20 | |

| View west of<br>TP309 | |

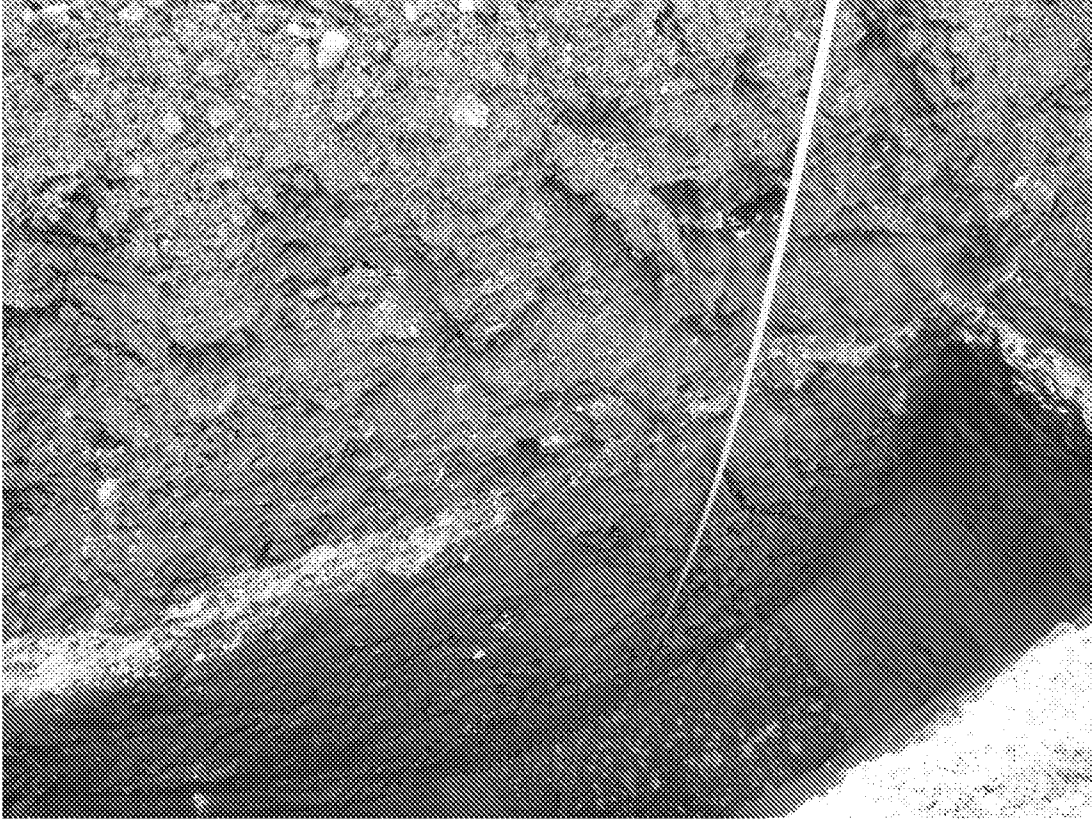
| Photo No.<br>21 | |

| Downhole<br>view of TP309 | |

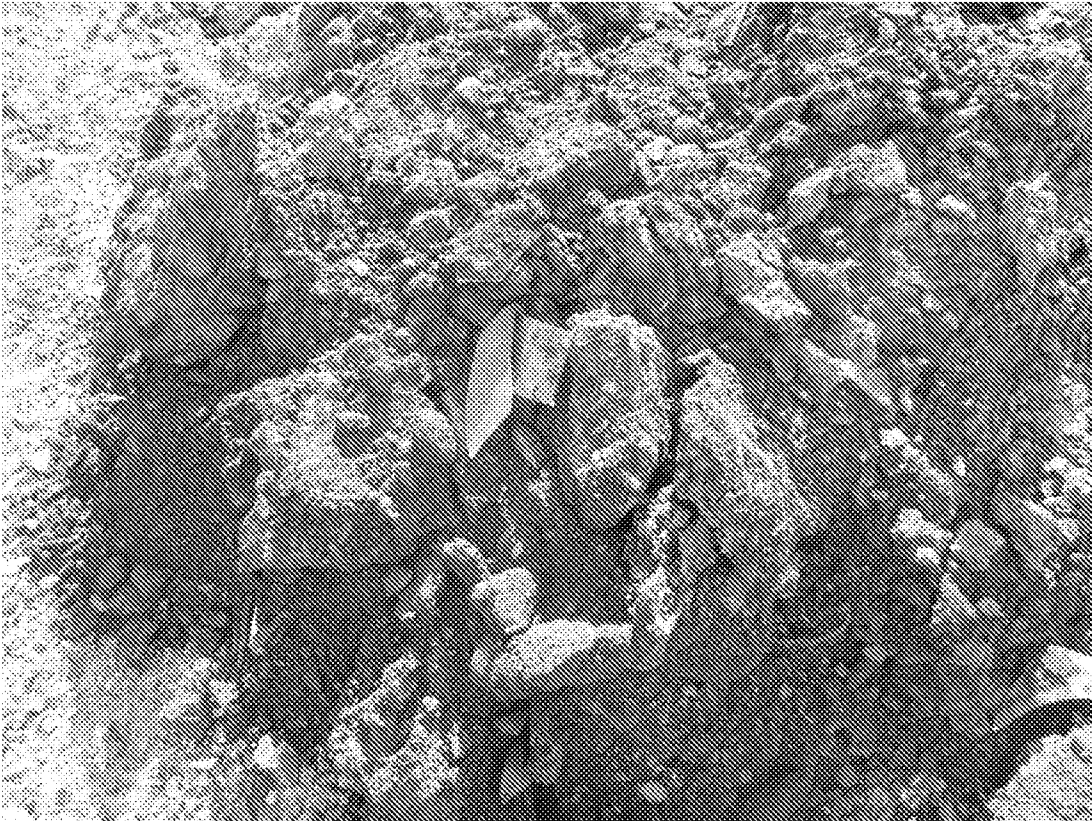
| Photo No.<br>22 | |

| Made ground<br>arisings from<br>TP309 | |

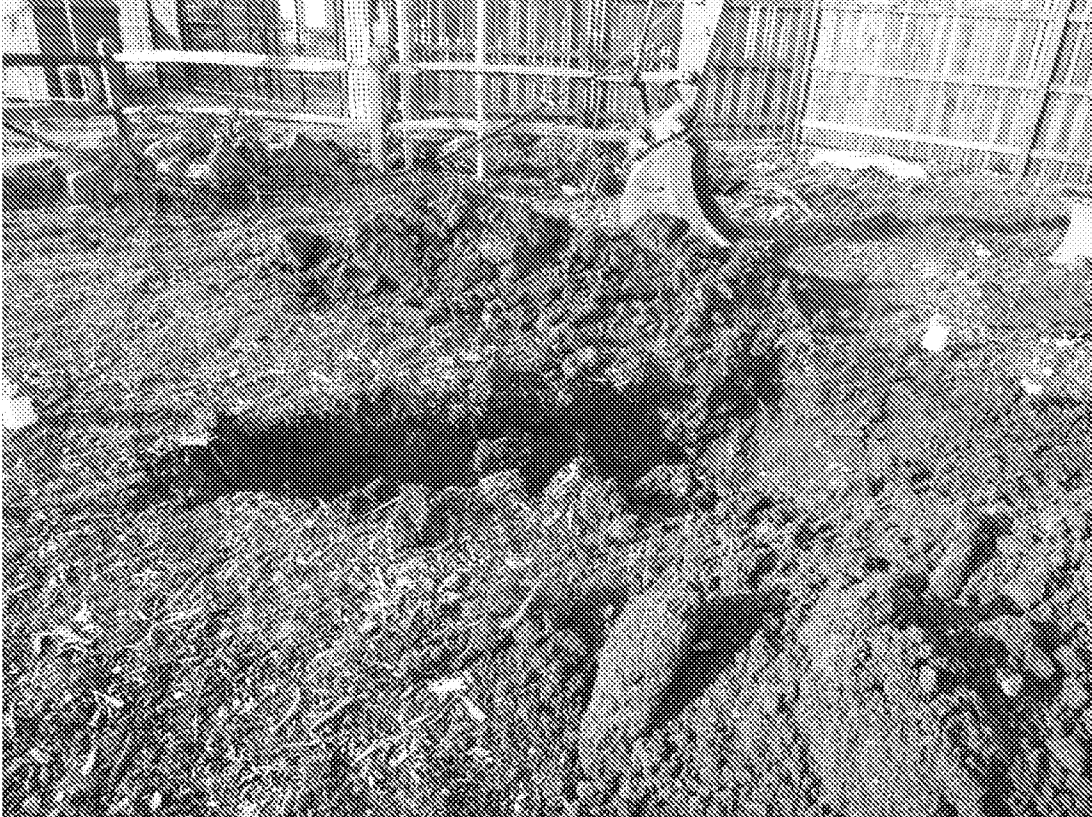
| Photo No.<br>23 | |

| View<br>northwest of<br>TP310 | |

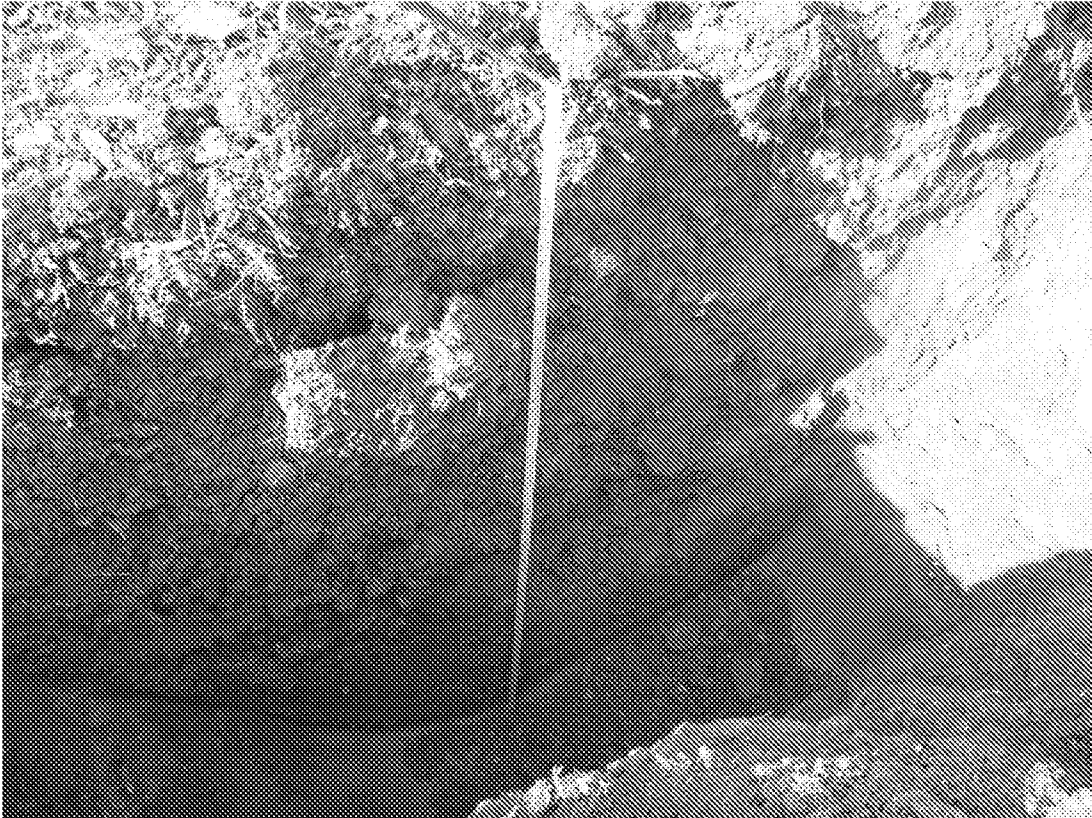
| Photo No.<br>24 | |

| Downhole<br>view of TP310 | |

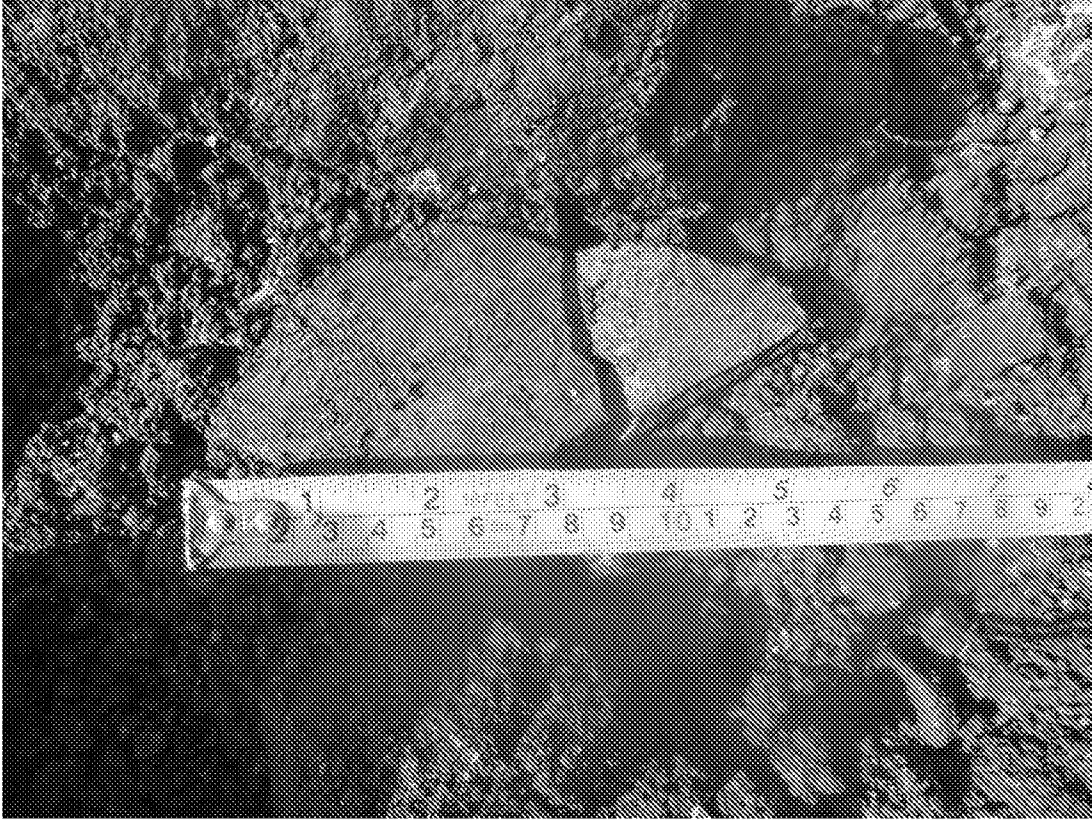
| PHOTOGRAPHIC LOG | |
|---|---|
| <b>Photo No.</b><br>25 | |

| PHOTOGRAPHIC LOG | |
|---|---|
| Suspected asbestos cement fragment found within TP310 | |
