**LAND AT WEST END NURSERY, ANGMERING**

**LOCATIONS WHERE SUSPECTED ASBESTOS CONTAINING MATERIALS (ACM) ENCOUNTERED IN PHASE 3**

## **PHOTOGRAPHIC LOG**

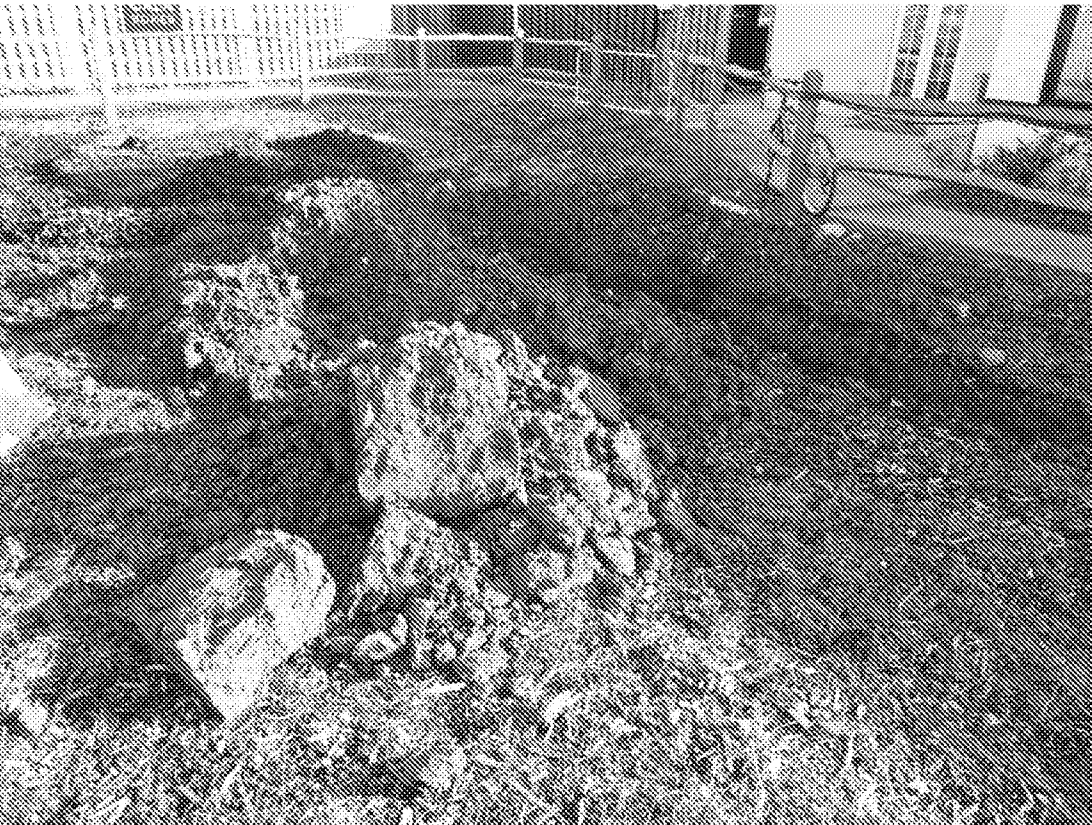
| PHOTOGRAPHIC LOG | |
|---|---|
| <b>Photo No.</b><br>26 | |

| PHOTOGRAPHIC LOG | |
|---|---|
| Southeast view of TP311 | |
