| PHOTOGRAPHIC LOG | |
| Site Location: Land at West End Nursery, Angmering | |

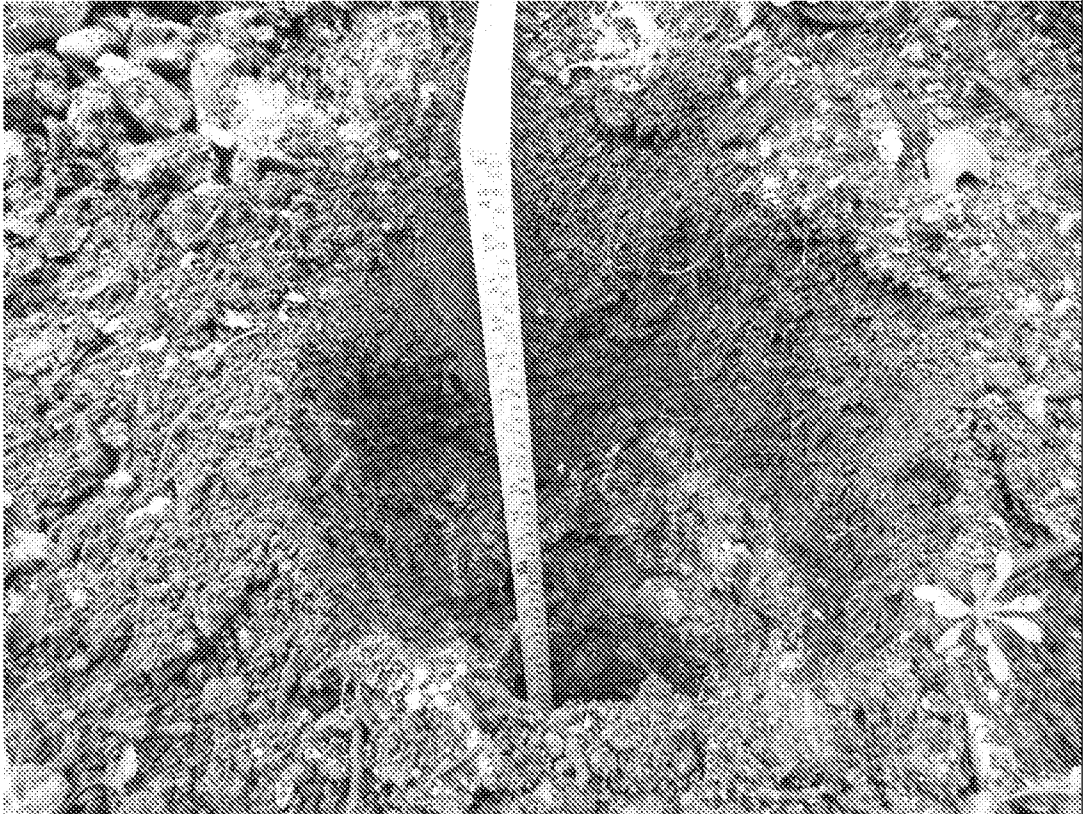
| PHOTOGRAPHIC LOG | |
|---|---|
| <b>Photo No.</b><br>39 | |

| PHOTOGRAPHIC LOG | |
|---|---|
| South West Bund A validation pit 1 overview. Capping layer thickness observed to be 600 mm thick. | |

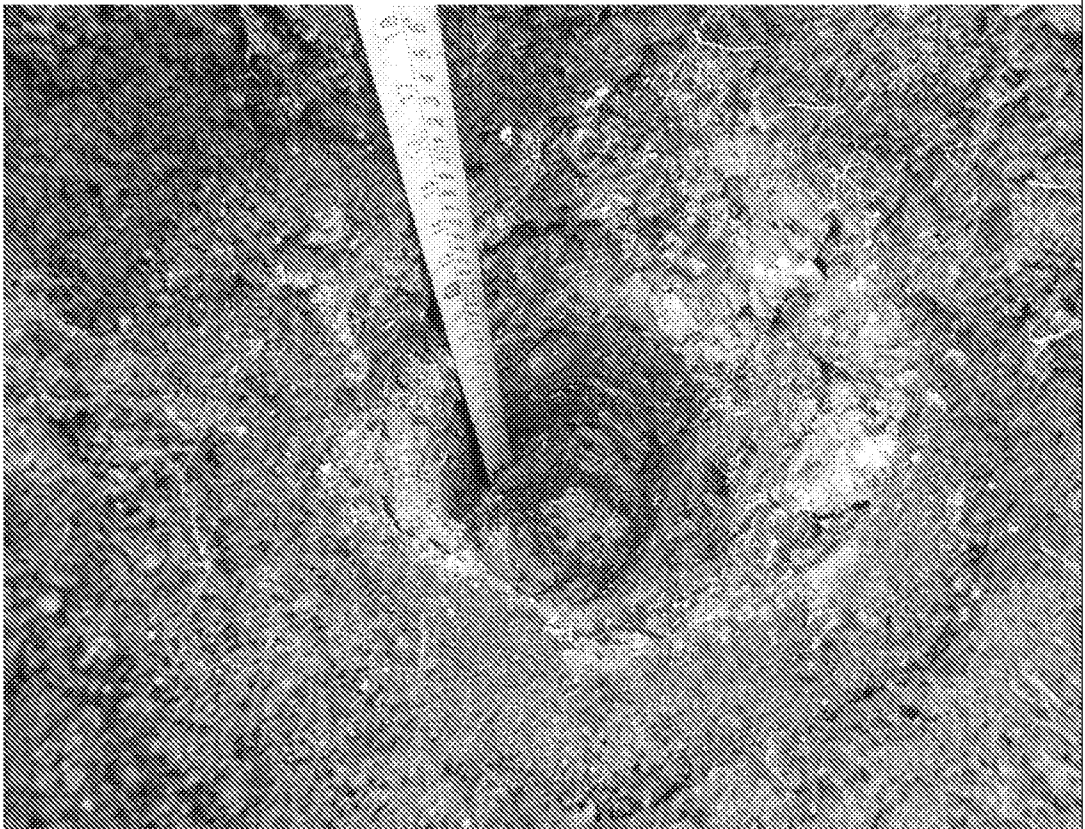
| PHOTOGRAPHIC LOG | |
|---|---|
| <b>Photo No.</b><br>40 | |

| PHOTOGRAPHIC LOG | |
|---|---|
| South West Bund A validation pit 2, detailed view showing orange marker membrane at the base. | |

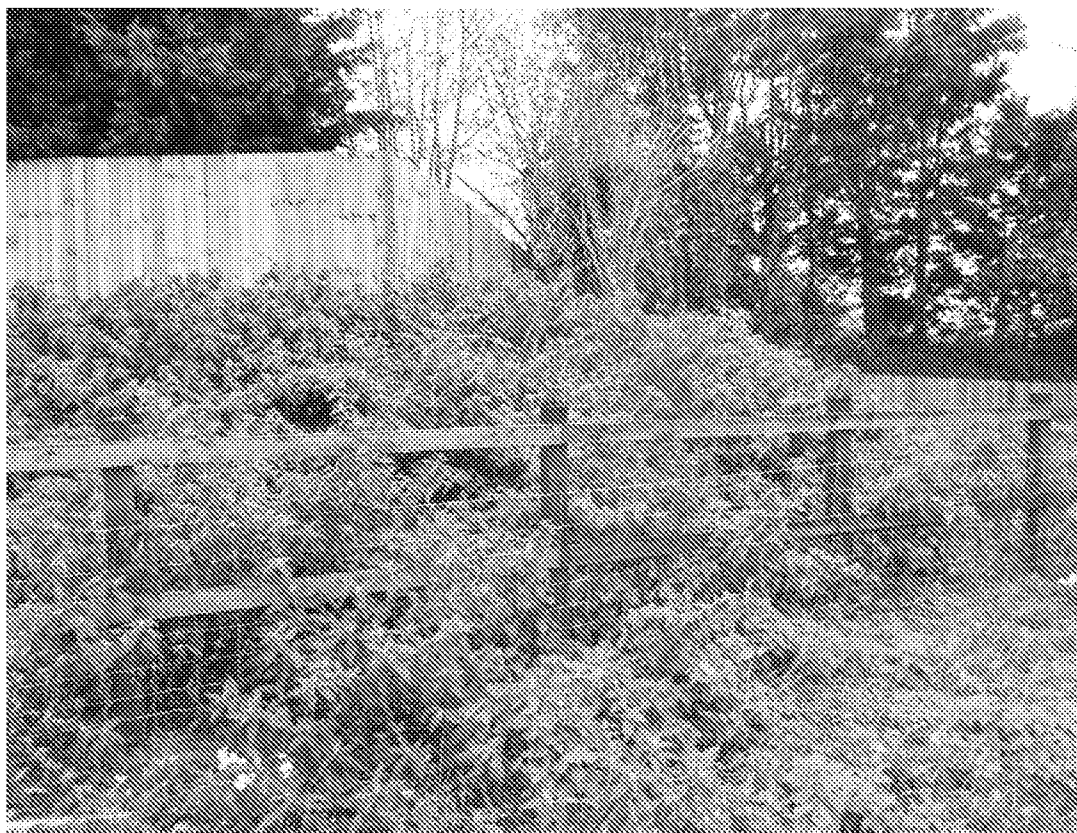
Photo No.  
41

View of west side of south west bund B. Bund observed to be fenced off and planted with prickly vegetation.

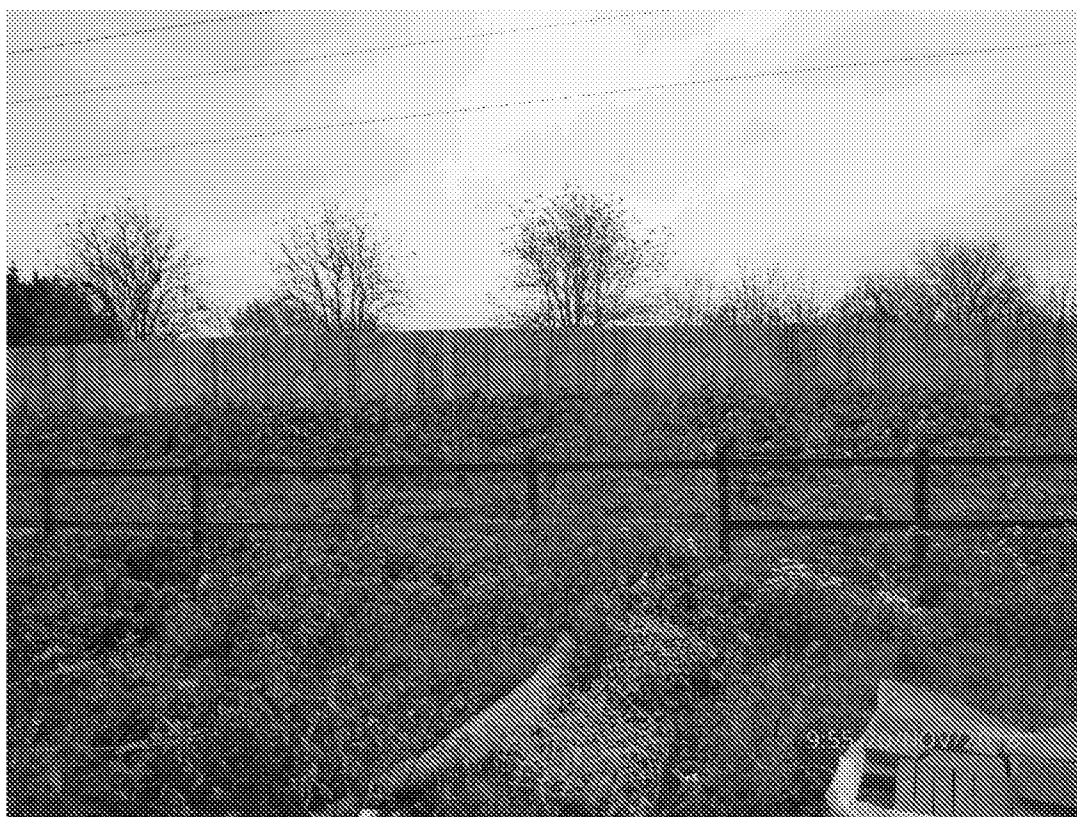
Photo No.  
42

View of centre of south west bund B. Bund observed to be fenced off and planted with prickly vegetation.

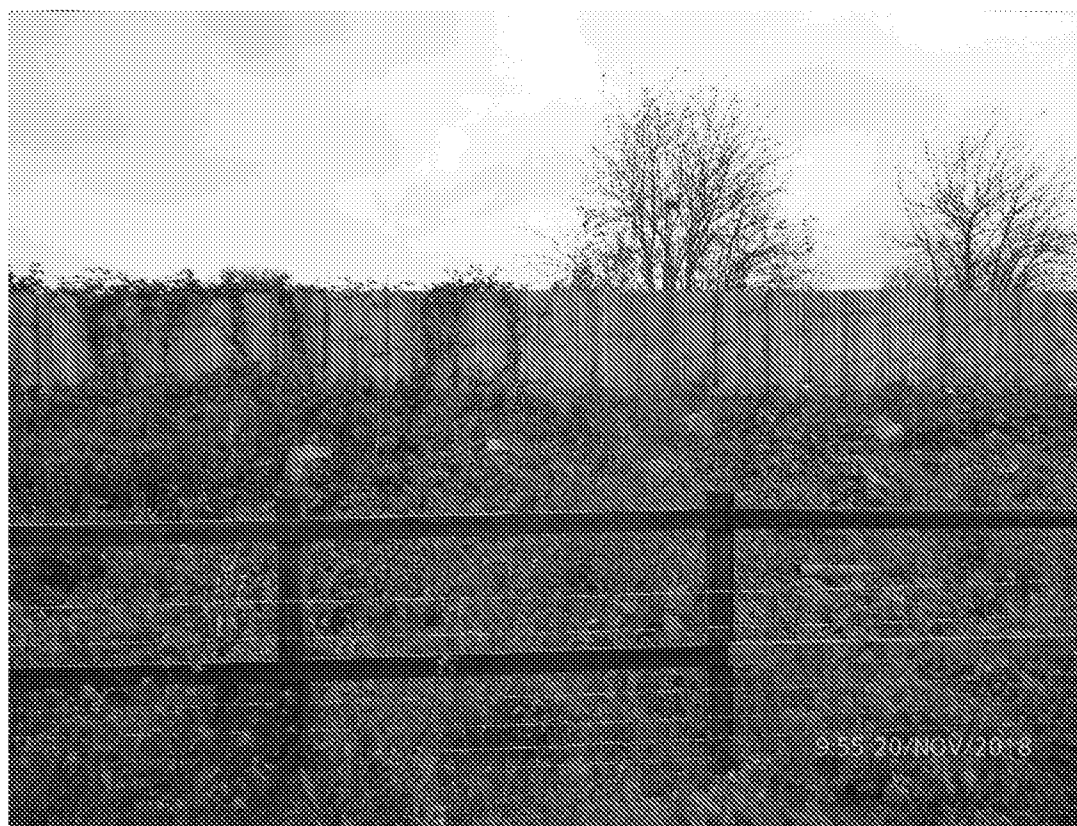
Photo No.  
43

View of centre of south west bund B. Bund observed to be fenced off and planted with prickly vegetation.

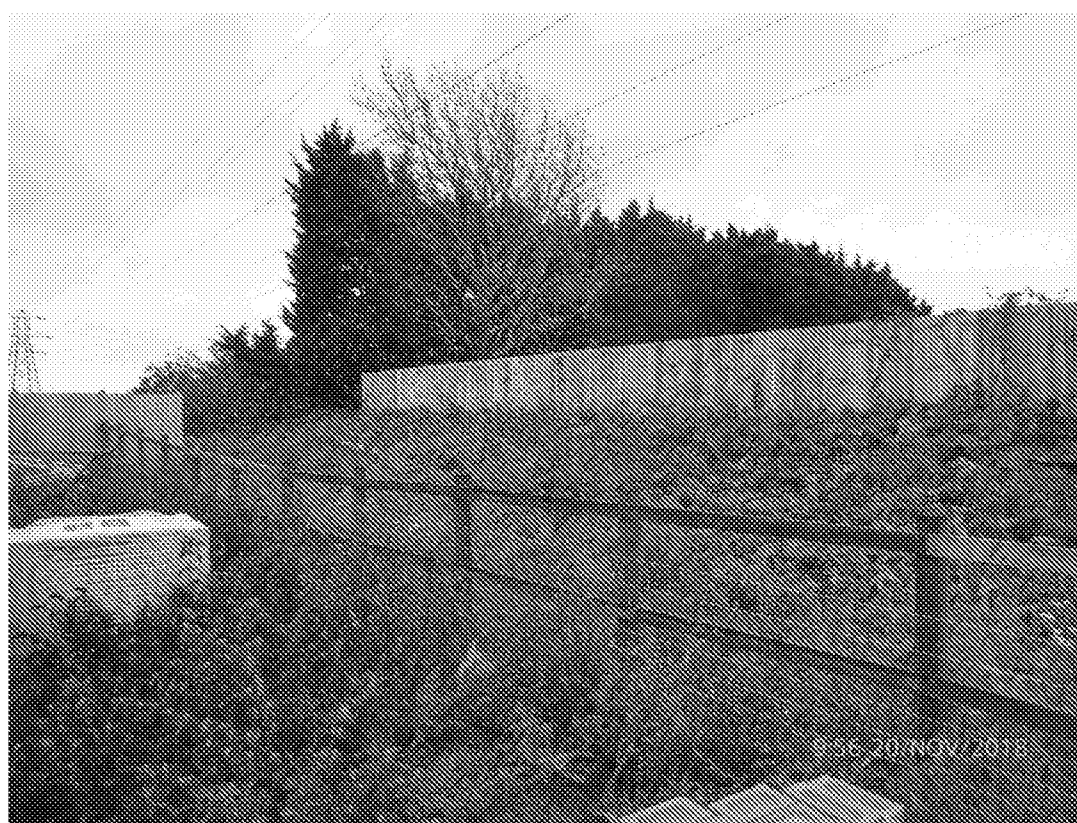
Photo No.  
44

View of east side of south west bund B. Bund observed to be fenced off and planted with prickly vegetation.

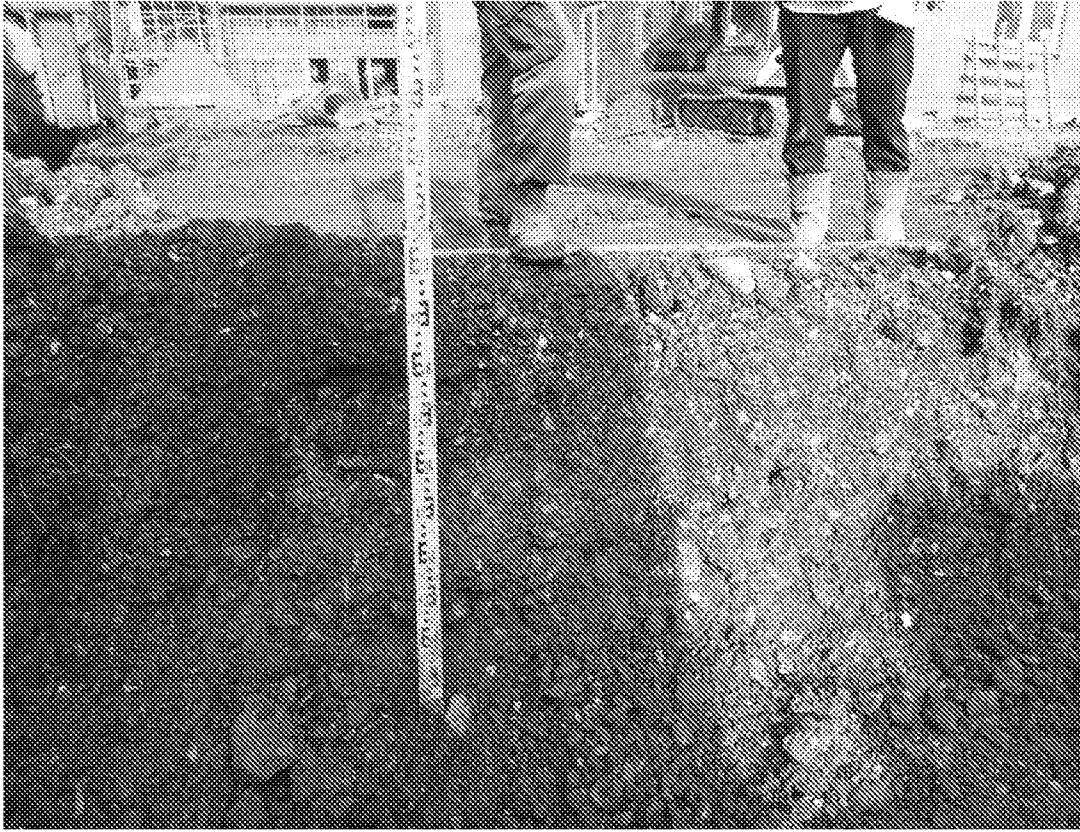
| PHOTOGRAPHIC LOG | |
|---|---|
| <b>Photo No.</b><br>45 | |

| PHOTOGRAPHIC LOG | |
|---|---|
| <p>Northern wall of validation trial pit at V2 (location of localised oil seepage observed during 2016 validation works) base sample 1 collected from the at 1.10 mbgl (approximately in the original location of V2). No visual or olfactory signs of hydrocarbon contamination observed.</p> | |

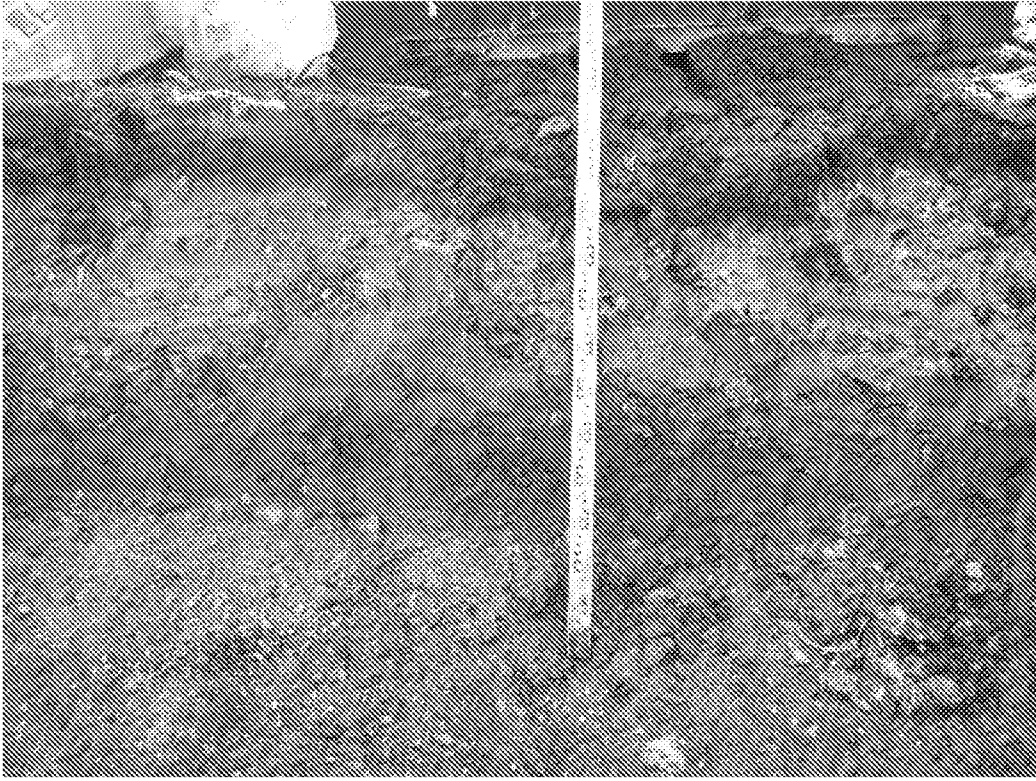
| PHOTOGRAPHIC LOG | |
|---|---|
| <b>Photo No.</b><br>46 | |

| PHOTOGRAPHIC LOG | |
|---|---|
| <p>Western wall of validation trial pit V2. Two validation samples collected at 0.7 m and 1.0 m. No visual or olfactory signs of hydrocarbon contamination observed.</p> | |

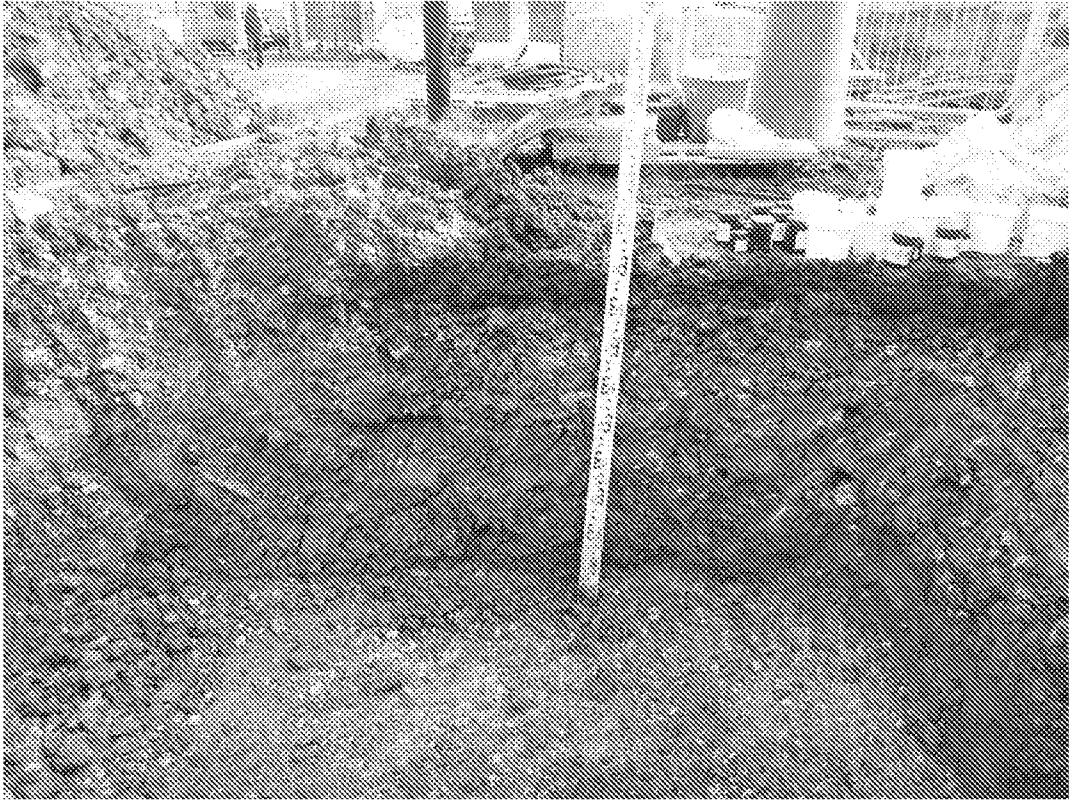
| PHOTOGRAPHIC LOG | |
|---|---|
| <b>Photo No.</b><br>47 | |

| PHOTOGRAPHIC LOG | |
|---|---|
| Eastern wall of validation trial pit V2. Two validation samples collected at 0.6 m and 0.9 mbgl. No visual or olfactory signs of hydrocarbon contamination observed. | |

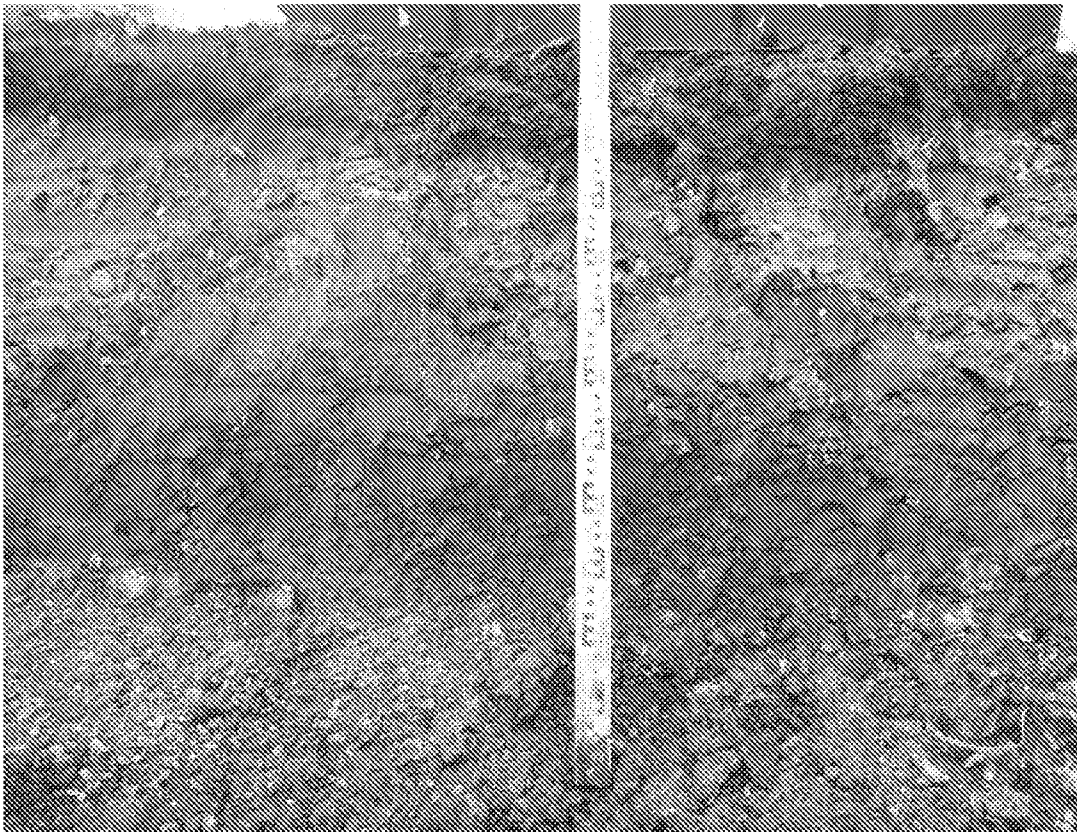
| PHOTOGRAPHIC LOG | |
|---|---|
| <b>Photo No.</b><br>48 | |

| PHOTOGRAPHIC LOG | |
|---|---|
| Southern wall of validation trial pit V2. Two validation samples collected at 0.5 m and 0.8 mbgl. No visual or olfactory signs of hydrocarbon contamination observed. | |

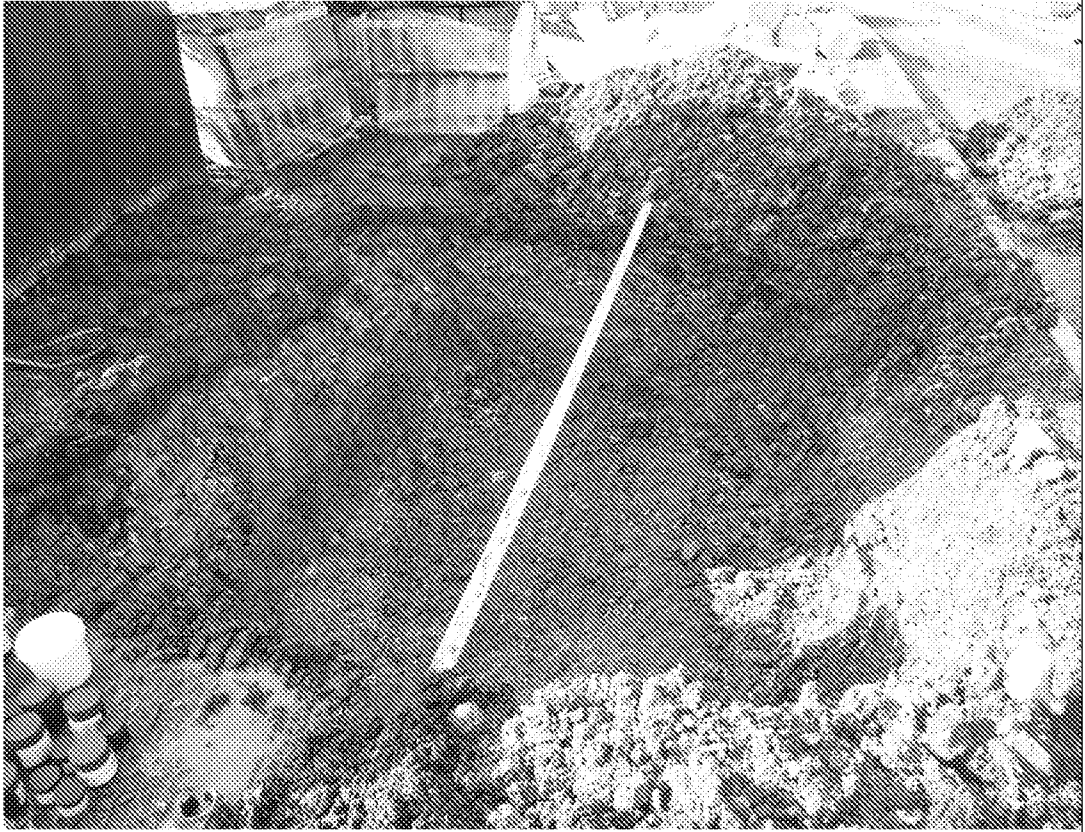
| PHOTOGRAPHIC LOG | |
|---|---|
| <b>Photo No.</b><br>49 | |

| PHOTOGRAPHIC LOG | |
|---|---|
| <p>View of validation trial pit V2 following excavation to 1.1 m bgl, prior to the trial pit being extended further to reach natural strata. No visual or olfactory signs of hydrocarbon contamination observed.</p> | |

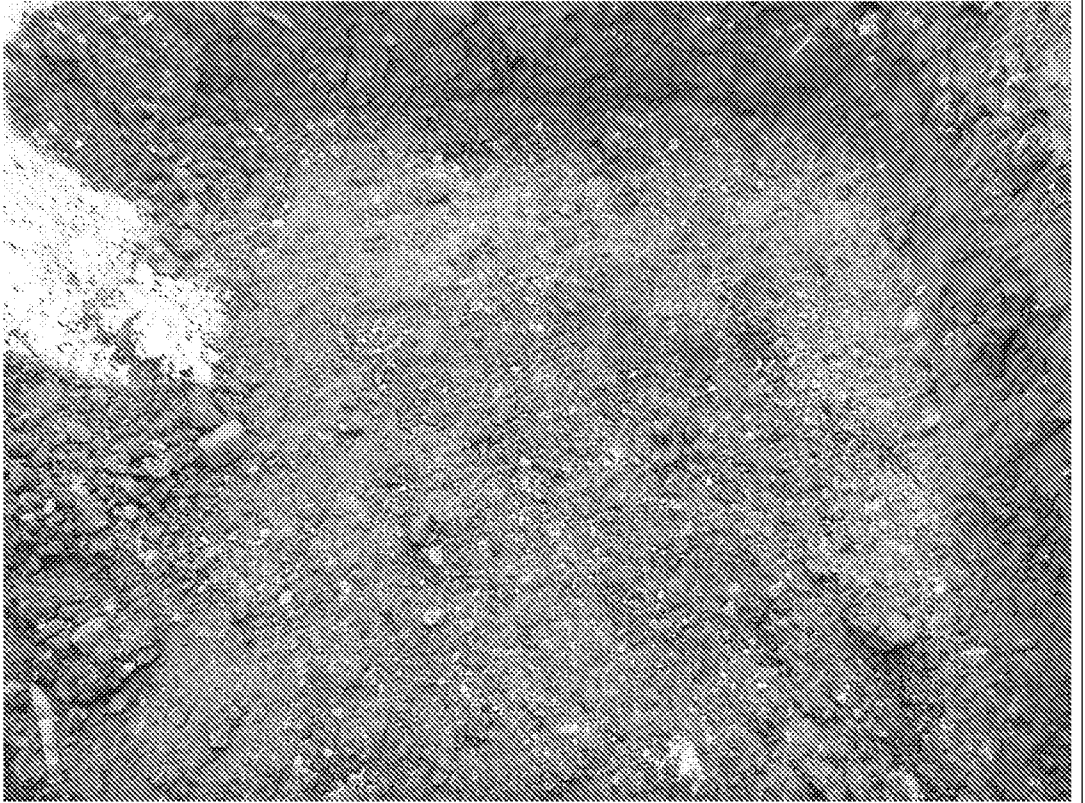
| PHOTOGRAPHIC LOG | |
|---|---|
| <b>Photo No.</b><br>50 | |

| PHOTOGRAPHIC LOG | |
|---|---|
| <p>View of validation trial pit V2 based at 1.1 m bgl, prior to the trial pit being extended further to reach natural strata. No visual or olfactory signs of hydrocarbon contamination observed.</p> | |

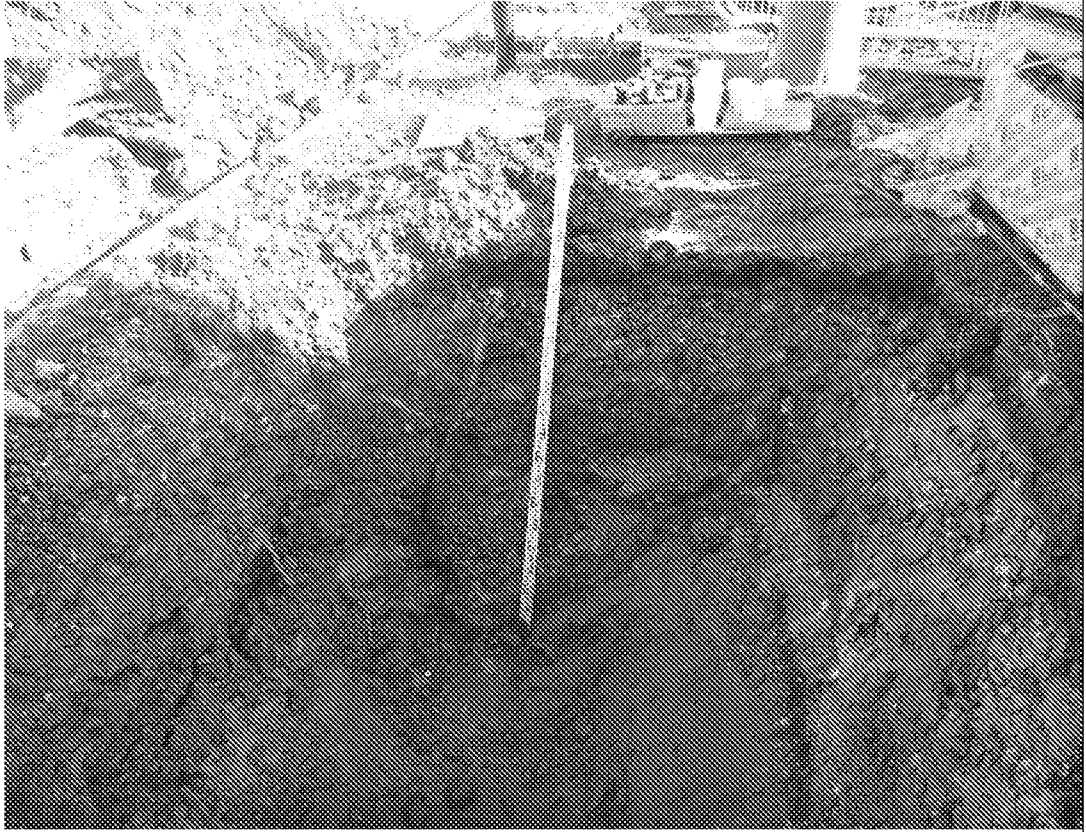
| PHOTOGRAPHIC LOG | |
|---|---|
| <b>Photo No.</b><br>51 | |

| PHOTOGRAPHIC LOG | |
|---|---|
| Eastern wall of validation trial pit V2 following excavation to the final trial pit depth of 2.0 m bgl. No visual or olfactory signs of hydrocarbon contamination observed. | |

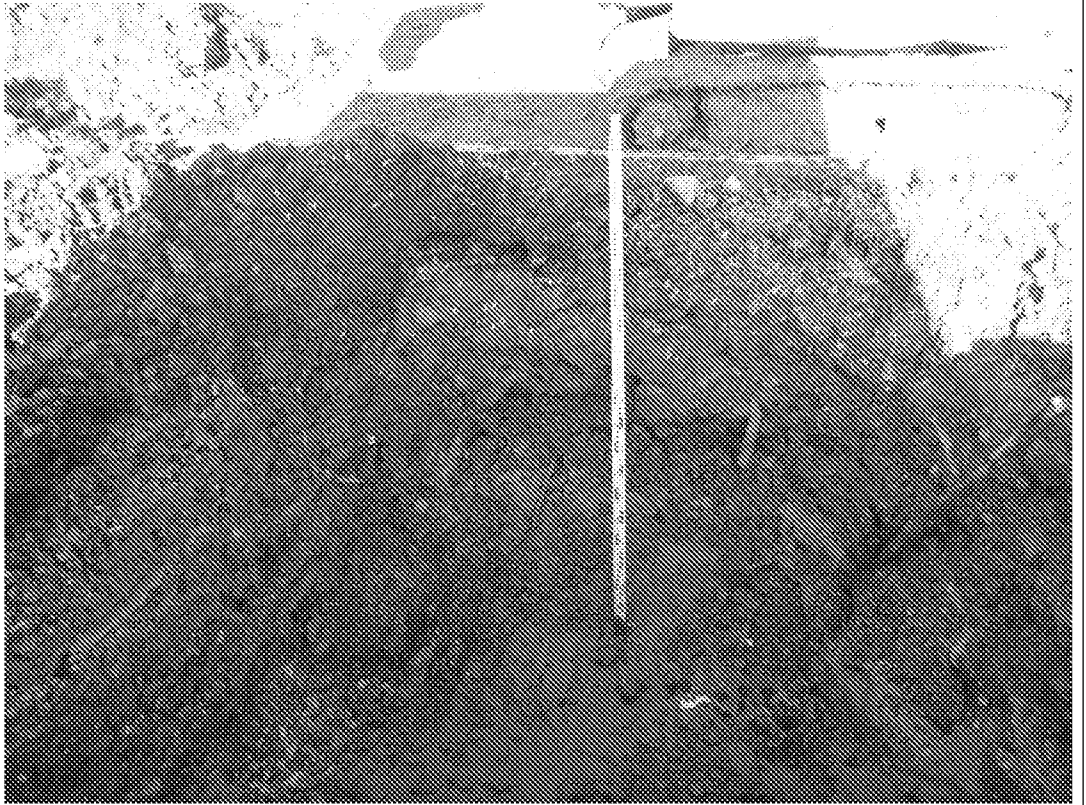
| PHOTOGRAPHIC LOG | |
|---|---|
| <b>Photo No.</b><br>52 | |

| PHOTOGRAPHIC LOG | |
|---|---|
| Northern wall of validation trial pit V2 following excavation to the final trial pit depth of 2.0 m bgl. No visual or olfactory signs of hydrocarbon contamination observed. | |

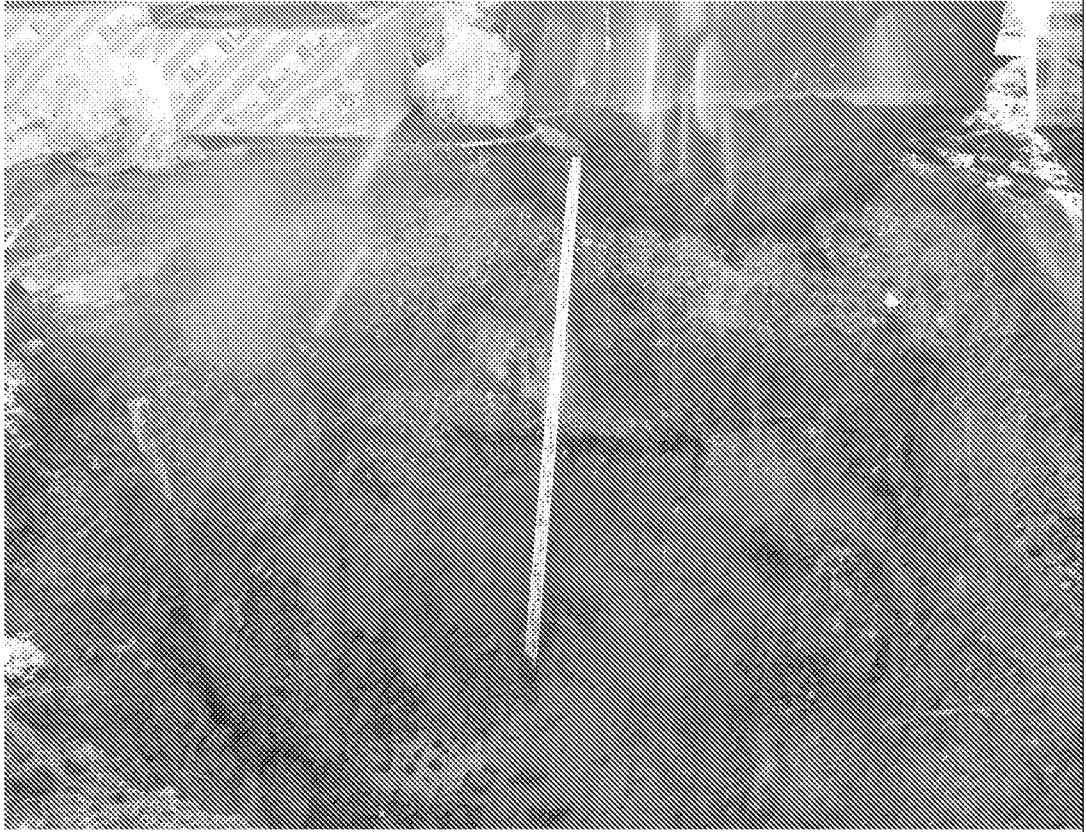
| PHOTOGRAPHIC LOG | |
|---|---|
| <b>Photo No.</b><br>53 | |

| PHOTOGRAPHIC LOG | |
|---|---|
| <p>Southern wall of validation trial pit V2 following excavation to the final trial pit depth of 2.0 m bgl. No visual or olfactory signs of hydrocarbon contamination observed.</p> | |

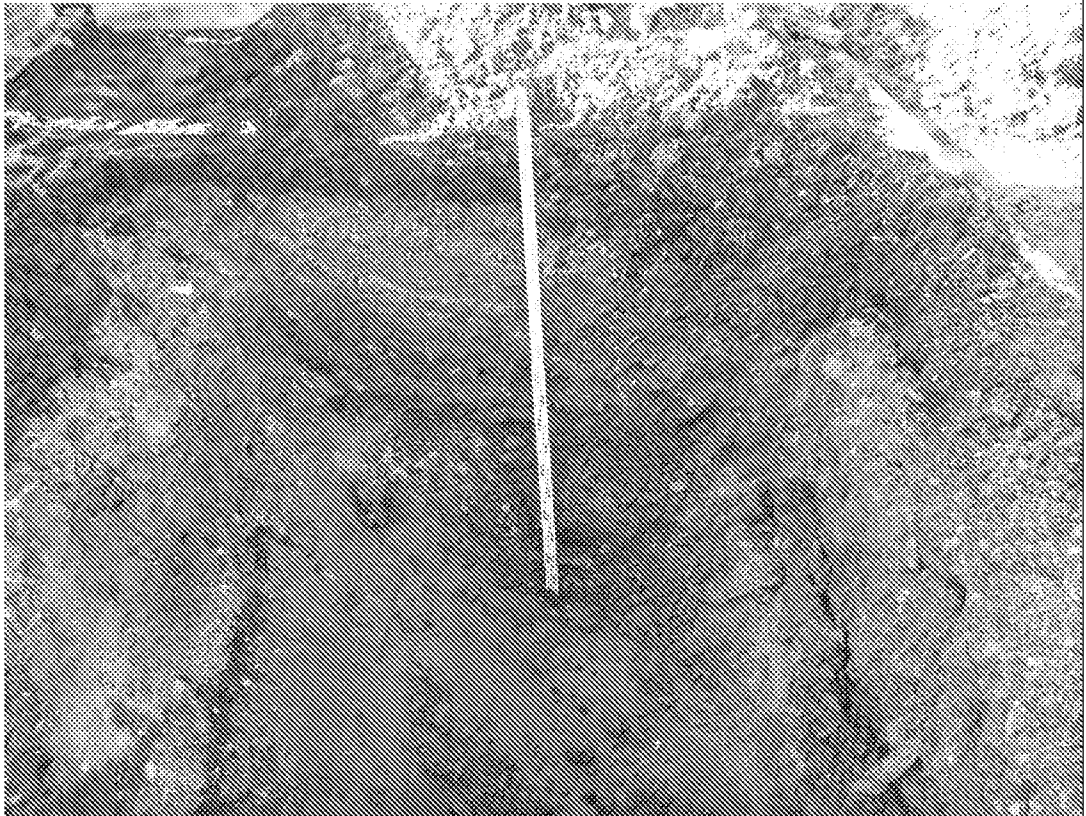
| PHOTOGRAPHIC LOG | |
|---|---|
| <b>Photo No.</b><br>54 | |

| PHOTOGRAPHIC LOG | |
|---|---|
| <p>Western wall of validation trial pit V2 following excavation to the final trial pit depth of 2.0 m bgl. No visual or olfactory signs of hydrocarbon contamination observed.</p> | |

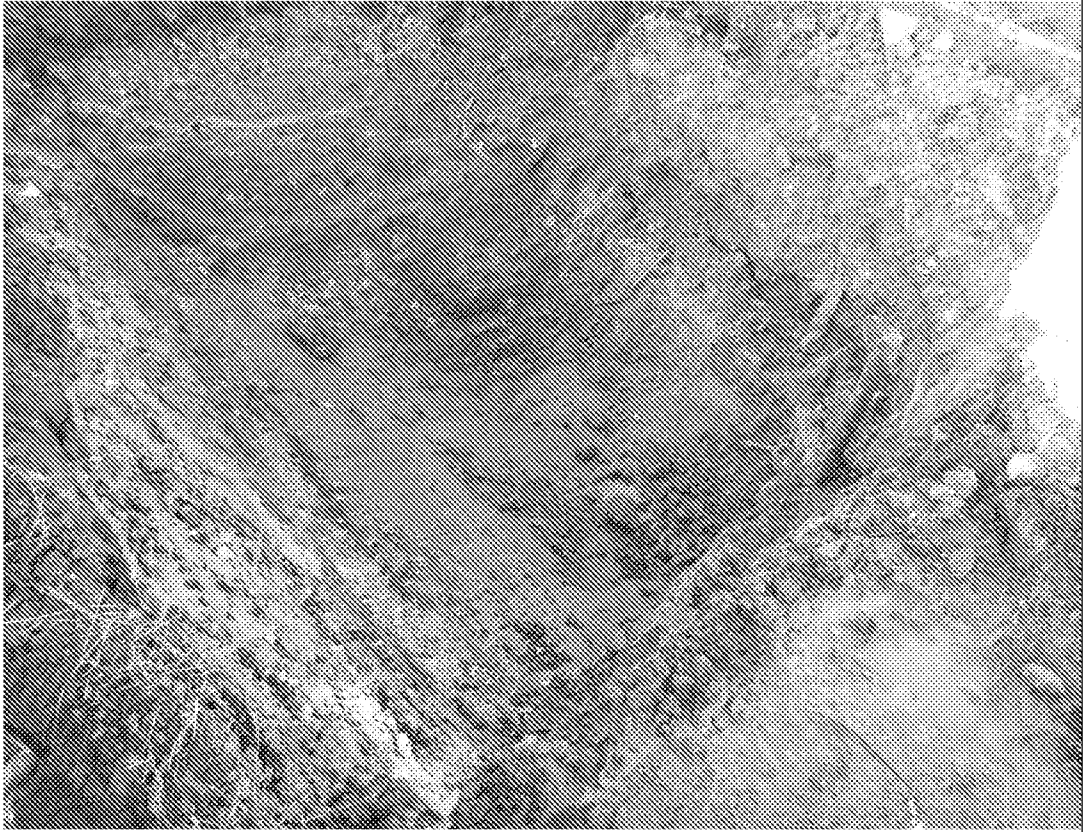
| PHOTOGRAPHIC LOG | |
|---|---|
| Photo No.<br>55 | |

| PHOTOGRAPHIC LOG | |
|---|---|
| View of validation trial pit V2 following excavation to the final trial pit depth of 2.0 m bgl. No visual or olfactory signs of hydrocarbon contamination observed. | |
