## Tree report for 23 Arundel road, Angmering

**Species: - Holm Oak (*Quercus ilex*)**

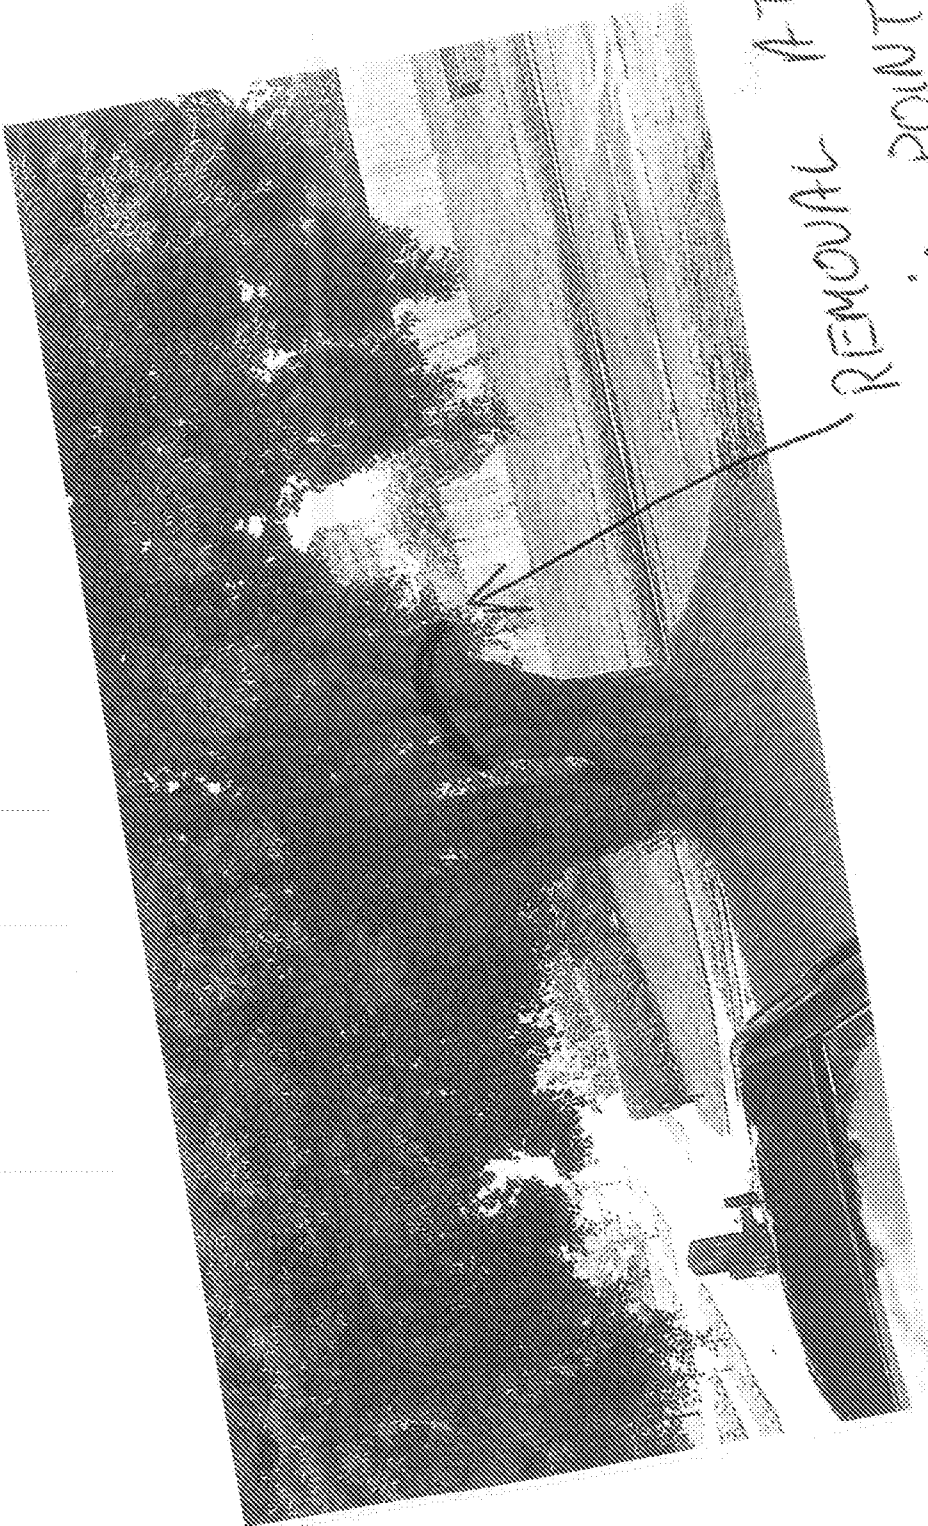
REMOVAL AT  
THIS POINT.

Due to the nature of the south stem fork formation I would recommend that all the branches on this stem are removed back to the old pollard points at 2.5m. The structural nature of this stem make the chance of future failure highly likely, and due to its position the chance of damage to property, vehicles or pedestrians is very high.
