**Project Name:** Rustington Golf Course  
**Project Description:** CCTV Survey, Trace & Plot  
**Project Status:** Complete  
**Project Date:** 03/05/2025  
**Inspection Standard:** MSCC5 Sewers & Drainage GB (SRM5 Scoring)

# **EYES ON DRAINAGE**

## **CCTV-Trace-Plot-Map-Repair**

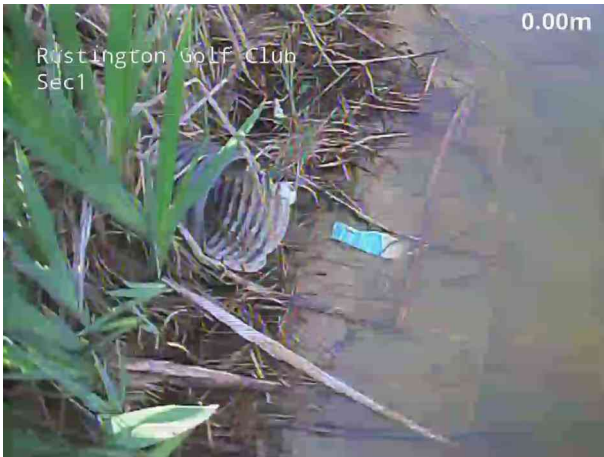
1, 00:00:00, 0.00 m  
Start node, outfall, reference: OF1, Assumed land drain

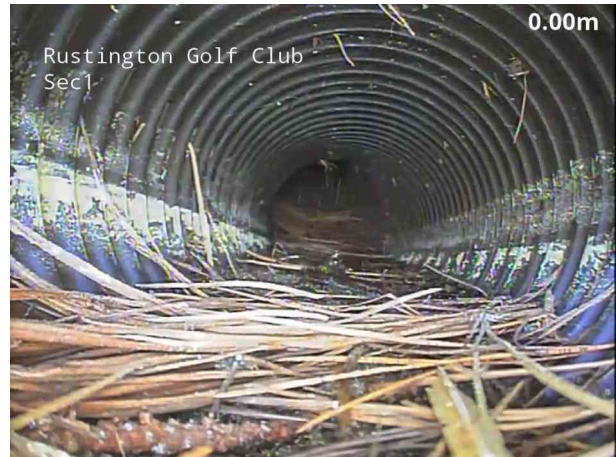
2, 00:00:19, 0.00 m  
Water level, 0% of the vertical dimension

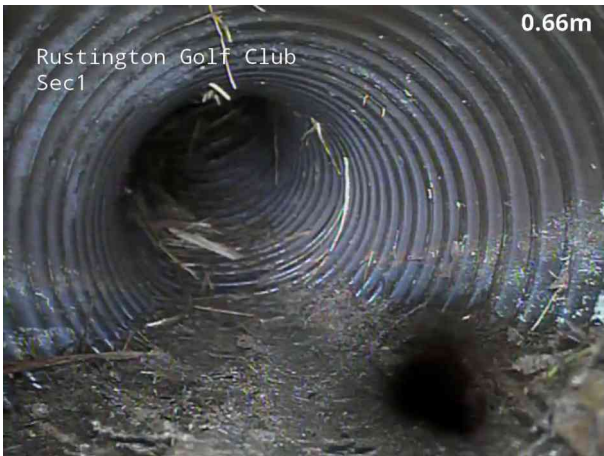
3, 00:00:32, 0.80 m  
Line deviates up

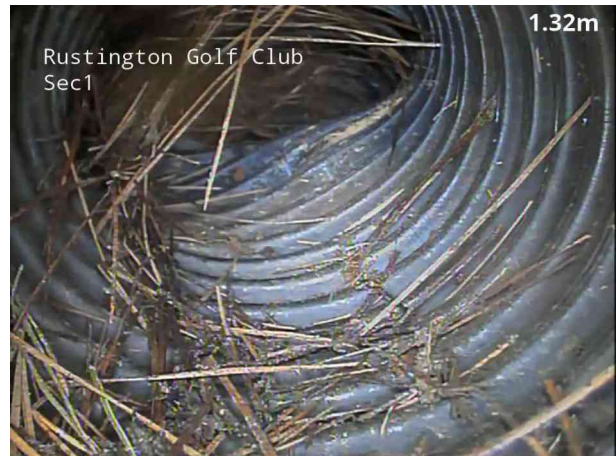
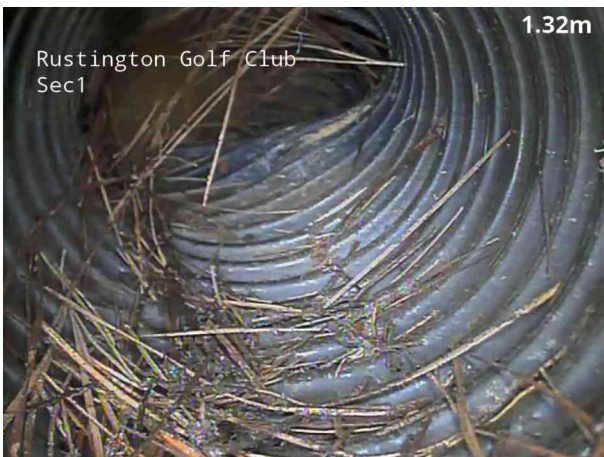
| Section | PLR | Grade | Description |
|---|---|---|---|
| 1 | AX | 5 | Deformed sewer or drain, 50% |

| Section | PLR | Grade | Description |
|---|---|---|---|
| 1 | AX | 4 | Deformed sewer or drain, 50% |

| Scale: | 1:50 | Position [m] | Code | Observation | MPEG | Photo | Grade |
|---|---|---|---|---|---|---|---|
| | 1.40 | D | Deformed sewer or drain, 50% | 00:01:15 | 4, 5 | | 5 / 4 |

4, 00:01:15, 1.40 m  
Deformed sewer or drain, 50%

5, 00:01:15, 1.40 m  
Deformed sewer or drain, 50%

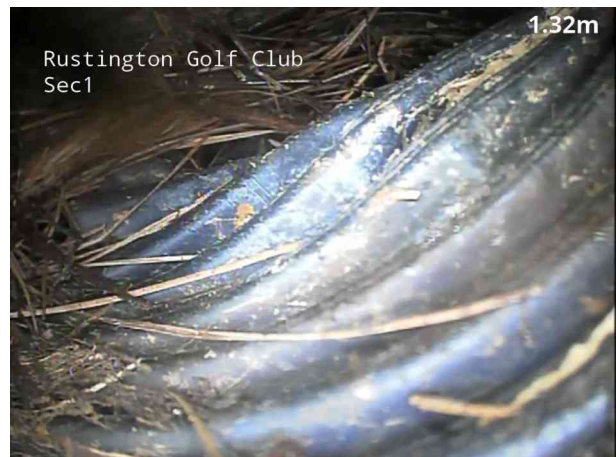
6, 00:01:18, 1.40 m  
Survey abandoned, Unable to pass

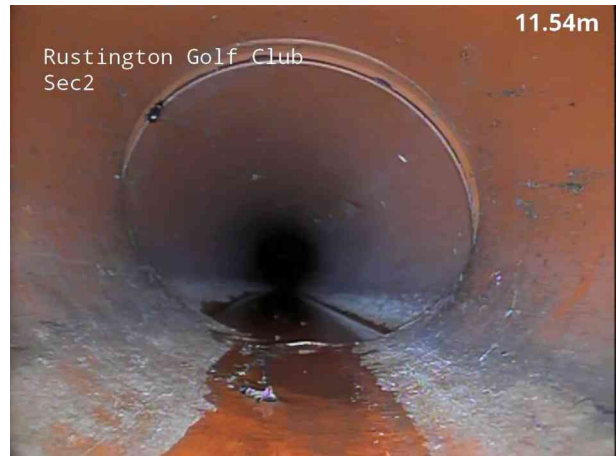
| Section | PLR | Grade | Description |
|---|---|---|---|
| 2 | SW1X | 3 | Joint displaced, medium |

| Scale: | 1:131 | Position [m] | Code | Observation | MPEG | Photo | Grade |
|---|---|---|---|---|---|---|---|
| | | 11.70 | JDM | Joint displaced, medium | 00:00:44 | 4 | 1 / 3 |

4, 00:00:44, 11.70 m  
Joint displaced, medium

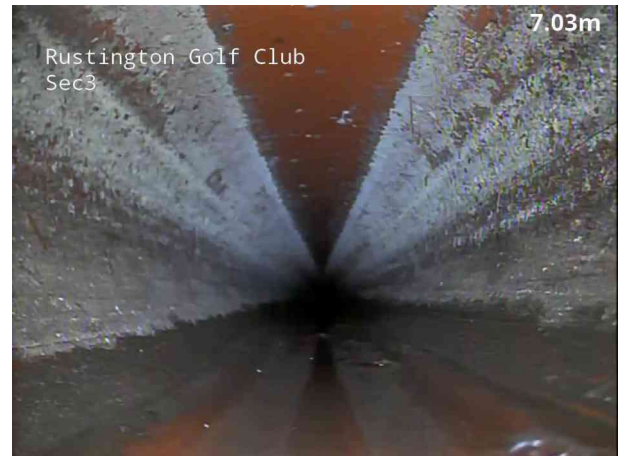
4, 00:00:32, 7.00 m  
Water level, 5% of the vertical dimension

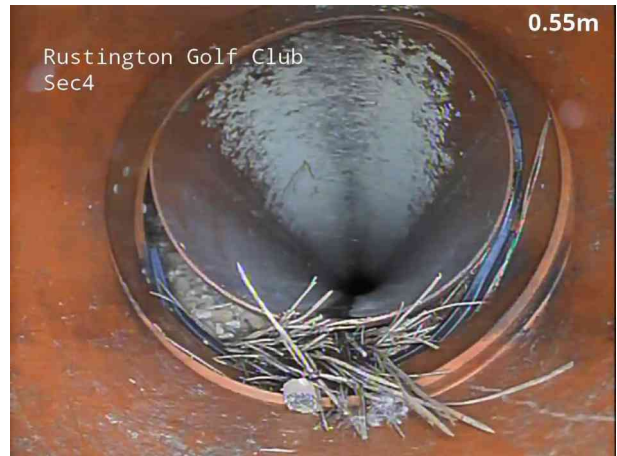
| Section | PLR | Grade | Description |
|---|---|---|---|
| 4 | SW3X | 4 | Joint displaced, large |

| Scale: | 1:138 | Position [m] | Code | Observation | MPEG | Photo | Grade |
|---|---|---|---|---|---|---|---|
| | | 0.70 | JDL | Joint displaced, large | 00:00:18 | 4 | 1 / 4 |

4, 00:00:18, 0.70 m  
Joint displaced, large

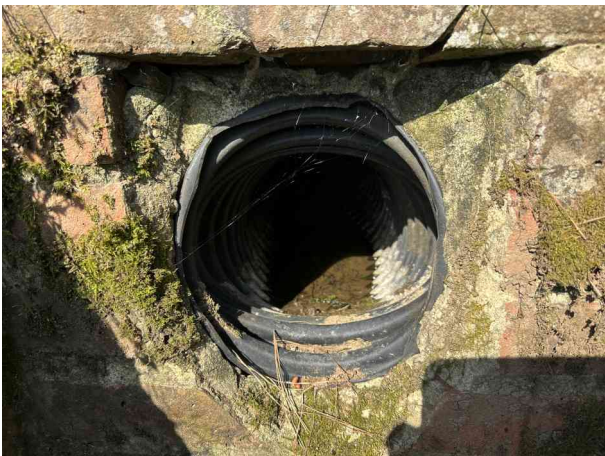
3, 0.00 m  
Survey abandoned, Unable to survey due to corrugated design
