## **Drainage Verification Report (Phase 1)**

**Merry England, Dappers Lane, Angmering**

Reference **C1249**

Date **12th August 2021**

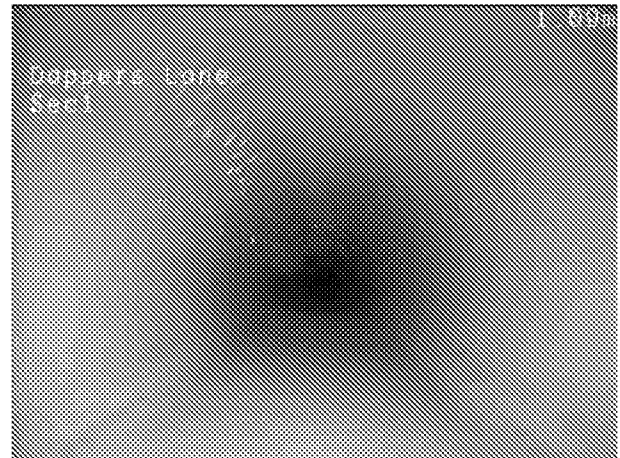
2, 00:00:11, 1.00 m  
Water level, 5% of the vertical dimension

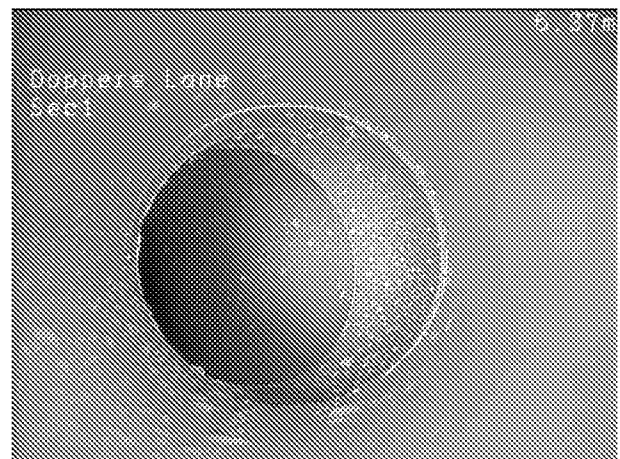
4, 00:00:37, 6.50 m  
Line deviates left

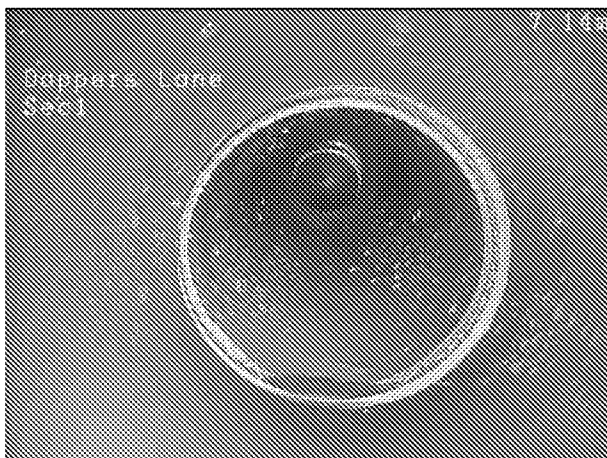
5, 00:00:42, 7.20 m  
Line deviates up

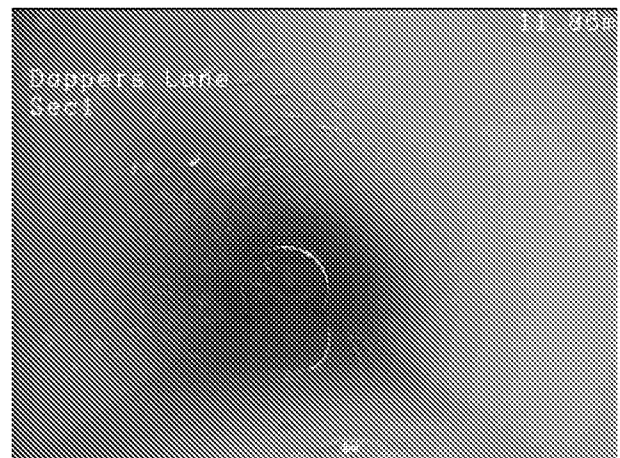
6, 00:00:58, 11.90 m  
Water level, 10% of the vertical dimension

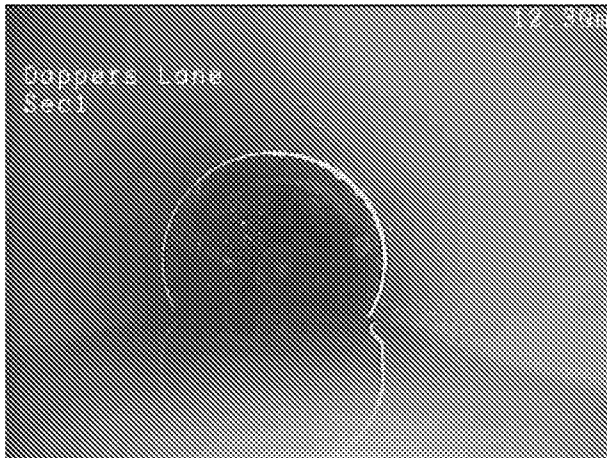
7, 00:01:10, 12.30 m  
Water level, 20% of the vertical dimension

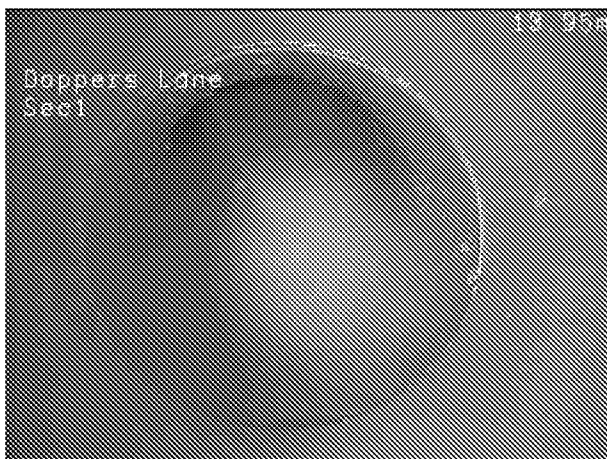
9, 00:01:30, 14.10 m  
Line deviates up

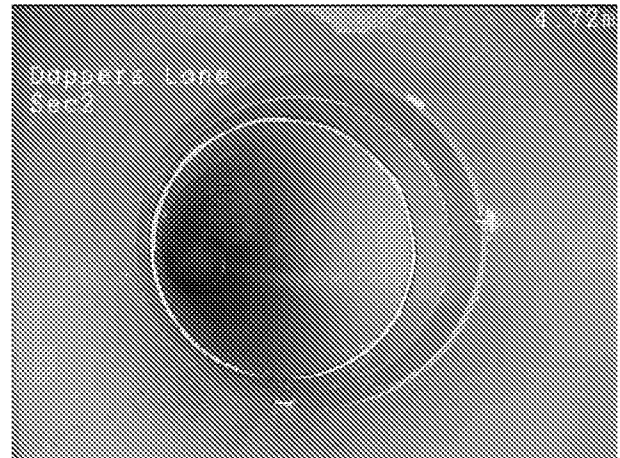
2, 00:00:25, 4.80 m  
Line deviates left

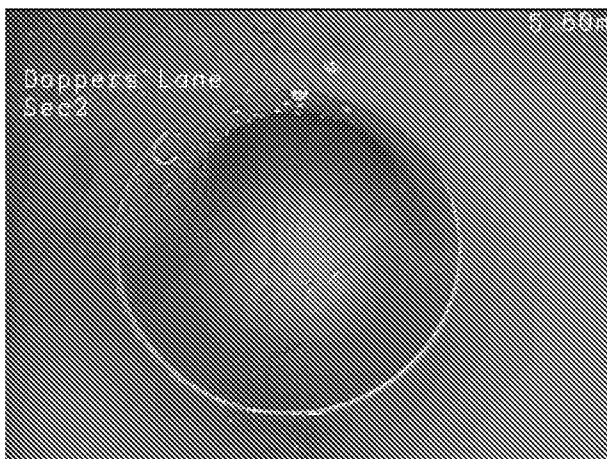
3, 00:00:29, 5.70 m  
Line deviates up

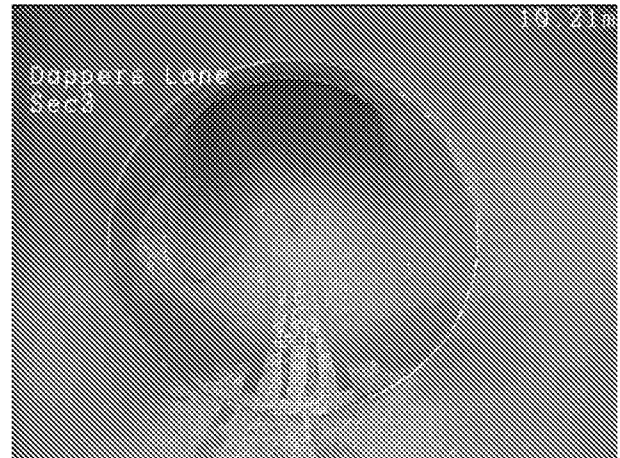
2, 00:00:40, 10.30 m  
Line deviates up

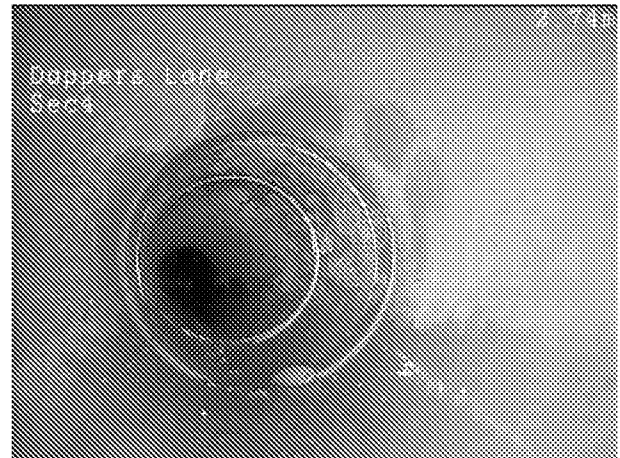
2, 00:00:17, 2.80 m  
Line deviates left

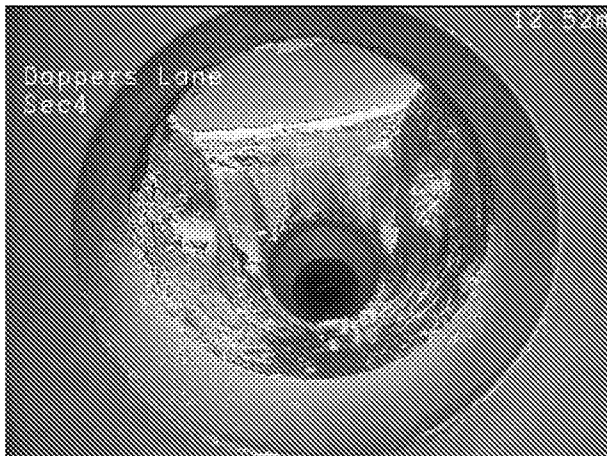
3, 00:00:44, 12.60 m  
Finish node, manhole, reference: F3, Not accessible

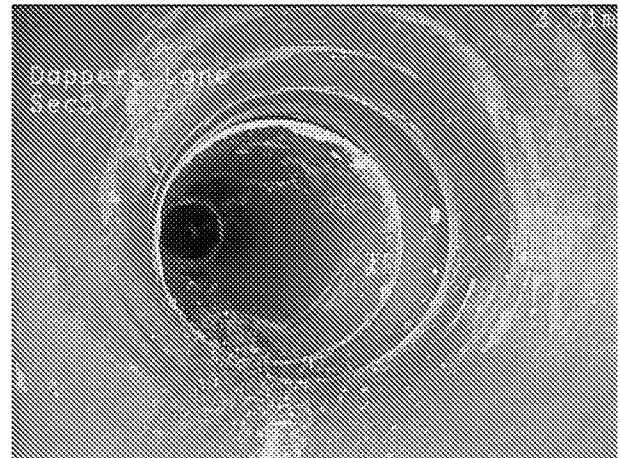
2, 00:00:20, 3.60 m  
Line deviates left

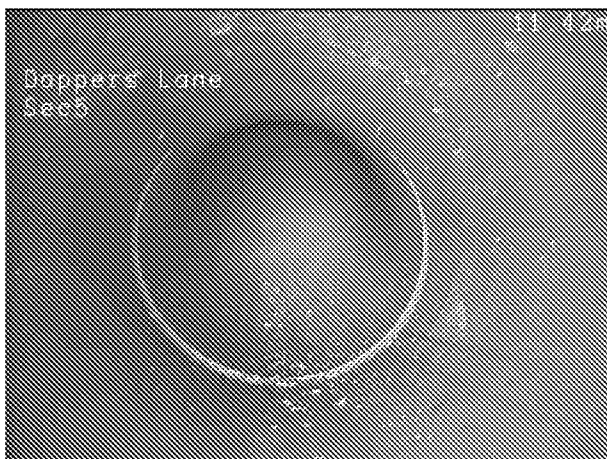
3, 00:00:42, 11.50 m  
Line deviates up
