## Section Inspection - 25/05/2021 - SP5X

| Town or Village: | Angmering | Inspection Direction: | Upstream | Upstream Node: | SP5 |
| Road: | Dappers Lane | Inspected Length: | 4.40 m | Upstream Pipe Depth: | |

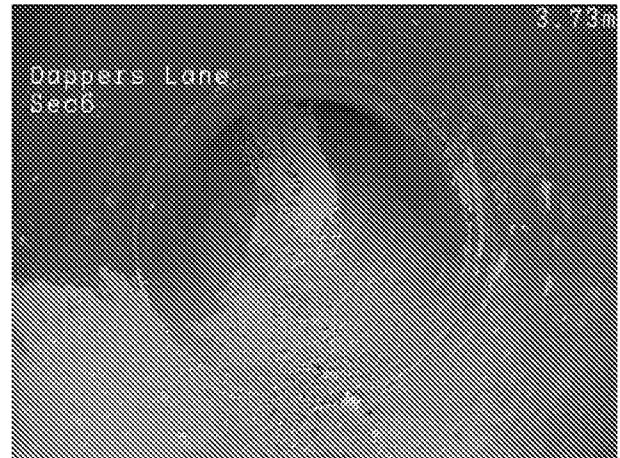
1, 00:00:05, 0.00 m  
Water level, 0% of the vertical dimension

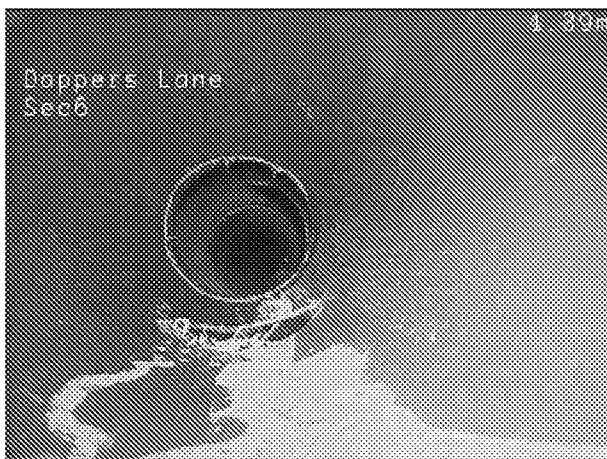
2, 00:00:24, 3.80 m  
Line deviates up

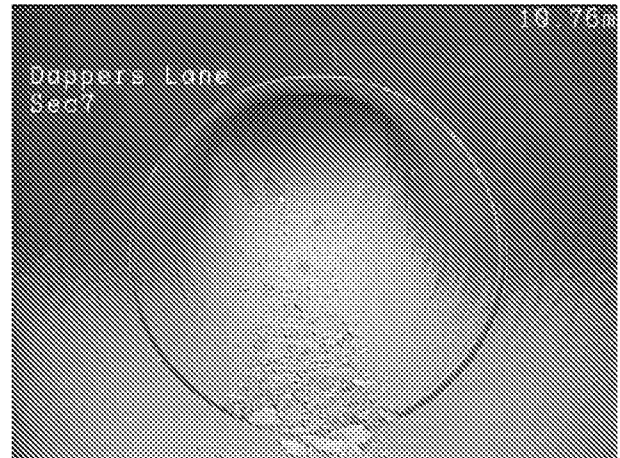
1, 00:00:09, 0.00 m  
Water level, 0% of the vertical dimension

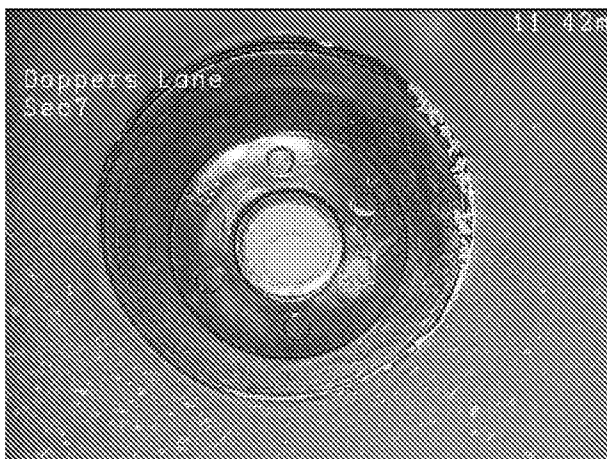
2, 00:00:49, 10.90 m  
Line deviates up

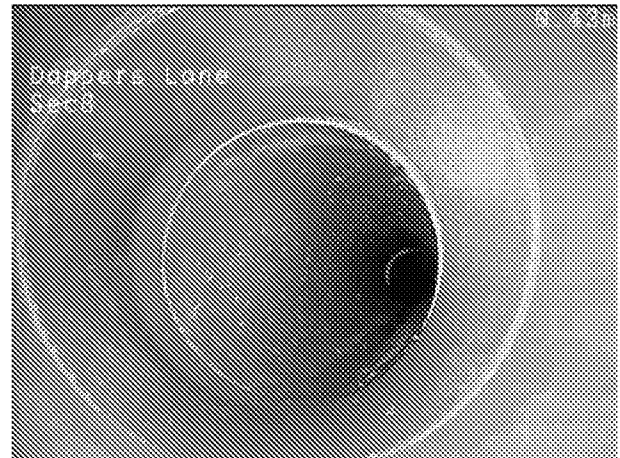
1, 00:00:00, 0.00 m  
Start node, manhole, reference: F17

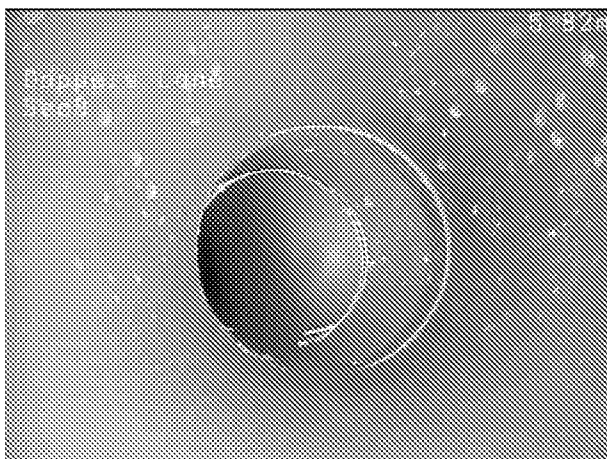
2, 00:00:09, 0.50 m  
Line deviates right

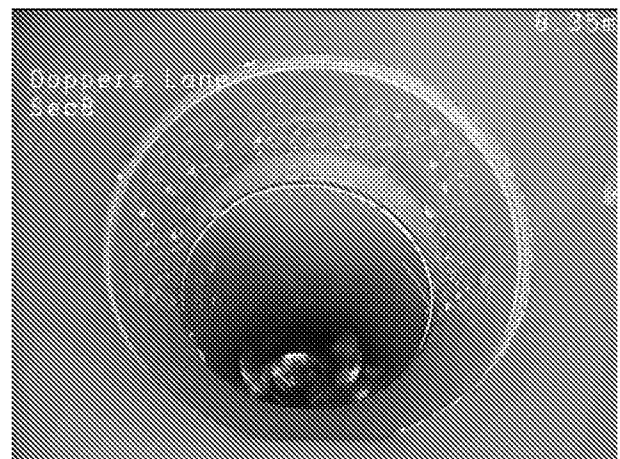
3, 00:00:24, 5.90 m  
Line deviates right

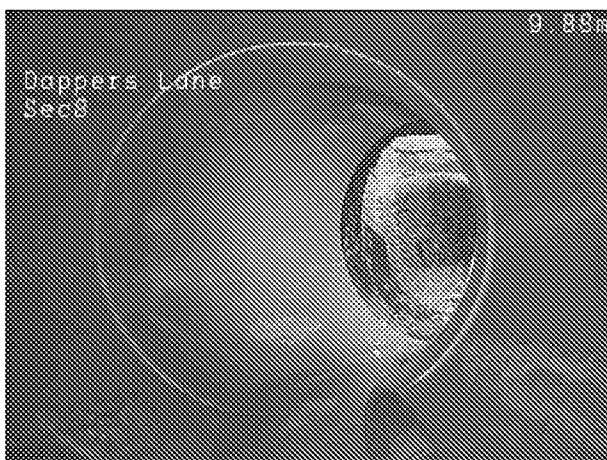
4, 00:00:36, 8.50 m  
Line deviates down

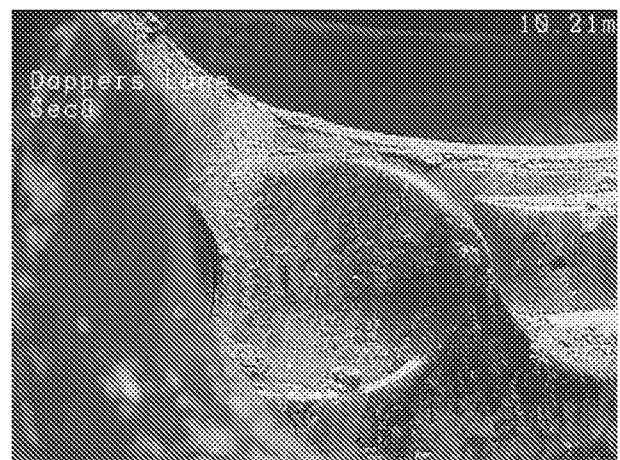
5, 00:00:46, 10.00 m  
Line deviates right

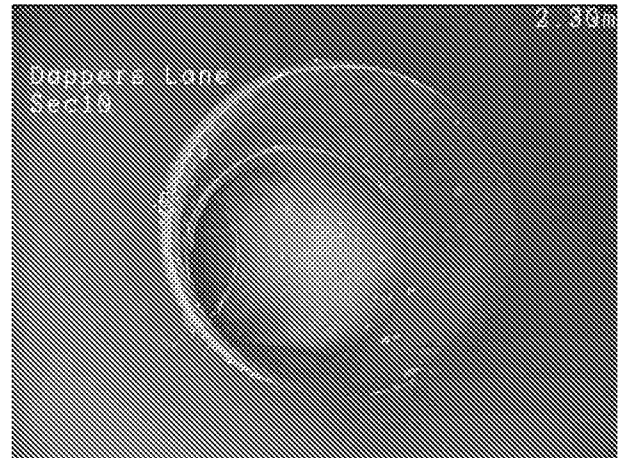
1, 00:00:00, 0.00 m  
Start node, manhole, reference: F19

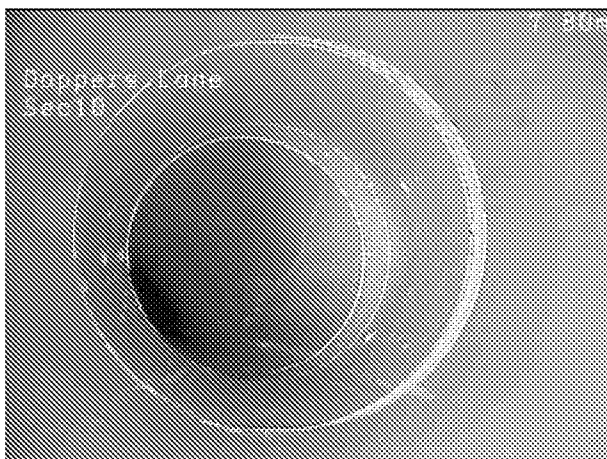
2, 00:00:23, 2.40 m  
Line deviates left

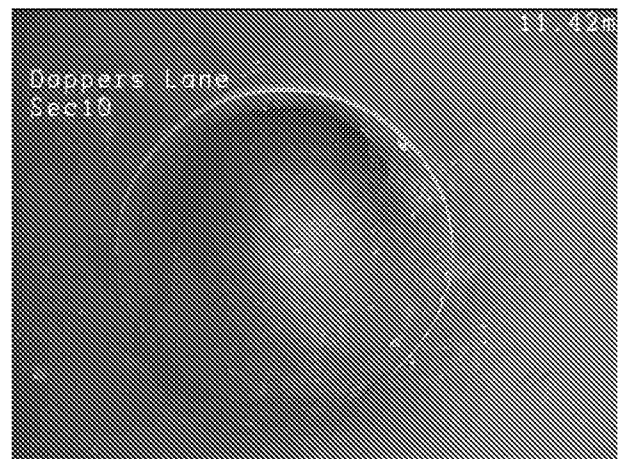
3, 00:00:52, 7.90 m  
Line deviates left

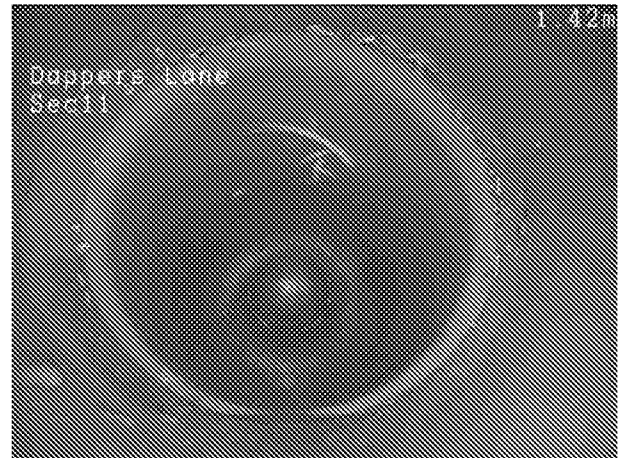
1, 00:00:06, 0.00 m  
Water level, 0% of the vertical dimension

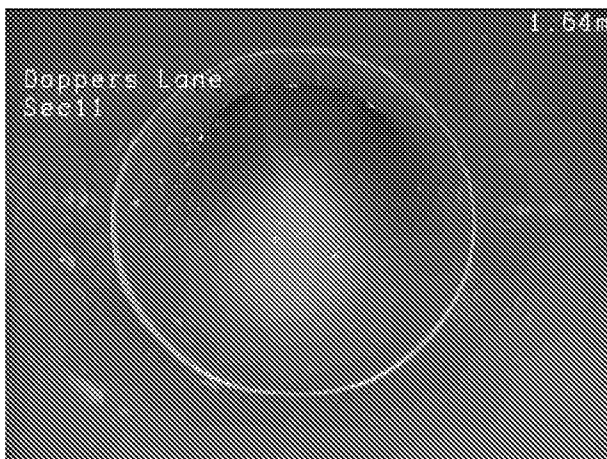
2, 00:00:20, 1.50 m  
Pipe material changes to vitrified clay at this point

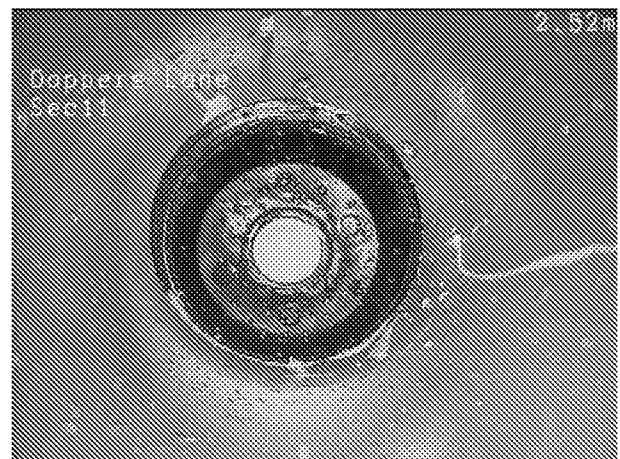
3, 00:00:23, 1.70 m  
Line deviates up

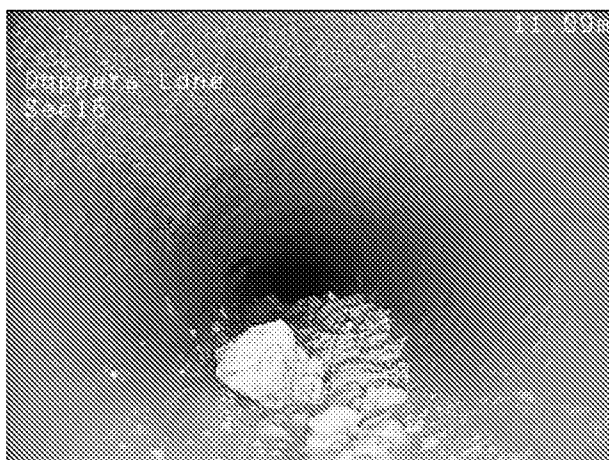
4, 00:00:39, 8.00 m  
Line deviates left

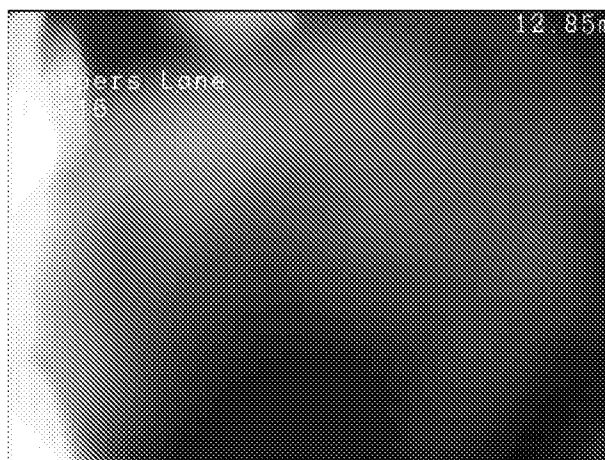
5, 00:00:53, 11.20 m  
Settled deposits, coarse, 30% cross-sectional area loss, start

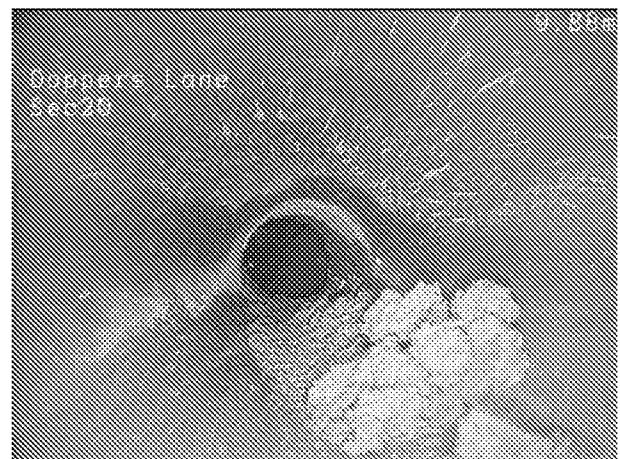
3, 00:00:32, 5.80 m  
Line deviates left

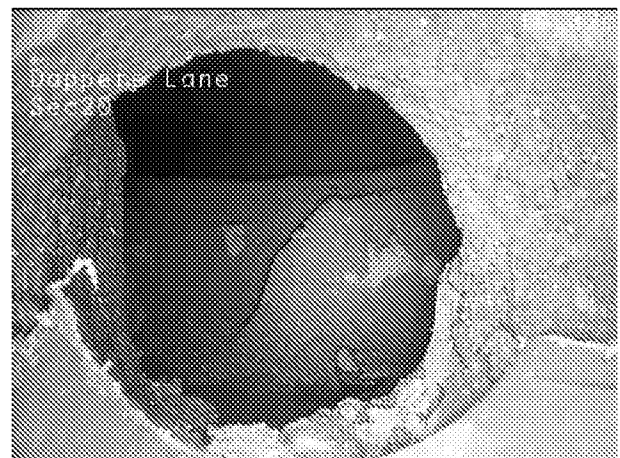
5, 00:00:55, 10.30 m  
General photograph taken at this point
