## Section Inspection - 26/05/2021 - SP22X

| Town or Village: | Angmering | Inspection Direction: | Upstream | Upstream Node: | SP22 |
| Road: | Dappers Lane | Inspected Length: | 13.10 m | Upstream Pipe Depth: | |

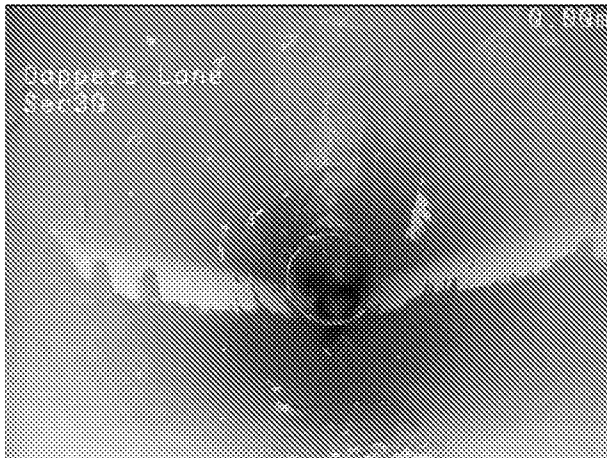
1, 00:00:09, 0.00 m  
Water level, 0% of the vertical dimension

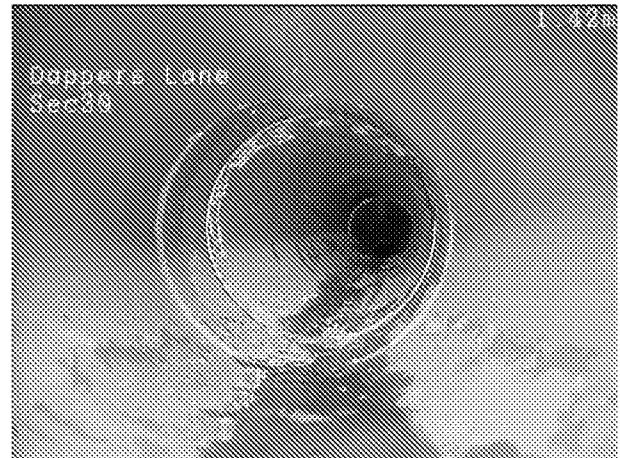
2, 00:00:22, 1.50 m  
Line deviates right

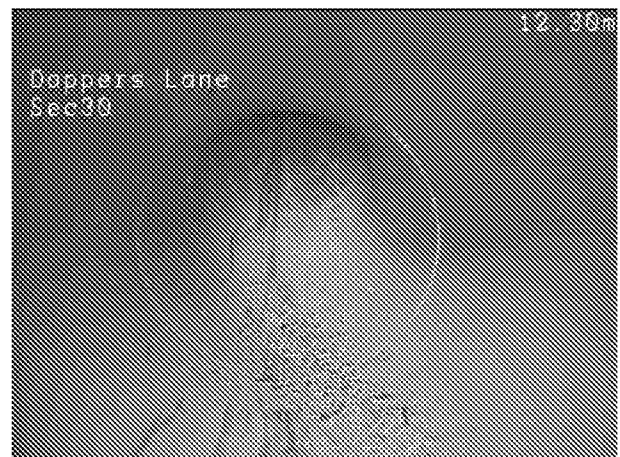
4, 00:00:52, 12.40 m  
Line deviates up

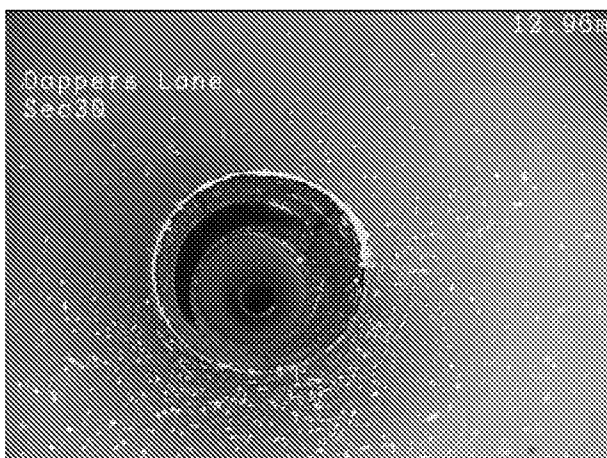
5, 00:00:56, 13.10 m  
Finish node, manhole, reference: SP22

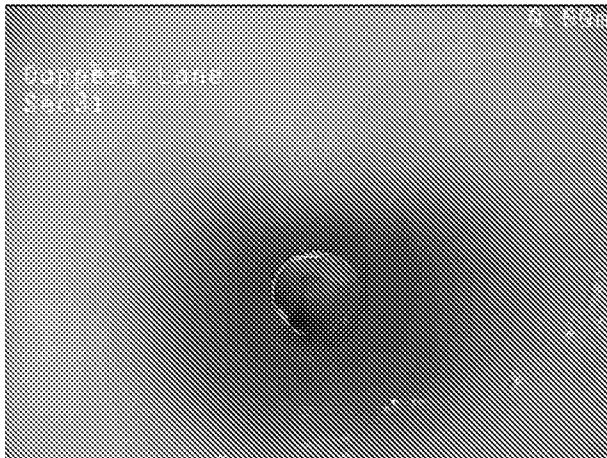
1, 00:00:05, 0.00 m  
Water level, 0% of the vertical dimension

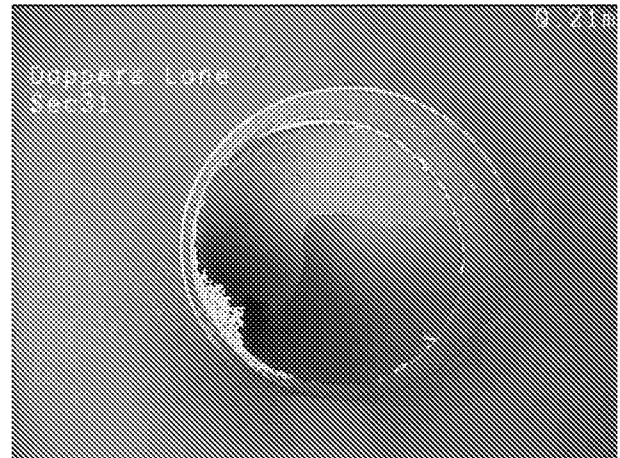
2, 00:00:09, 0.30 m  
Line deviates left

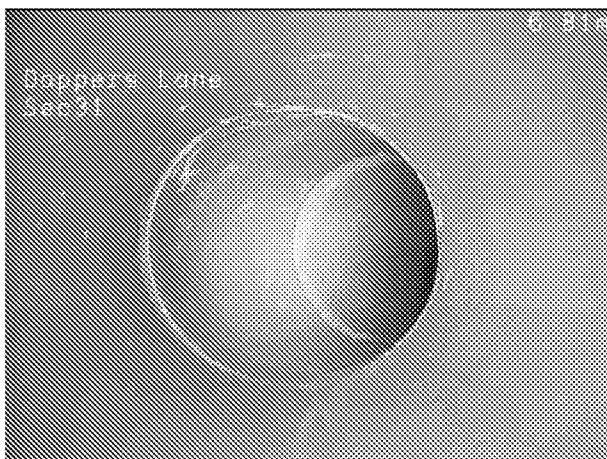
3, 00:00:34, 6.90 m  
Line deviates right

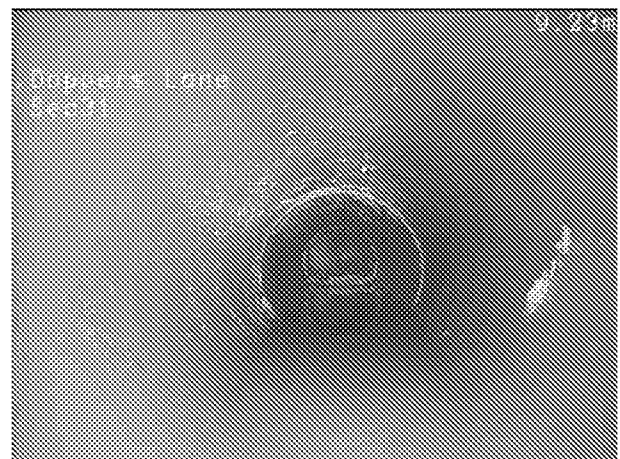
4, 00:00:51, 9.20 m  
Water level, 5% of the vertical dimension

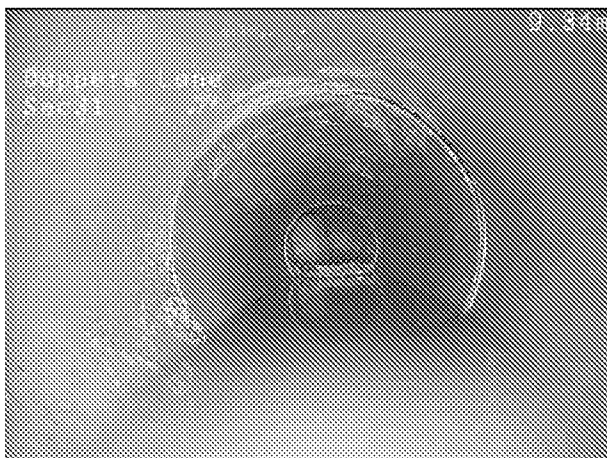
5, 00:01:01, 9.30 m  
Water level, 10% of the vertical dimension

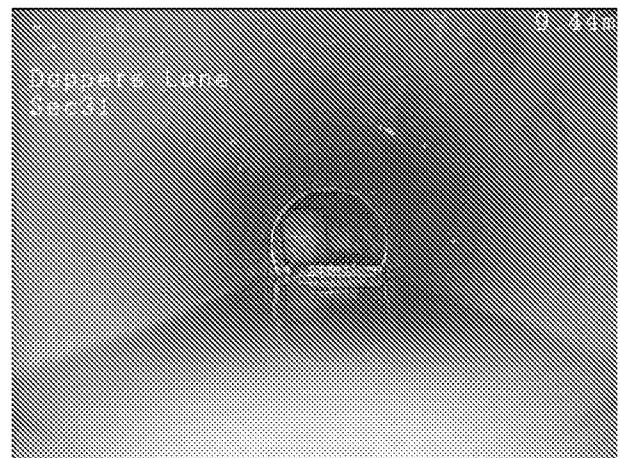
6, 00:01:05, 9.40 m  
Water level, 20% of the vertical dimension

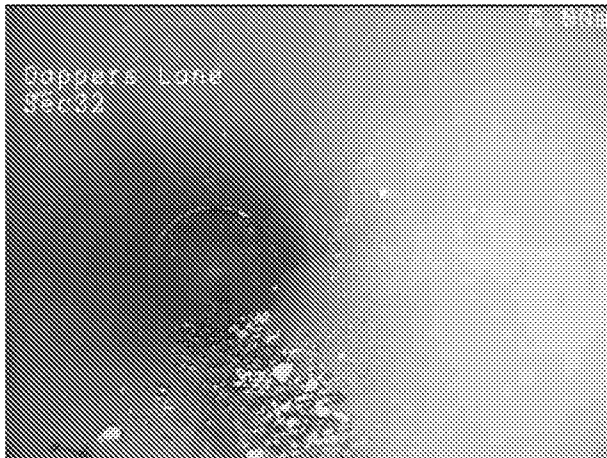
1, 00:00:00, 0.00 m  
Start node, manhole, reference: F32

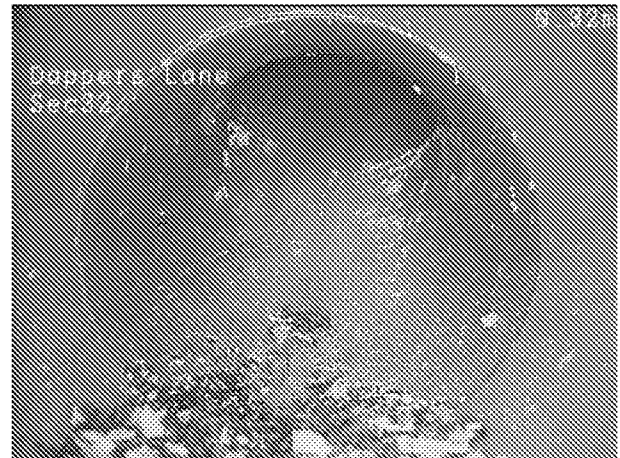
2, 00:00:09, 0.40 m  
Line deviates up

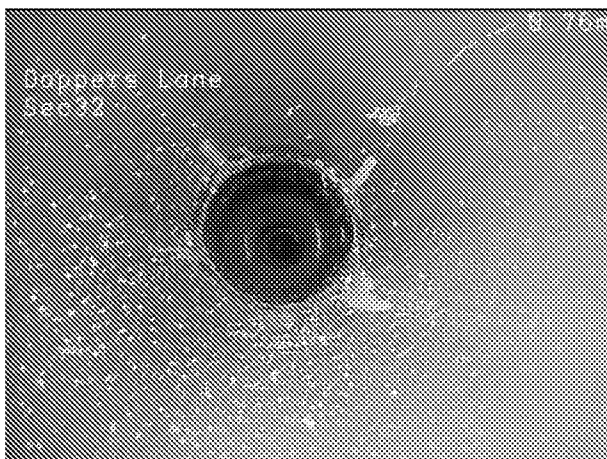
3, 00:00:13, 0.80 m  
Finish node, manhole, reference: SP23

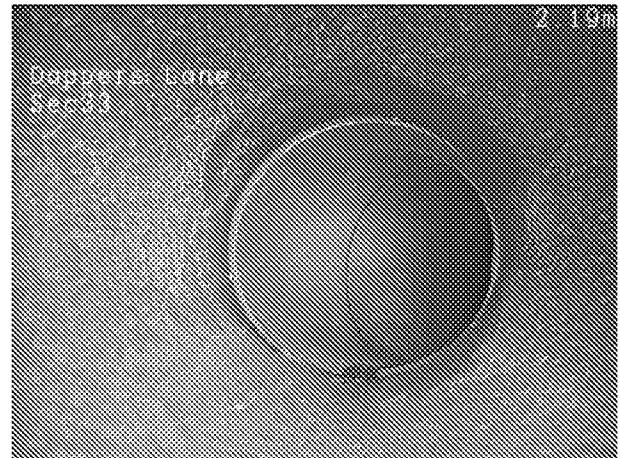
2, 00:00:18, 2.30 m  
Line deviates right

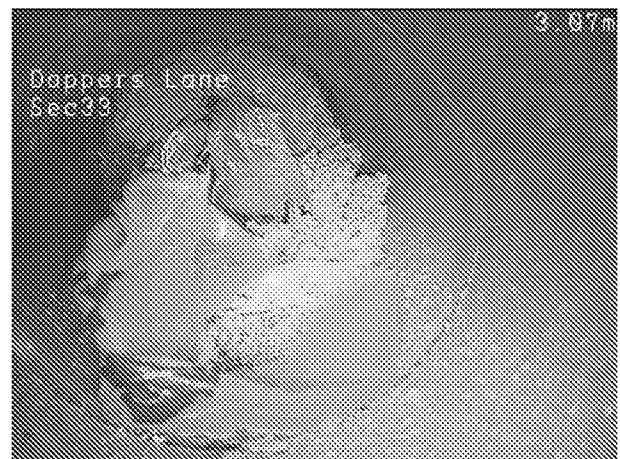
4, 00:00:26, 3.20 m  
Survey abandoned, Possibly redundant

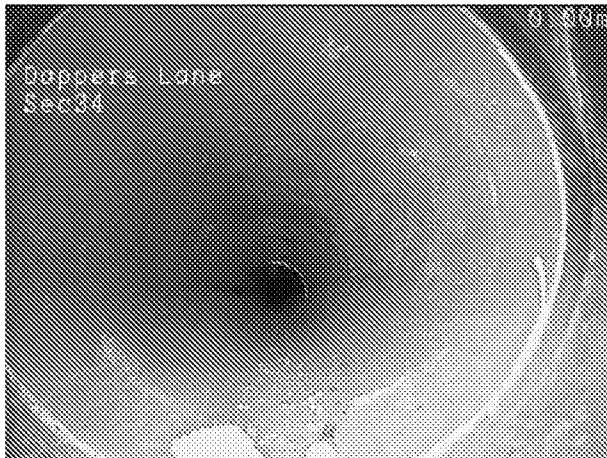
1, 00:00:00, 0.00 m  
Start node, manhole, reference: F32

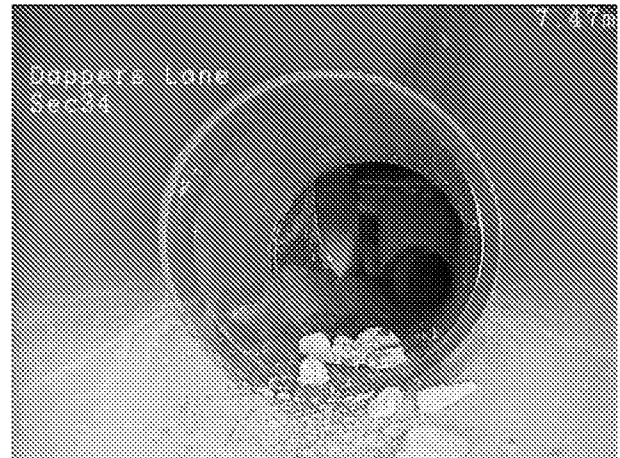
2, 00:00:32, 7.47 m  
Line deviates right

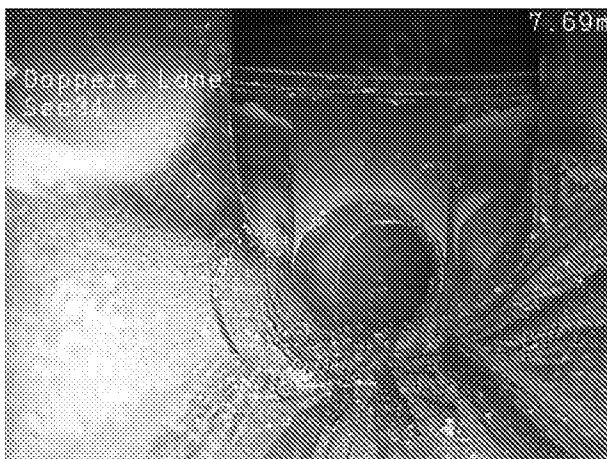
3, 00:00:38, 7.70 m  
Finish node, manhole, reference: F31

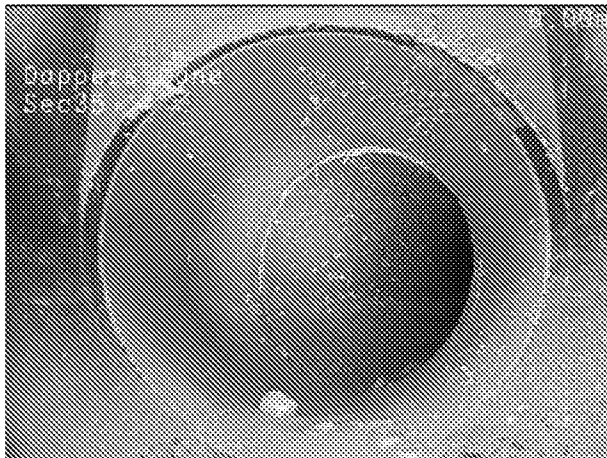
1, 00:00:01, 0.00 m  
Water level, 0% of the vertical dimension

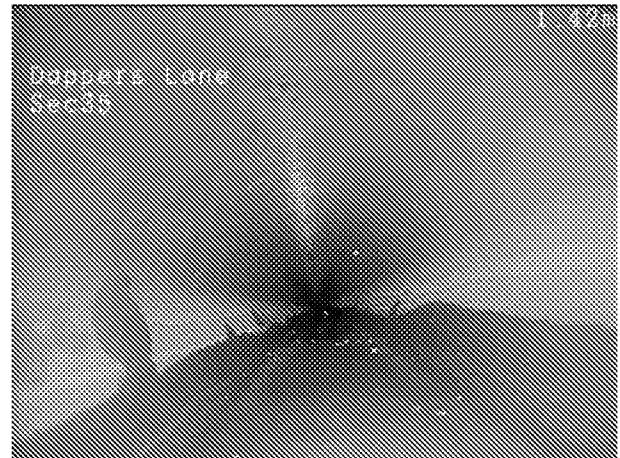
2, 00:00:10, 1.40 m  
Water level, 5% of the vertical dimension

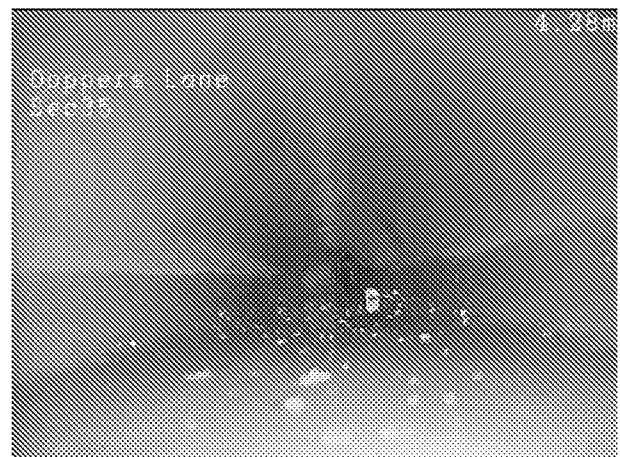
4, 00:00:36, 4.30 m  
Water level, 20% of the vertical dimension

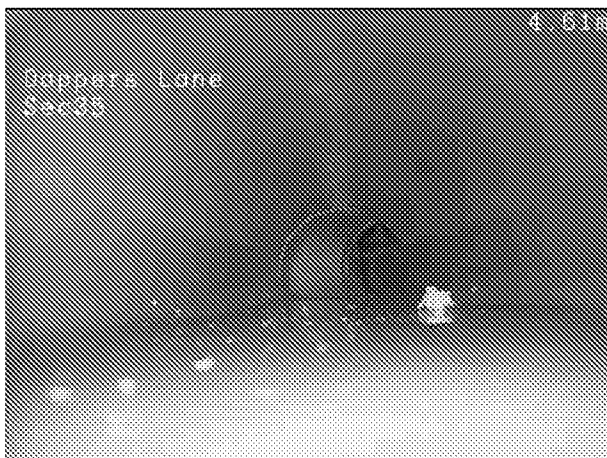
5, 00:00:44, 4.60 m  
Water level, 40% of the vertical dimension

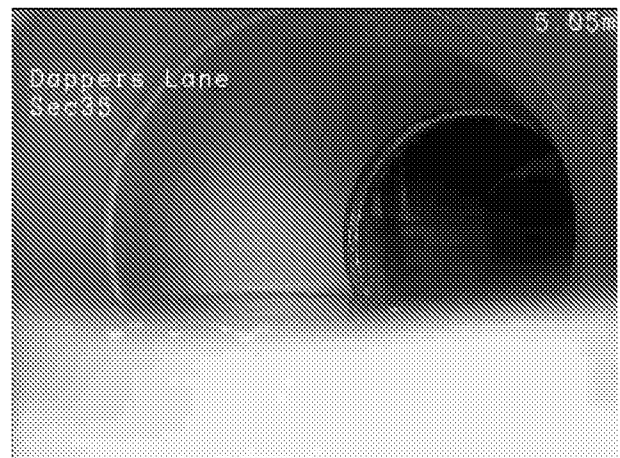
6, 00:00:54, 5.10 m  
Line deviates right

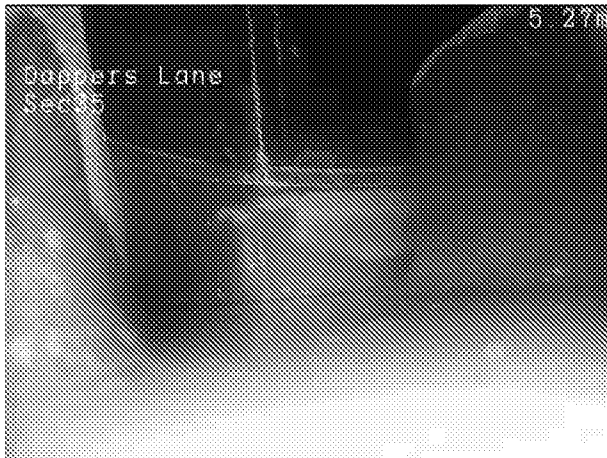
7, 00:01:00, 5.30 m  
Finish node, manhole, reference: F14

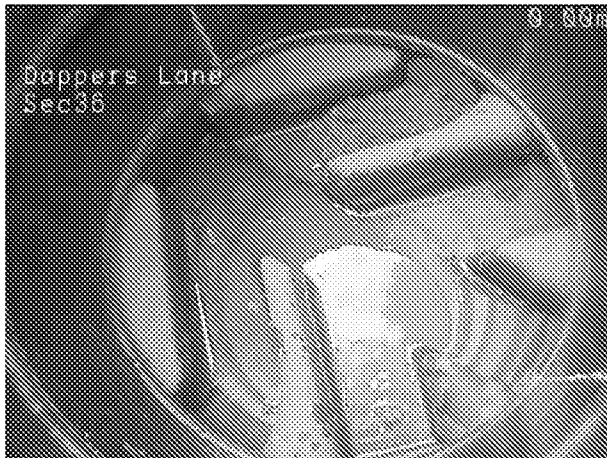
1, 00:00:00, 0.00 m  
General photograph taken at this point, Water level in chamber

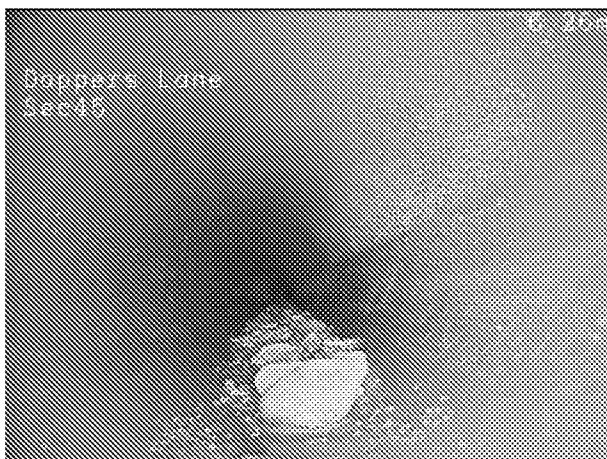
3, 00:00:38, 6.30 m  
Settled deposits, coarse, 20% cross-sectional area loss, start

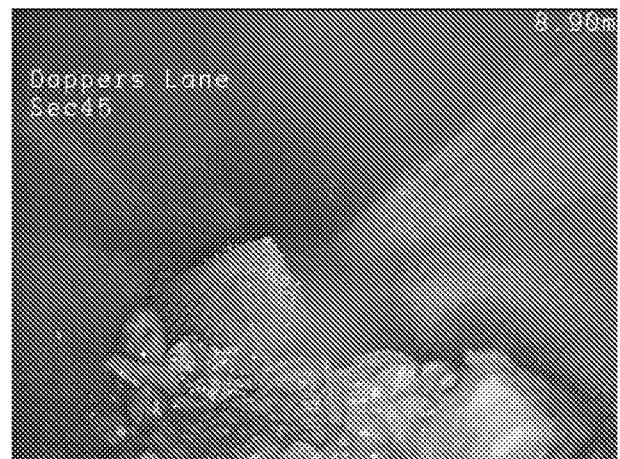
4, 00:00:02, 8.90 m  
Settled deposits, coarse, 50% cross-sectional area loss

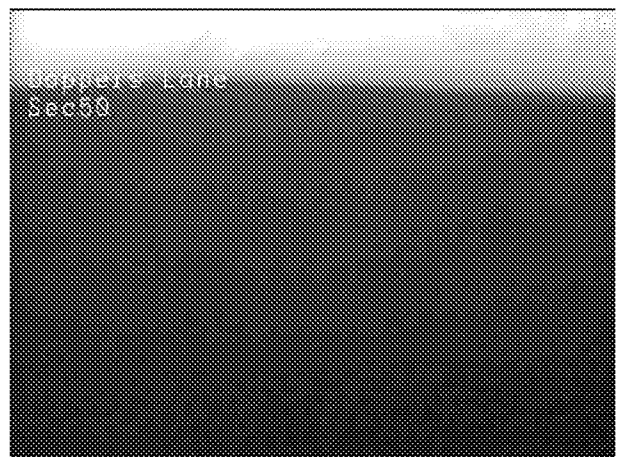
4, 00:00:46, 7.00 m  
Loss of vision, silt
