## Section Inspection - 26/05/2021 - SP36X

| Town or Village: | Angmering | Inspection Direction: | Upstream | Upstream Node: | SP36 |
| Road: | Dappers Lane | Inspected Length: | 4.00 m | Upstream Pipe Depth: | |

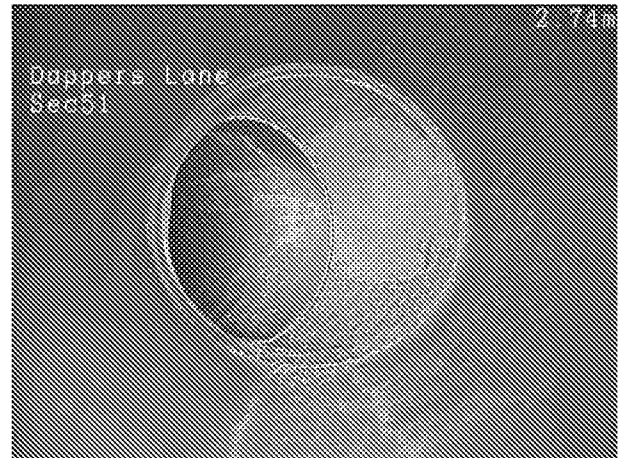
1, 00:00:00, 0.00 m  
Start node, manhole, reference: F24

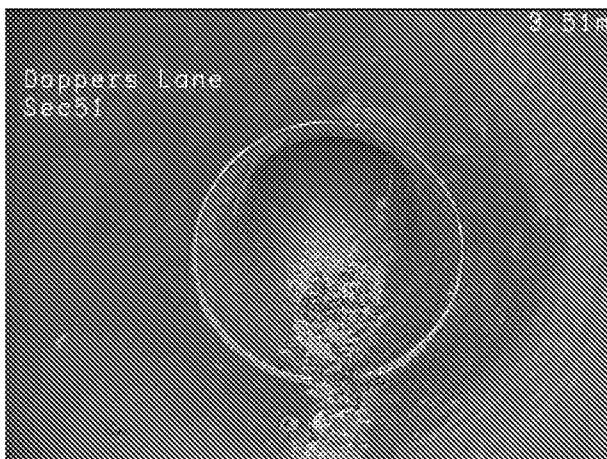
2, 00:00:16, 2.80 m  
Line deviates left

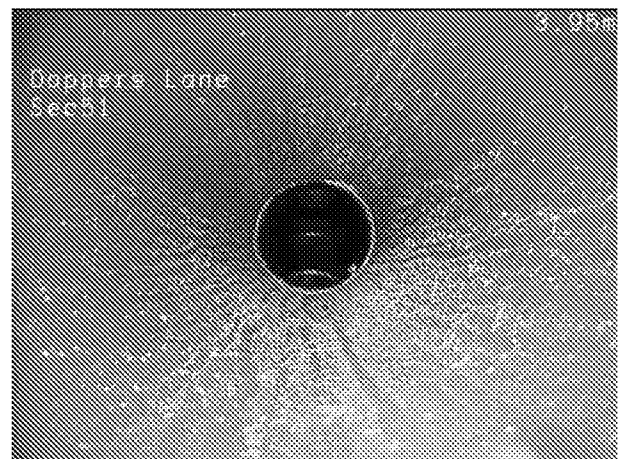
3, 00:00:23, 3.60 m  
Line deviates up

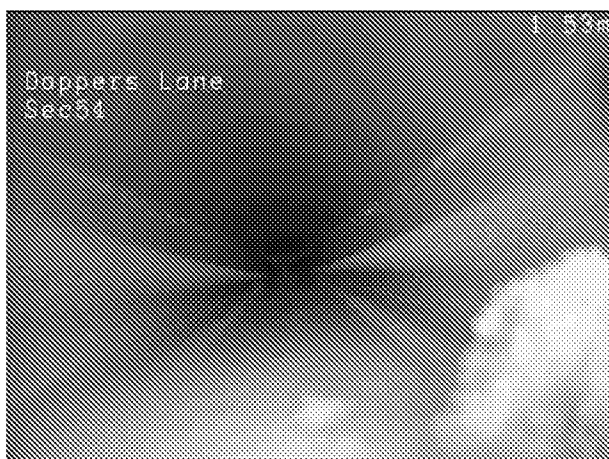
2, 00:00:13, 1.30 m  
Water level, 5% of the vertical dimension

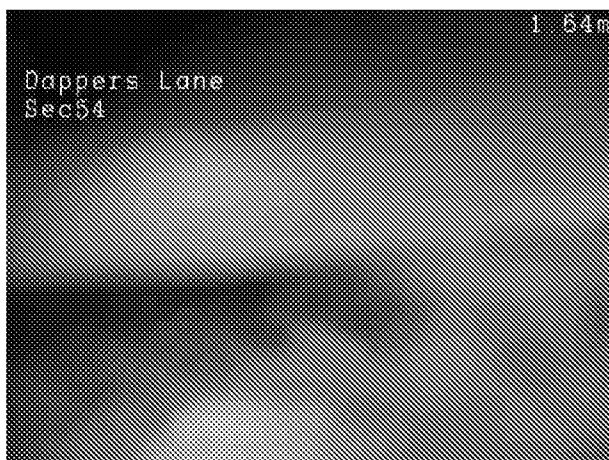
4, 00:00:20, 1.60 m  
Water level, 20% of the vertical dimension

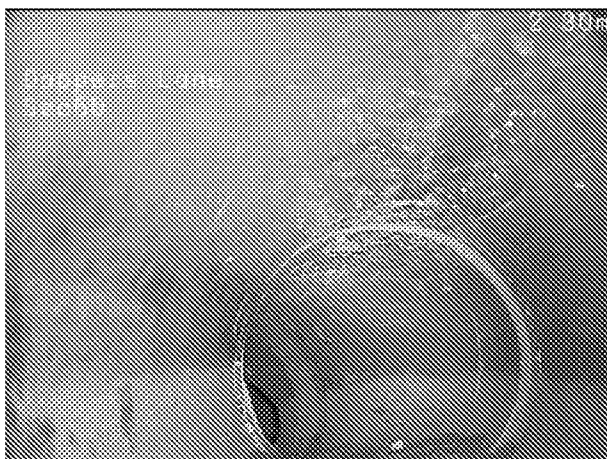
2, 00:00:23, 1.80 m  
Settled deposits, coarse, 15% cross-sectional area loss

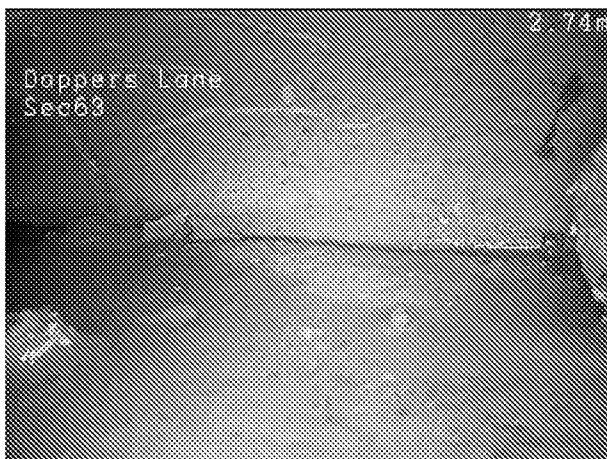
3, 00:00:40, 2.70 m  
Finish node, major connection without manhole, reference: JN,  
Heavy deposits in channel

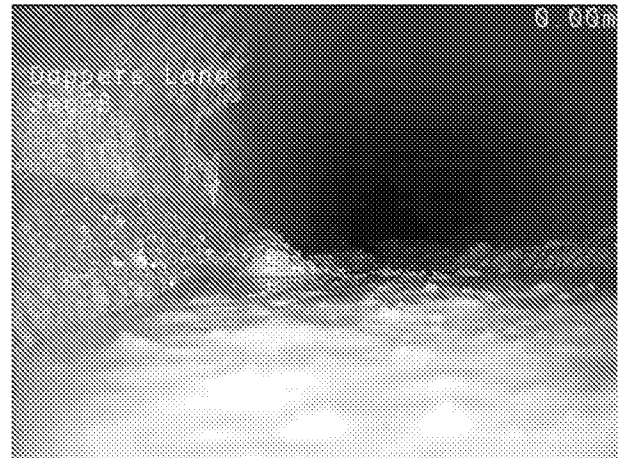
2, 00:00:00, 0.00 m  
Settled deposits, fine, 30% cross-sectional area loss, start

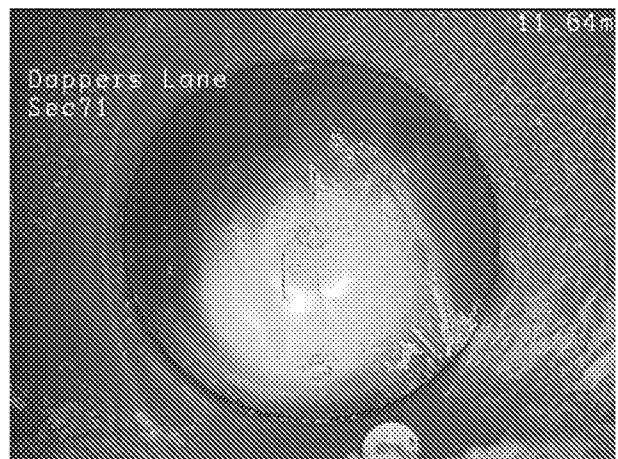
4, 00:00:39, 11.50 m  
Survey abandoned, Capped, rodding eye not installed

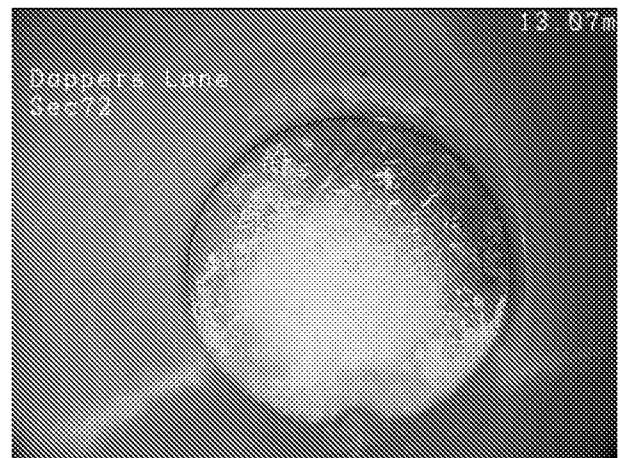
6, 00:01:21, 13.30 m  
Survey abandoned, Capped, rodding eye not installed

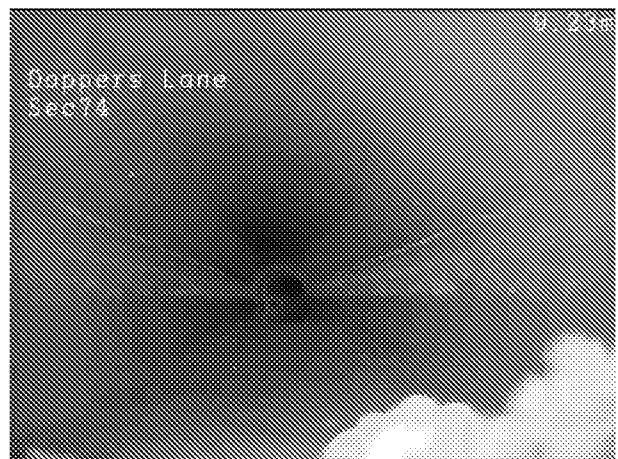
3, 00:00:48, 8.50 m  
Settled deposits, coarse, 5% cross-sectional area loss

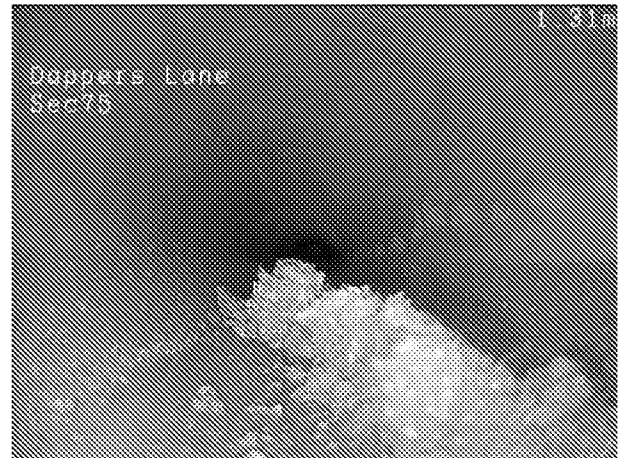
2, 00:00:45, 1.40 m  
Settled deposits, coarse, 15% cross-sectional area loss, change

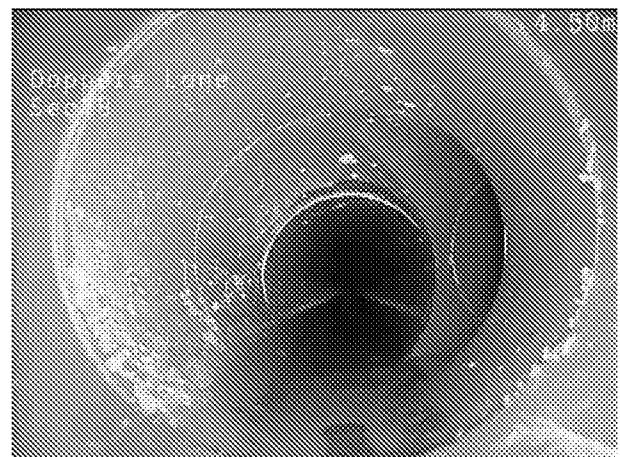
3, 00:00:22, 0.60 m  
Sealing ring intruding, loop hanging above centre from 12 o'clock to 3 o'clock
