## Section Inspection - 27/05/2021 - LDX

| Town or Village: | Angmering | Inspection Direction: | Upstream | Upstream Node: | LD |
| Road: | Dappers Lane | Inspected Length: | 14.10 m | Upstream Pipe Depth: | |

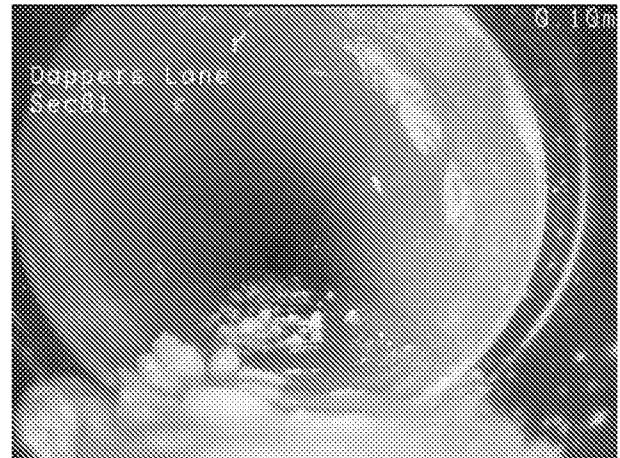
2, 00:01:05, 0.10 m  
Settled deposits, coarse, 15% cross-sectional area loss, start

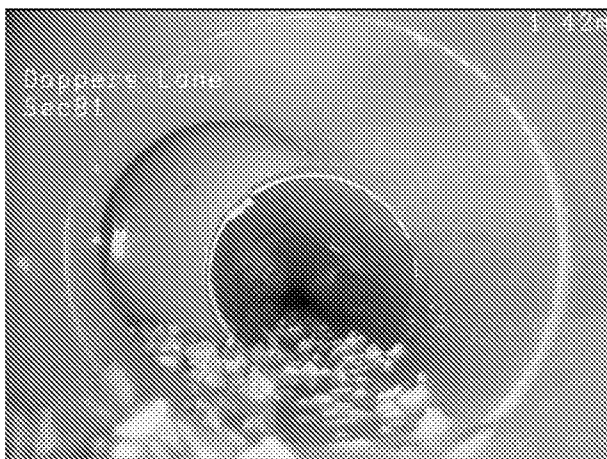
3, 00:00:49, 1.50 m  
Junction at 10 o'clock, 100mm dia

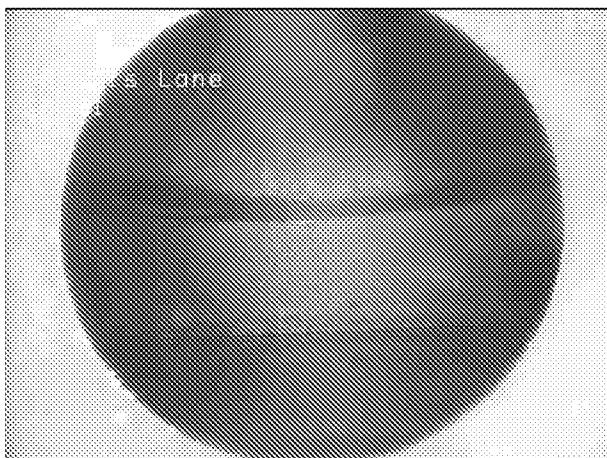
5, 00:00:00, 11.70 m  
Finish node, manhole, reference: S3, Not accessible

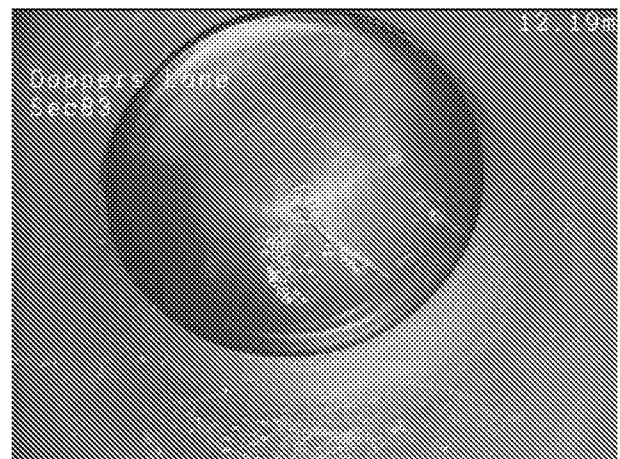
4, 00:00:57, 12.20 m  
Survey abandoned, Capped, rodding eye not installed

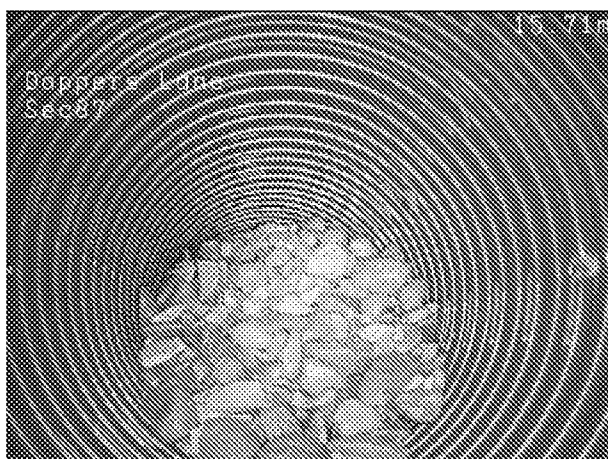
3, 00:00:55, 15.80 m  
Settled deposits, coarse, 100% cross-sectional area loss

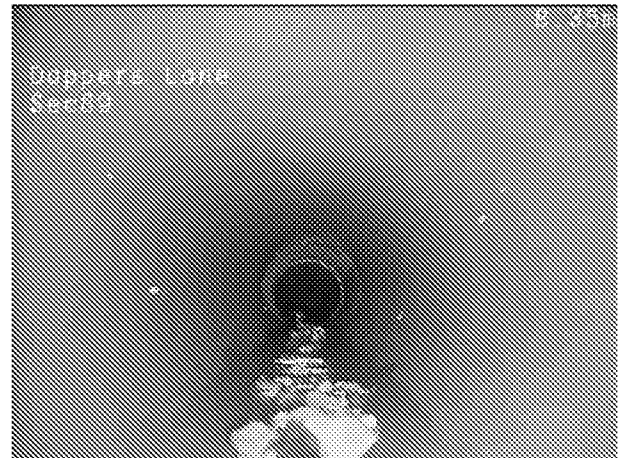
2, 00:00:33, 8.40 m  
Settled deposits, coarse, 10% cross-sectional area loss, start

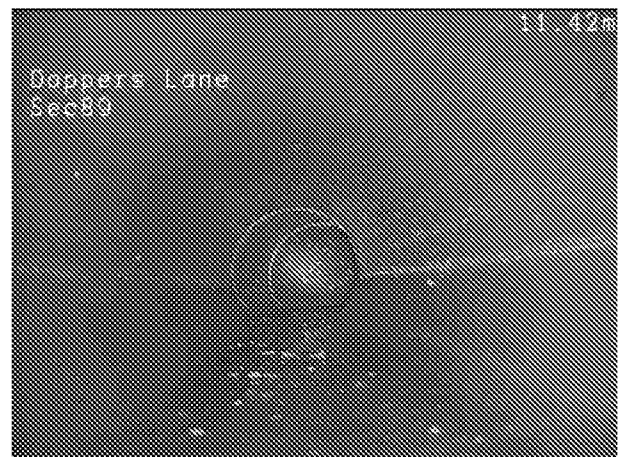
4, 00:00:50, 11.40 m  
Settled deposits, fine, 10% cross-sectional area loss, start

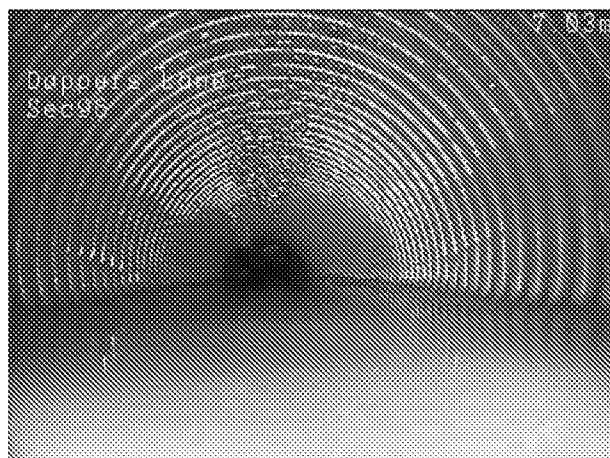
7, 00:01:06, 7.30 m  
Water level, 50% of the vertical dimension

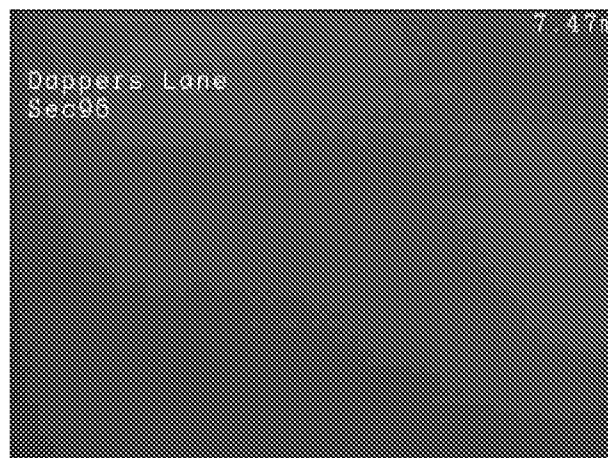
8, 00:01:10, 7.50 m  
Loss of vision, camera under water

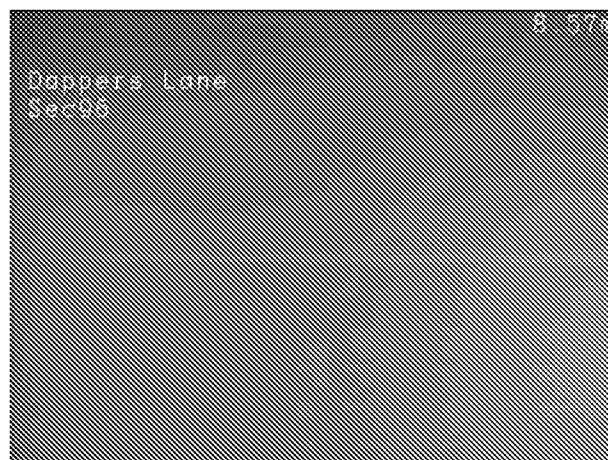
12, 00:01:27, 8.60 m  
Loss of vision, camera under water
