## Section Inspection - 28/05/2021 - RWPX

| Town or Village: | Angmering | Inspection Direction: | Upstream | Upstream Node: | RWP |
| Road: | Dappers Lane | Inspected Length: | 1.40 m | Upstream Pipe Depth: | |

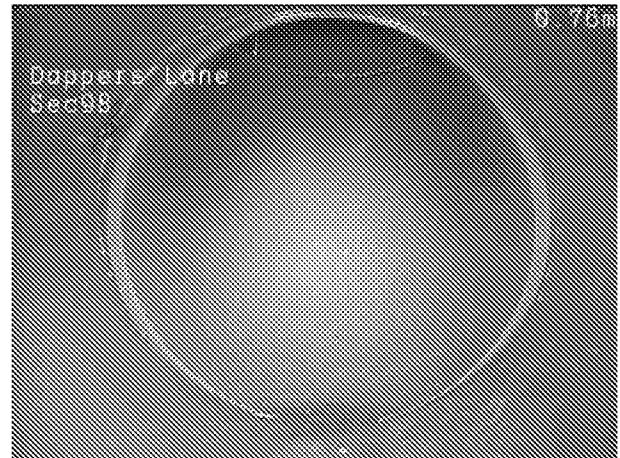
2, 00:00:11, 0.80 m  
Line deviates up

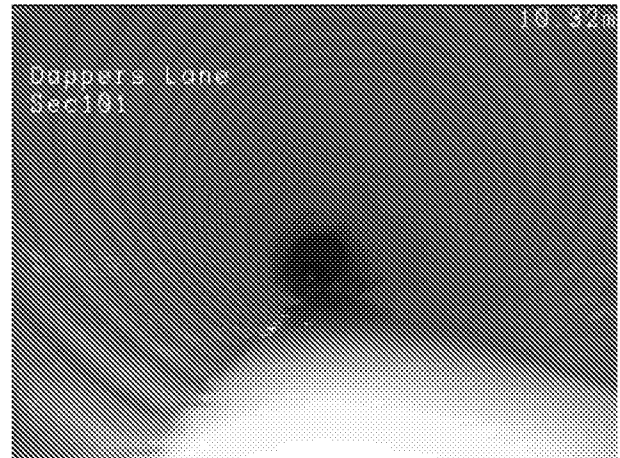
2, 00:00:55, 10.30 m  
Water level, 5% of the vertical dimension

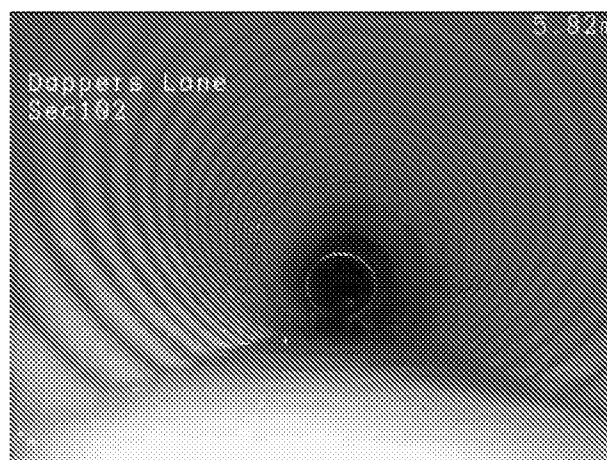
2, 00:00:48, 5.80 m  
Water level, 5% of the vertical dimension

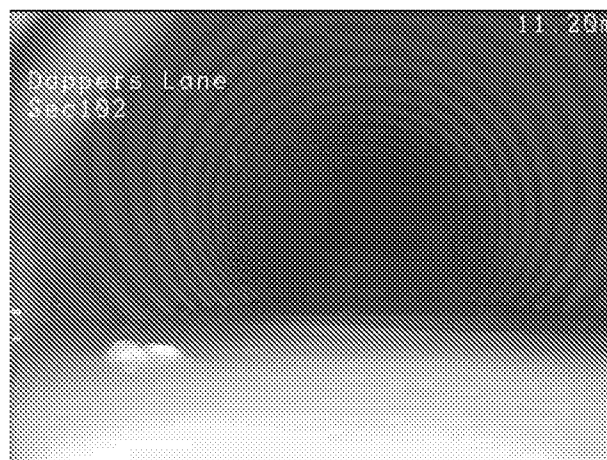
6, 00:01:24, 11.20 m  
Water level, 20% of the vertical dimension

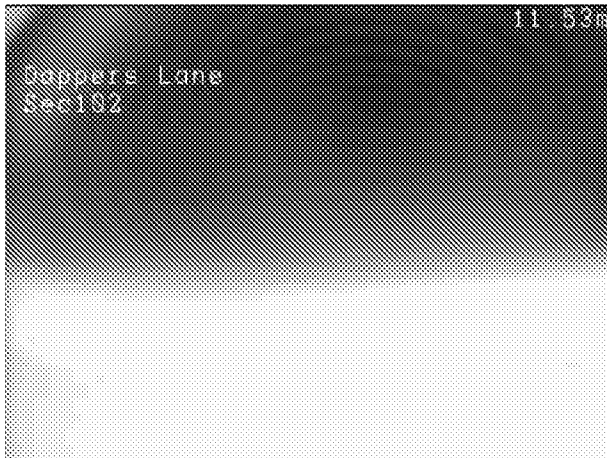
7, 00:01:27, 11.50 m  
Water level, 30% of the vertical dimension

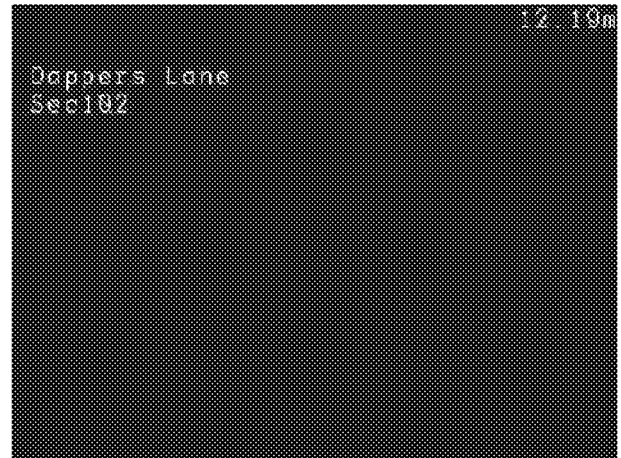
8, 00:01:33, 12.10 m  
Loss of vision, camera under water

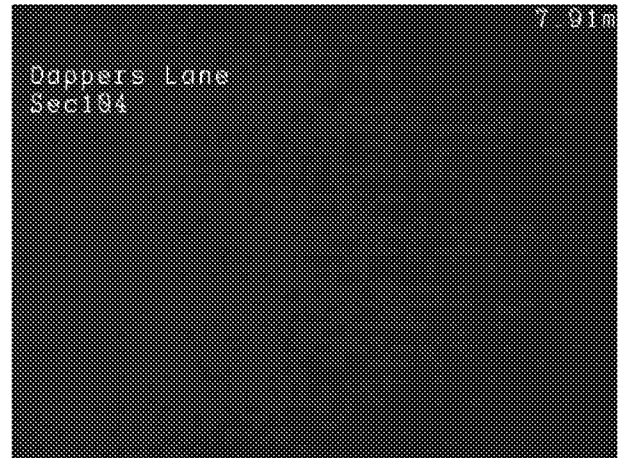
8, 00:00:56, 7.90 m  
Loss of vision, camera under water

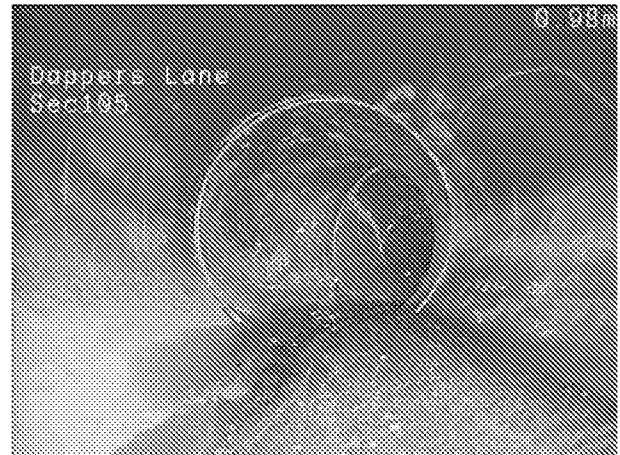
2, 00:00:09, 0.90 m  
Settled deposits, fine, 10% cross-sectional area loss, start

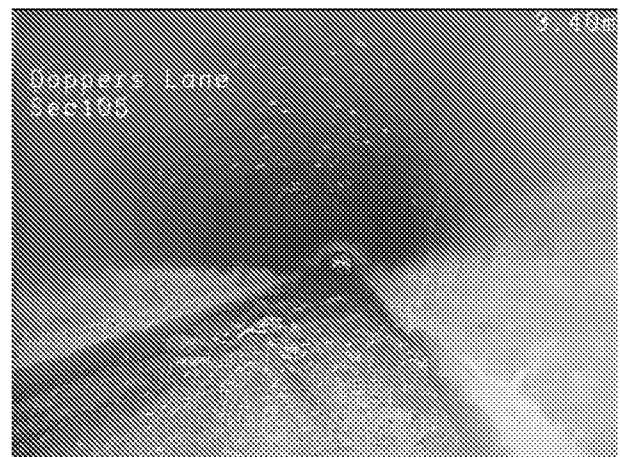
4, 00:00:20, 3.40 m  
Settled deposits, fine, 20% cross-sectional area loss, change

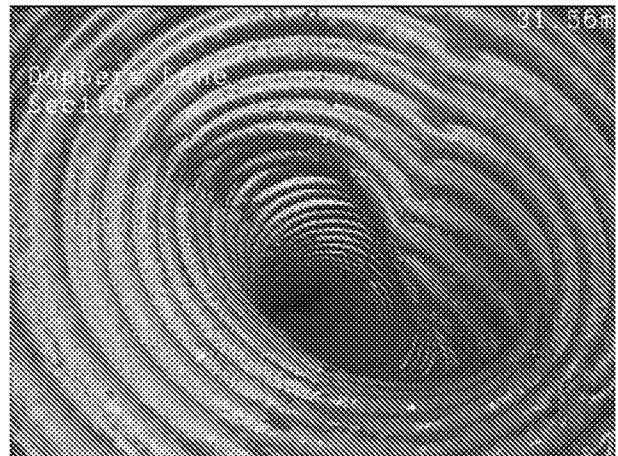
4, 00:02:12, 31.60 m  
Survey abandoned, Unable to continue

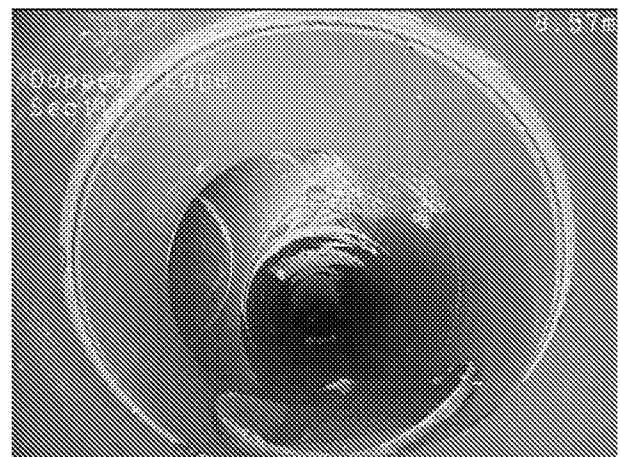
4, 00:00:39, 8.60 m  
Other obstacles, pipe material in invert from 4 o'clock to 7 o'clock, 5% cross-sectional area loss

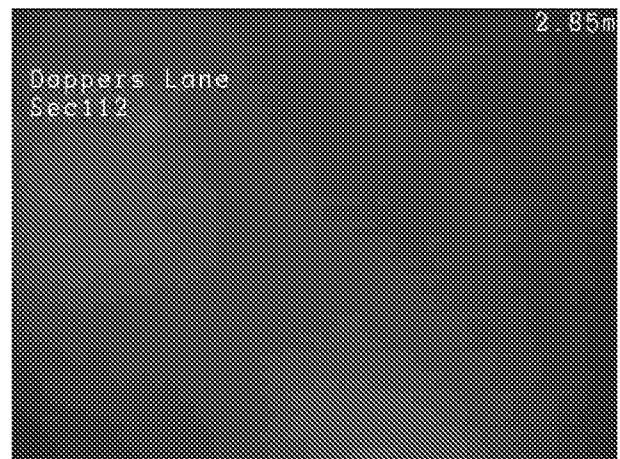
4, 00:00:29, 2.80 m  
Loss of vision, camera under water

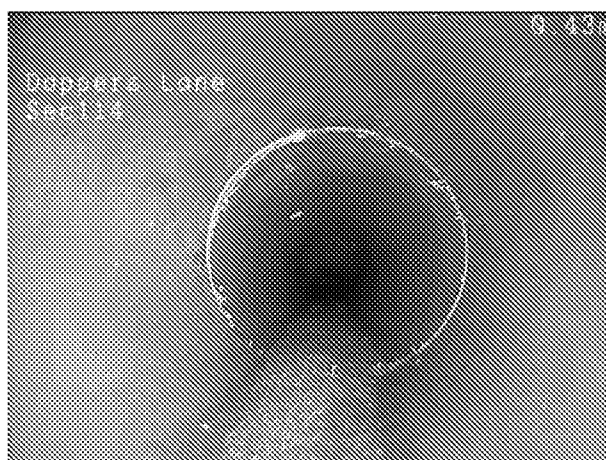
2, 00:00:14, 0.40 m  
Settled deposits, fine, 5% cross-sectional area loss
