## Section Pictures - 28/05/2021 - F29AX

| Town or Village: | Angmering | Inspection Direction: | Downstream | Upstream Node: | F29B |
| Road: | Dappers Lane | Inspected Length: | 2.30 m | Upstream Pipe Depth: | |

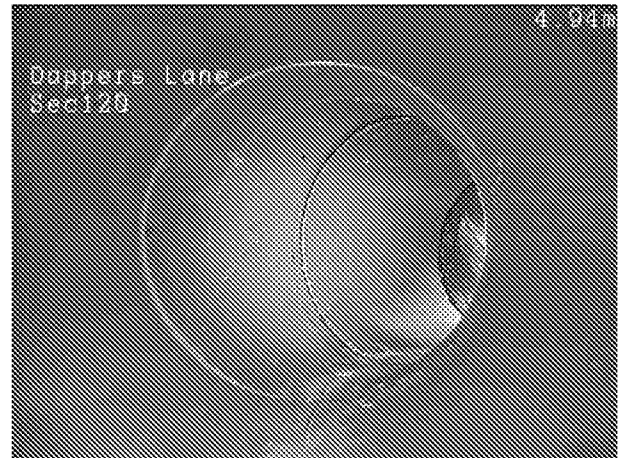
2, 00:00:30, 5.00 m  
Line deviates right

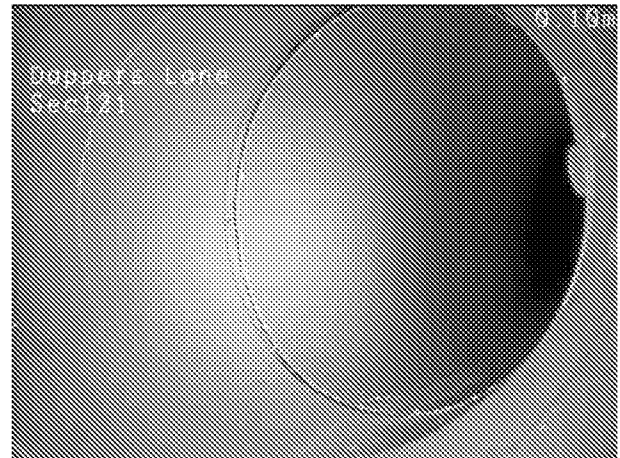
2, 00:00:07, 0.20 m  
Line deviates right

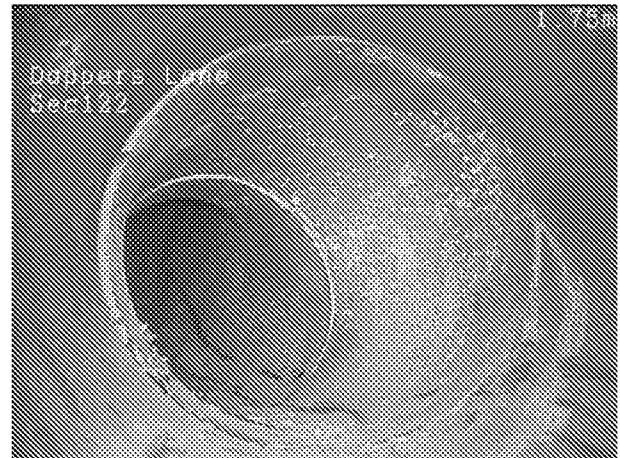
2, 00:00:30, 1.80 m  
Line deviates left

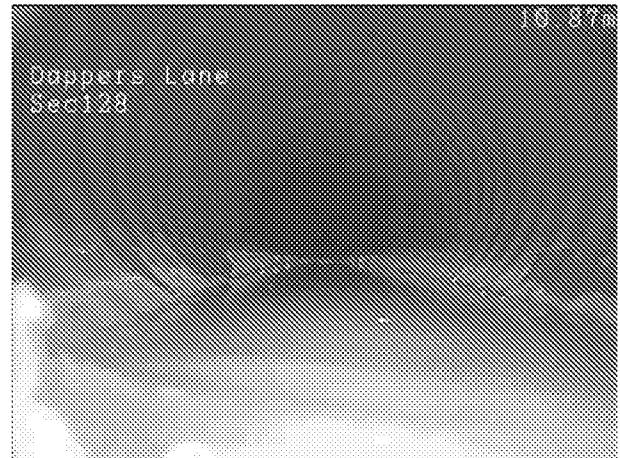
2, 00:01:12, 10.80 m  
Water level, 10% of the vertical dimension

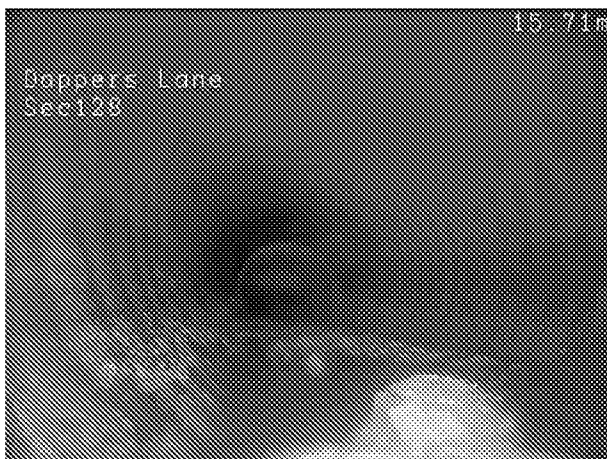
3, 00:01:35, 15.70 m  
Settled deposits, fine, 15% cross-sectional area loss, start

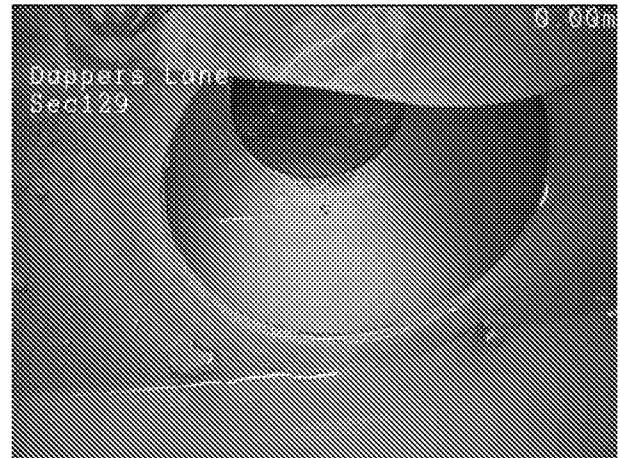
2, 00:00:33, 0.00 m  
Survey abandoned, Unable to cctv past hydrobrake

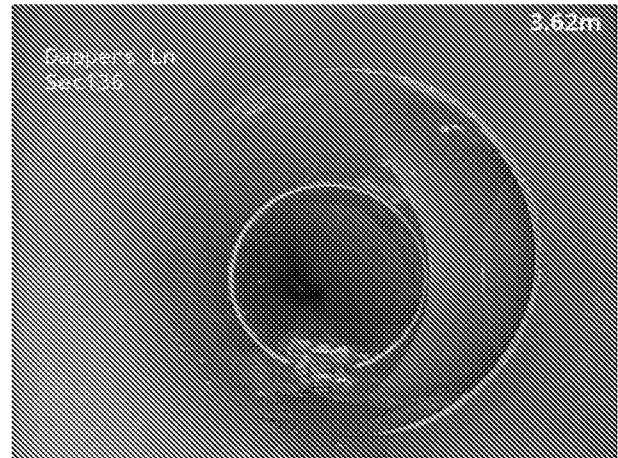
2, 00:00:16, 3.70 m  
Junction at 3 o'clock, 100mm dia

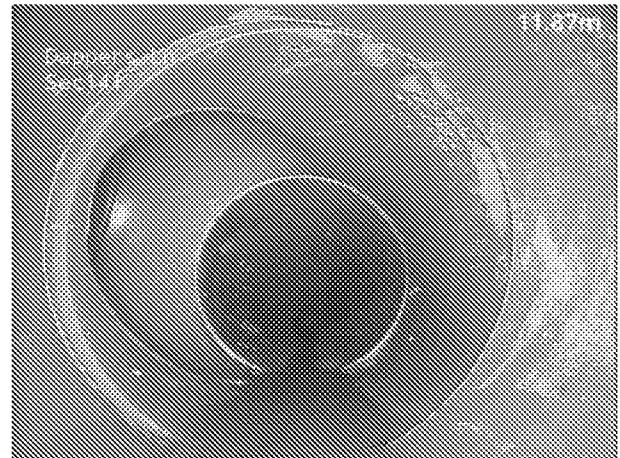
2, 00:00:48, 12.00 m  
Junction at 9 o'clock, 100mm dia

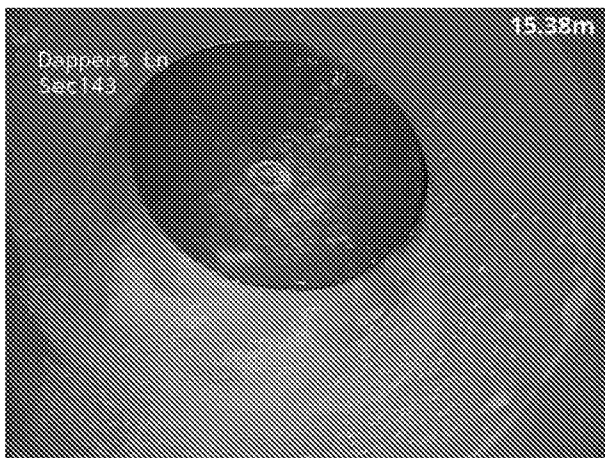
5, 00:01:04, 15.50 m  
Survey abandoned, Capped
