## Section Inspection - 20/07/2021 - S18X

| Town or Village: | Angmering | Inspection Direction: | Downstream | Upstream Node: | S18 |
| Road: | Dappers Lane | Inspected Length: | 14.00 m | Upstream Pipe Depth: | |

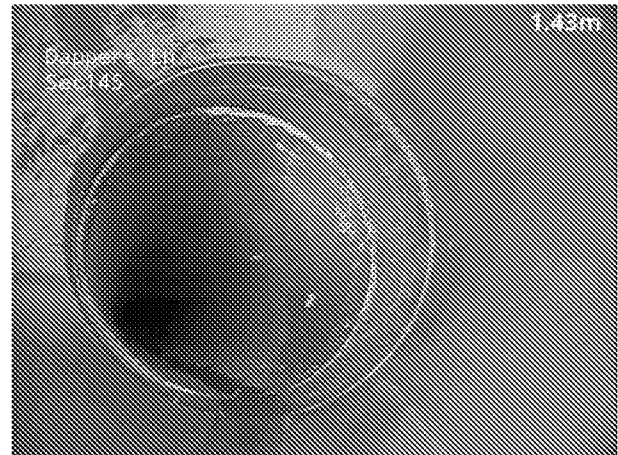
1, 00:00:03, 0.10 m  
Line deviates left

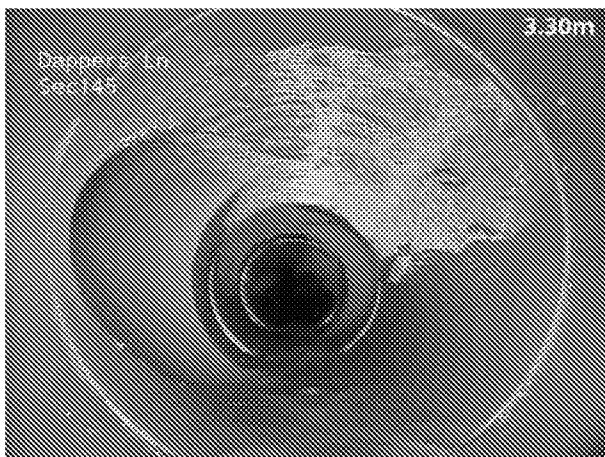
2, 00:00:14, 1.50 m  
Line deviates left

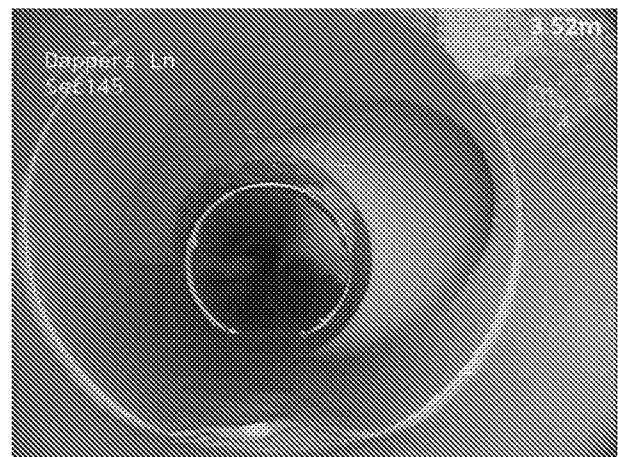
3, 00:00:25, 3.20 m  
Junction at 9 o'clock, 100mm dia

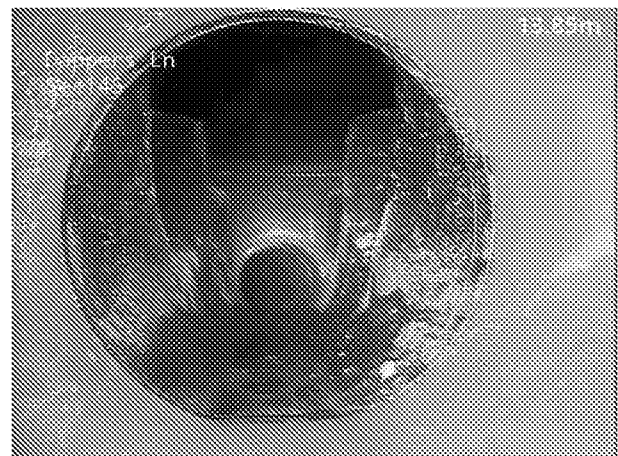
5, 00:01:02, 9.60 m  
Junction at 11 o'clock, 100mm dia

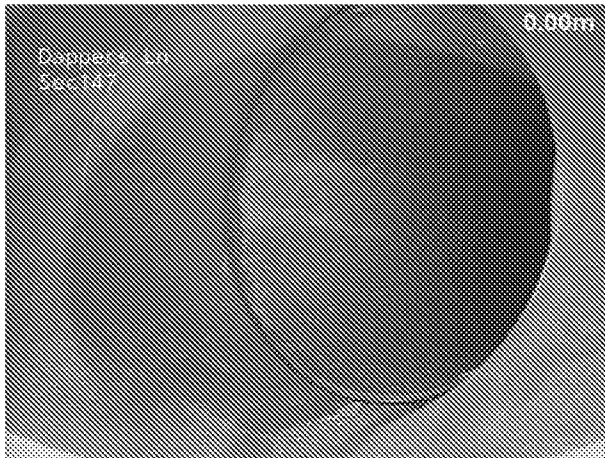
1, 00:00:03, 0.10 m  
Line deviates right

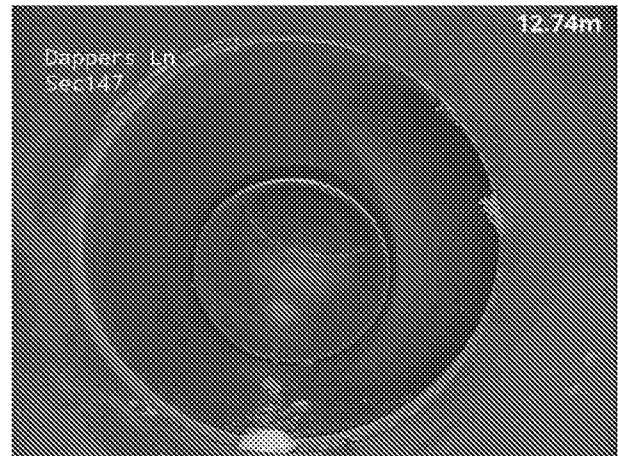
4, 00:00:49, 12.90 m  
Junction at 3 o'clock, 100mm dia

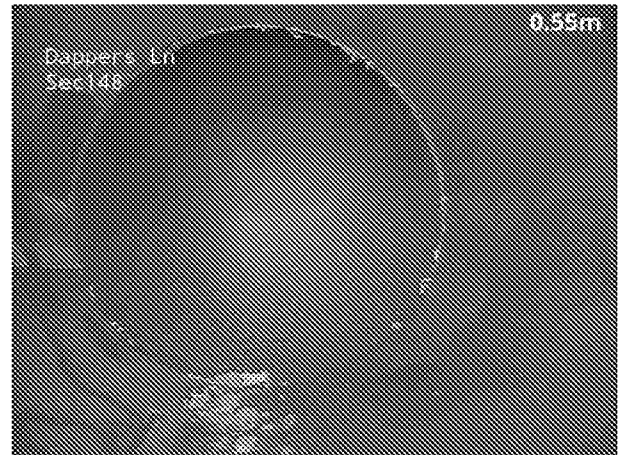
2, 00:00:12, 0.70 m  
Line deviates up

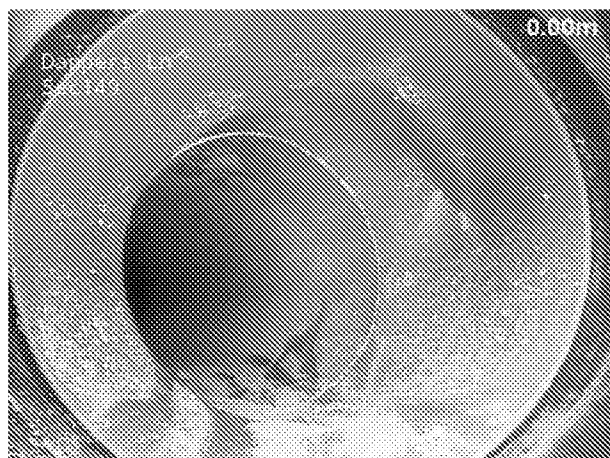
1, 00:00:02, 0.10 m  
Line deviates left

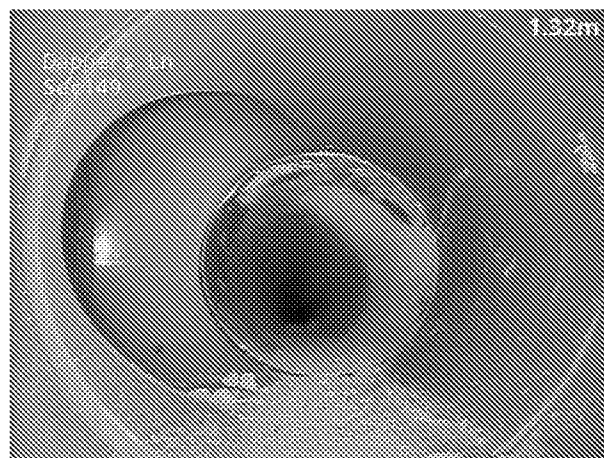
2, 00:00:10, 1.40 m  
Junction at 9 o'clock, 100mm dia

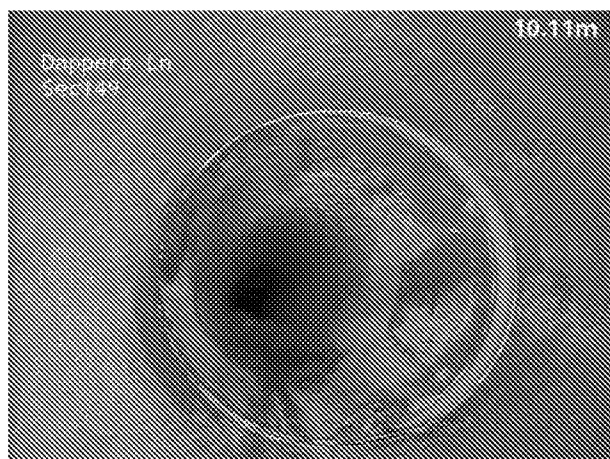
3, 00:00:37, 10.30 m  
Line deviates left

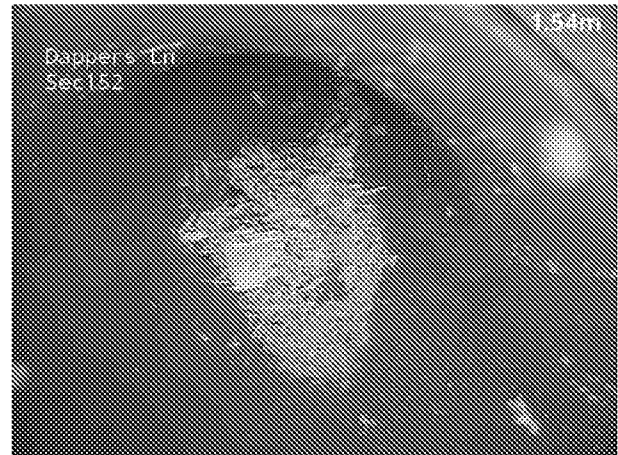
2, 00:01:21, 1.50 m  
General remark, Rest bend

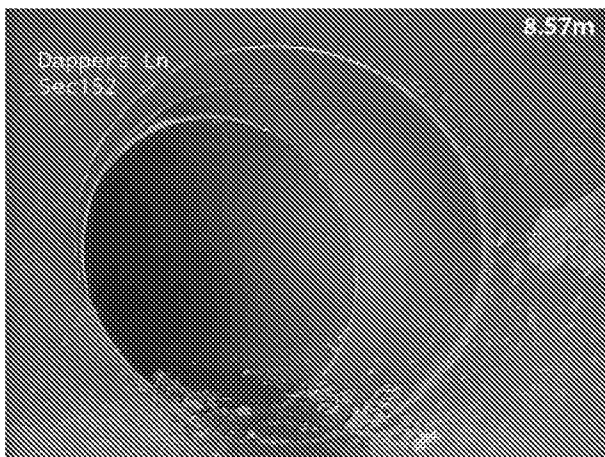
3, 00:00:50, 8.70 m  
Line deviates left

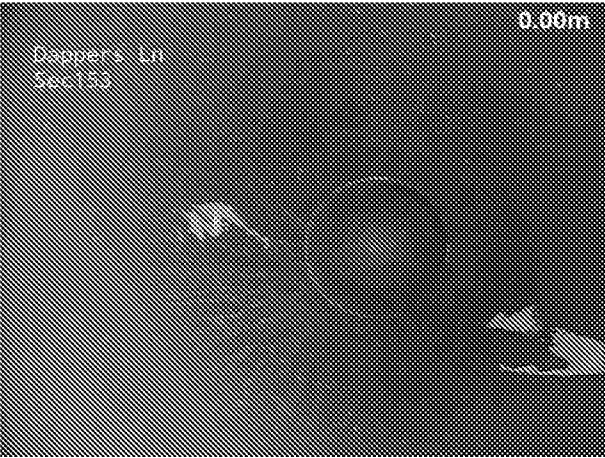
| <p>1, 00:00:02, 0.00 m<br/>Water level, 0% of the vertical dimension</p> | <p>2, 00:00:06, 0.60 m<br/>General remark, Rest bend</p> |

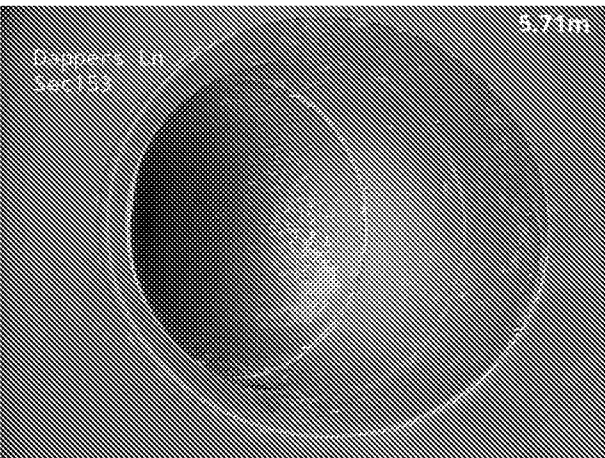
| <p>5, 00:00:43, 5.80 m<br/>Line deviates left</p> | <p>6, 00:01:07, 9.40 m<br/>Finish node, manhole, reference: F20</p> |

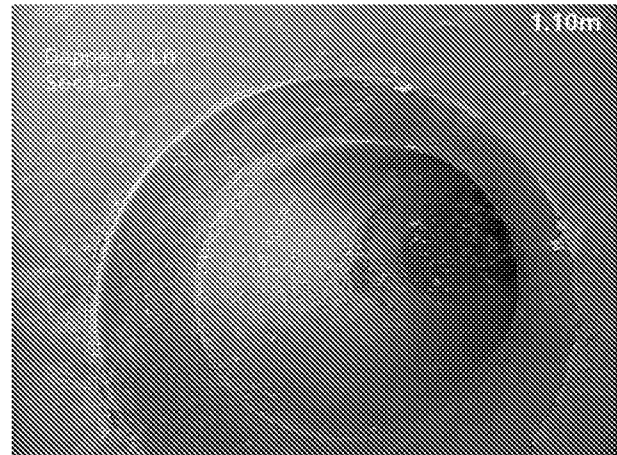
2, 00:00:13, 1.30 m  
General remark, Rest bend

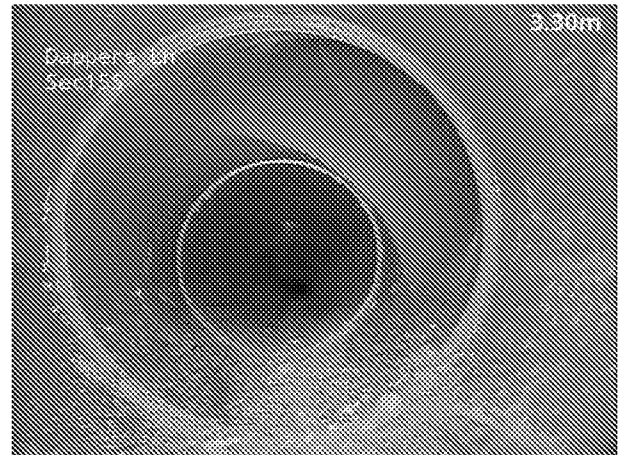
2, 00:00:46, 3.50 m  
Junction at 2 o'clock, 100mm dia

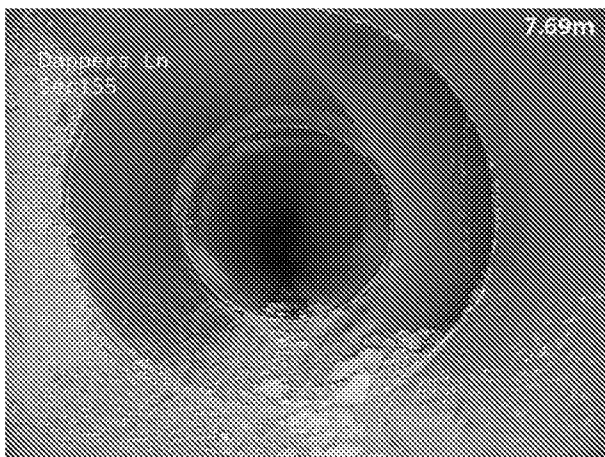
3, 00:00:29, 7.80 m  
Junction at 3 o'clock, 100mm dia

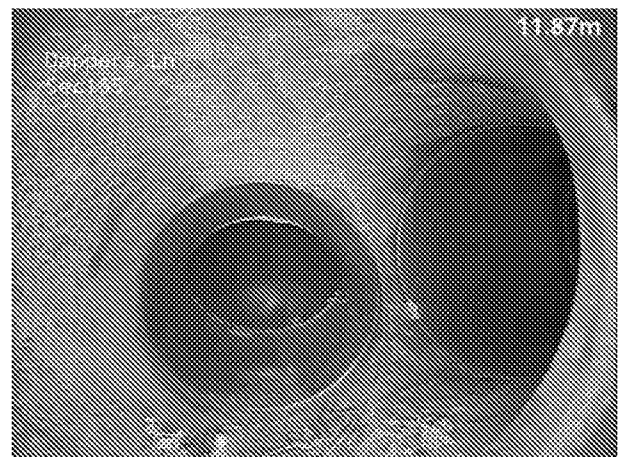
4, 00:00:11, 12.00 m  
Junction at 3 o'clock, 100mm dia

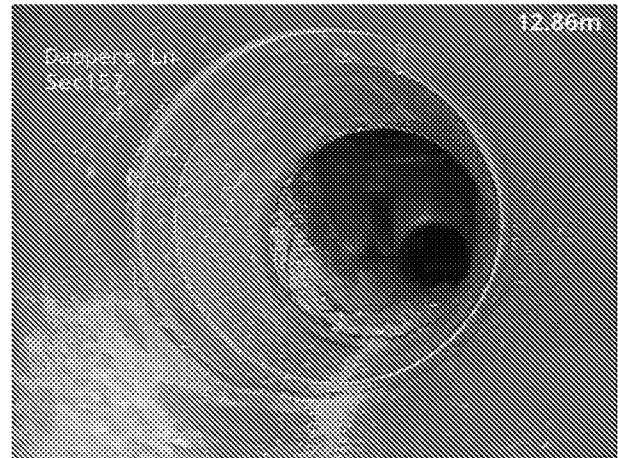
2, 00:00:35, 13.00 m  
Line deviates right

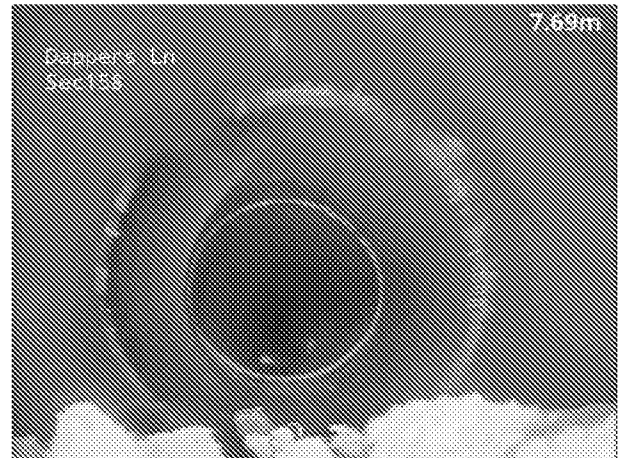
2, 00:00:23, 7.80 m  
Junction at 9 o'clock, 100mm dia

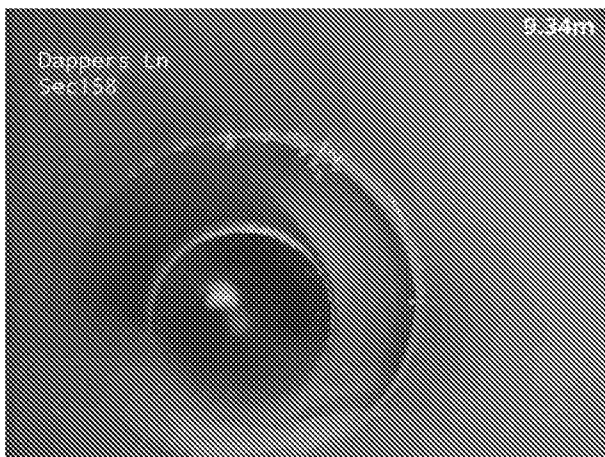
3, 00:00:25, 9.50 m  
Junction at 3 o'clock, 100mm dia

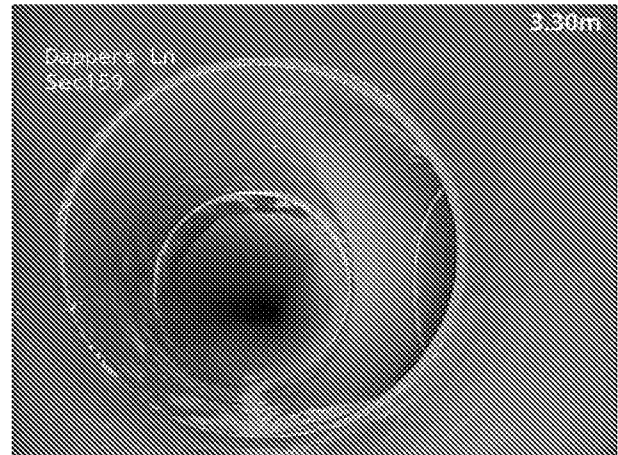
2, 00:00:13, 3.40 m  
Junction at 3 o'clock, 100mm dia

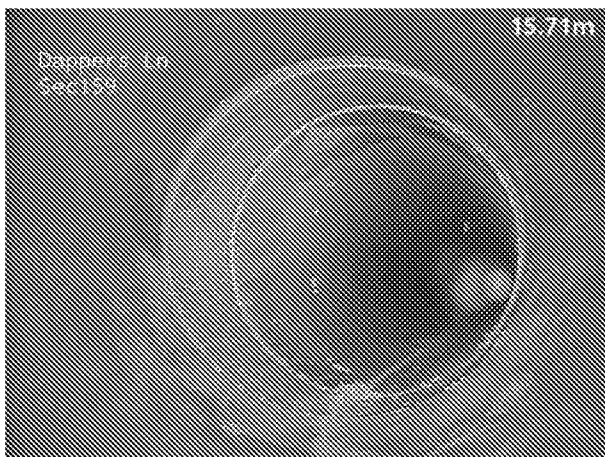
3, 00:00:37, 15.80 m  
Line deviates right

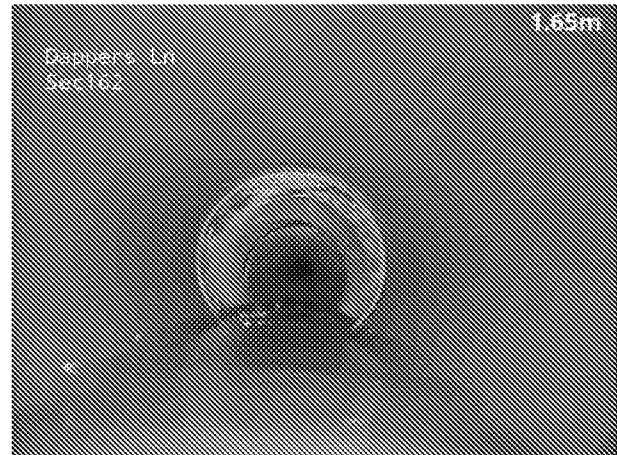
2, 00:00:19, 1.60 m  
Water level, 10% of the vertical dimension
