**Project Name:** Mackoy Ltd - Langmead Place Angmering

**Project Date:** 04/11/2025

**Inspection Standard:** MSCC5 Sewers & Drainage GB (SRM5 Scoring)

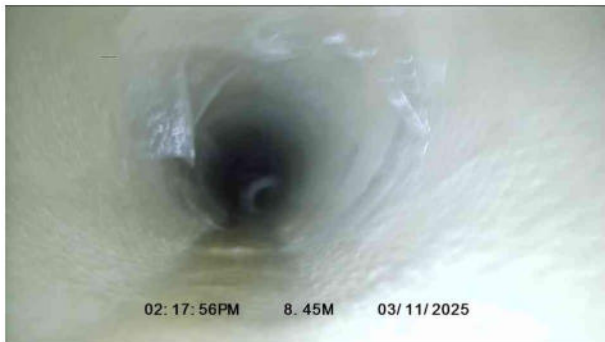
2, 00:00:18, 1.53 m  
Point repair, localised lining from 12 o'clock to 11 o'clock, start

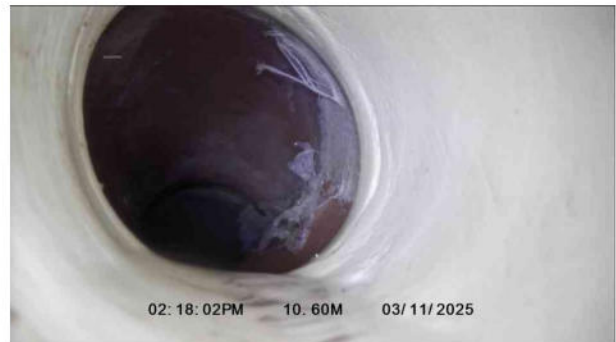
3, 00:00:29, 8.45 m  
Point repair, localised lining from 12 o'clock to 11 o'clock, start

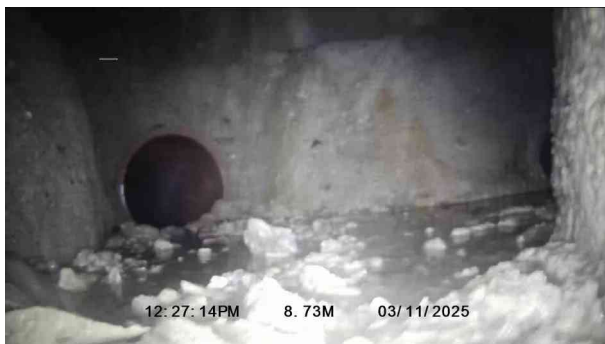
2, 00:00:15, 0.76 m  
Point repair, localised lining from 12 o'clock to 11 o'clock, start

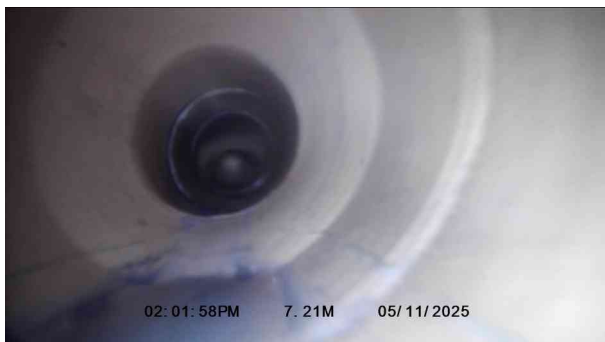
2, 00:00:07, 0.00 m  
Point repair, localised lining from 12 o'clock to 11 o'clock, start

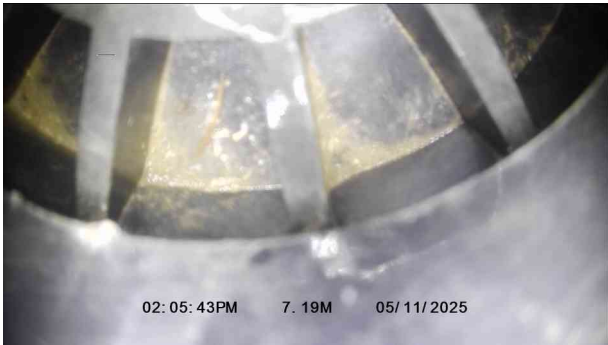
2, 00:00:08, 0.00 m  
Point repair, localised lining from 12 o'clock to 11 o'clock, start
