# Tree Condition Survey Report (VTA)

**Site:** Angmering Medical Centre, Station Road, Angmering,  
West Sussex BN16 4HL

**Client:** **Workman LLP**

| <i>GC Document Reference</i> | J250869 | | |

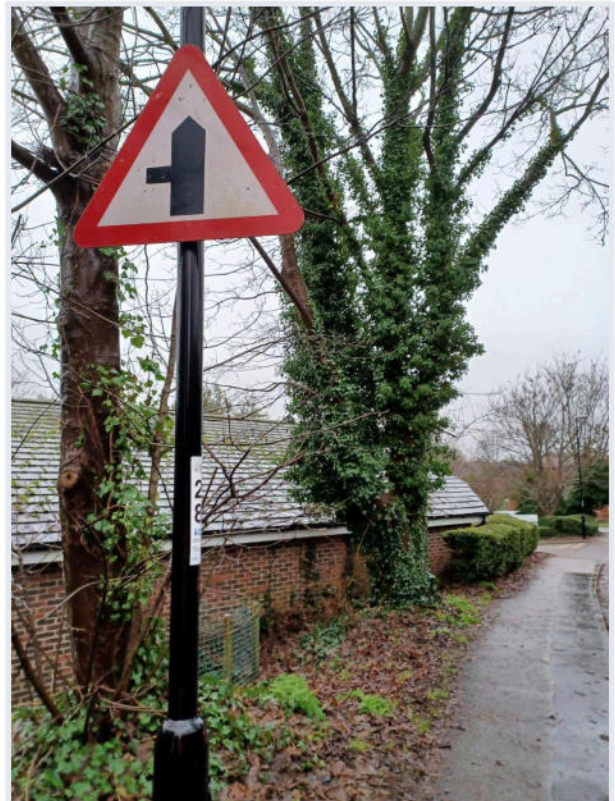
## Sycamore Tree ID #4

| Tree Survey Schedule | | | | | | | | | | | | | | | | | |
|---|---|---|---|---|---|---|---|---|---|---|---|---|---|---|---|---|---|
| 4 | | Sycamore | Acer pseudoplatanus | 16-20m | 500 | Early-mature | Good | Fair | Ivy restricting inspection of union at tree base. Previous works completed but not maintained and has regrown. | No access | Co-dominant Stem, Ivy Covered Stem, Multi-Stem | None Significant | None Observed | Building, Footpath, Road, Street light/furniture | High | No access to base/stem | Client |

| Structural Condition: | Fair |

| Tree / Group ID | Common Name | Work Task | Work Priority | Description | Tag No |
|---|---|---|---|---|---|
| 4 | Sycamore | Sever and Remove Ivy to<br>1.5m Above Ground<br>Level | Within 6 - 12<br>Months | | |

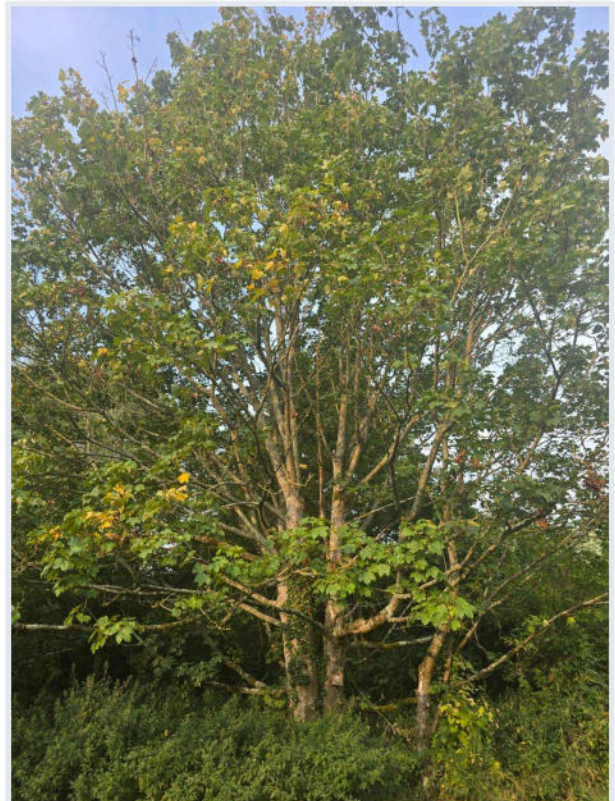
## Sycamore Tree ID #5

| Tree Survey Schedule | | | | | | | | | | | | | | | | | |
|---|---|---|---|---|---|---|---|---|---|---|---|---|---|---|---|---|---|
| 5 | No access to stem to tag. | Sycamore | Acer pseudoplatanus | 11-15m | 400 | Mature | Poor | Poor | No access to base due to dense vegetation wounding on northern stem at 3m exposing heartwood will require yearly monitoring. 3 co-dominant stems. | No access | Bark Wounding/Damage, Climber Present - Ivy, Co-dominant Stem | Major Dead Wood Over 50mm Diameter | None Observed | Building, Open space, Inaccessible woodland | High | No access to base/stem | Client |

| Structural Condition: | Poor |

| Tree / Group ID | Common Name | Work Task | Work Priority | Description | Tag No |
|---|---|---|---|---|---|
| 5 | Sycamore | Remove Dead Wood | Within 3 - 6<br>Months | | No<br>access<br>to<br>stem<br>to tag. |

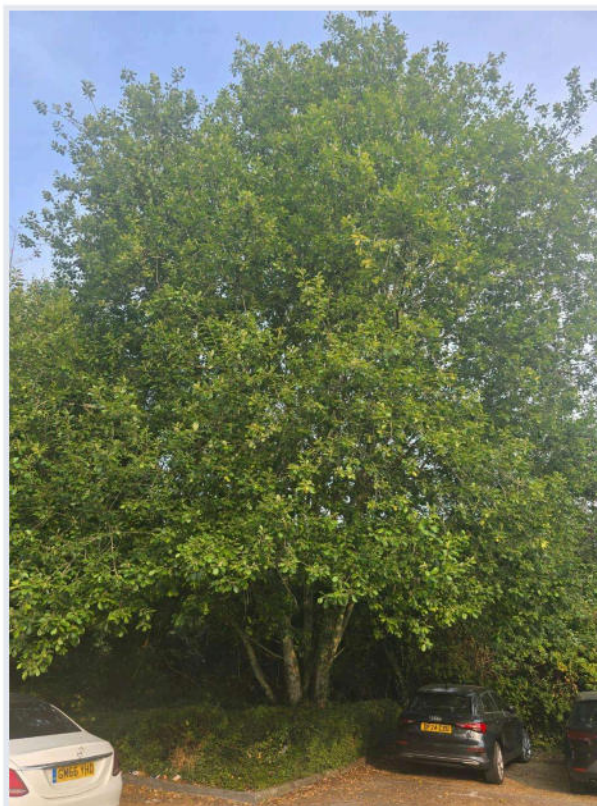
## Goat willow Tree ID #6

| Tree Survey Schedule | | | | | | | | | | | | | | | | | |
|---|---|---|---|---|---|---|---|---|---|---|---|---|---|---|---|---|---|
| 6 | 4461 | Goat willow | Salix caprea | 11-15m | 300 | Mature | Fair | Fair | No access to base due to dense vegetation. 9 stems. | No access | Bark Wounding/Damage, Co-dominant Stem, Multi-Stem | Low Crown, Minor Dead Wood Under 50mm Diameter | None Observed | Car park, Inaccessible woodland | High | No access to base/stem | Client |

Structural Condition: Fair

| Tree / Group ID | Common Name | Work Task | Work Priority | Description | Tag No |
|---|---|---|---|---|---|
| 6 | Goat willow | Crown Lift Over Car<br>Park/ Footpath to 2.5m | Within 3 - 6<br>Months | | 4461 |

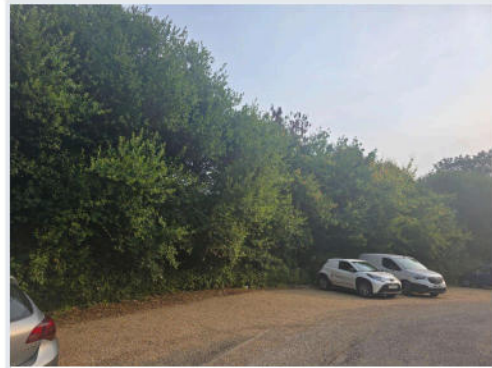
## Group ID #2

| Tree Group Survey Schedule | | | | | | | | | | | | | | | | | | |
|---|---|---|---|---|---|---|---|---|---|---|---|---|---|---|---|---|---|---|
| 2 | | Field maple, Lawson cypress, Common ash, Wild cherry, Elder | Acer campestre, Chamaecyparis lawsoniana, Fraxinus excelsior, Prunus avium, Sambucus nigra | Approximately 30 | 11-15m | 150-300mm | Early-mature | Good | Good | No access to base due to dense vegetation. | No access | Co-dominant Stem, Multi-Stem | Low Crown | None Observed | Car park, Inaccessible woodland | High | No access to base/stem | Third Party |

| Tree / Group ID | Common Name | Work Task | Work Priority | Description | Tag No |
|---|---|---|---|---|---|
| Group 2 | Field maple,<br>Lawson<br>cypress,<br>Common ash,<br>Wild cherry,<br>Elder | Crown Lift Over Car<br>Park/ Footpath to 2.5m | Within 3 - 6<br>Months | | |
