## RICS Home Surveys Building Survey

Dormouse Cottage  
The Square  
Angmering  
LITTLEHAMPTON  
BN16 4EA

2nd February 2021

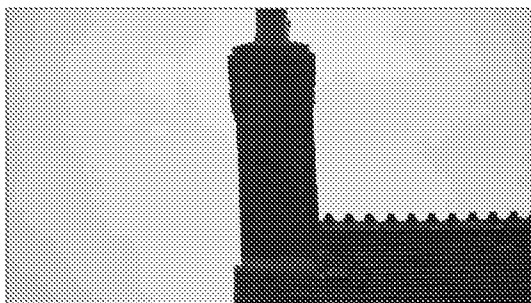
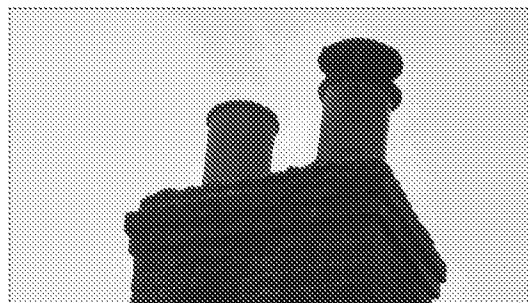
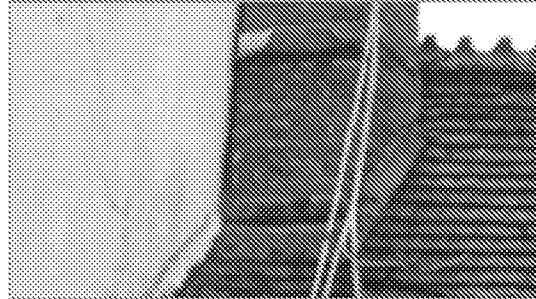
The southernmost chimney is a single stack with a single clay pot and serves the fireplace in the dining room. There is moss to the top of this chimney which should be removed and the flashings at the base of the chimney, at the junction with the main roof, is in mortar. This has cracked which is often caused by expansion and contraction during the various seasons and it is recommended that the mortar is renewed

An internal inspection in the roof void revealed damp staining and high damp reading. There are also spalling bricks. The pointing should be renewed and the bricks replaced.

The effects of the sun has led to slight curvature of the chimney. This can ultimately lead to chimneys becoming unstable in extreme conditions. Curvature occurs because mortar joints facing south are dried by the sun and wind. North facing mortar joints do not dry out as fast as those facing south. As a consequence crystals form in the mortar on the north facing mortar joints, which causes the mortar to expand and the chimney stacks to curve towards the south. The slight lean is considered to be within acceptable limits.

The bedroom and living room fires had been lit on our inspection. When we opened the loft hatch there was distinct smell of smoke. Unfortunately stored items prevented an inspection of the chimney. It is recommended that a smoke test of the chimney is carried out and any leaks within the roof void are repaired.

Condition rating 3. These works/investigations should be carried out immediately.

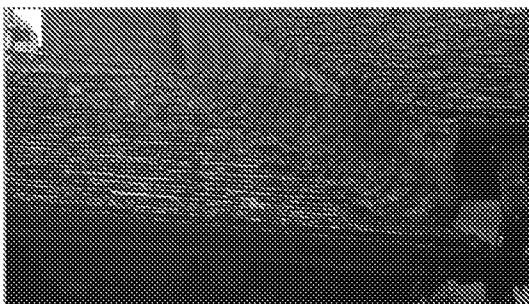
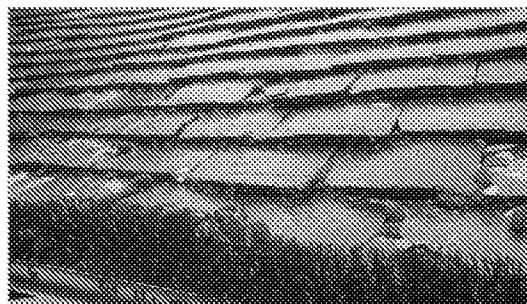
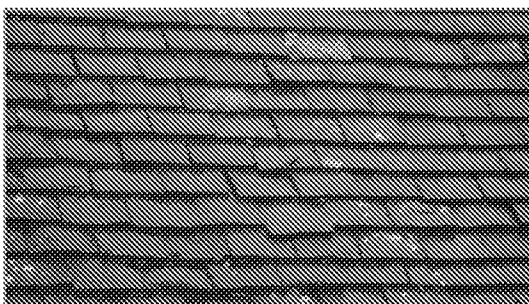
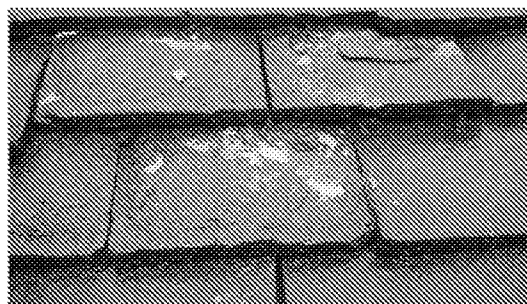
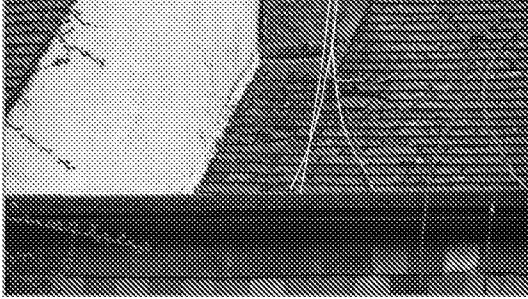
Where the roof meets the adjacent owners property to the front and rear slopes the junction has been formed in mortar. This is not good practice due to the risk of cracks forming and the mortar should be renewed in lead.

Moss was observed to the roof surfaces. This should be carefully removed as it tends to retain moisture, which can cause damage to roof coverings over a period of time.

To the rear roof slope some of the tiles have delaminated and there are some cracked tiles. This is often caused by moss or frost action and the affected tiles should be renewed.

We were unable to view the flat roof to the rear of the property and cannot confirm the type or condition. However from a limited inspection of the edging felt we have assumed the roof is old and may be coming to the end of its economic life. You should arrange for an inspection by a Property care association (PCA) contractor.

Condition rating 3. These works/investigations should be carried out immediately.

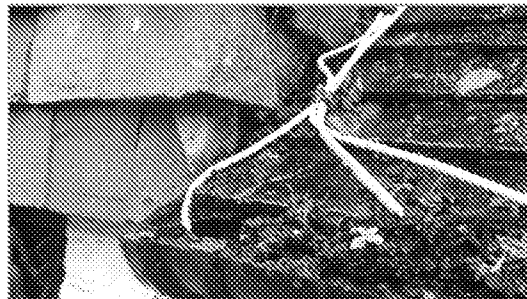
Photo - 12

Whilst it was not raining during the course of the inspection it had been raining over night. The cast iron gutter joints to the front of the property were leaking and the leaf guard to the rear gutters are blocked.

The front cast iron gutters are out of alignments and therefore consideration should be given to replacement in PVCu.

Condition rating 3. These works should be carried out immediately.

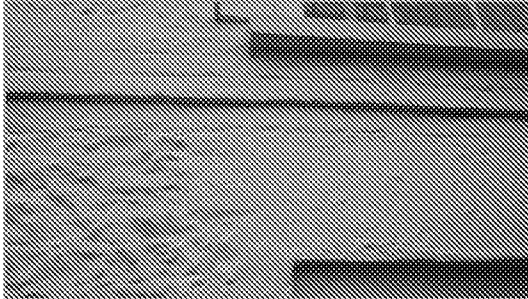
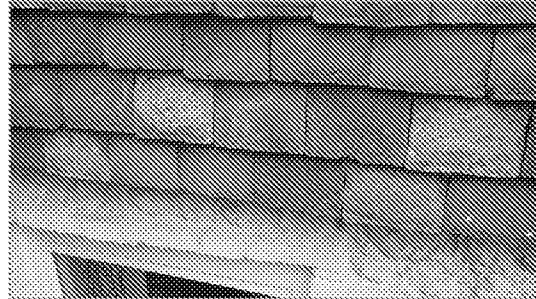
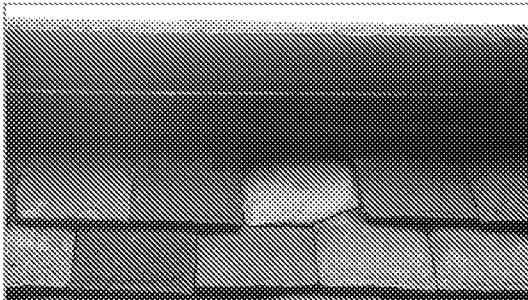
To the front elevation there are some filled thermal cracks which appear sound.

To the rear of the property there is an area of vertical plain tiles. Some tiles are missing and there is delamination to some of the tiles. These should be renewed to help reduce the risk of damp to internal areas.

Condition rating 3. These works should be carried out immediately.

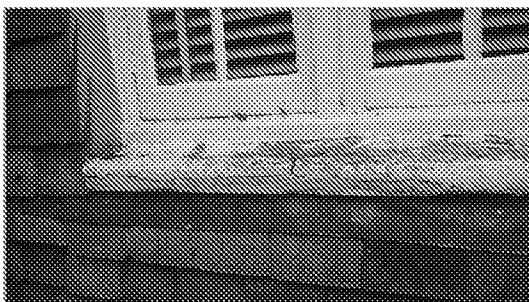
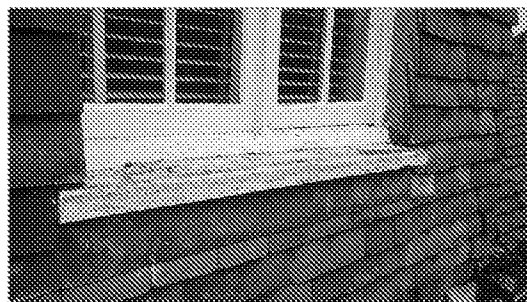
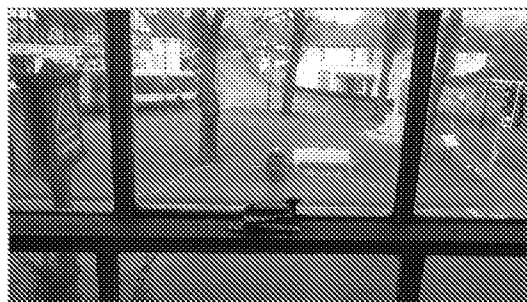
The windows are of timber box sash construction and some areas of softness and rot are evident and repairs/replacement are now required to the two rear first floor windows. Although I have inspected a sample of timber, the possibility of hidden defects being present to concealed timbers cannot be entirely ruled out. It should be possible with routine maintenance to repair and refurbish the windows and you may wish to seek quotations for these works prior to commitment to purchase.

There are a number of cracked panes which require replacement.

We attempted to open windows but the majority would not operate and therefore you should budget to overhaul all windows.

Condition rating 3. These works should be carried out immediately.

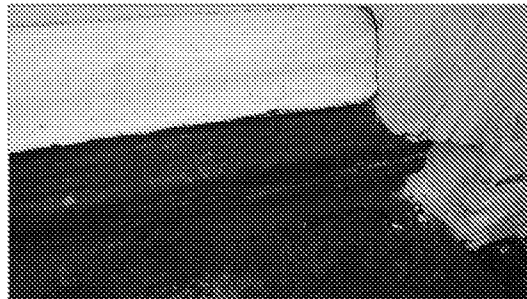
Photo - 21

The front door is timber and sits within a timber frame. The door has a weatherboard which is good practice and helps deflect rainwater from more vulnerable areas. There is wet rot to the threshold which should be renewed.

The rear door is timber and glazed in a stable style. The door is in poor condition with rot at its base and should be renewed.

Condition rating 3. These works should be carried out immediately.

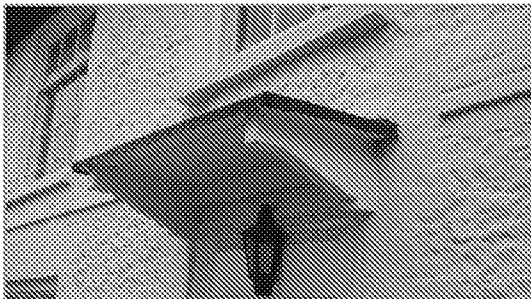
Photo - 23

These appear to be in generally satisfactory condition but a closer inspection may reveal areas of rot behind guttering.

External decorations are deteriorating in some areas. The affected sections should be thoroughly prepared and redecorated in the near future.

Condition rating 2. These works should be carried out soon.

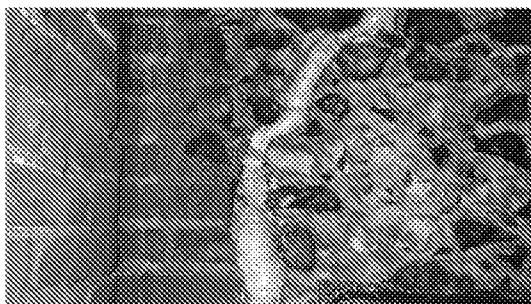
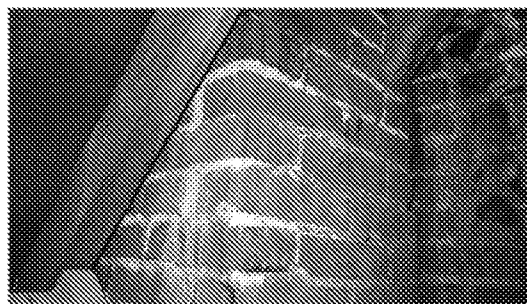
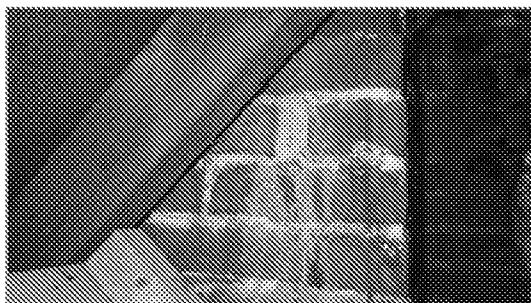
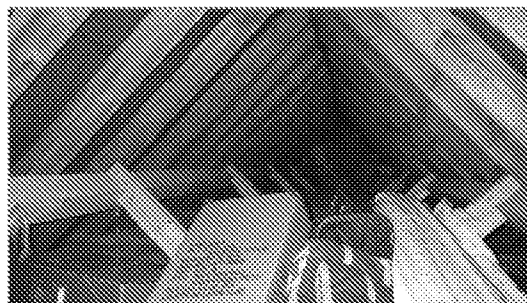
There is a flint party wall with the adjacent owner. There is a rather crude attempt to fill a gap in the flint wall with expanding foam. The gap should be repaired with lime mortar to help reduce the risk of the spread of smoke and fire.

As discussed there is damp to the south chimney. There is also damp staining to the party wall likely to

be caused by the mortar flashing reported earlier. External repairs have been recommended.

The chimney to the north could not be seen but as discussed there is a smell of smoke in the roof void and we suspect that either the pointing is poor or bricks may have deteriorated.

There were signs of vermin and mice droppings present. Baited traps should be placed as a precautionary measure. If an active presence of vermin is discovered on occupation, it would be prudent to investigate further with a suitably qualified pest control contractor.

Condition rating 3. These works should be carried out immediately.

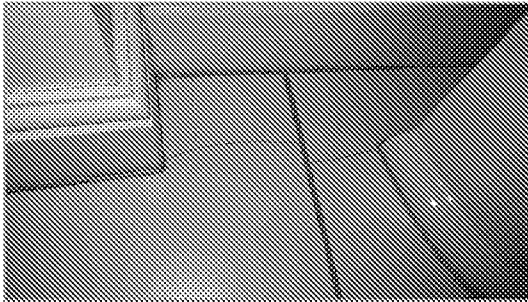
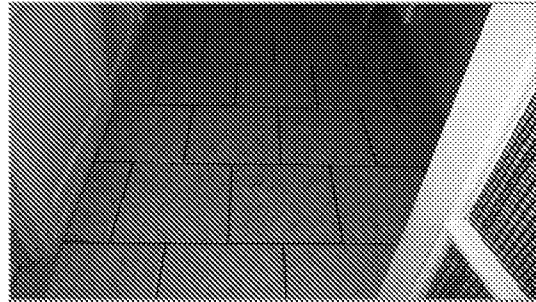
Ceramic tiles have been laid in the bathroom. Some of these tiles are cracked due to the fact that they are inherently brittle and become cracked when laid on timber flooring due to the natural springiness of the floor construction. The cracked tiles should be replaced.

Condition rating 2. These works should be carried out soon.

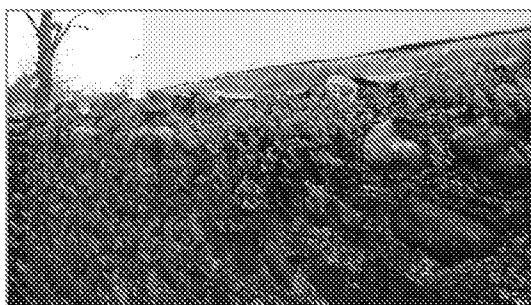
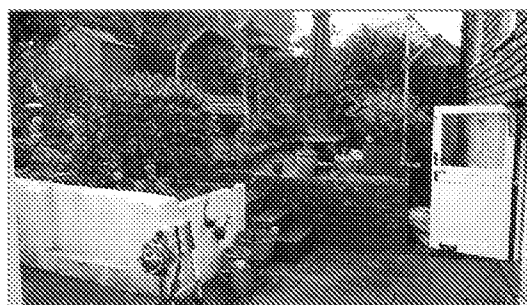
The retaining wall and steps to the rear have no hand rails to prevent falls from height and they would benefit from drainage channels.

Condition rating 3. These works should be carried out immediately.
