**Bellamy Wallace Partnership**  
Consulting Structural Engineers

**REPORT ON VISUAL INSPECTION OF  
CONDITION OF EXISTING BUILDINGS AT  
SITE OF PROPOSED REDEVELOPMENT**

**Arundel Road  
Angmering,  
Littlehampton,  
BN16 4ET**

Date: 01 March 2023

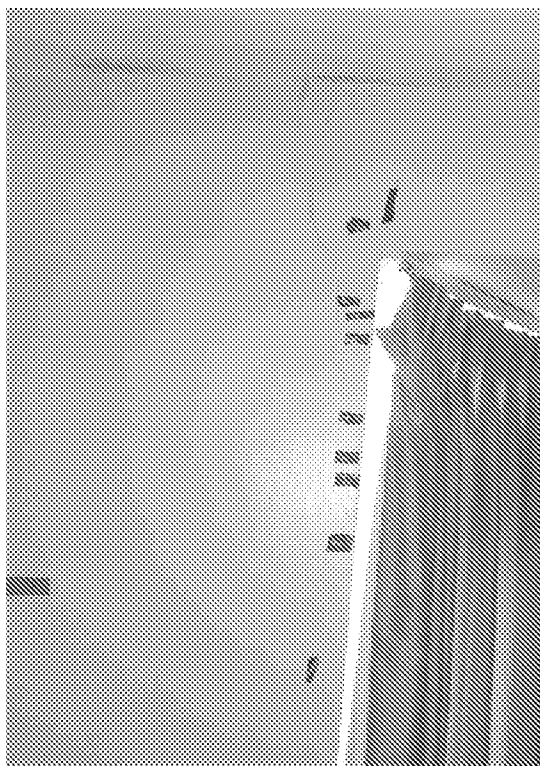
- 3.1.1 The ground bearing slab appears to be settling unevenly as evidenced by the cracking shown in the photos 6 to 10 and 13 and may be subject to heave.
- 3.1.2 Cracking of the ground bearing slab outside the house and in the drive would appear to be indicative of further settlement.
- 3.1.3 The beam propping the roof of the garage appears to have inadequate restraint.
- 3.1.4 Cracks to the walls within the building would appear to be consistent with settlement of the ground bearing slab.

Photo 7 - Block A - crack in wall to the left of front bay window

Given the uneven settlement of the ground bearing slab and the cracking that this appears to have caused to the walls of the house and garage it is recommended that the house and garage be demolished.

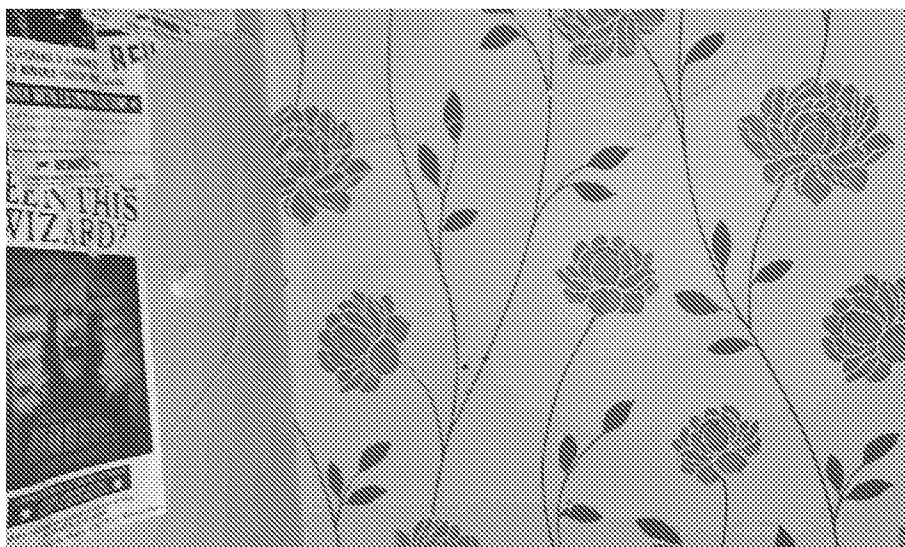
Photo 9 - Block A - crack in the return wall to the right of front bay window

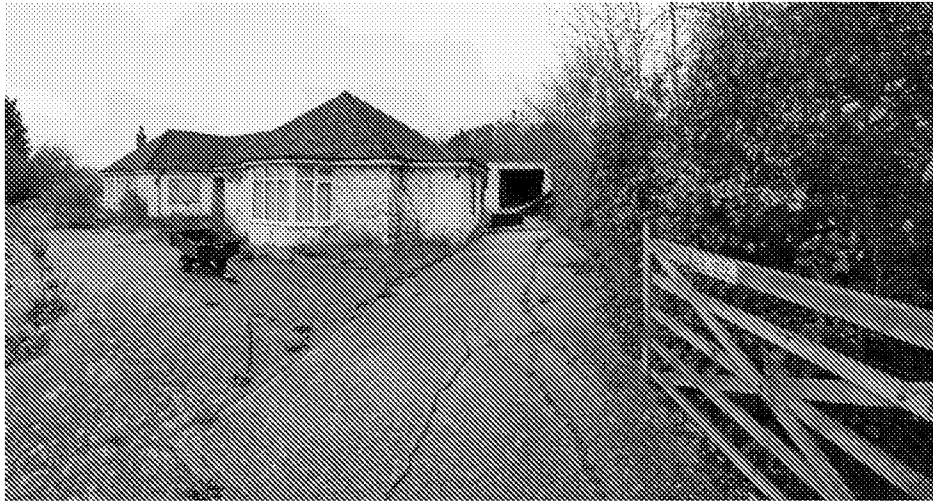
Photo 10 - Block A - view of concrete slabs at the front of the house

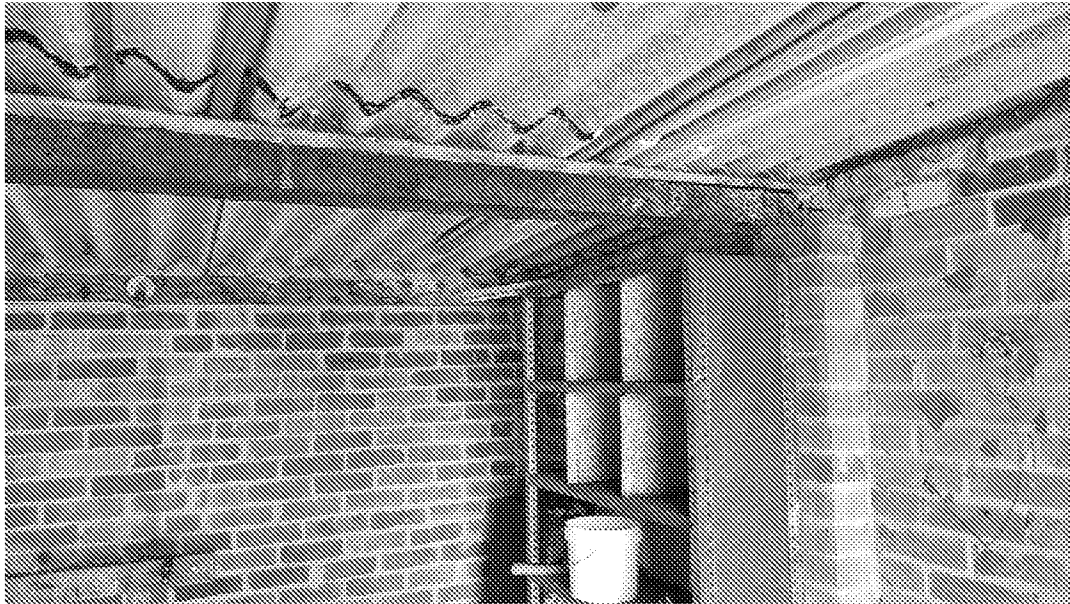
- 3.0.1 Block A comprises a brick-built bungalow with load bearing masonry walls. The roof tiles comprise concrete tiles as seen from Photos 1-5.
- 3.0.2 The house is founded on a ground bearing slab, with a raised timber floor to internal areas.
- 3.0.3 Cracking was noted to the masonry walls of the building as shown in photos 6-9.
- 3.0.4 The garage shown in photos 11 and 12 comprises single leaf brick walls. An intermediate beam props the roof mid-length of the garage.
- 3.0.5 In photo 12 cracking can be seen in the wall in the right-hand side of the photo.

Photo 12 - Block A – view of beam supporting garage roof propped on the brick pier

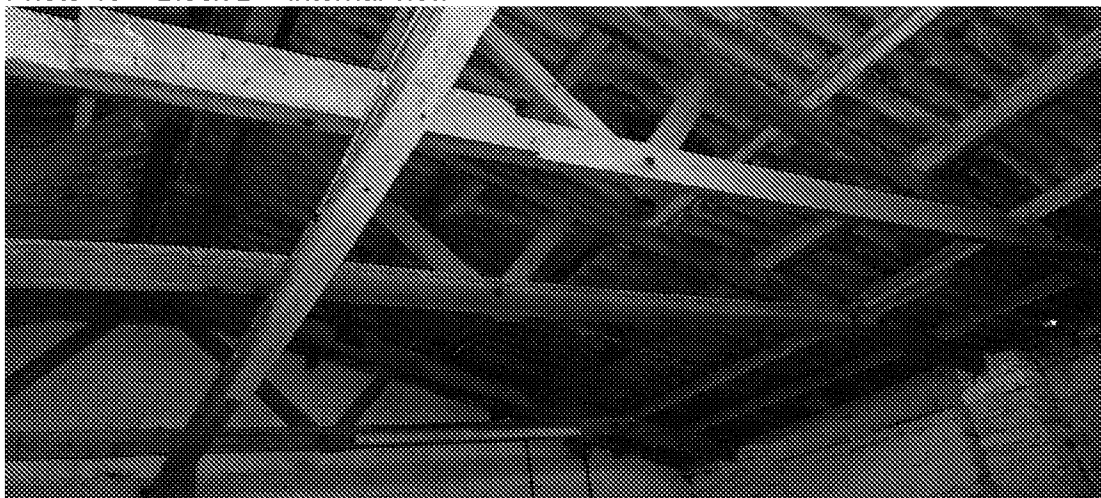
Photo 20 – Block B- Roof truss propped by timber beam

The vertical wall extension is potentially unsafe, the gable end of the extension is cracking and the roof would appear to be unsafe. Given these factors it is recommended that the building be demolished.

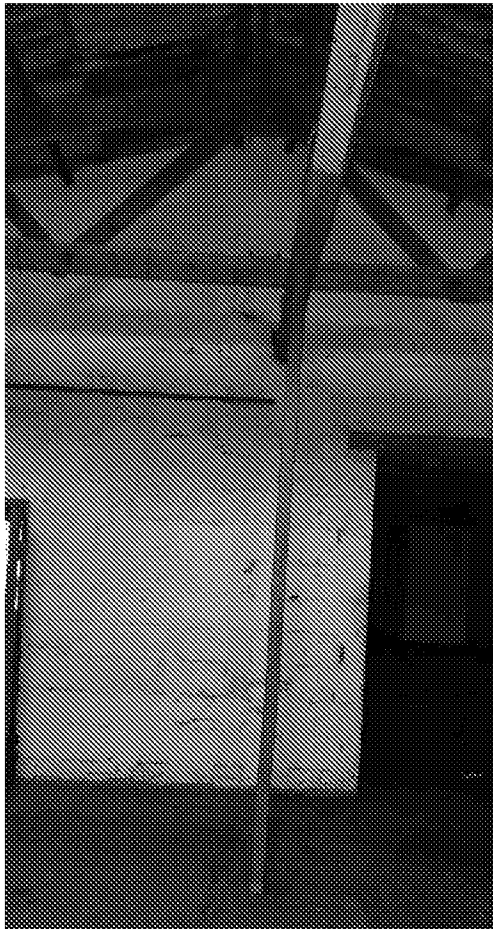
- 4.1.1 The wall detail in photo 17 with a concrete block vertical extension on top is not of robust construction and the quality of construction cannot be verified.
- 4.1.2 Photo 21 shows a prop to support the roof beam and trusses. This would appear not to meet the requirements of robustness and has the potential for collapse as the removal of this prop could cause the roof to become unsafe.
- 4.1.3 The extension at the end in rendered block is cracking in the gable wall.

Photo 21 – Block B – vertical prop supporting the beam that props the truss

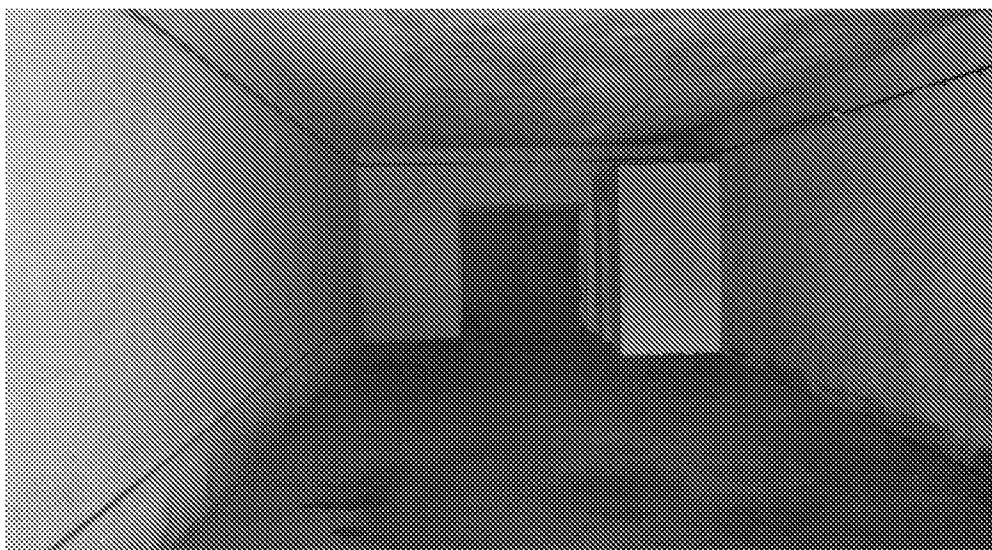
- 4.0.1 Block B comprises a large shed with load bearing masonry walls. The roof is of corrugated iron construction.
- 4.0.2 The walls comprise stone block with a concrete block vertical extension on top, as shown in photo 17.
- 4.0.3 The roof ceiling would appear to be sagging as can be seen in photo 22.
- 4.0.4 Photo 20 shows the beam that supports the roof trusses to be sagging.
- 4.0.5 Photo 21 shows a prop to support the roof beam that in turn supports the trusses.
- 4.0.6 An extension has been built to the end of the building which appears to be of rendered block. Photo 26 shows cracking to the gable end of the extension wall.

Photo 22 – Block B – internal view

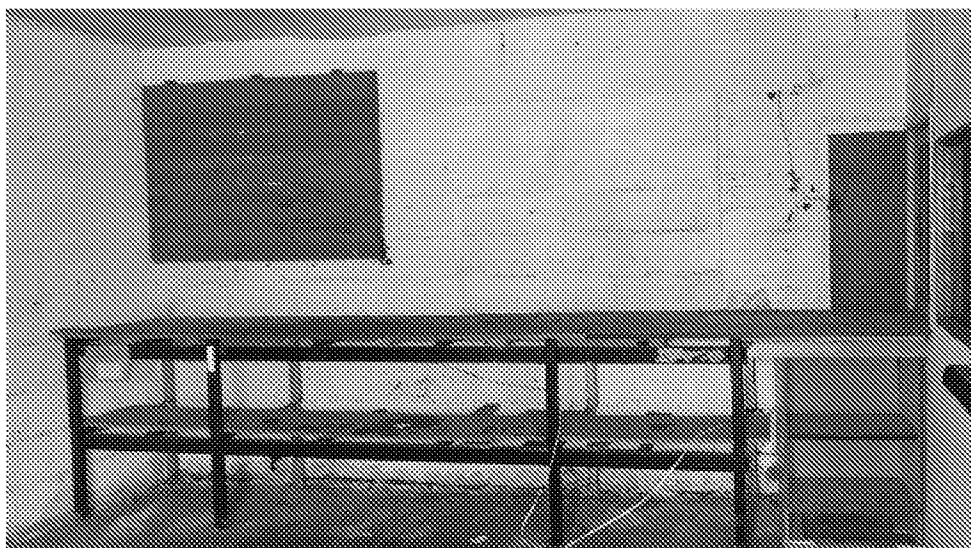
Photo 26 – Block B – internal view in the end extension

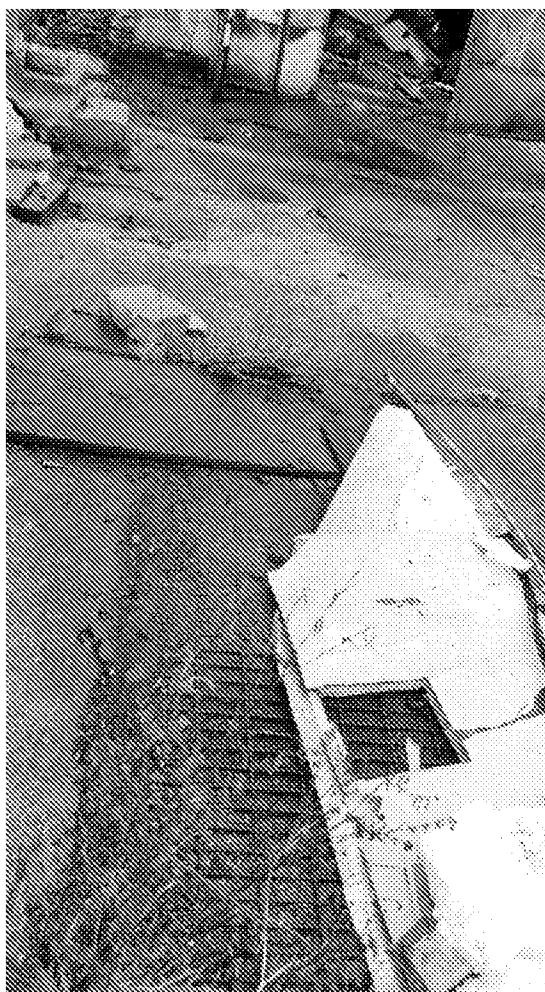
- 5.1.1 There is cracking and some damage to the gable walls of the huts.
- 5.1.2 There is cracking indicative of settlement in some of the ground bearing slabs.
- 5.1.3 There was a smell of oil in some of the huts and an oil storage bund or petrol interceptor in front of hut C5. Therefore, there is potentially oil contamination in the ground which might necessitate removing and replacing the ground as part of remediation.

Photo 32 – Block C – Oil contamination visible outside Hut C4

- A) The ground bearing slabs show cracking, the gable walls are cracking and damaged and there is the potential of oil contamination in the ground. Given these factors it is recommended that the buildings be demolished.
- B) The existing petrol interceptor should be further inspected in order to ascertain its setting out and extent i.e. depth and form of construction.

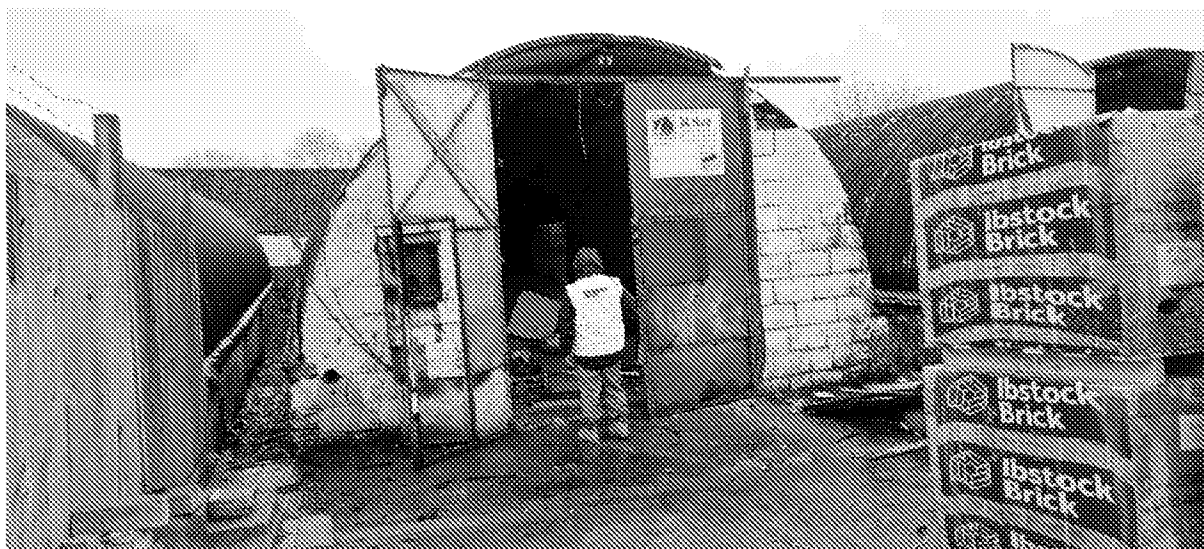
Photo 34 – Block C - Hut C4 – Apparent oil contamination visible

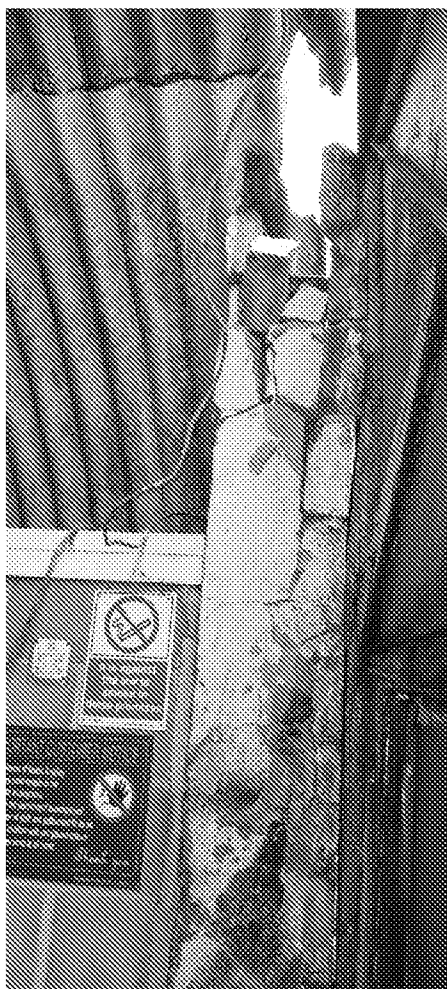
Photo 35 – Block C – Gable entrance of Hut C4 showing damage to the wall

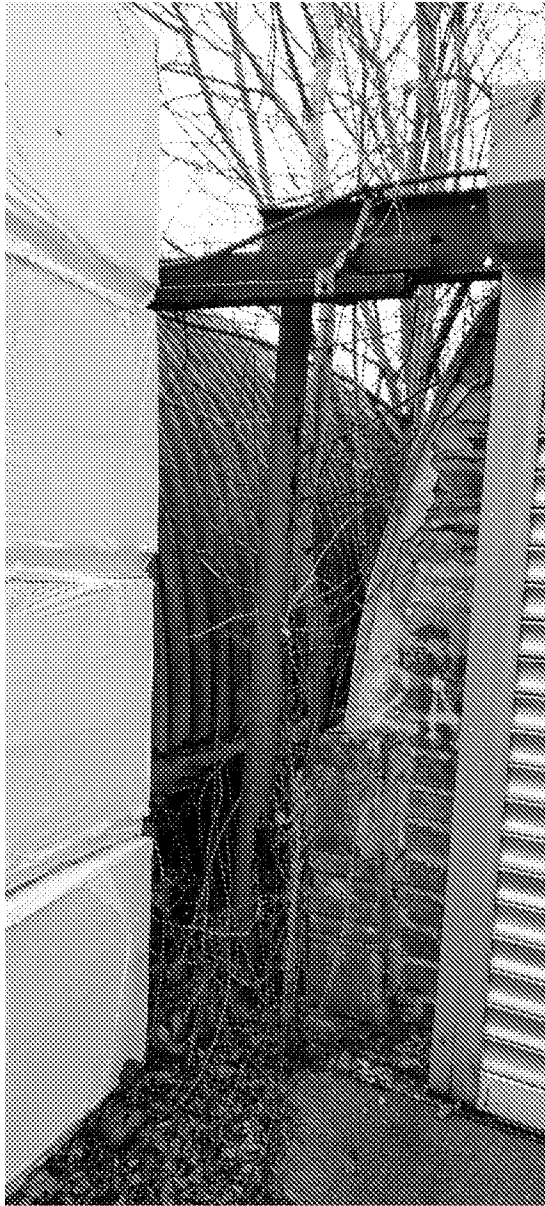
- 5.0.1 Block C comprises 5no. Nissen style huts comprising concrete block walls with a curved corrugated iron roof. The gable walls are concrete block.
- 5.0.2 In front of hut C5 there appears to be an oil storage bund or petrol interceptor. There was oil present at the site.
- 5.0.3 Photos 29 and 30 show cracking in the ground bearing slab.
- 5.0.4 Photo 35 shows damage and cracking to the gable wall of one of the huts.
- 5.0.5 Photo 36 shows cracking to the gable wall of one of the huts.
- 5.0.6 Photo 37 shows cracking to the ground bearing slab.
- 5.0.7 Photo 38 shows a steel column and beam supporting the roller shutter door in the gable wall of one of the huts. The column is in poor condition.

Photo 38 – Block C – Steel frame support to rear roller shutter door – The steel post is badly corroded

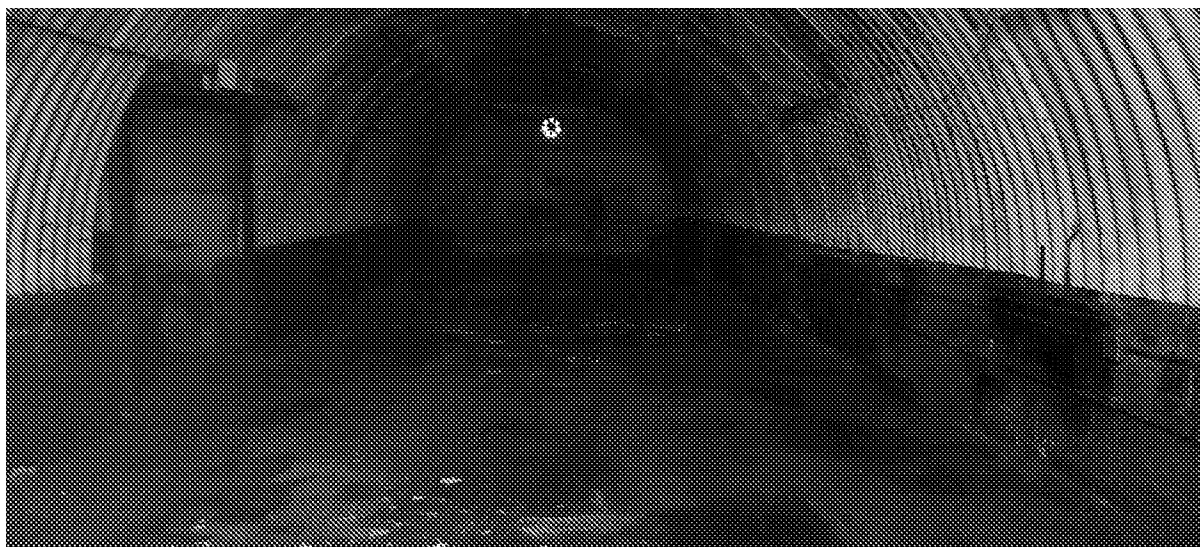
Photo 40 – Block C – Oil contamination inside Hut C1

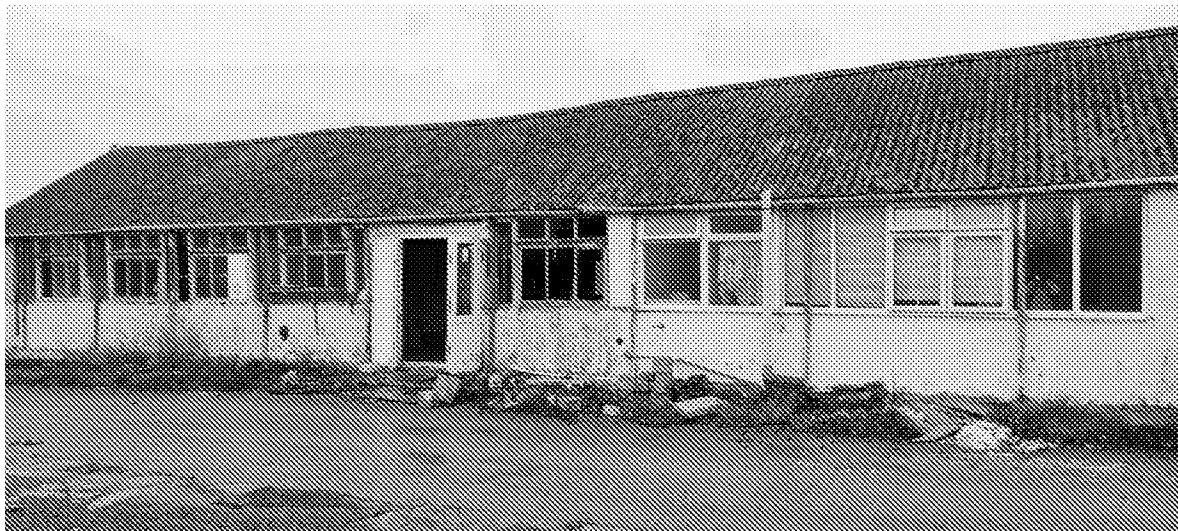
- 6.0.1 Block D comprises a single building in load bearing blockwork with a corrugated cement roof.
- 6.0.2 Photo 41 shows the roof to be sagging unevenly across its length.
- 6.0.3 Photo 44 shows the rear wall of the building leaning outwards
- 6.0.4 Photo 45 shows the roof to be propped with steel props.
- 6.0.5 Photo 46 shows cracking in the ground bearing slab.

- 6.1.1 The roof is sagging and the props supporting the roof appear to be temporary props rather than permanent construction.
- 6.1.2 There is cracking indicative of settlement in the ground bearing slab.
- 6.1.3 The rear wall is leaning outwards in which could be spread from the roof load above.

Photo 41 – Block D – Side elevation view

The ground bearing slab is cracking and the rear wall and roof are non-robust and potentially unsafe. The ground bearing slab is cracking, which implies some ground movement and subject to further soils investigation should be removed. The existing roof structure would appear to be of a sub-standard form of construction and is propped temporarily throughout. Spread of the roof at the eaves would appear to have affected the perimeter walls, which now appear out of tolerance. Given these factors it is recommended that the buildings be demolished.

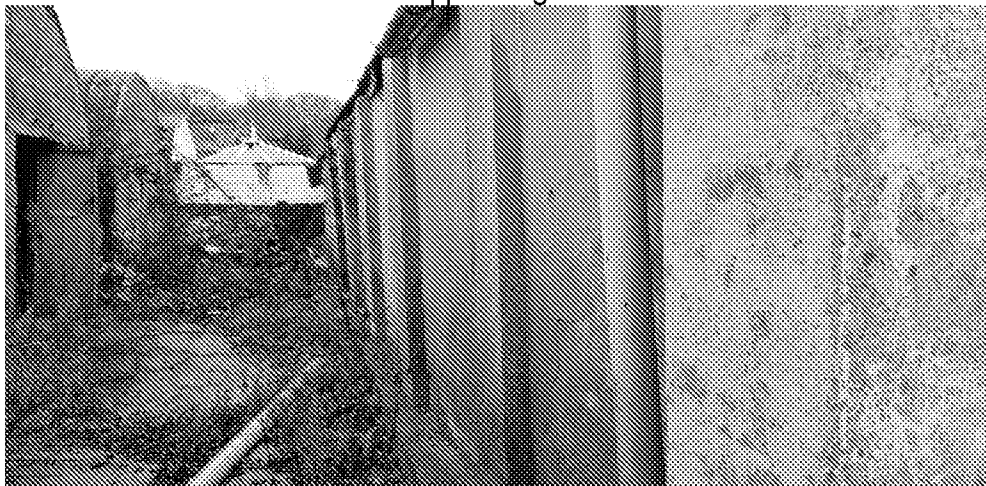
Photo 44 – Block D – View along side rear elevation showing wall leaning

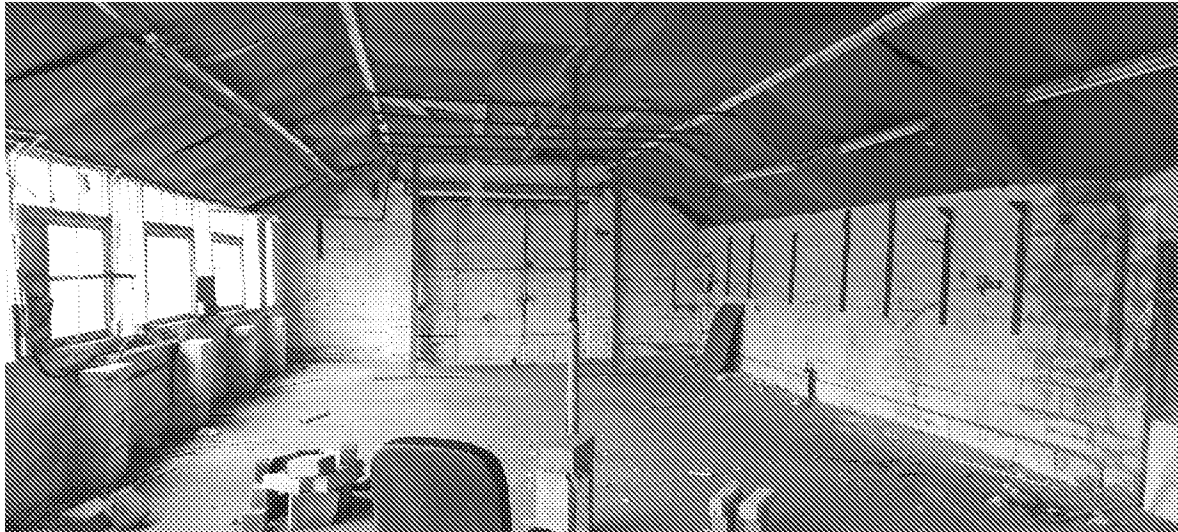
Photo 45 – Block D – view of roof showing vertical prop

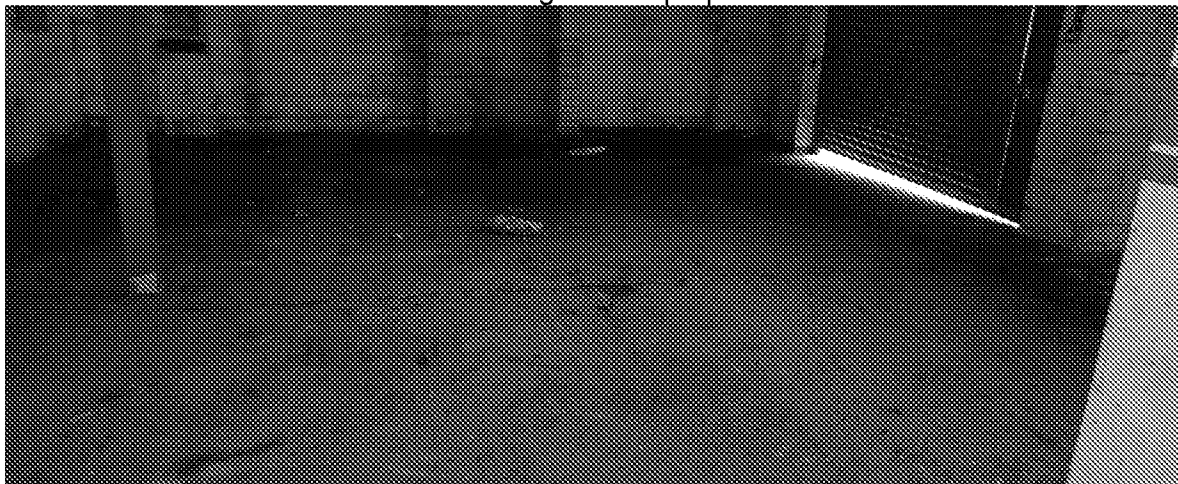
Photo 46 – Block D – cracking in the concrete floor

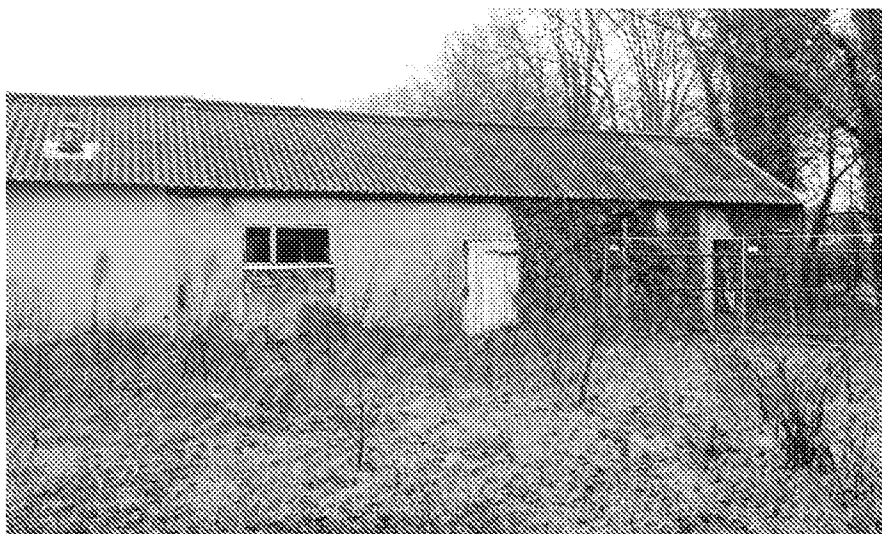
- 7.0.1 Block E comprises a single building in load bearing rendered blockwork with a corrugated iron roof.
- 7.0.2 Photo 48 shows the roof to be sagging unevenly.
- 7.0.3 Photo 51 shows cracking in the entrance gable wall.
- 7.0.4 Photo 52 shows the walls propped laterally using precast concrete posts that are strapped to the wall to provide lateral propping to the blockwork wall panels.

- 7.1.1 The roof is sagging.
- 7.1.2 The gable wall is cracked.
- 7.1.3 The construction method of propping the wall laterally is not robust and is in poor condition. Precast concrete posts are strapped to the wall to provide lateral propping to the blockwork wall panels. This does not appear to be a robust method of propping, which could leave the wall panel without adequate lateral support.

Photo 48 – Block E – View of side elevation

Given the factors listed in 7.1 is recommended that the buildings be demolished.

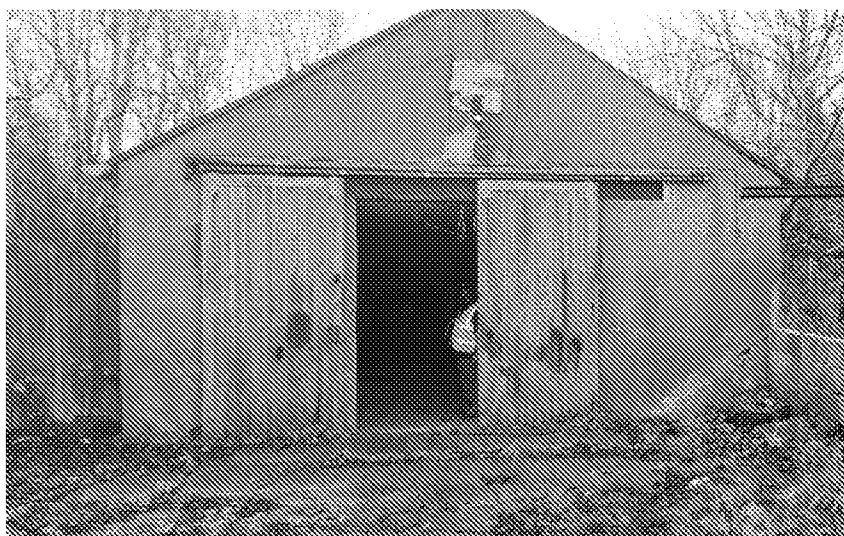
Photo 51 – Block E – View of gable end

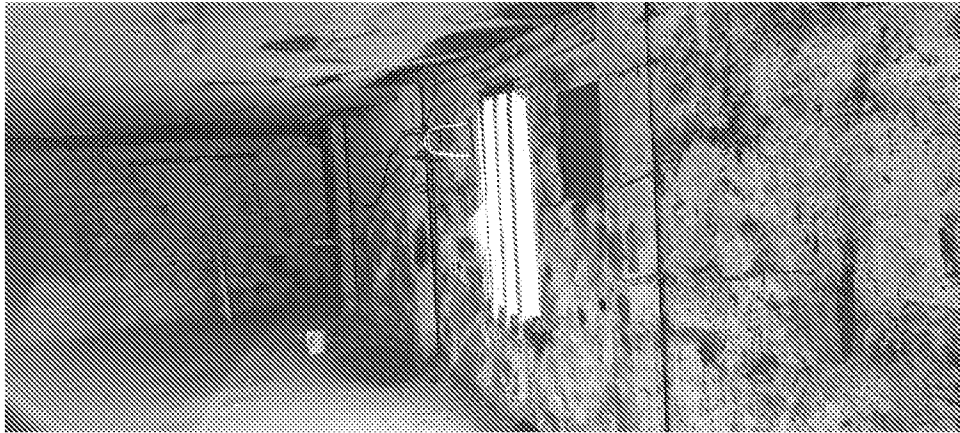
Photo 52 – Block E – View of precast posts providing lateral support to the walls. The posts are connected to the walls by means of straps.

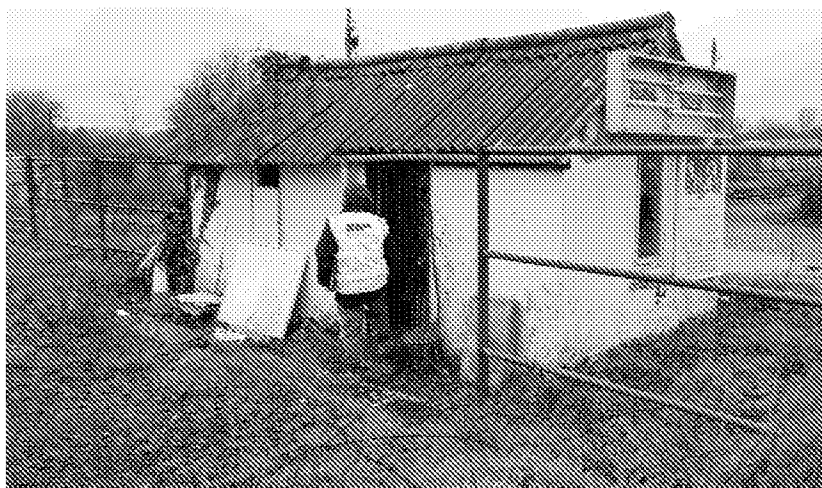
8.2 Photo 56 shows the roof to be sagging unevenly along its ridge and also cable ducts outside the building.

8.1.1 Access was not possible during our site visit, therefore it is difficult to provide any further comments. However, given the uneven sag of the existing roof ridge and bearing in mind the remaining structures surveyed it would be our conclusion that similar aspects also affect this small building.

8.1.2 Cable ducts outside the building indicate that it might have been a plant room. The cable ducts are redundant and will need to be removed as part of the development.

Photo 56 – Block F – View of the building. The cable ducts are visible outside.

Given the factors listed in 8.1 is recommended that the building be demolished.

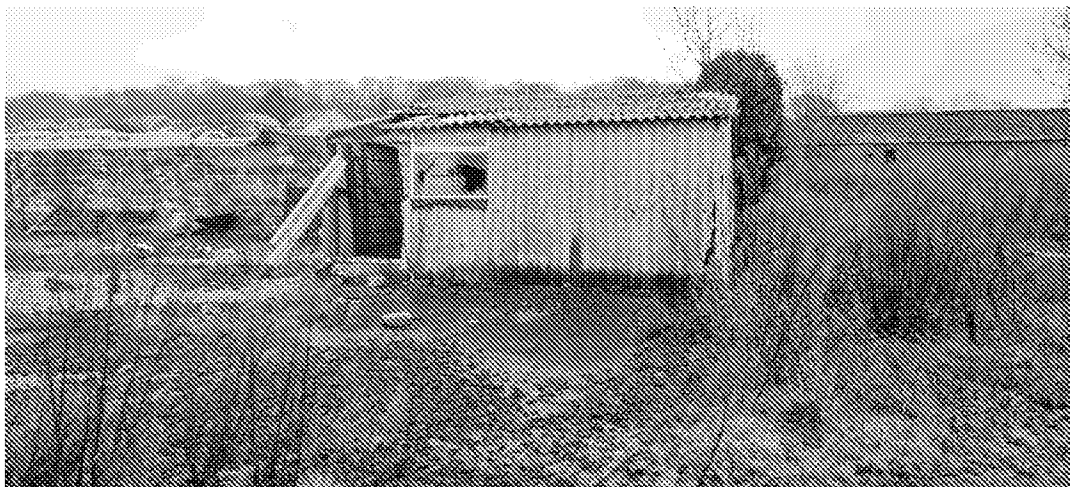
- 9.0.1 Block G comprises a single small building with corrugated cement panel walls with a corrugated iron roof.
- 9.0.2 Photo 58 shows the building to be dilapidated and sections of wall and roof are missing.

- 9.1.1 The building is a prefabricated structure and is dilapidated possible due to its age and/ or neglect.

Photo 58 – Block G – Side view – Section of wall and roof missing

Given the factors listed in 9.1 it is recommended that the building be demolished.

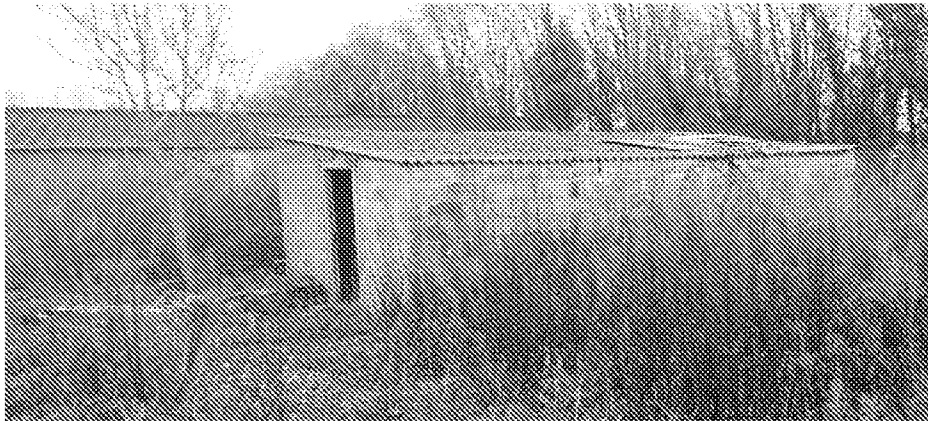
10.0.2 It appears that the building was constructed using a combination of stone and concrete blocks. Photo 60 shows the side wall in stone block and the gable wall in concrete block.

10.1.1 The building seems to be a composite construction of a wall in stonework coupled with a wall in blockwork and the two wall types do not seem to be keyed-in properly at the corner where they meet. The building is dilapidated state possibly due to its age and/ or neglect.

Photo 60 – Block H – Side view – Gable end is in concrete block and the side elevations are in stone block.

Given the factors listed in 10.1 it is recommended that the building be demolished.

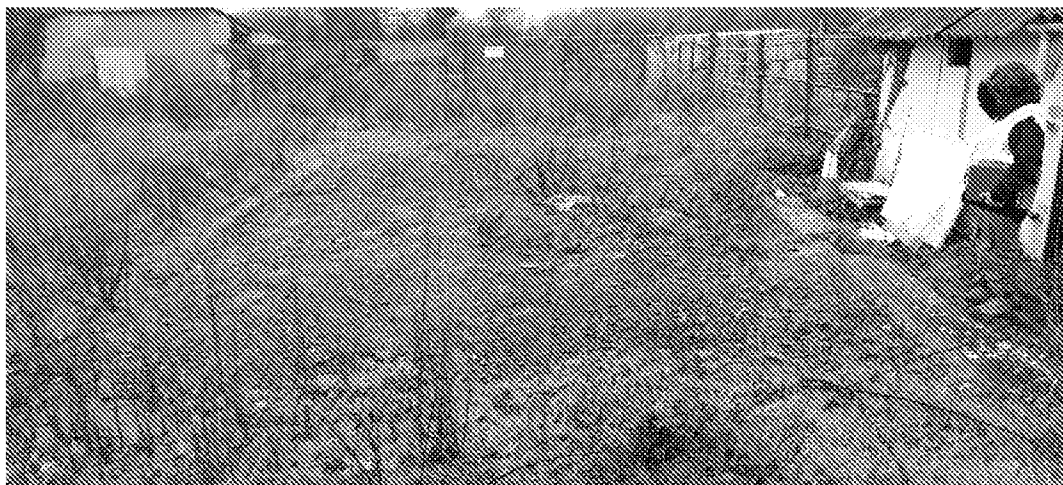
12.0.2 In Photo 63 a cable duct is visible in the right hand side of the photo.

12.0.3 In Photo 63 an isolated block wall is visible in the background.

12.1.1 The isolated ground bearing slabs would appear to be redundant along with the cable ducts.

Photo 63 – Next to Block F – Isolated ground bearing slab with cable ducts alongside

Given the factor listed in 12.1 it is recommended that the items listed be removed.

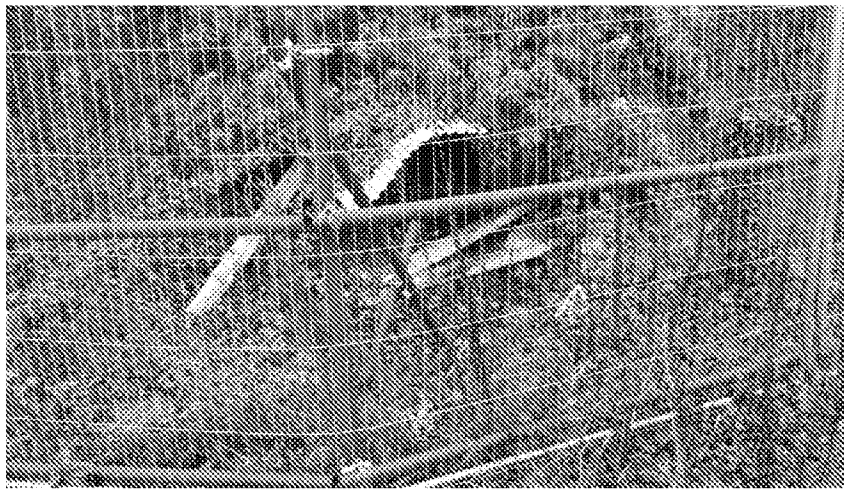
13.0.1 At the southern boundary of the site there appears to be a buried structure. It lies immediately outside the site boundary.

13.1.1 Given that there might be a buried structure at this location it could affect the foundations of any proposed buildings along the boundary.

Photo 65 – Adjacent to Block E – Possible buried structure just outside the southern site boundary

Given the factor listed in 13.1 it is recommended that the potential buried structure be investigated, with its size and extent determined further.
