**PHASE 1  
GEOTECHNICAL AND GEO-ENVIRONMENTAL  
SITE INVESTIGATION**

**CAFFYNS VOLVO  
WORTHING**

**CAFFYNS PLC (EASTBOURNE)**

46357-001

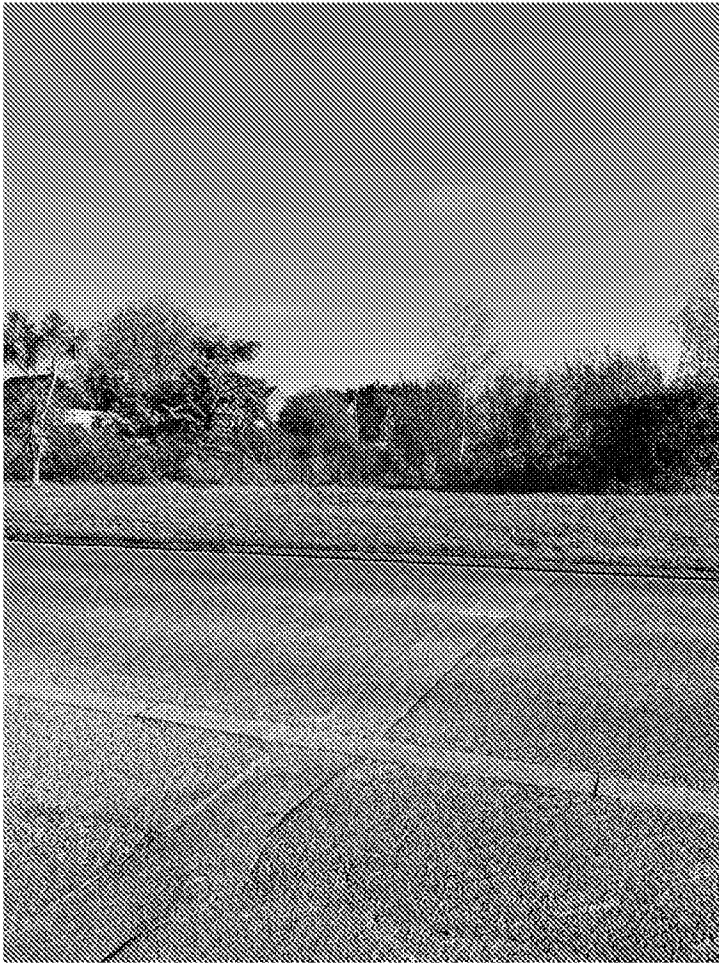
**View of site directly opposite Mayflower Way West of site**

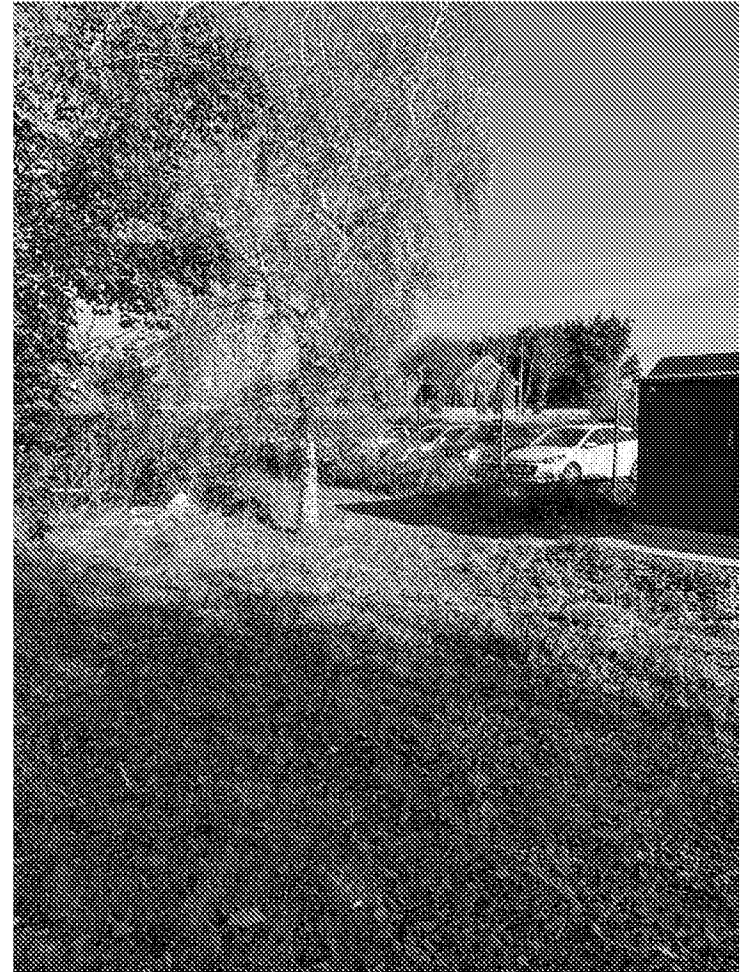
**Entrance of site from Bottom Eastern Corner**

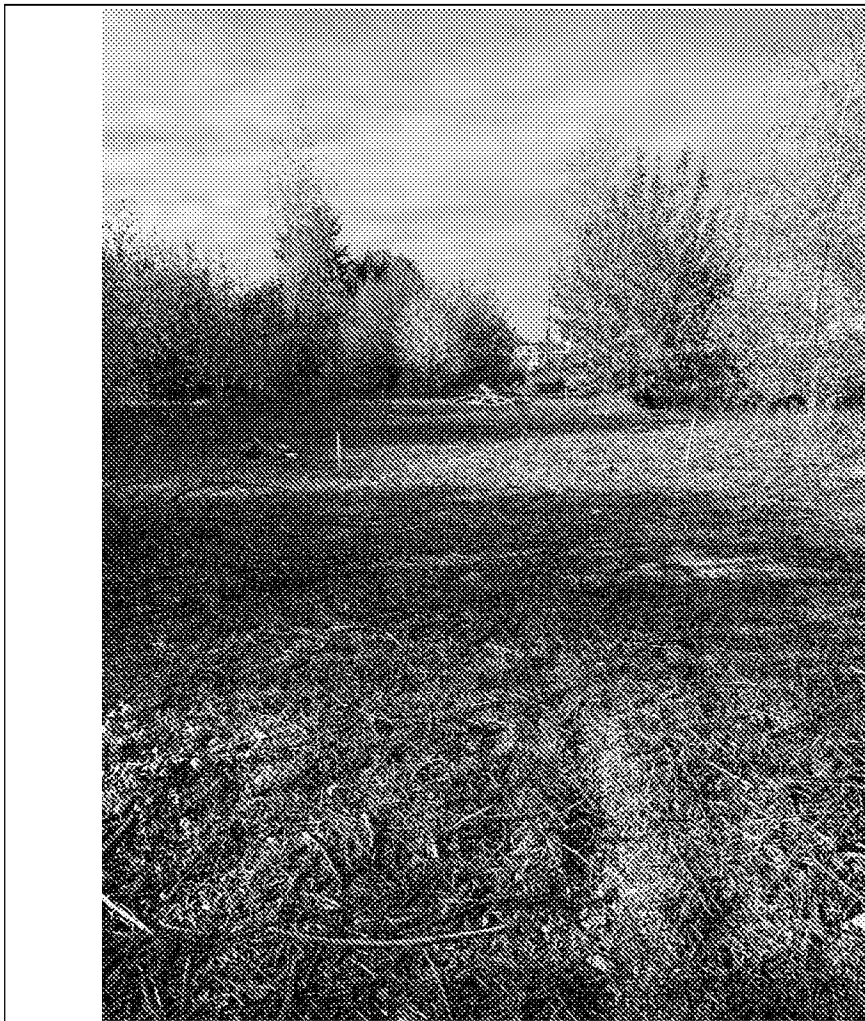
Inside of the site immediately west of the entrance

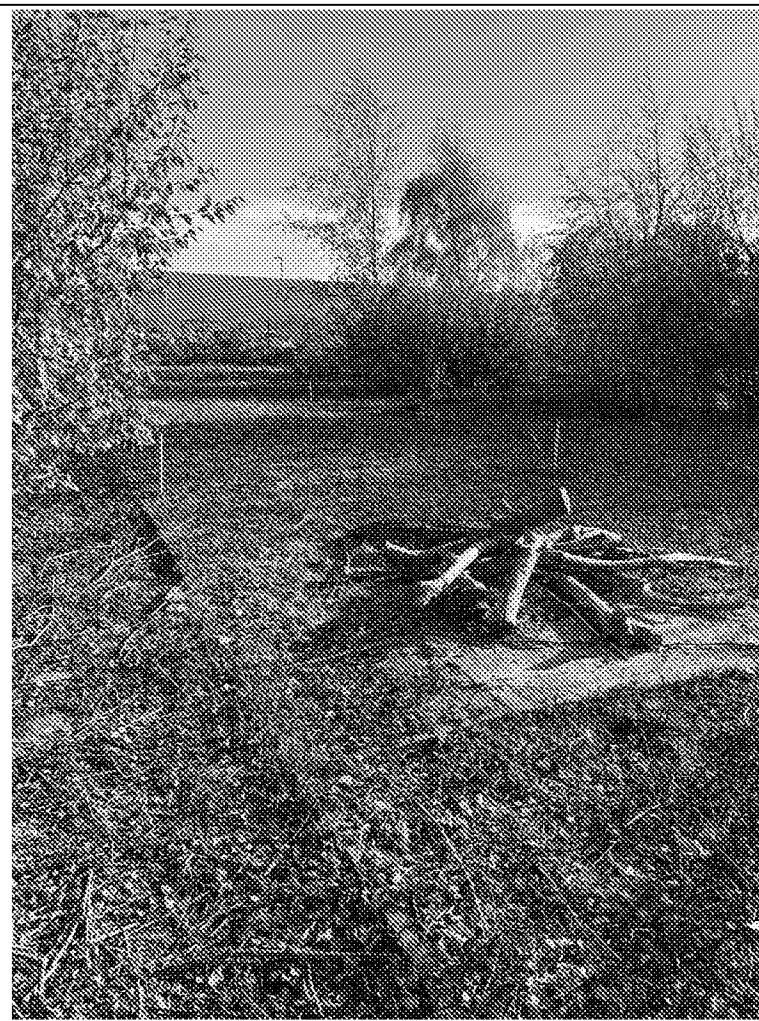
Photo facing southeast towards the entrance

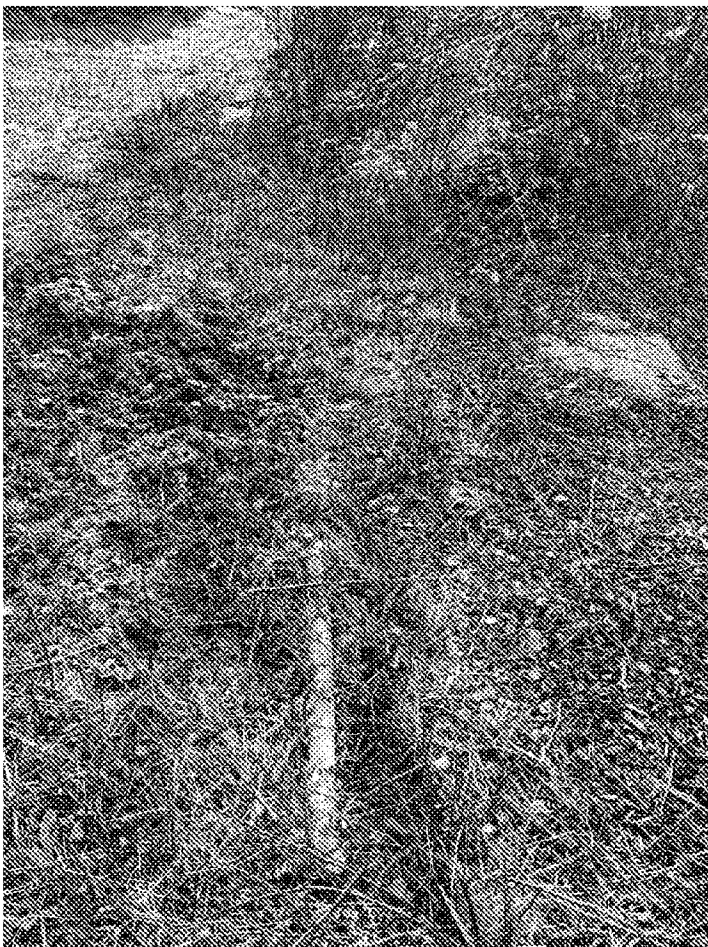
**White coloured gas pipe spotted next to the entrance spotted east of the site**

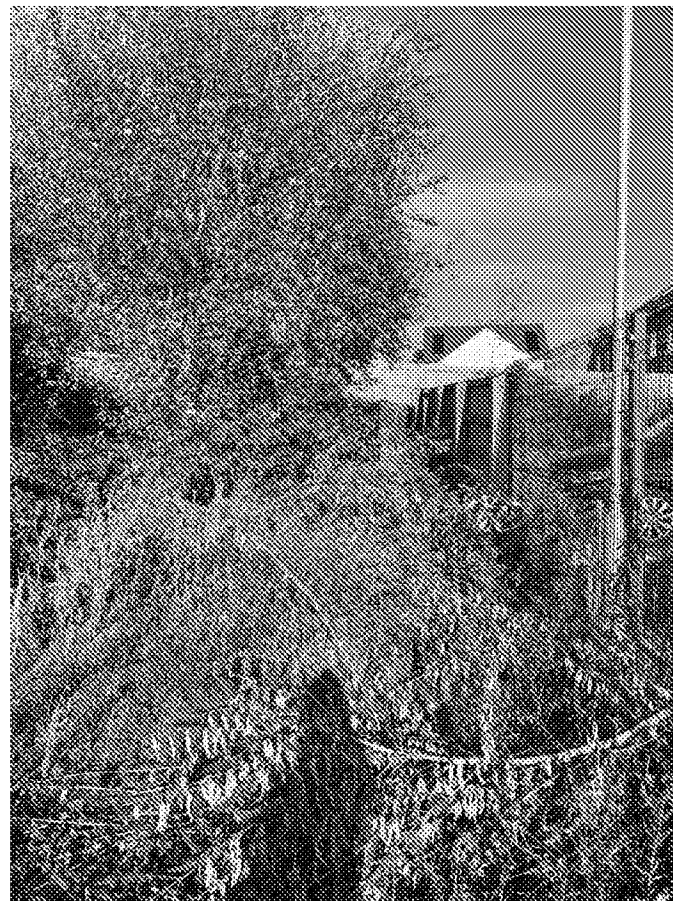
**Gas Pipe leads directly to a green Gas Box northeast of the site**

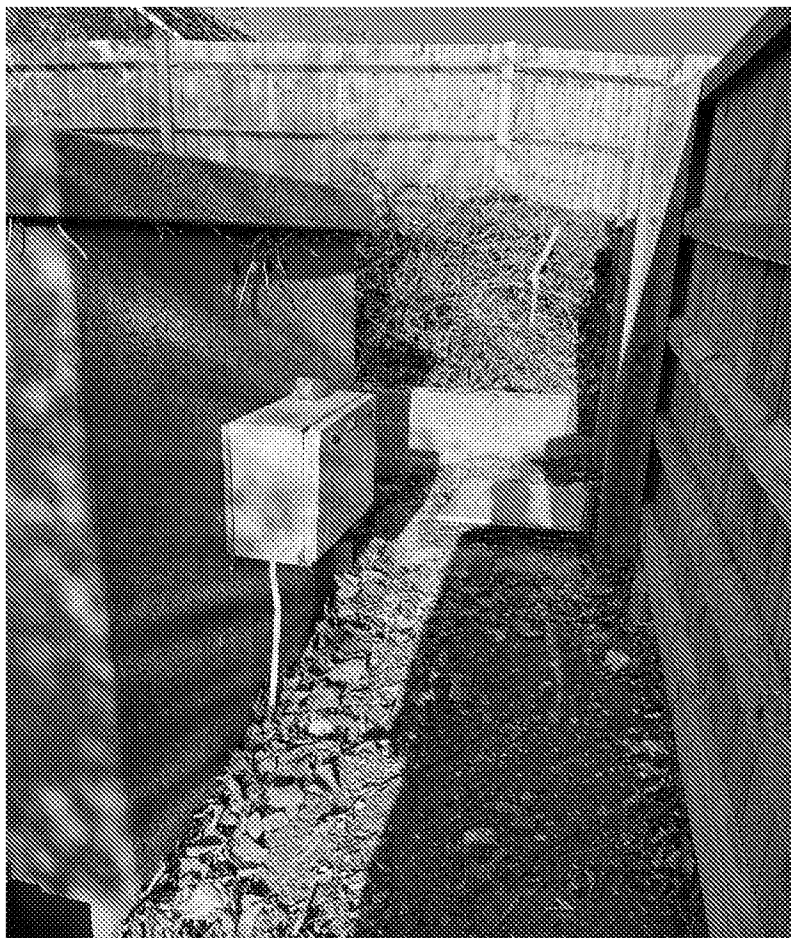
**Gas Pipe leading off from the green Gas Box**

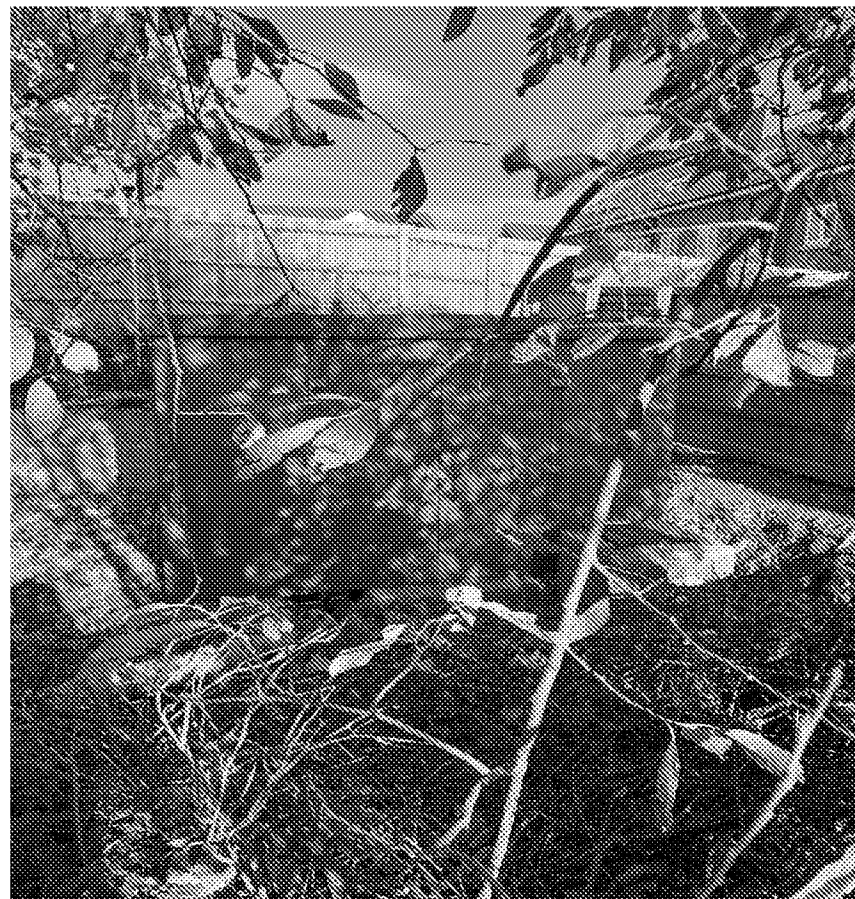
In the south east corner of the site is a green box structure which is assumed to house a gas governor serving the adjoining Audi dealership.

**Green Gas Box located northeast of the site**

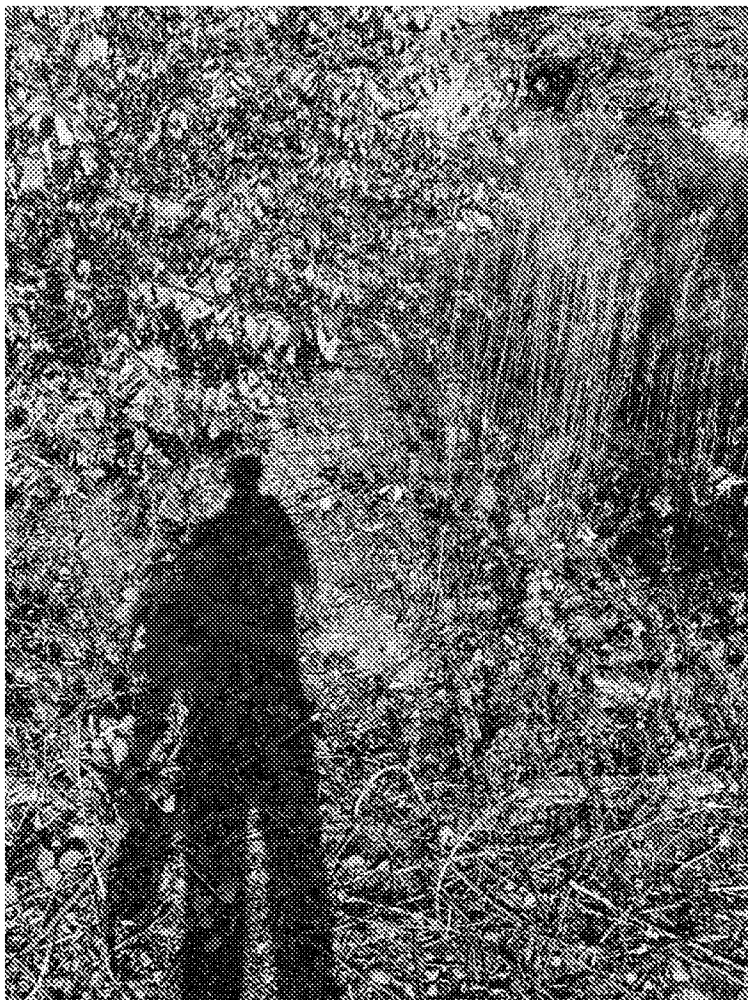
**Paths of tarmac covered by dense grass vegetation in the centre of the site**

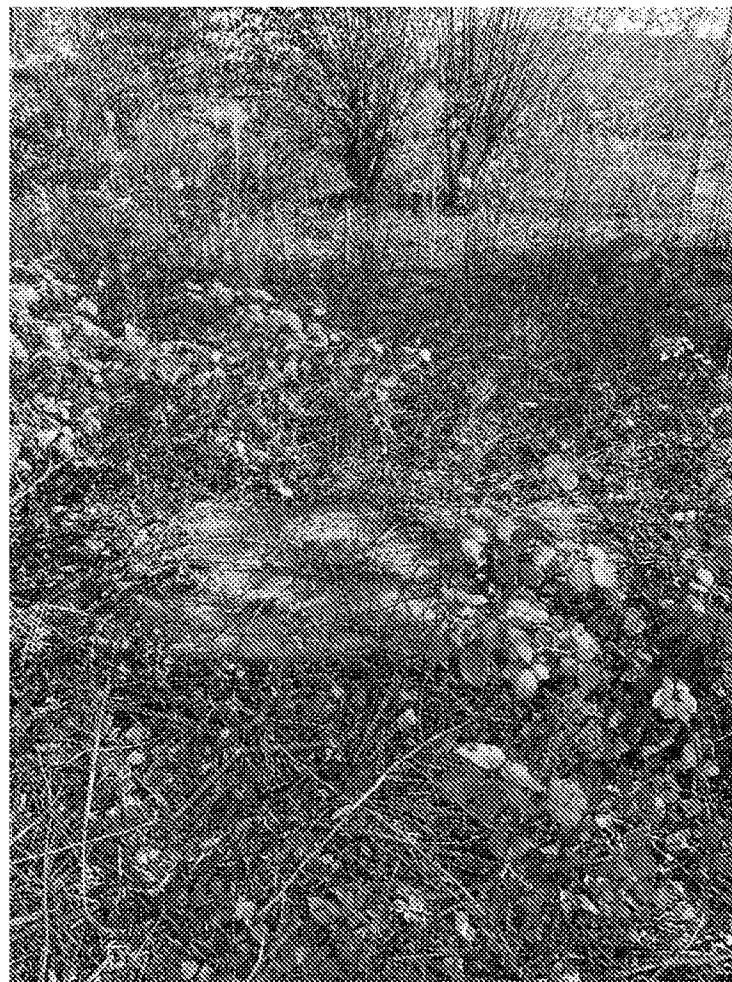
**One of the tarmac paths trending north of the site (facing east)**

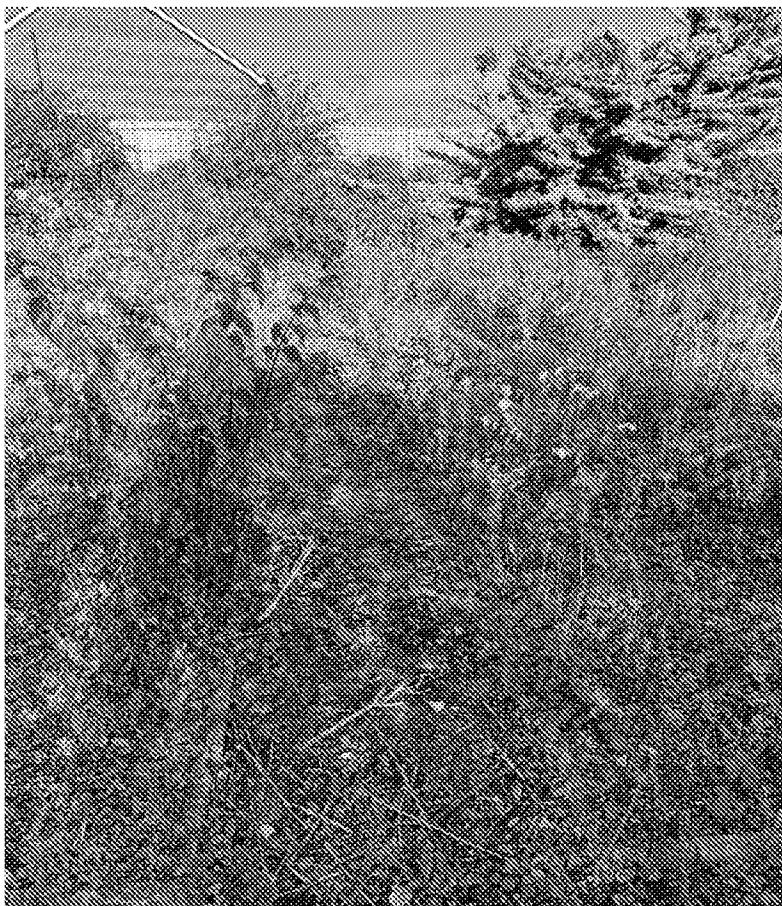
Path covered by dense vegetation on the western portion of the site

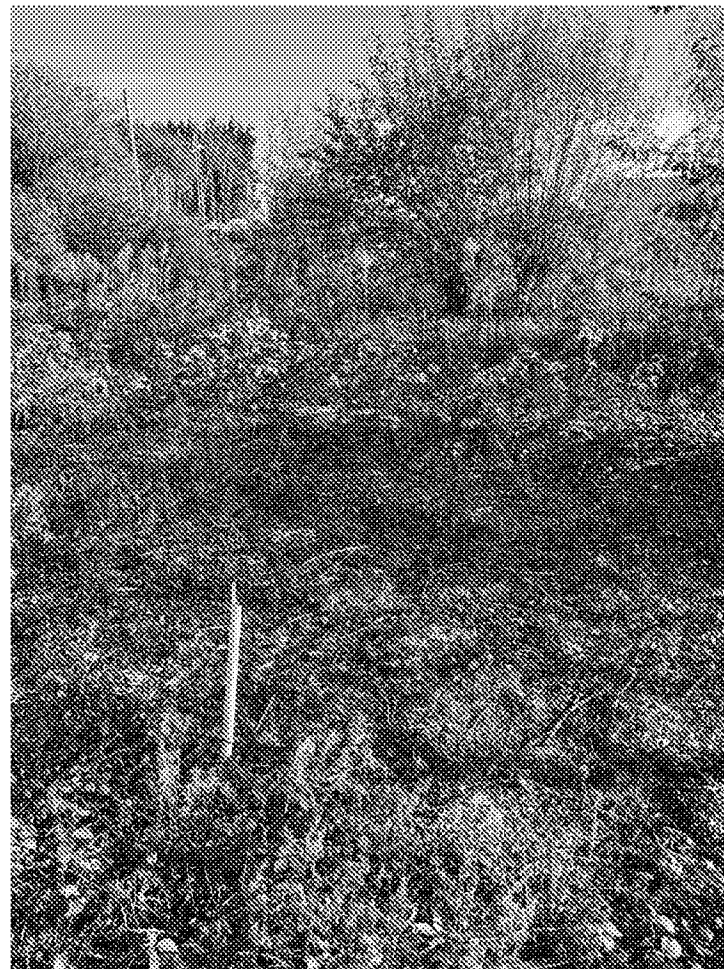
Dense vegetation in the northwest region of the site

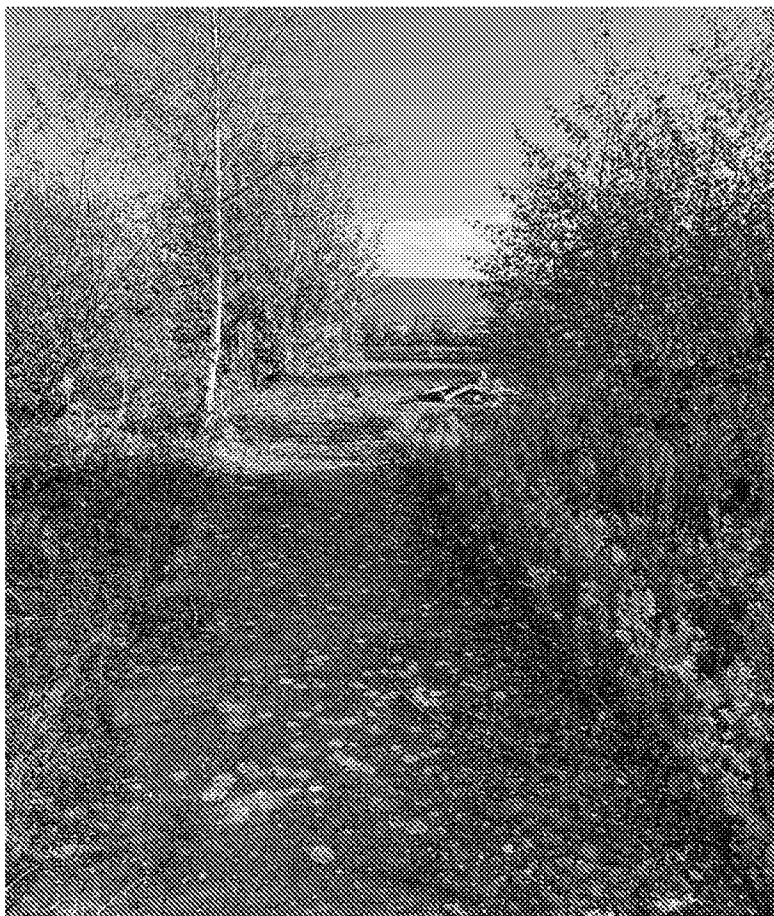
Central Tarmac path. Photo taken from the west of site

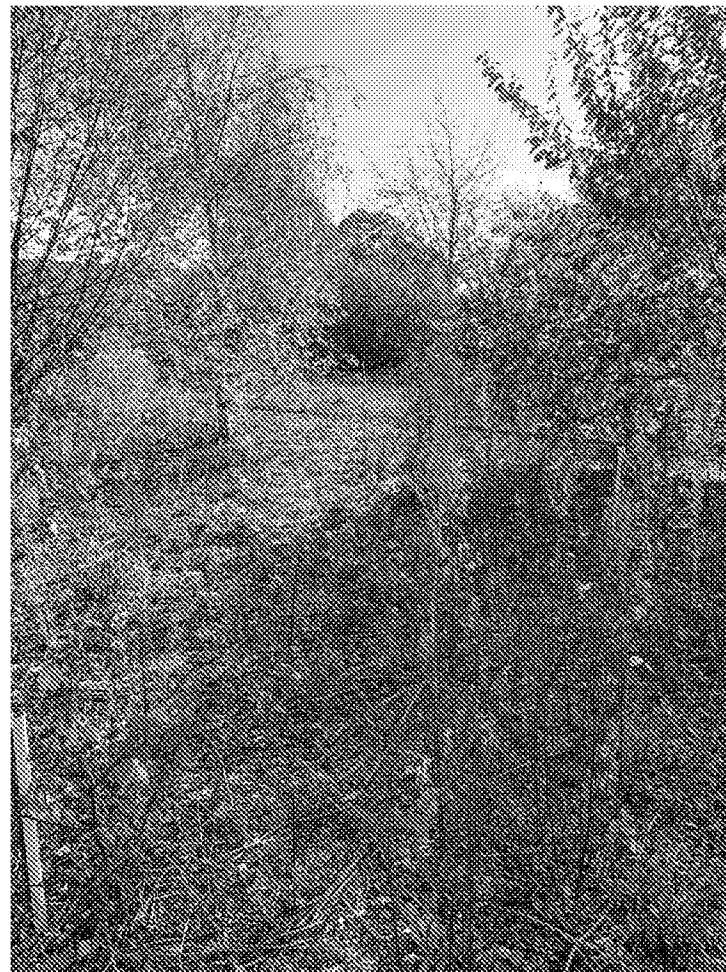
Birch trees and grass present in the centre. (Facing south)
