# Damp Survey

The Vestry Cottage  
Arundel Road  
Angmering  
West Sussex BN16 4JS

Our Reference: 2601050126DW

## Damp Report

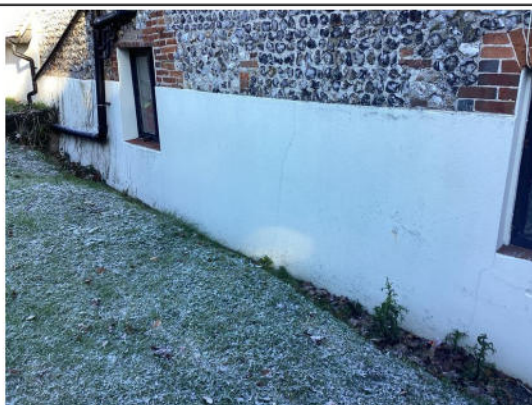
To the rear elevation there is in place a dense sand and cement render applied directly to the original construct beyond up to a height of approximately 1.6m. This undoubtedly will be of no benefit to the construct and its drying process. The external renders also continue down past the high external ground level to an unknown depth. I would suggest that this is removed then a period of observation and reflection upon what is exposed when the dense sand and cement renders are removed. I have allowed to achieve this within my costings.

Sand and cement renders to the rear elevation

Externally to the rear elevation South East Timber & Damp to remove as carefully as possible the introduced dense sand and cement renders in their entirety up until the right hand single storey elevation and discard resultant debris from site. Pictures and a video will be made of the exposed areas once the renders have been removed for your records. I have made no allowance to carry out any reinstatement works to the external.

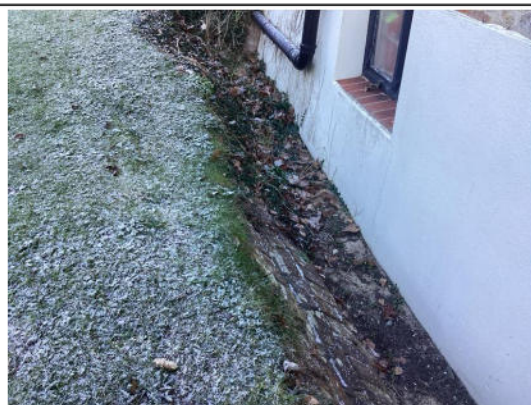
Ground levels to the left-hand and rear elevations are higher than that of the internal finish solid floor level. If you have the opportunity in the future to reduce these at the contact point with the building this would be of benefit, however it is not completely essential. You would have to gain permission from surrounding land owners to achieve ground reducing works.

High external ground levels to the rear elevation

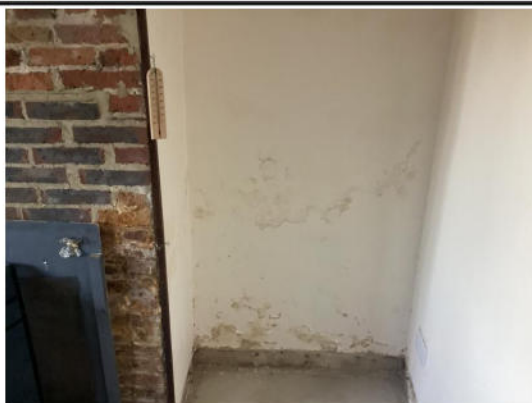
Decorative spoiling in first left-hand reception room

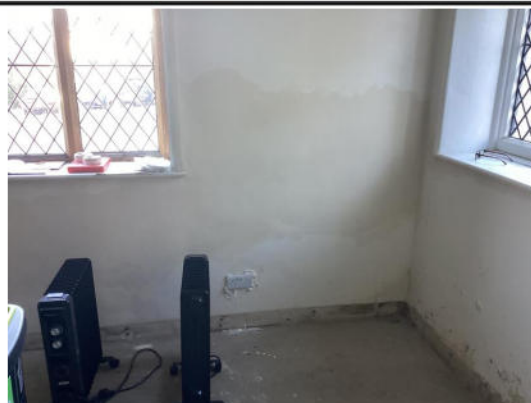
Further spoiling in first reception room

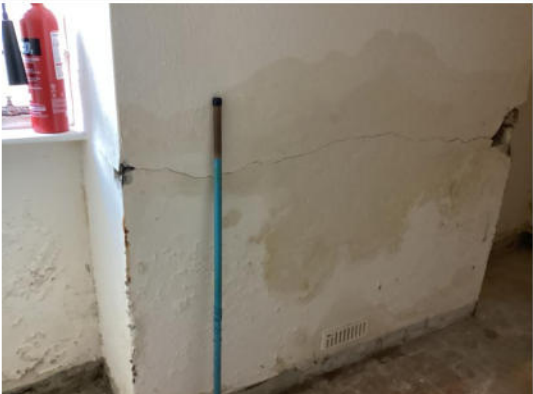
Within the second middle reception room there is a very large crack which runs from side to side on the chimney breast. I would suggest during our works that we remove the plaster from the chimney breast in its entirety to expose the construct behind therefore giving us an insight into what needs to be achieved to prevent future movement of this masonry going forward. Removing the plaster from the chimney breast itself and removing the in situ vent will allow us also to enlarge the opening of the ventilator space, clear out any resultant debris from within and reintroducing a ventilator of an increased size as part of the internal moisture managing system.

| <p>Further spoiling issues</p> | <p>Chimney breast in second reception room</p> |

We would be happy to work with you internally in the middle reception room once the exposed area has been suitably inspected and a program of ongoing introductions recommended, any additional works in this area will be subject to a charge.

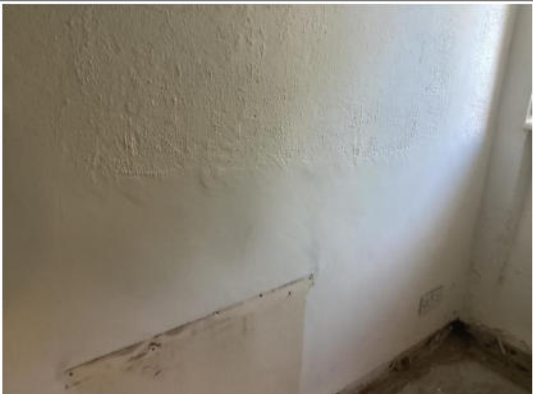
| <p>Previous remedial dampproofing works introduced by others</p> | <p>Previously introduced renovating water resistant plaster covers</p> |

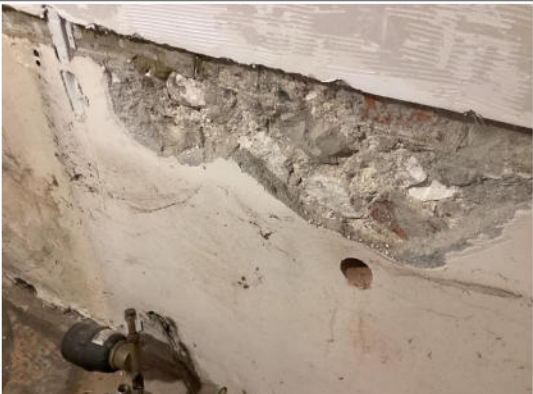
The current internal system in place is a lightweight renovating plaster over, in some areas some form of bitumen product at low level. This was a very common form of trying to control moisture in the construct introduced during the late 80s and early 90s. It was however problematic and often failed, as has occurred in this instance.

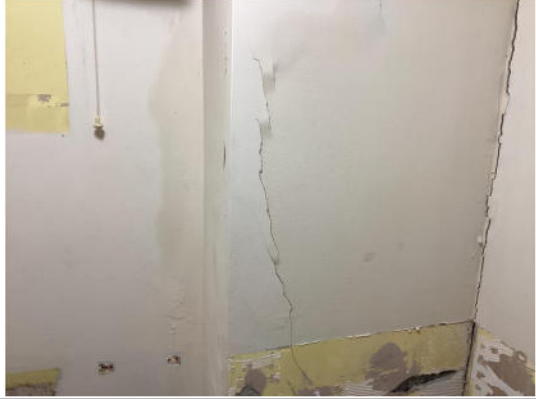
| <p>Issues in the bathroom at first floor level</p> | <p>Spoiling adjacent to staircase</p> |

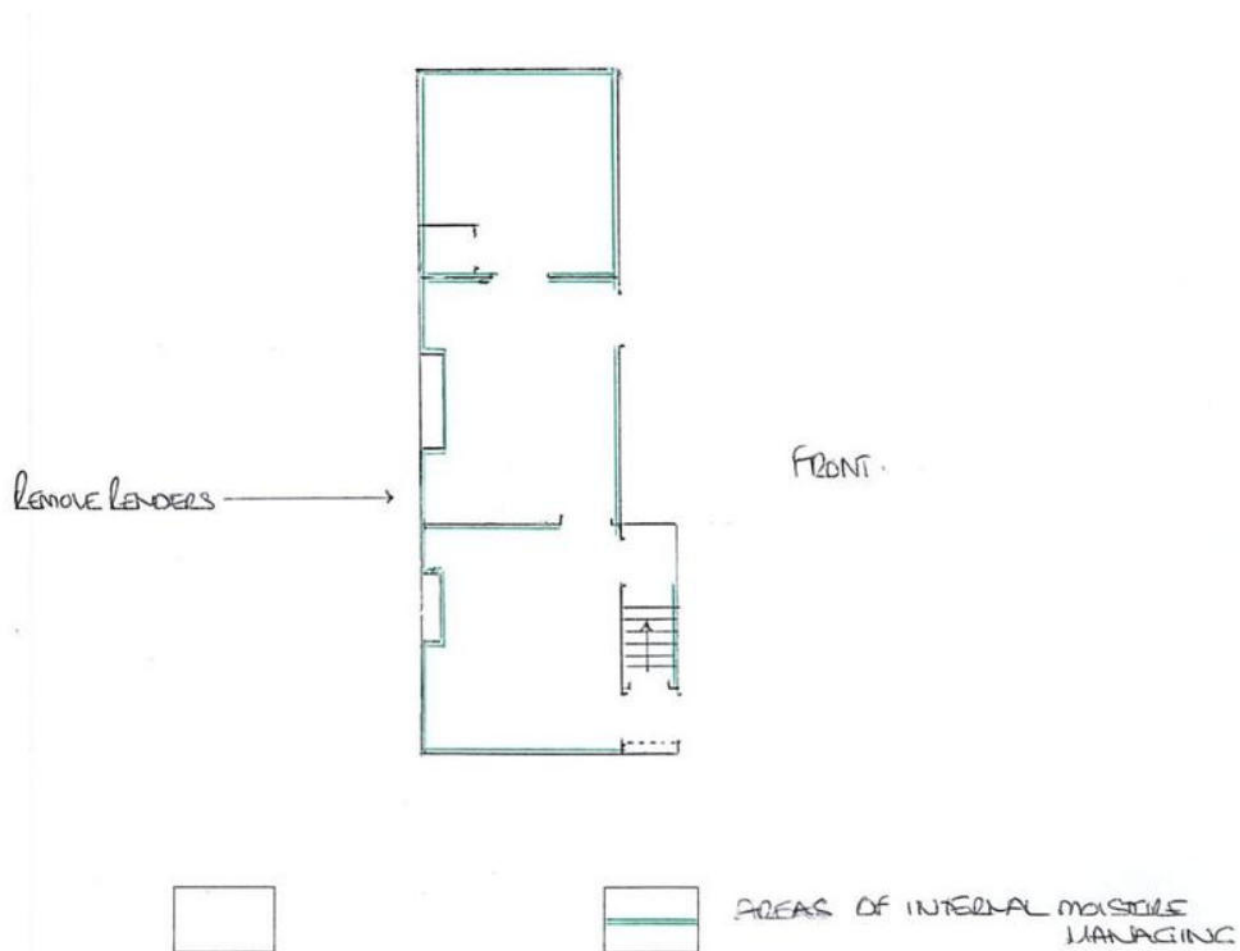
Inspection of the ground floor walls where accessible and using a dual mode protimeter surveymaster moisture meter and visual evidence in our opinion revealed evidence of rising damp to the walls indicated on the sketch plan.

To the areas clearly marked on the attached sketch plan for South East Timber & Damp Ltd to introduce our certificated, fail safe, full height moisture managing system to include all preparation work (the removal of any electrics, necessary window boards, to introduce anti-bridging gaps in the vertical plasters at the wall floor junction), to remove the plaster from the second middle reception room chimney breast in its entirety full height and discard from site and to remove the plaster on the front elevation wall in the stairwell.
