# Damp Survey

The Vestry Cottage  
Arundel Road  
Angmering  
West Sussex BN16 4JS

6 January 2026

Our Reference: 2601050126DW

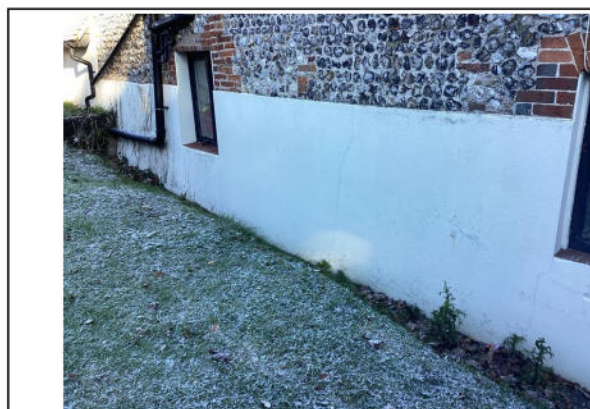
To the rear elevation there is in place a dense sand and cement render applied directly to the original construct beyond up to a height of approximately 1.6m. This undoubtedly will be of no benefit to the construct and its drying process. The external renders also continue down past the high external ground level to an unknown depth. I would suggest that this is removed then a period of observation and reflection upon what is exposed when the dense sand and cement renders are removed. I have allowed to achieve this within my costings.

Sand and cement renders to the rear elevation

- \* Naturally present moisture in the ground below the property rising vertically through the construct by capillary action.
- \* Some long-term external defects contributing to internal issues, including the application of dense sand and cement renders to the external rear elevation.
- \* Condensation.

Externally to the rear elevation South East Timber & Damp to remove as carefully as possible the introduced dense sand and cement renders in their entirety up until the right hand single storey elevation and discard resultant debris from site. Pictures and a video will be made of the exposed areas once the renders have been removed for your records. I have made no allowance to carry out any reinstatement works to the external.

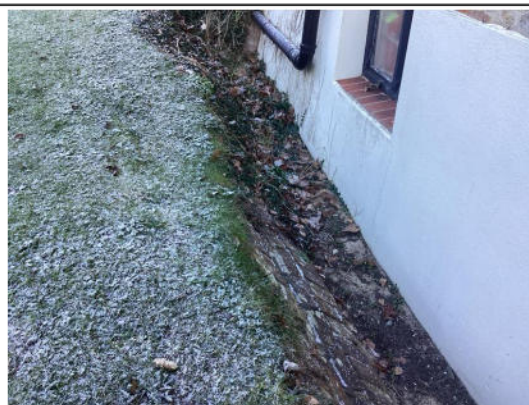
Ground levels to the left-hand and rear elevations are higher than that of the internal finish solid floor level. If you have the opportunity in the future to reduce these at the contact point with the building this would be of benefit, however it is not completely essential. You would have to gain permission from surrounding land owners to achieve ground reducing works.

High external ground levels to the rear elevation

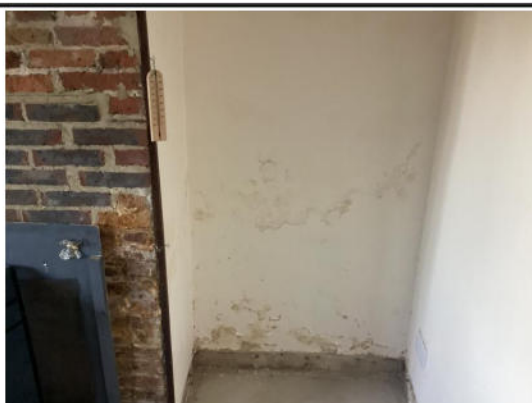
Within the first reception room there is exposed masonry on the chimney breast as a decorative finish either side of the fire opening. There are signs of an excess of moisture in the construct leading to the deterioration of mortar joints, which is a common phenomenon and unless any modern internal moisture managing system is to be introduced this will always remain in the same condition.

Decorative spoiling in first left-hand reception room

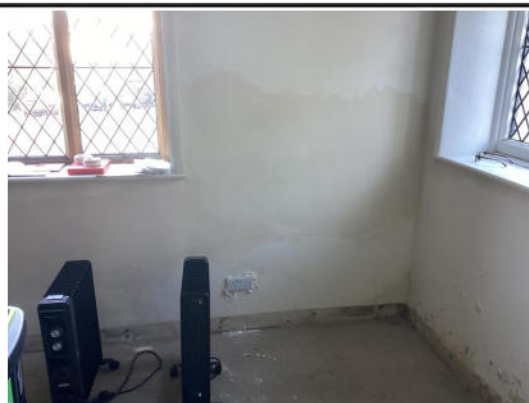
Further spoiling in first reception room

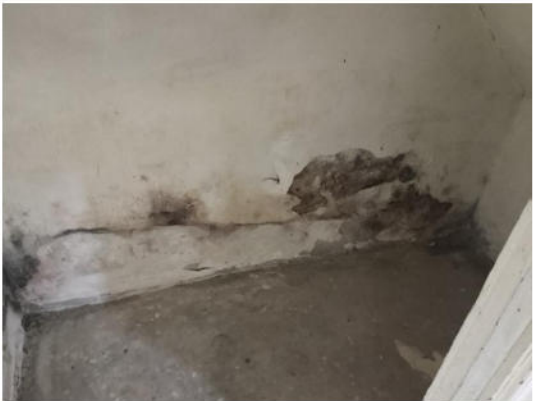
| <p>Further spoiling issues</p> | <p>Chimney breast in second reception room</p> |

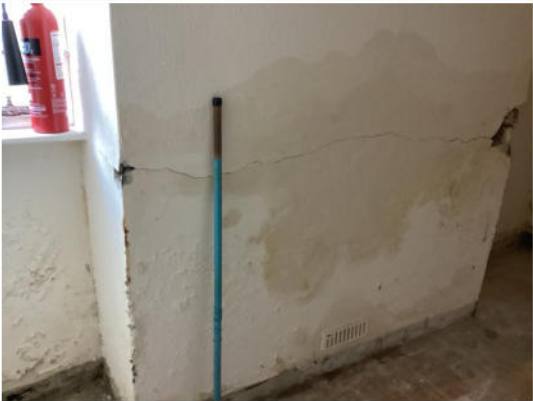
Within the second middle reception room there is a very large crack which runs from side to side on the chimney breast. I would suggest during our works that we remove the plaster from the chimney breast in its entirety to expose the construct behind therefore giving us an insight into what needs to be achieved to prevent future movement of this masonry going forward. Removing the plaster from the chimney breast itself and removing the in situ vent will allow us also to enlarge the opening of the ventilator space, clear out any resultant debris from within and reintroducing a ventilator of an increased size as part of the internal moisture managing system.

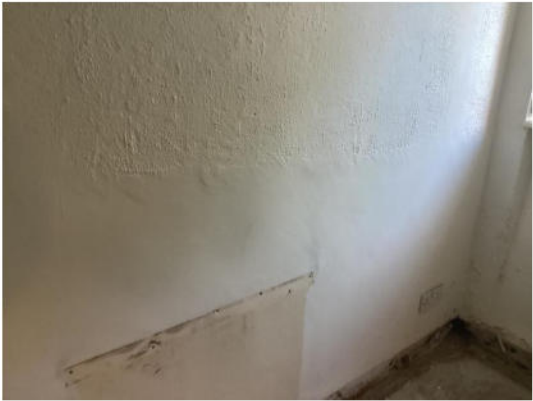
Internally there are many obvious signs of decorative spoiling caused by an excess of moisture in the construct. There is evidence also of previously introduced remedial damp proofing works in some areas. It would be prudent to investigate any certification that may or may not exist for any previous remedial works.

| <p>Previous remedial dampproofing works introduced by others</p> | <p>Previously introduced renovating water resistant plaster covers</p> |

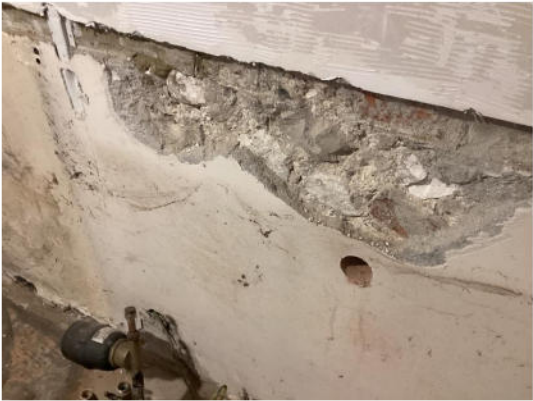
The current internal system in place is a lightweight renovating plaster over, in some areas some form of bitumen product at low level. This was a very common form of trying to control moisture in the construct introduced during the late 80s and early 90s. It was however problematic and often failed, as has occurred in this instance.

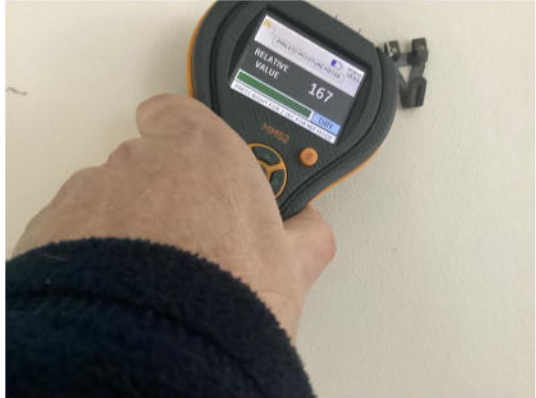
| <p>Dry reference reading</p> | <p>High moisture presence reading from first reception room</p> |

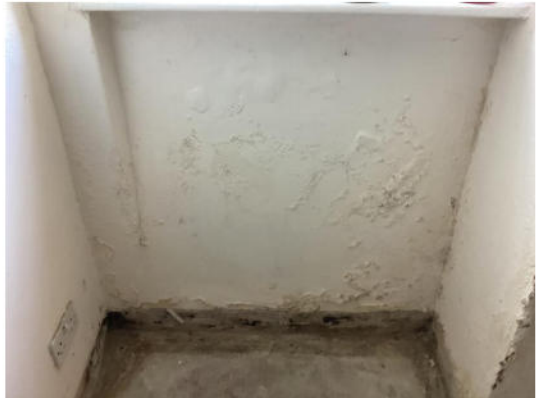
| <p>Further spoiling in second reception</p> | <p>Internal linings affected by moisture in the construct</p> |

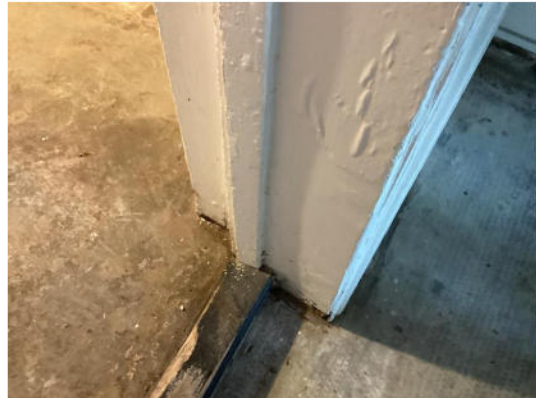
Internally some door linings have been affected by long-term contact with the moisture in the construct therefore you may wish to exchange these during the renovation process.

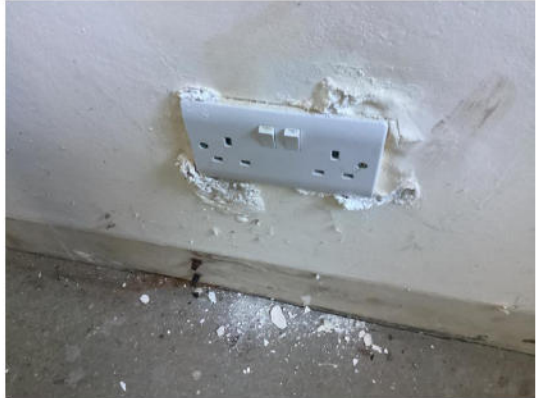
Salt contamination issues around electric sockets were very evident and all internal plasters extend down to the finish floor level and may indeed go beyond past the screed.

| <p>First reception room socket area</p> | <p>Movement issues at first floor level adjacent to chimney breast</p> |

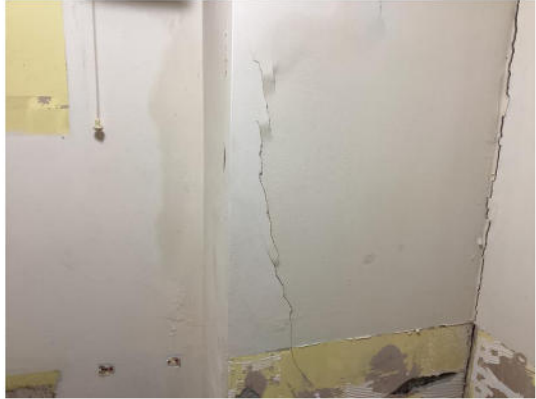
| <p>Issues in the bathroom at first floor level</p> | <p>Spoiling adjacent to staircase</p> |
