**Tree Survey, Appraisal  
and  
Arboricultural Impact Assessment**  
in accordance with BS 5837 : 2012  
Trees in relation to design, demolition and construction - Recommendations.

Trees in relation to  
**Proposed highway improvement works**  
**Manor Nursery, High Street, Angmering,  
West Sussex.**

Prepared for  
Hanbury Properties.  
March 2014

**ARBORTECH** (Consultancy)

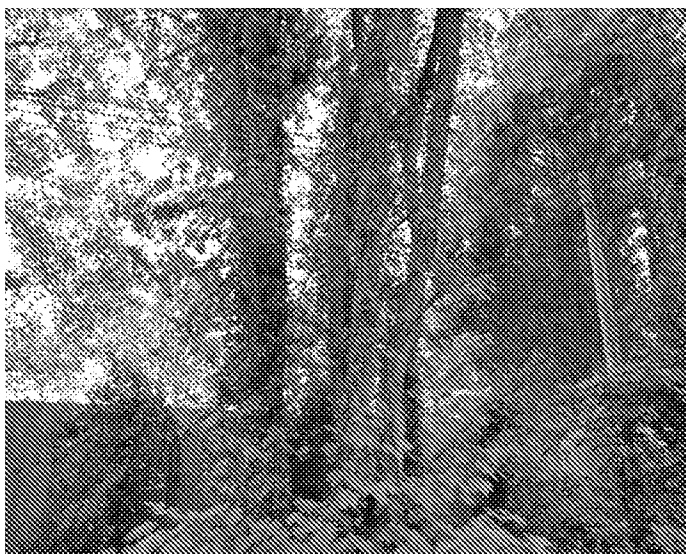
- 3.1 This line of trees stand in an elevated position on the southern side of the High Street approach to Manor Nursery. The trees are growing directly beneath/adjacent multiple overhead service cables and associated utility poles.

- 3.2 Although the trees currently contribute to the amenity of this localised area, this contribution is not considered sustainable for the reasons;

Figure 1. Multi-stemmed Sycamore viewed from High street, indicating proximity of overhead cables and service poles.

- 3.3 At some point in the past these trees have been coppiced (cut to ground level) which has produced a multi-stemmed tree structure. This may have been in response to the overhead utility service installation and/or maintenance. It has resulted in poor conformation with associated irremediable weaknesses for these trees. (See Figure 1 above).
- 3.4 These trees have been assessed as C/U category in accordance with BS 5837 2012 tree quality assessment i.e trees of low quality which in the context of the current land use are unlikely to be retained for longer than 10 years.

- The trees are growing in an elevated position upon a bank immediately adjacent the public access road.
- The trees range from 10-13m in height.
- The prevailing wind direction (South West) is towards the road.

- Any benefits provided by the trees is limited in time, mainly due to tree condition and conformation, given the tree location adjacent public access road.
- The trees are located beneath utility service poles and numerous overhead cables (See Figure 1).
- It is evident, due to location and structure that the trees require regular and ongoing maintenance with associated costs, for safety and practical reasons to limit encroachment upon the utility services.
- The dense foliage creates areas of dense darkness when in leaf and the wet leaves create a slip hazard upon leaf fall.
- This species has limited benefits for wildlife.

- 3.7 In consideration of the above; the management options for these trees are very limited and the only sensible course of action is to re-coppice or fell.

- 3.9 Felling is considered the most sensible course of action to limit the risk of random tree failure and due to the overriding principle that this species is unsuitable for the location (beneath/adjacent utility service cables).

- 3.10 It is therefore suggested that an opportunity has arisen to actively manage the situation by way of tree removal and replacement with an improved native planting scheme.
