St. Margaret's

ANGMERING

**Re: St Margaret's Angmering, Tree works (Section 211 notification)**

## Tree safety inspection at St Margaret's churchyard, Angmering

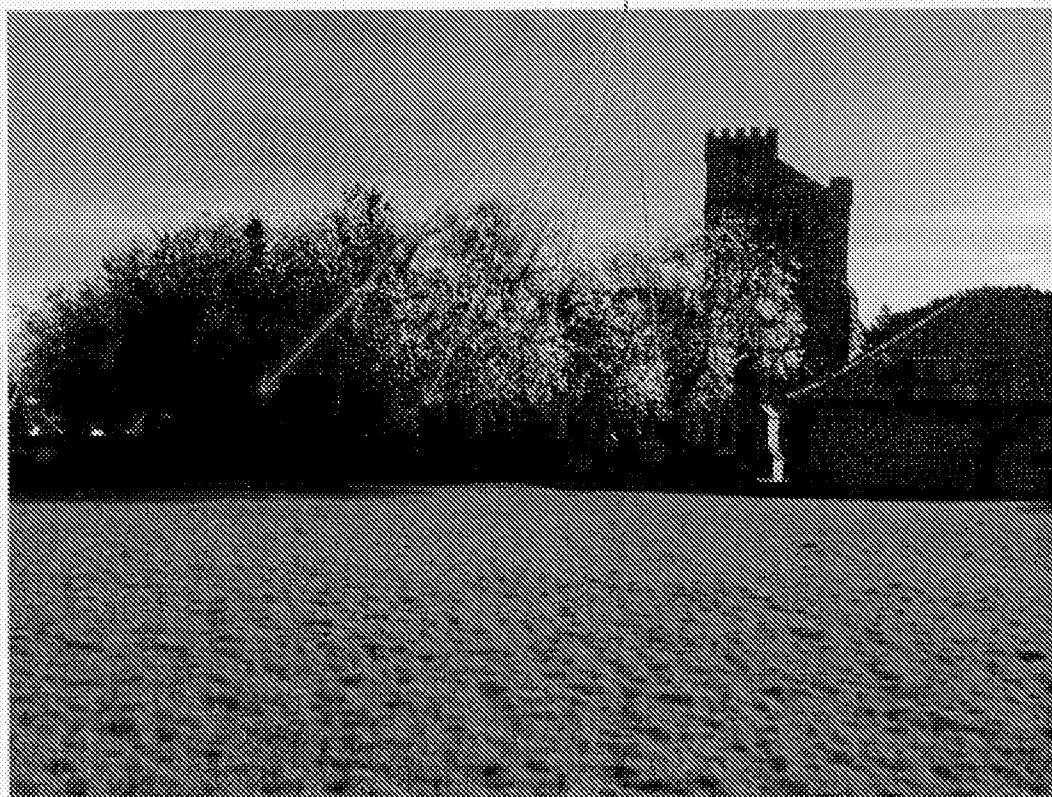
- **G3:** Fell the four wild plum trees to the northern boundary with Fletchers Field. The trees are diseased and in the opinion of Dr Dobson have reached the end of their safe useful life.

Trees to be felled (on safety grounds) , roots ground out and 4 new trees planted.  
(2 no. Liquidambar Straciflua and 2 no. Acer Negundo)

*For your information we propose to plant four new trees (2 no. Liquidambar Straciflua and 2 no. Acer Negundo, both of which have been suggested by Dr Dobson as growing to a similar size to the existing and having better resistance to honey-fungus).*

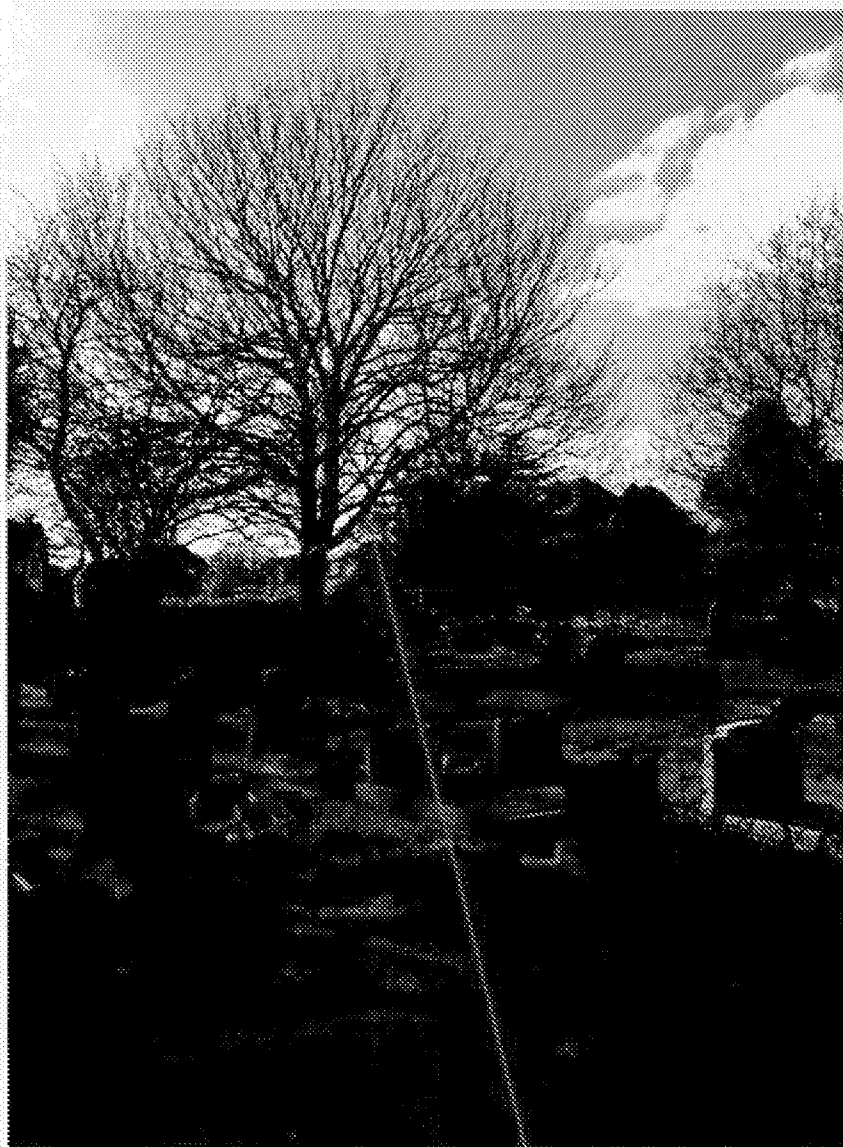
(T8) Sycamore to the western boundary  
Limb to be pruned back (on safety grounds) where it has become overly long with the risk it falling as its weight increases.

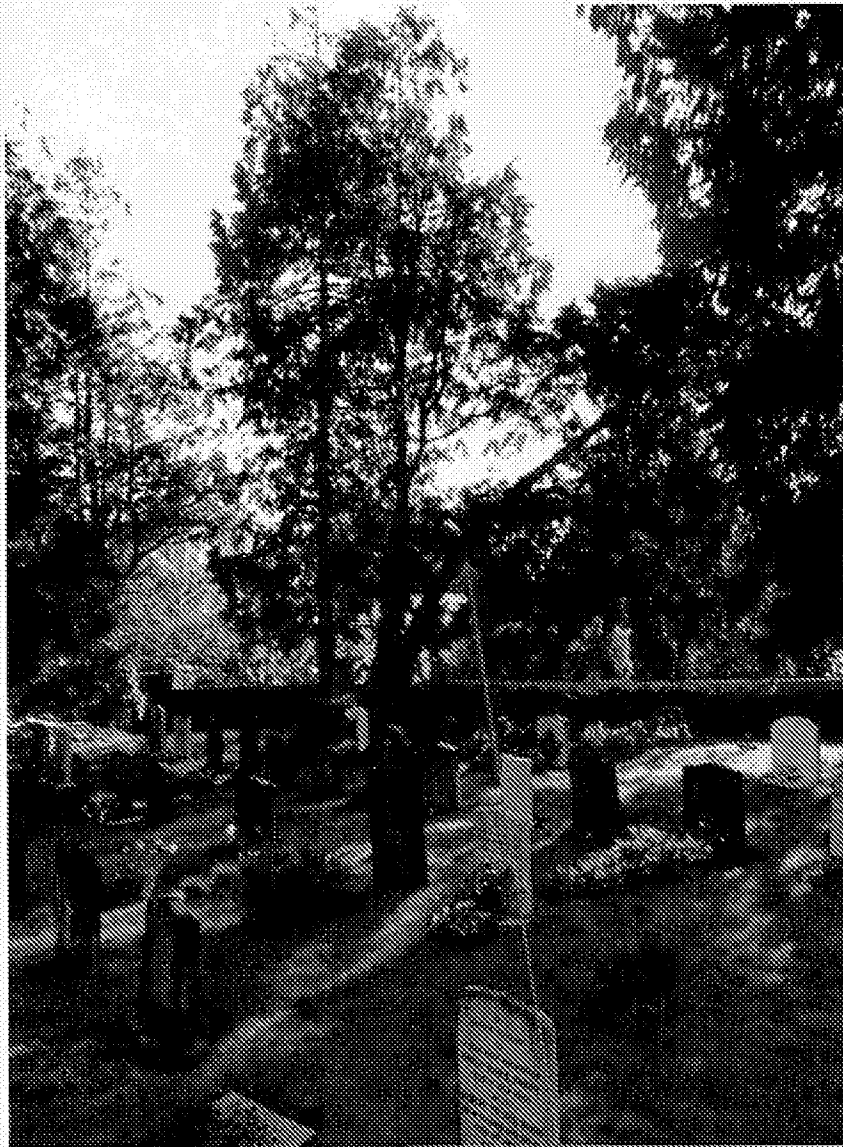
(T9) Western Red Cedar to the west boundary  
Leaning limb to be felled (on safety grounds) where this is leaning at a dangerous angle over the road.

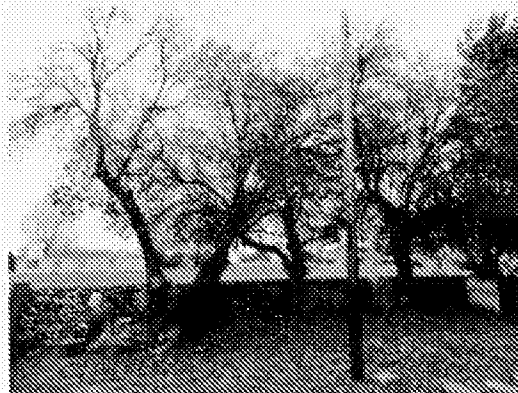
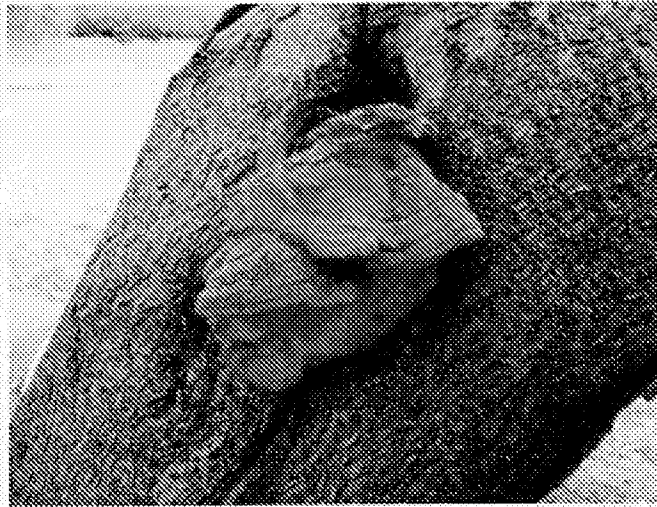
G3 Purple plum x 4 – there is a row of overmature Purple plums (*Prunus*) adjacent to the boundary flint wall. Each of the trees is infected with the wood rotting fungus *Ganoderma*, some more obviously than others. Fruiting bodies were apparent on two of the trees at various positions. The implication of the presence of the fungus is that the trunk and branches are likely to fail in the foreseeable future. There is a risk that such damage may result in harm to the boundary wall which was being repointed at the time of my inspection. **In my opinion the trees have reached the end of their safe useful life and should be removed and replaced. Replacement planting should be at a distance of at least 1 m from the wall to minimise the potential for future disruption by tree roots.**

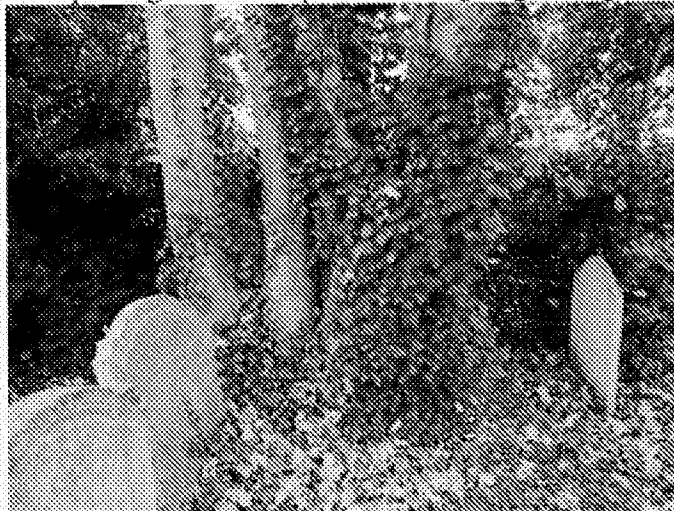
T4 Sycamore – it seems likely that this tree along with other Sycamores in the churchyard was self sown and has grown up with no management. The tree has a number of tightly congested stems with included bark between them. This arrangement represents a potential weakness and there is a risk of failure in the future. Whilst the danger is most likely not imminent consideration should be given to the possibility of replacing the tree as part of an ongoing management plan.

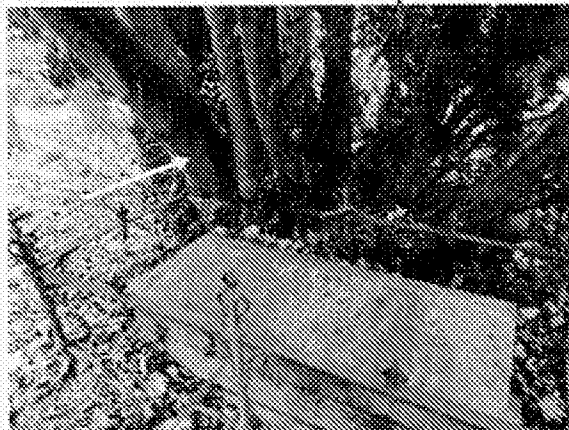
T6 Sycamore – as above. The situation with this tree is worse than for T4 and T5 because it has grown immediately adjacent to graves with stone capping and railings. The graves have already been damaged and that will only worsen with time. Further, the railing on the N side of the tree has constricted the growth of one limb suggesting that it may soon become dangerous and need to be removed. **It is recommended that the limb constricted by the metal railing should be removed.**

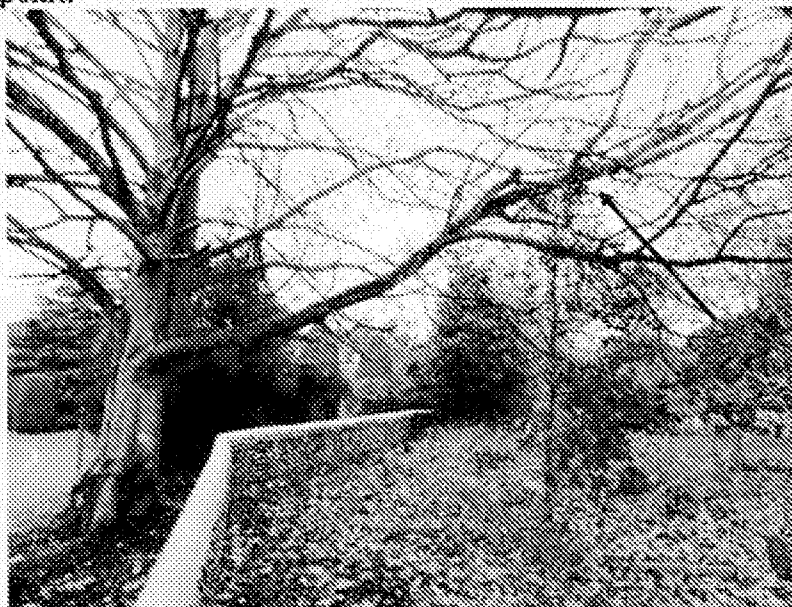
T8 Sycamore – the tree grows outside the boundary of the churchyard but there is a long heavy horizontal branch growing over the churchyard which may be a problem in the future as its weight increases. **It is recommended that a small degree of shortening should be undertaken to reduce the leverage on the branch. The branch should therefore be reduced by a contractor working to BS3998: 2010 *Tree works. Recommendations* by approximately 2 – 3 m cutting back to a suitable growth point.**

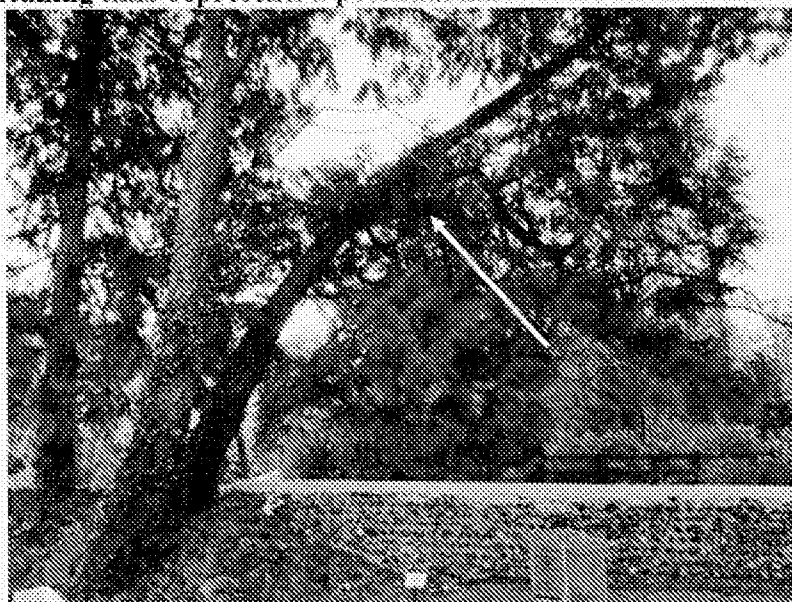
T9 Western red cedar – the tree has two main limbs, one of which leans over the adjacent road at a steep angle. **The leaning limb represents a potential hazard and should be removed.**

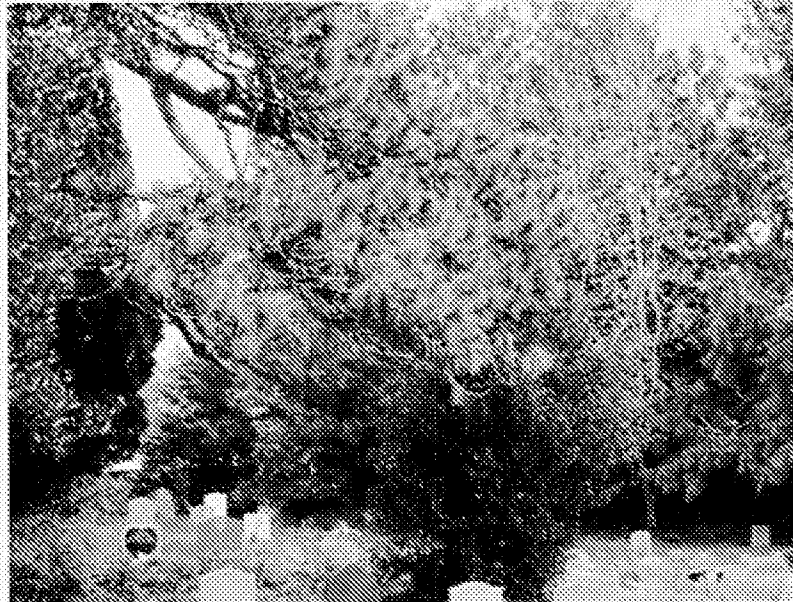
T11 Monterey pine – comments as for T8
