24<sup>th</sup> September 2019

Our Ref: EG/404231/eg

**RE: Structural survey of the existing buildings at Glebe Farm,  
Angmering**

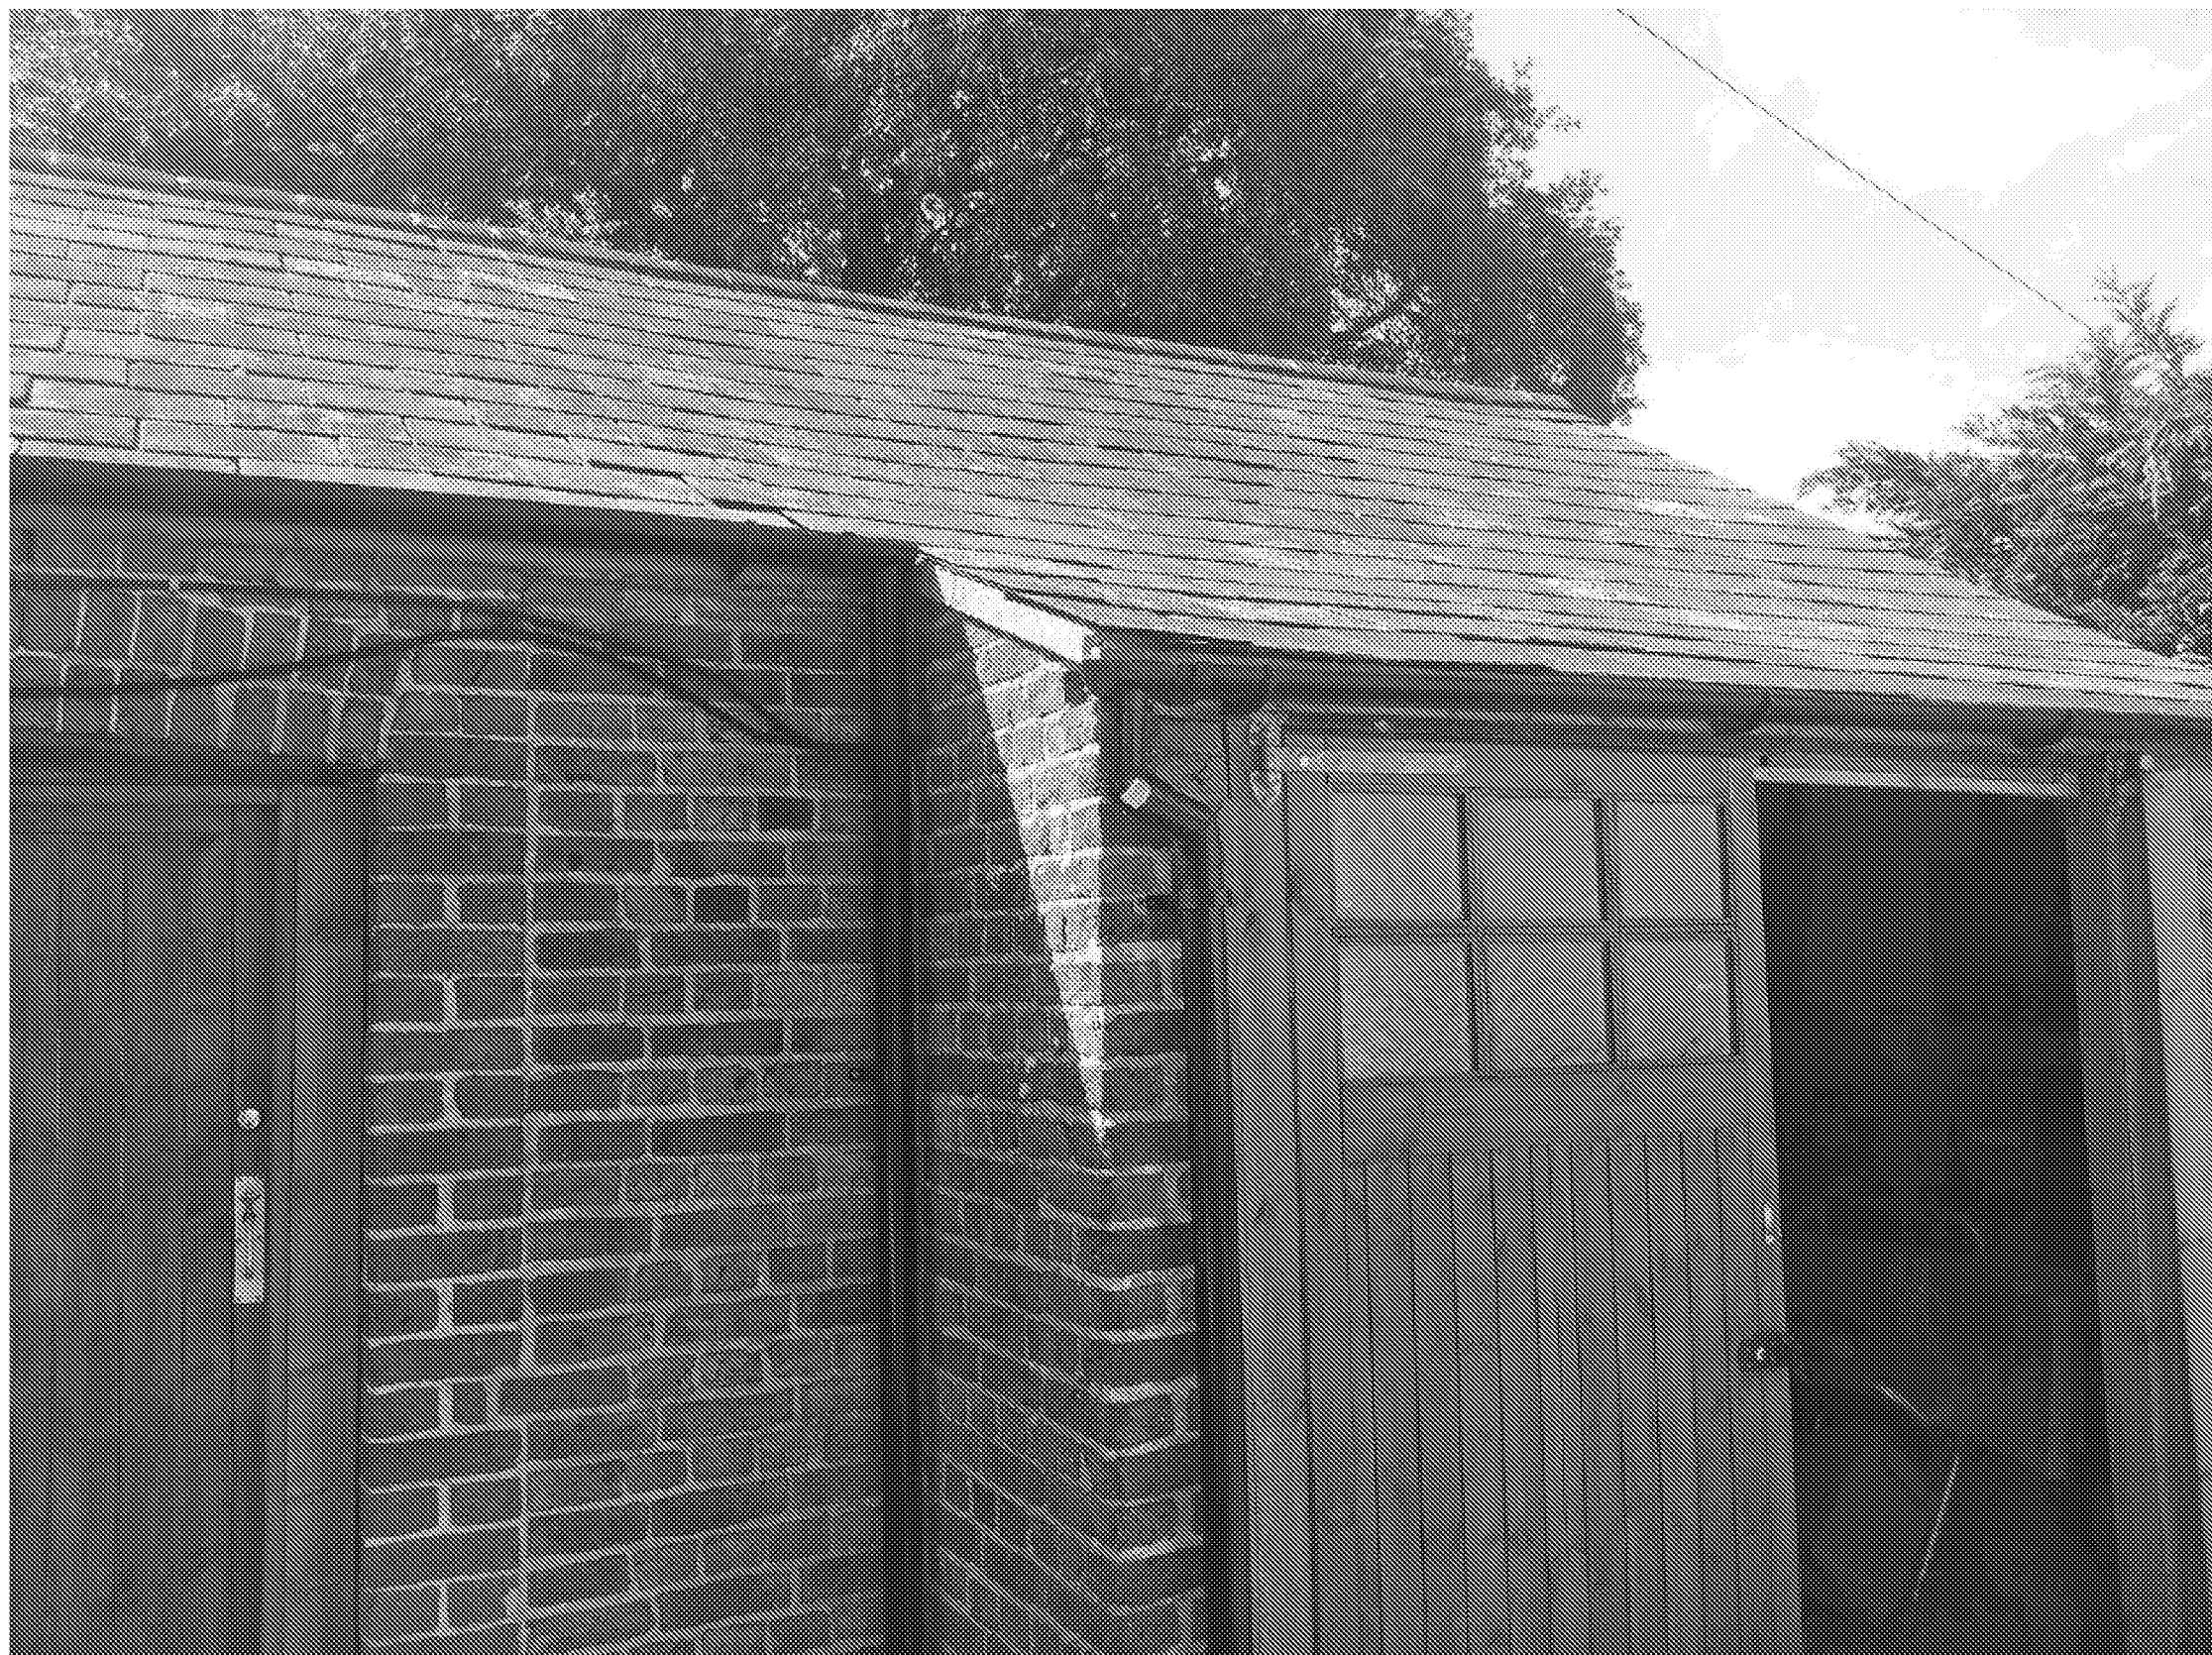
- 3.1 The roof of this building is constructed of timber trusses and timber support beams. There are some undulations present to the roof structure when viewed externally but this is not unusual in a building of this age and type. Some roof works maybe required during any renovation works to replace rotted or damaged timbers. There are some slates missing or slipped which again will need to be replaced as part of the renovation works.

- 3.2 The building walls appear in fair condition and there is a slate DPC present within the lower courses of the walls. There are also some cracks that will need to be repaired as part of any proposed renovation works. These are on the Western rear wall. There is also some cracking to the lintels over the windows. Some areas will also need to be repointed where weather damage has damaged the wall finish.

External view of Building 1

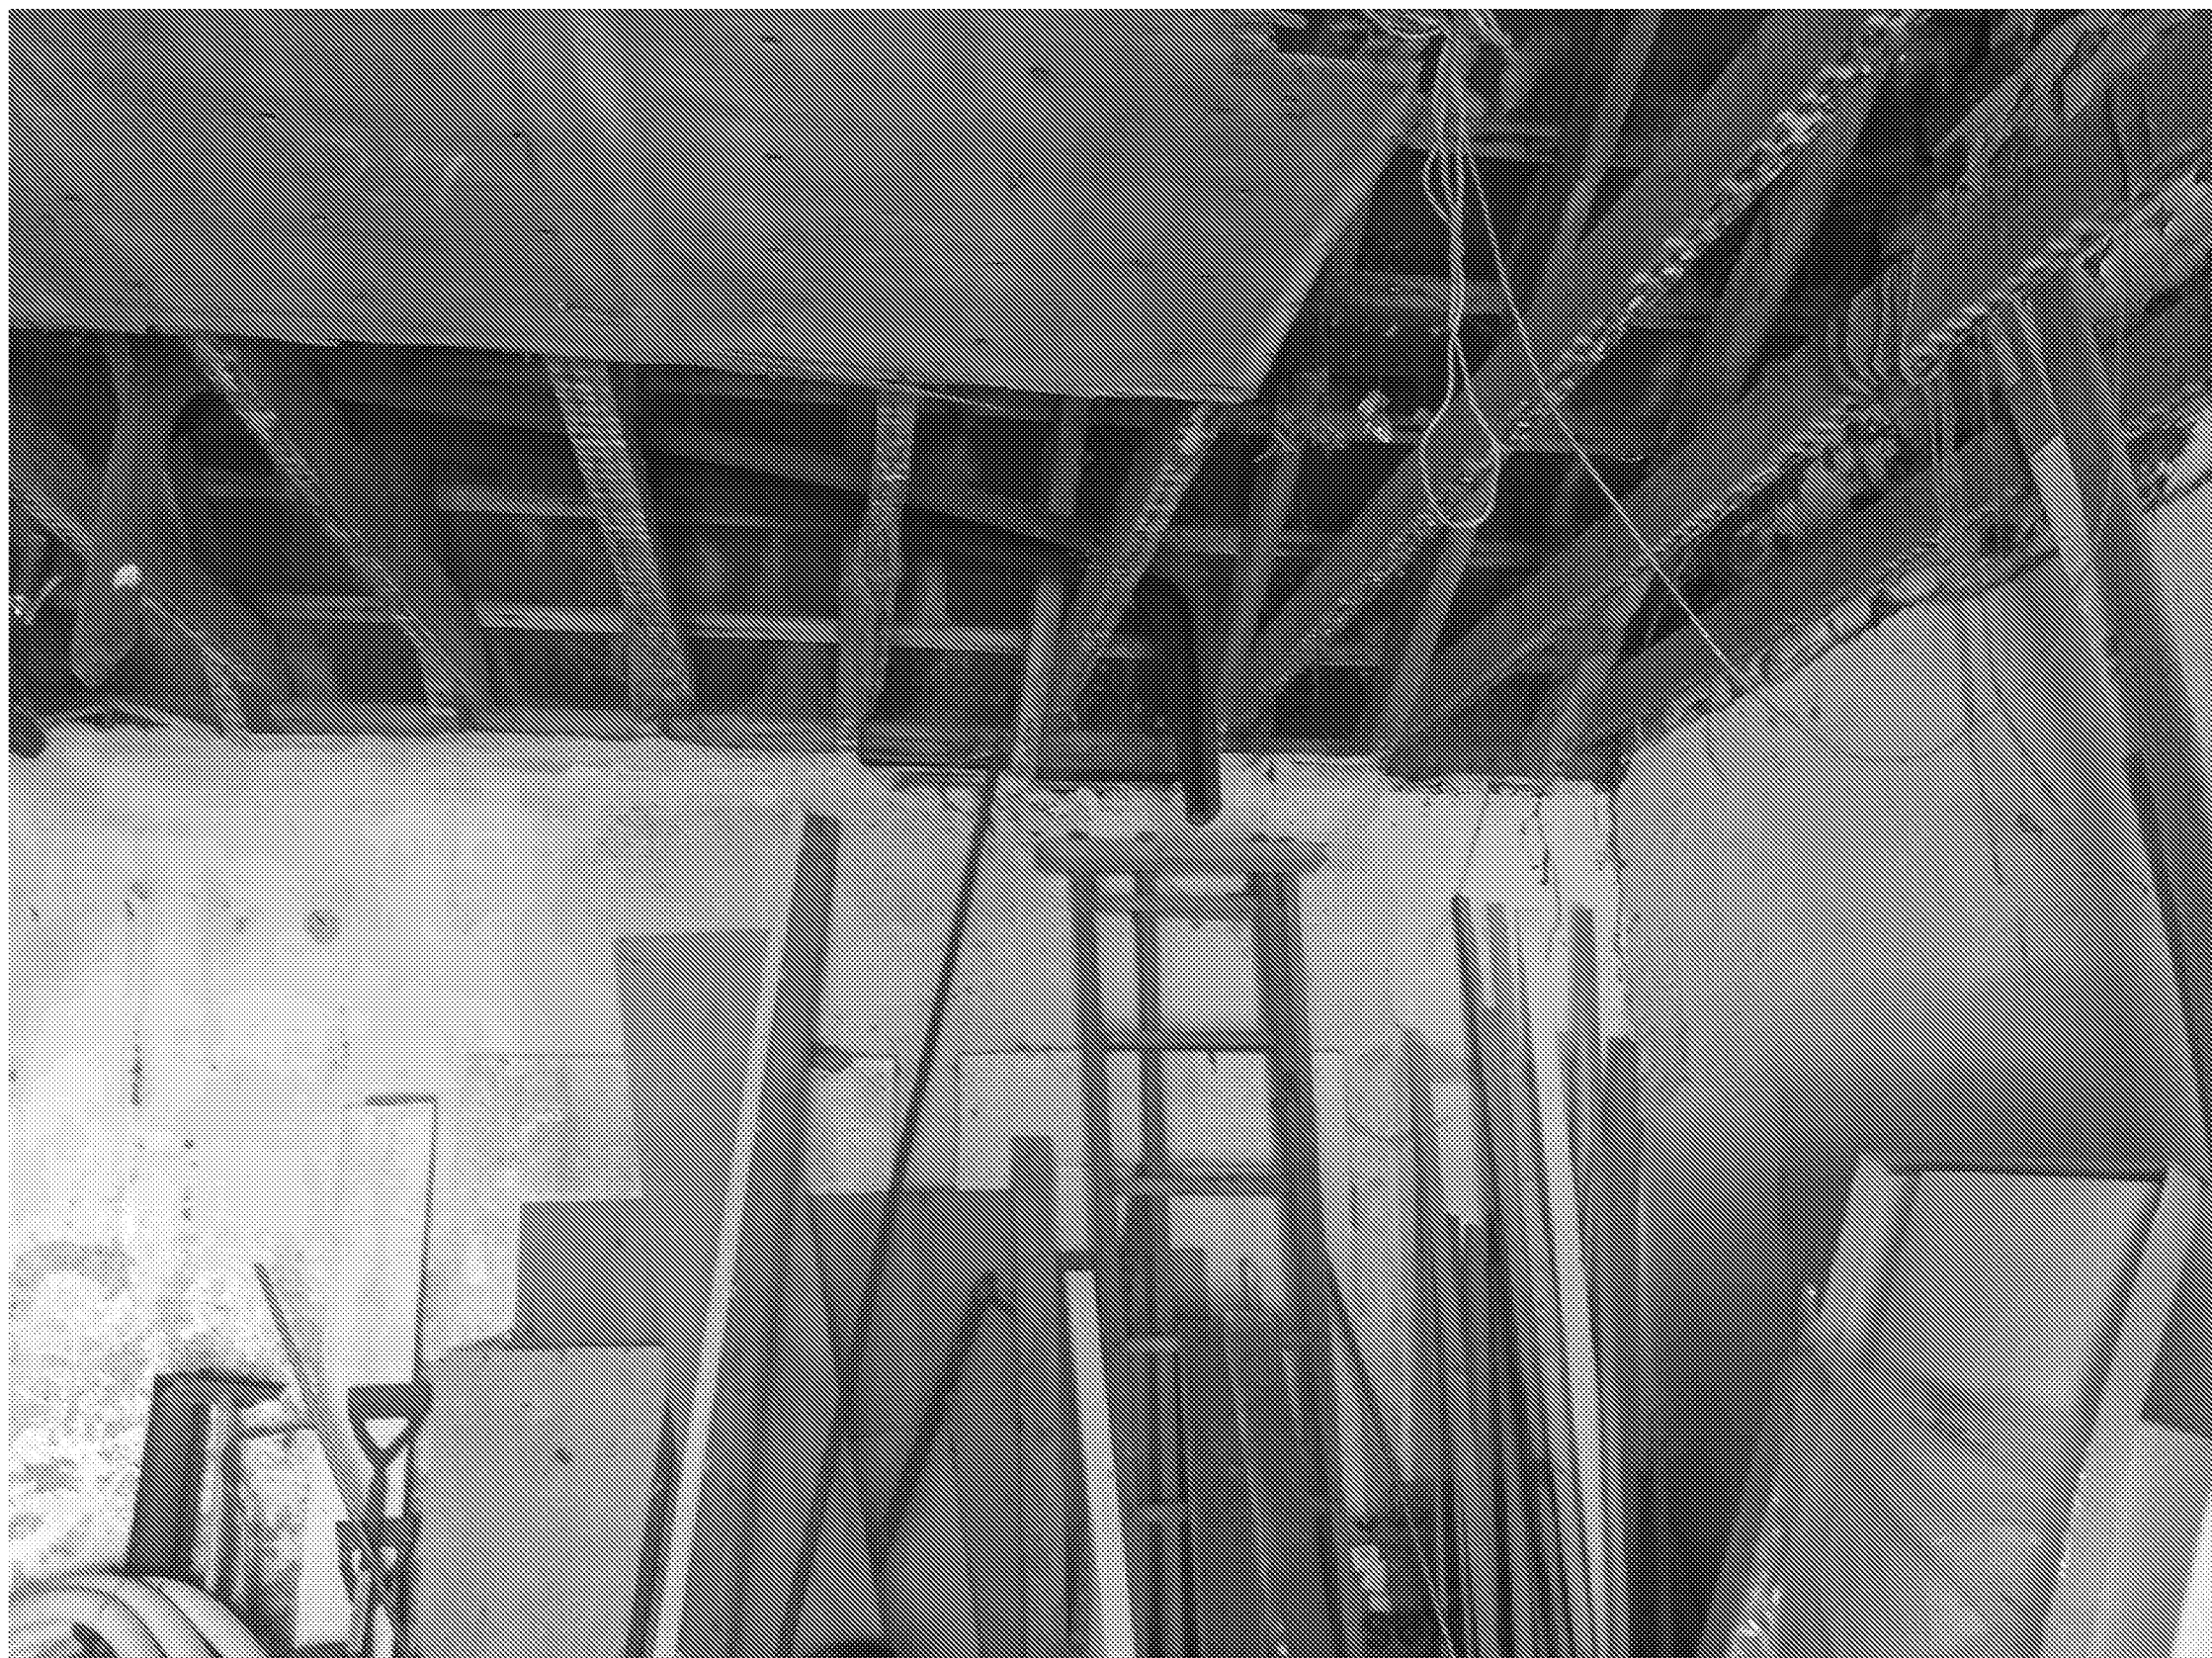
- 3.4 The ground floor in this building appears to be a ground bearing concrete slab. This is likely to be uninsulated. The slab is in fair condition and appears suitable for continued use but will require some repairs as part of the proposed renovation works.

Internal view of Building 1

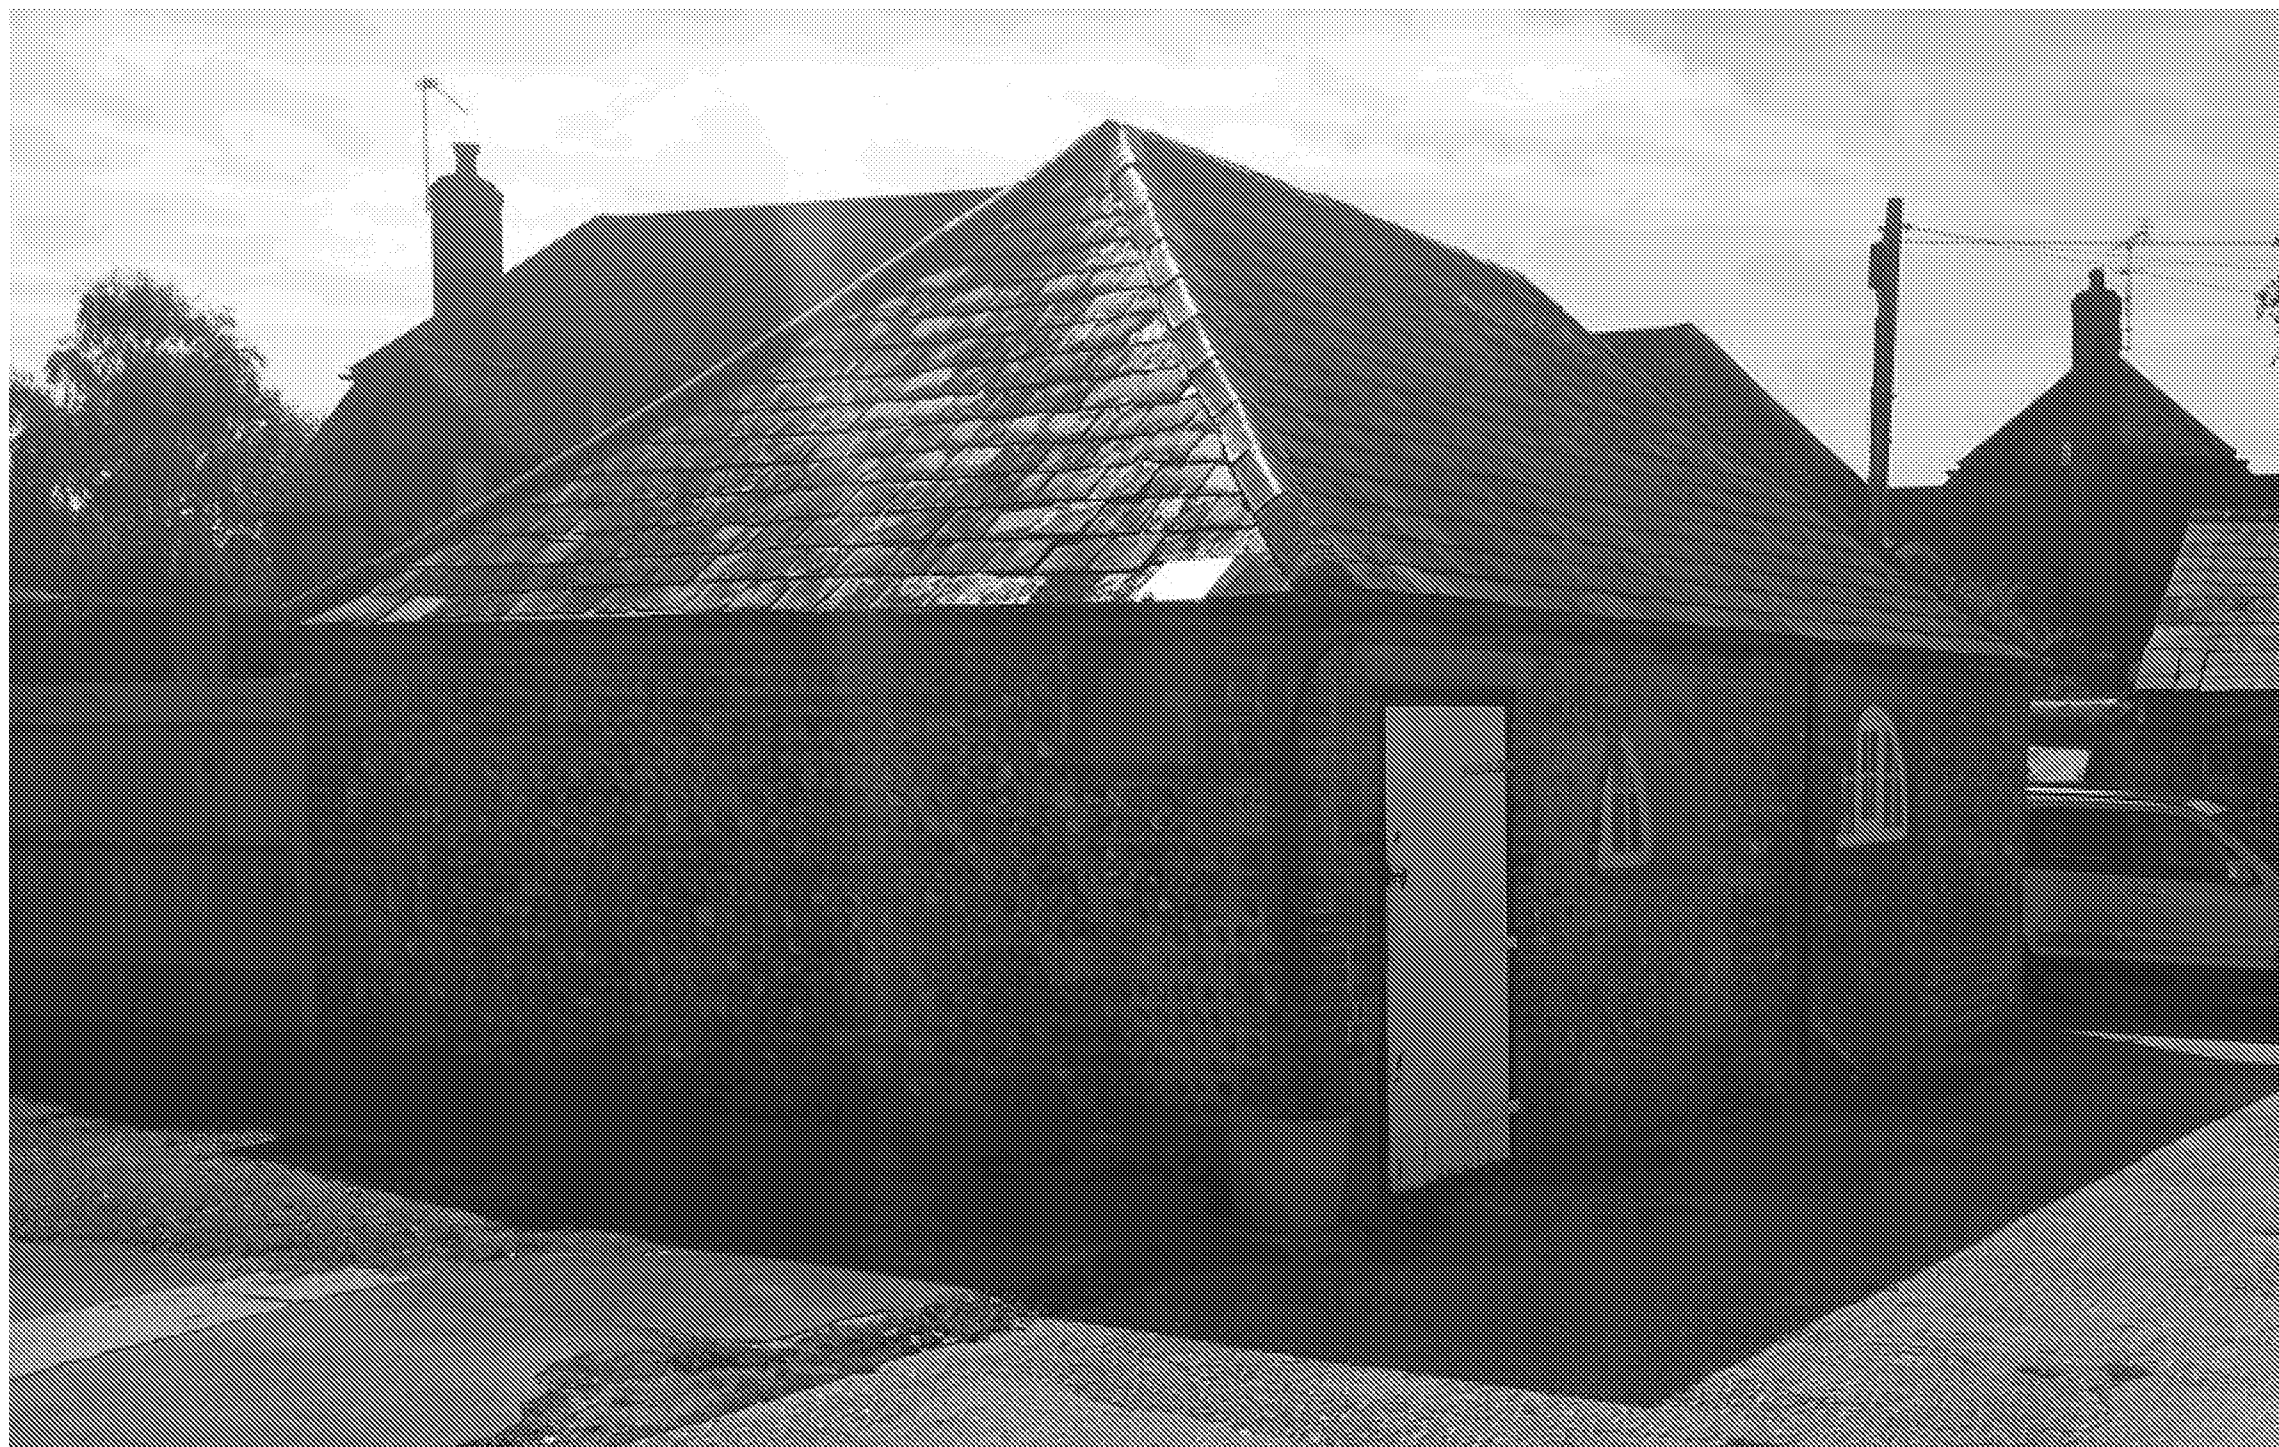
- 3.6 This building is constructed in a similar manner to building 1 but is perhaps slightly older. It has some large timber feature trusses internally. The roof coverings are in very poor condition with numerous previous por repairs having been carried out. This building will need completely new roof coverings.
- 3.7 There appears to be no DPC within the external walls of this building. The walls appear in sound condition but some works maybe necessary to ensure this lack of DPC does not become an issue when the building is renovated. Some of the flint work to the external walls has been badly repaired in the past and needs proper repair during the renovation works.
- 3.8 The walls, timber purlins and steel beams appear in sound condition and only some minor crack repairs will be required to the existing external walls.

External view of Building 2

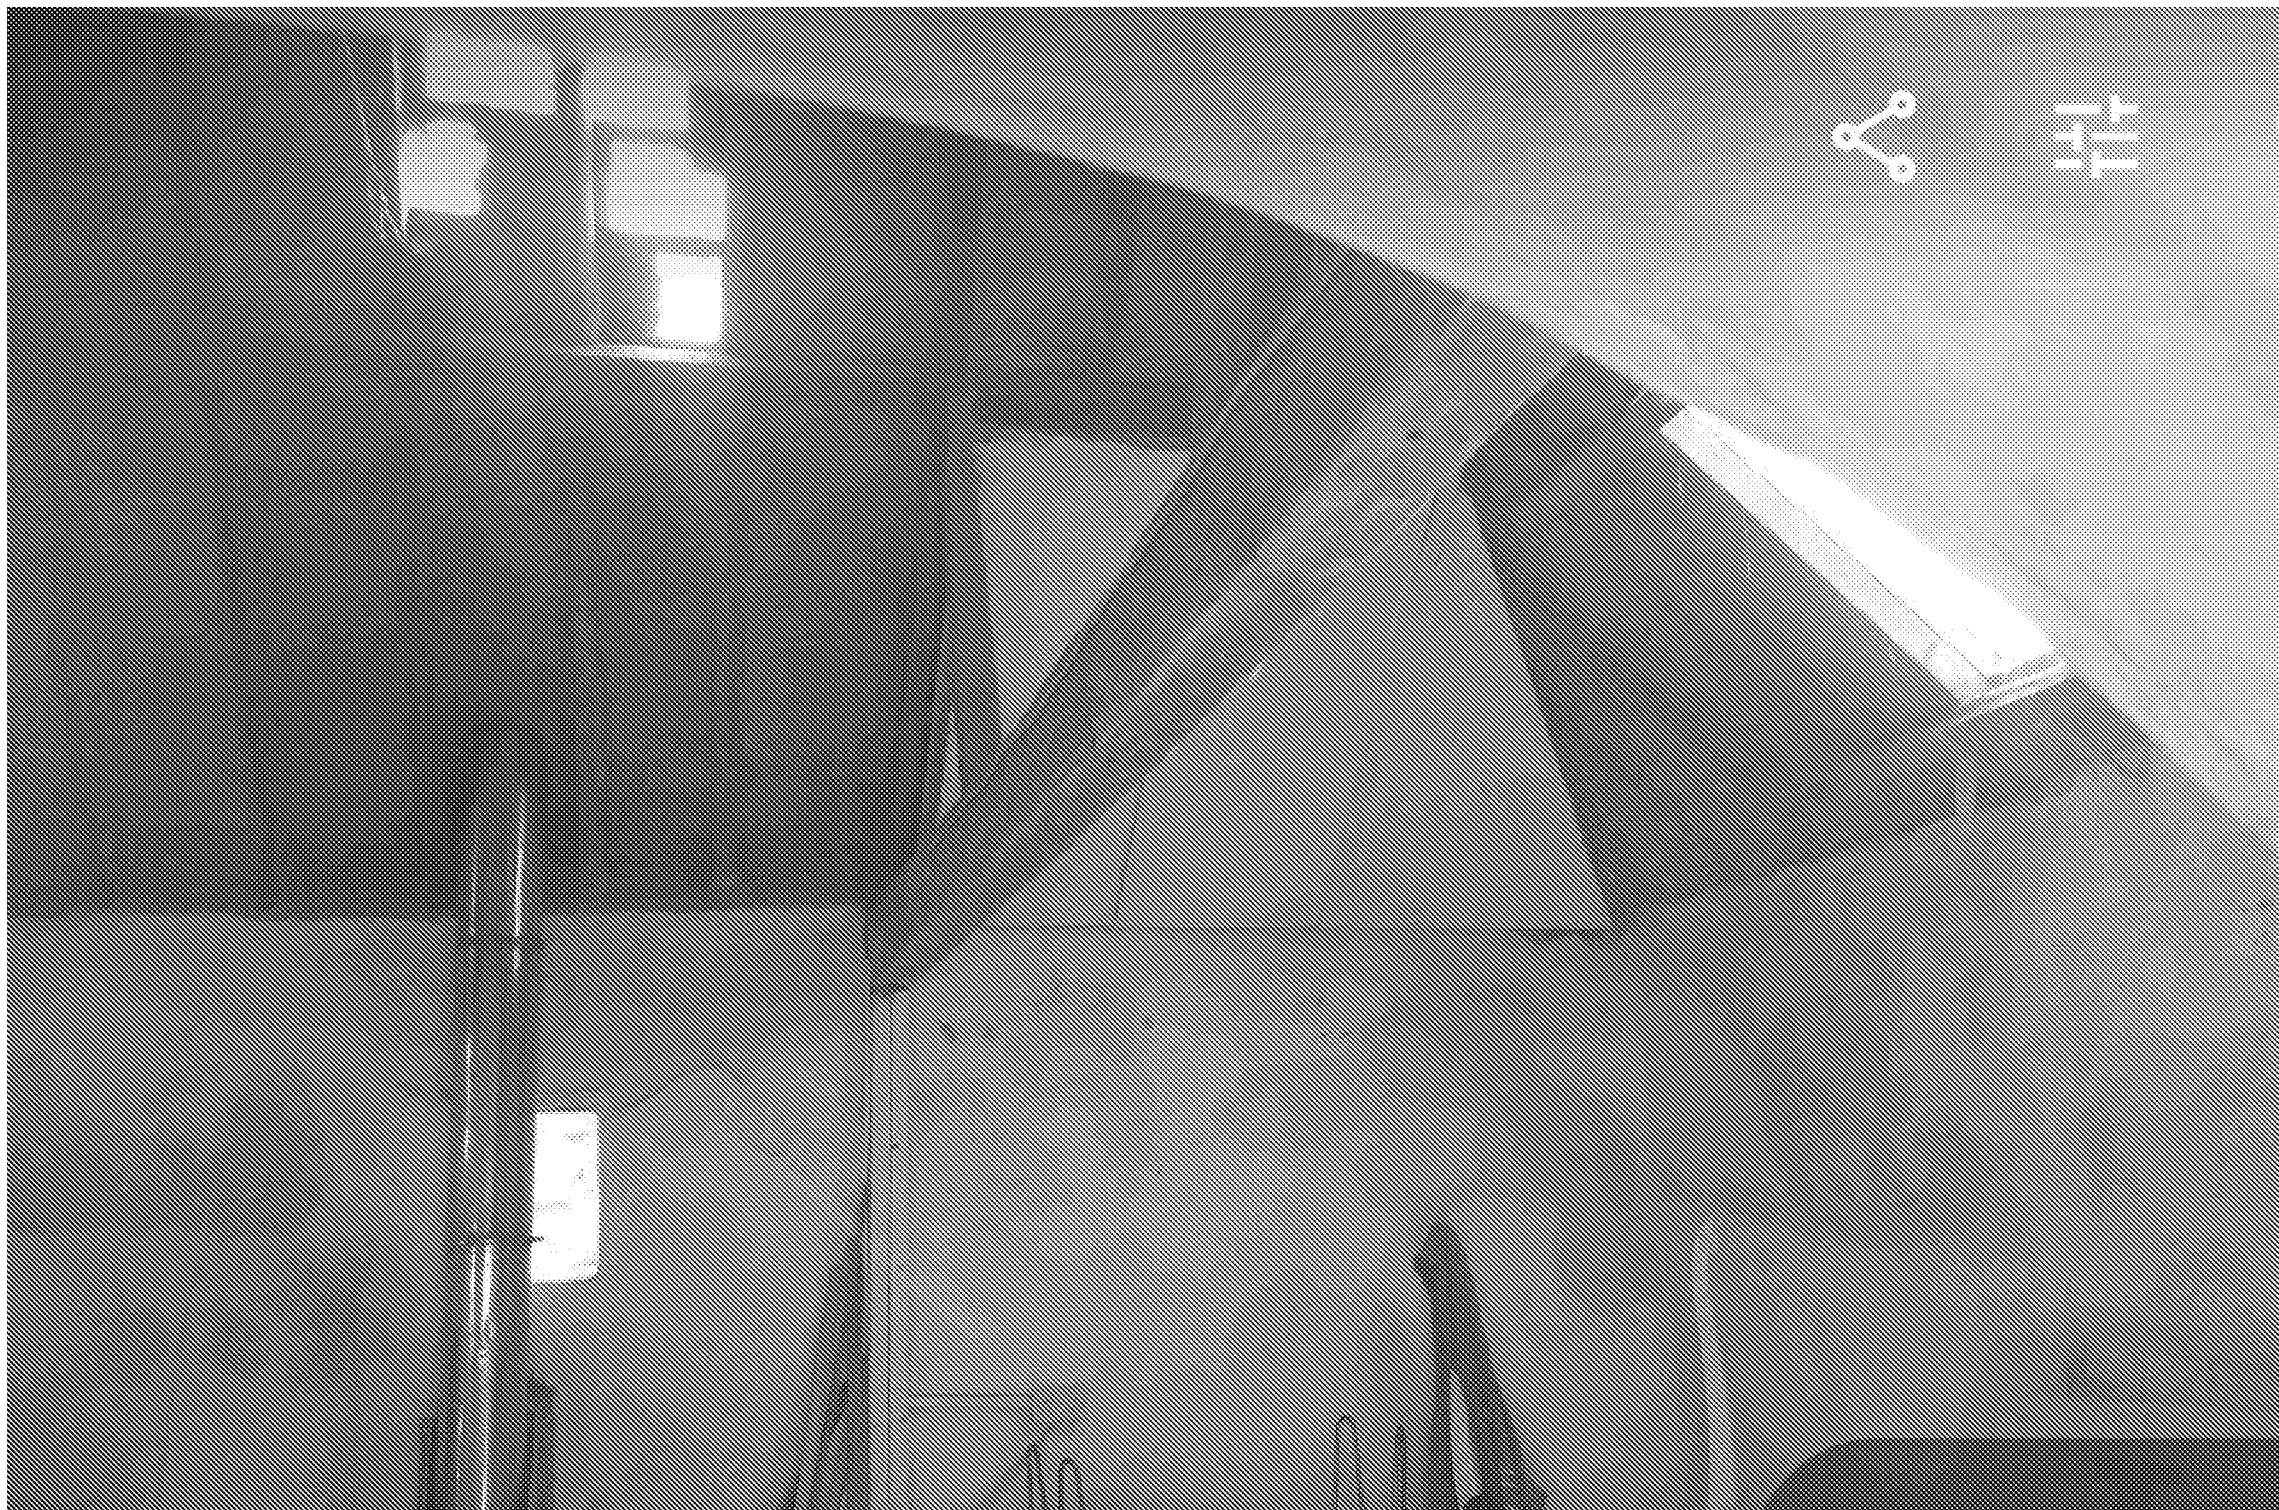
Internal view of Building 2
