**From:** Ian Wieck Surveying [REDACTED]  
**Sent:** 02 July 2018 10:41  
**To:** Zac Denton  
**Subject:** A/73/18/tc Section 211 Notification - St Margaret's Church Angmering - Proposed Tree Works

18 July 2016

**Tree survey in churchyard at St Margaret's Church, Angmering.**

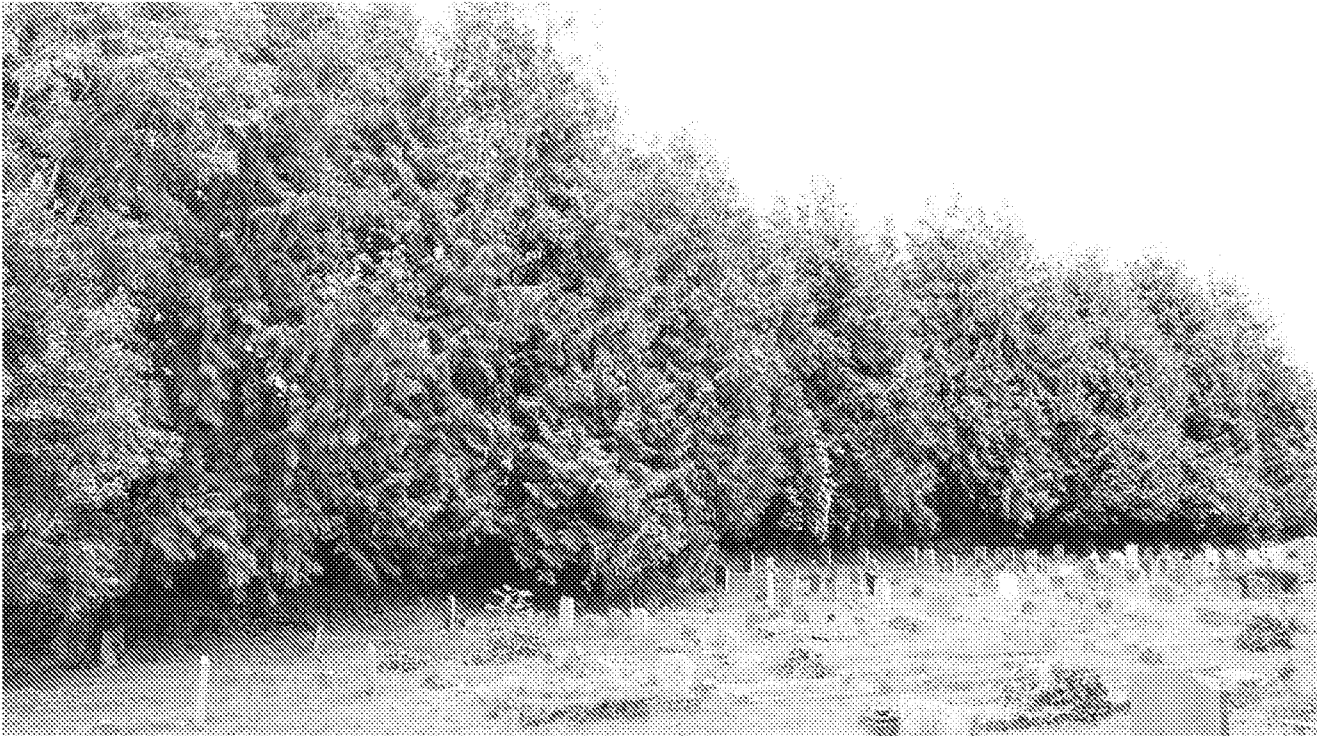
5. In general, the WRC trees are regarded as being in good health (Figure 1) with no features that would make them hazardous. The exceptions are two trees which both lean towards Station Road at an angle of about 40 degrees, one leaning towards the village hall (Figure 2), which houses the Angmering Village Preschool, and one which leans toward the village hall car park.

**Figure 1.** View of western red cedars taken facing south west.

desirable to reduce wind resistance and shading, would remove a significant number of the branches which currently make up the crown. In view of the limited options for pruning and the fact that the trees have become overly dominant, I believe that felling and replacing the entire row of trees would be a suitable management choice.

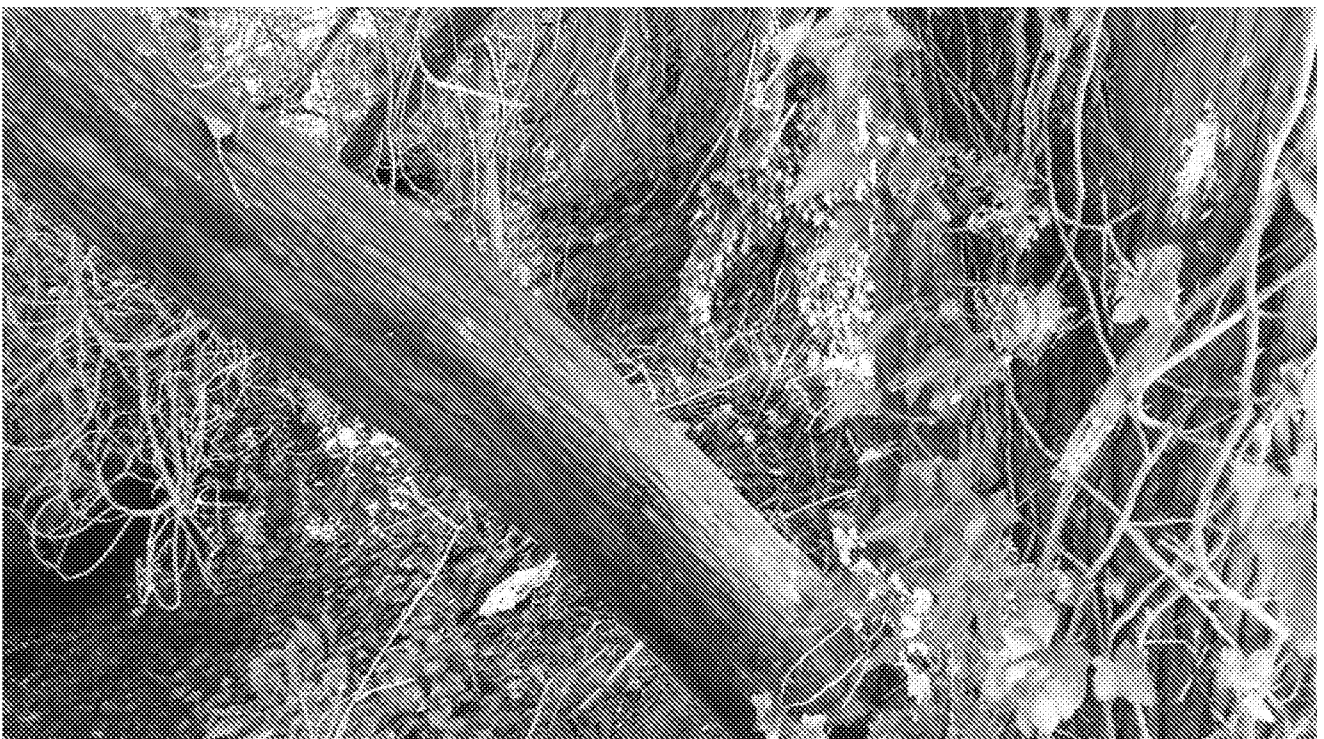
**Figure 2.** Trunk of leaning western red cedar.

6. Whilst it is probable that the leaning trees will not collapse in the short-term it is considered that they are not appropriate for retention since there are significant targets within falling distance. It is therefore recommended that both leaning trees are felled.

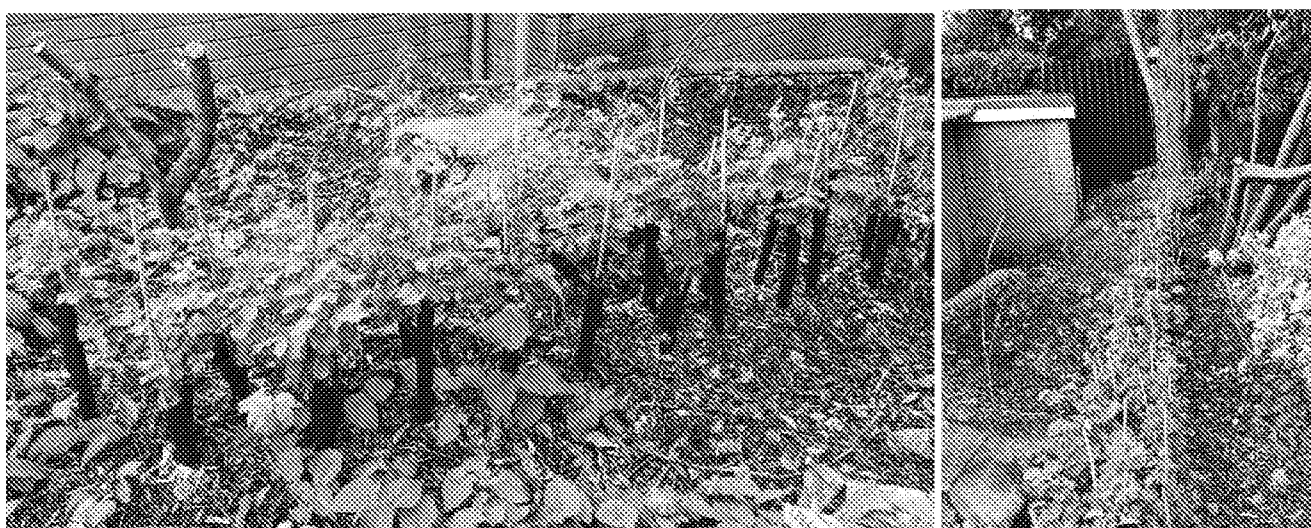
8. During my previous site visit I was asked to assess options for management of a continuation of the line of western red cedars along the eastern boundary, due to them overhanging neighbouring garages. These trees have since been removed and have been replaced by an attractive young mixed hawthorn/hazel hedge interspersed with occasional pre-existing bay. The hedge has established well and will in a short time produce a manageable screen between the church yard and garages. If the remaining WRCs are felled, as I believe is appropriate, then a similar replanting scheme should be undertaken.

**Figure 3.** Native hedge comprising hawthorn, hazel and bay which has replaced the former western red cedar

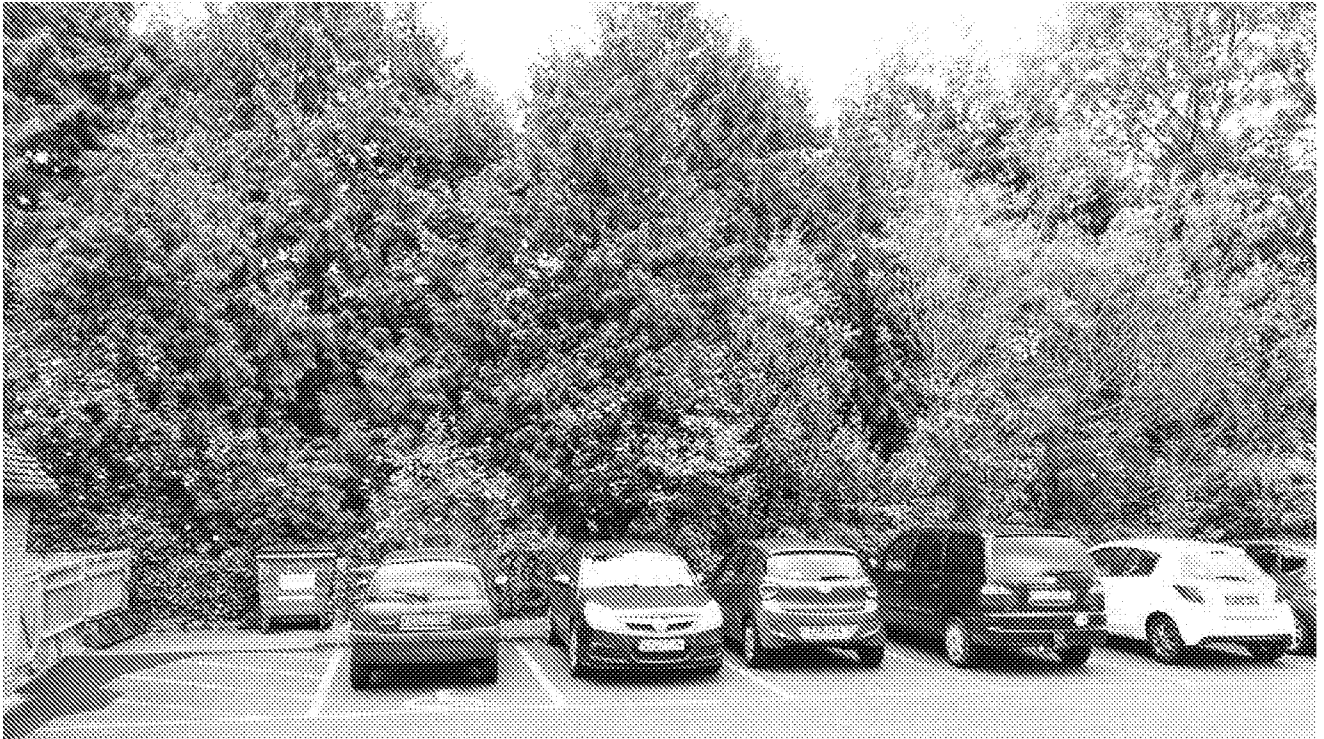
9. The implications of removing the WRC trees are that views of the church would be opened up from Station Road since the green screen would largely be removed. However, in the short term there would be continued low level screening comprised of elder and willow, which would allow views of the church at the same time as providing a green backdrop to the village hall and car park. In addition, a mixed row of trees has been planted in the verge of the car park which will become significant trees in the medium term (Figure 5) and a line of cherry trees in the car park verge close to Station Road provides visual interest in the foreground (Figure 6).

**Figure 4.** View towards the churchyard from Station Road. There is a significant understorey of elder and willow below the western red cedar.

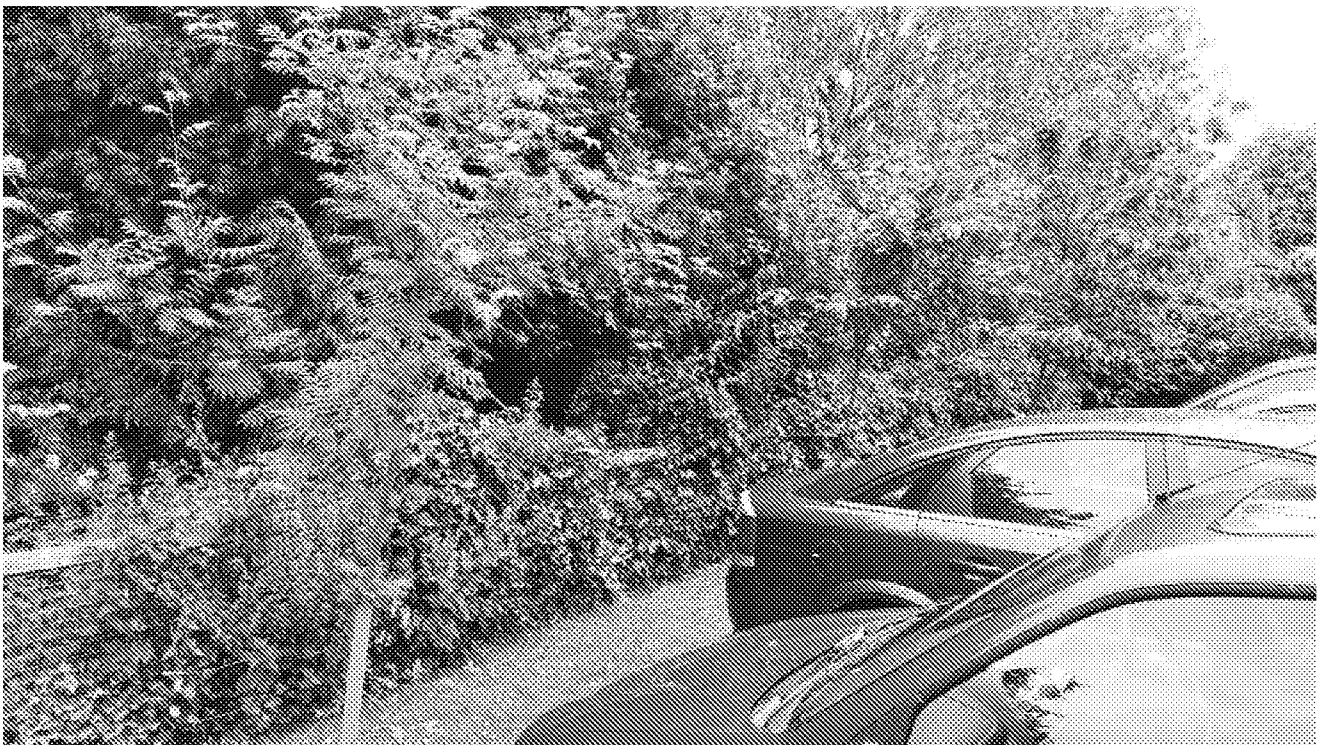
**Figure 5.** New tree planting in verge of car park

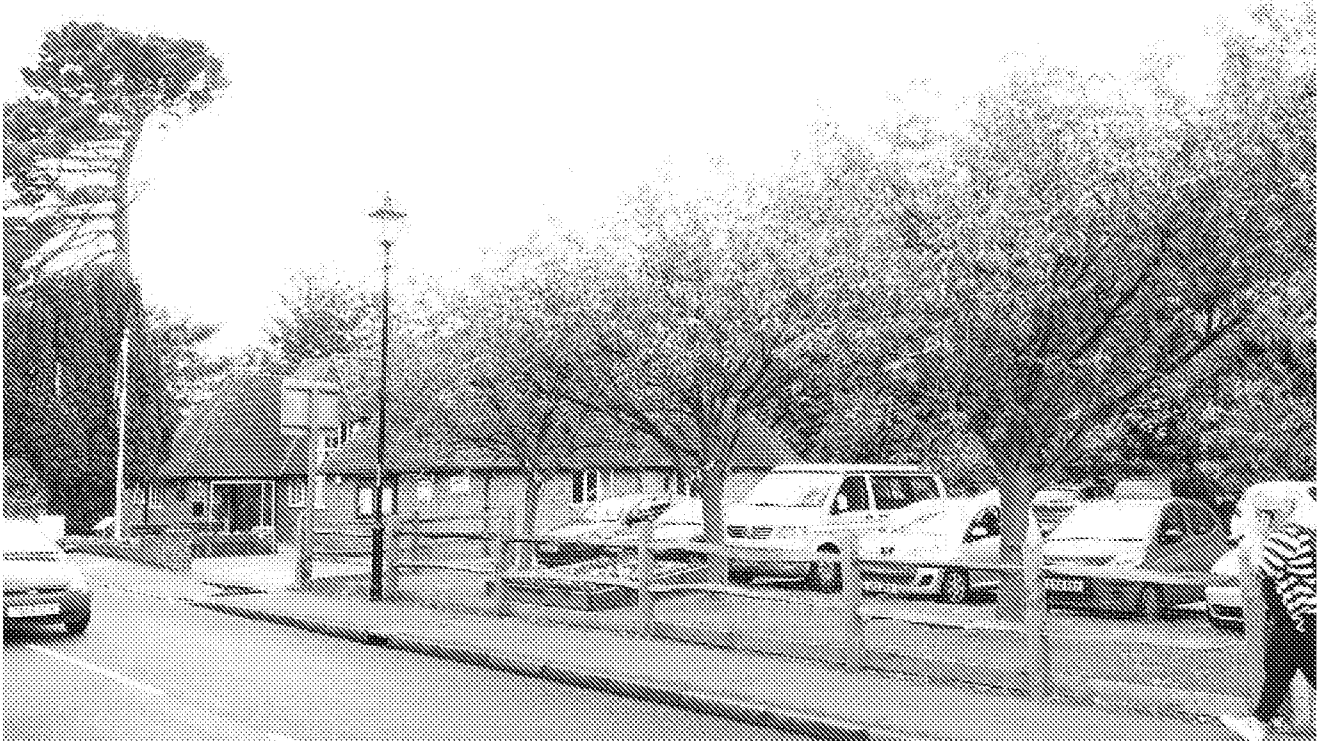
**Figure 6.** Line of cherry trees in car park verge beside Station Road.

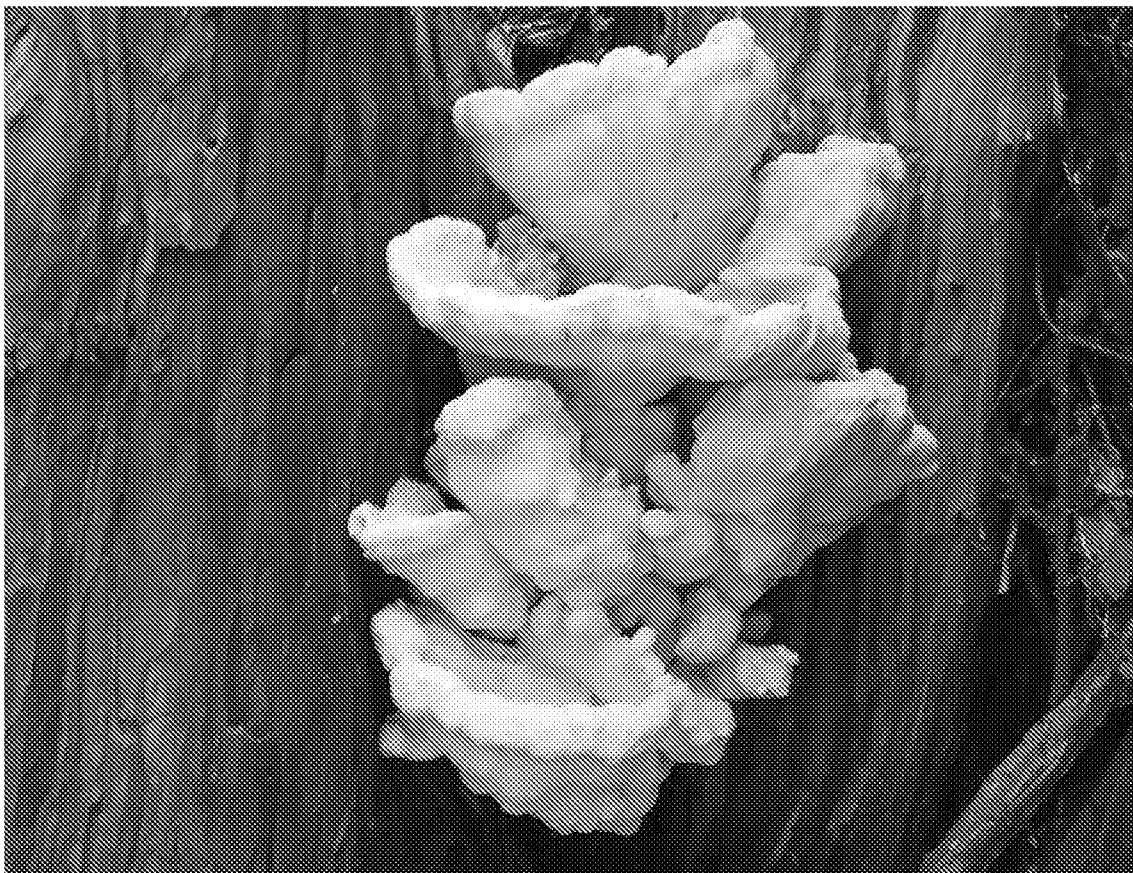
13. The yew T1 which was previously reported to be infected with the fungus 'chicken of the woods' (*Laetiporus sulphureus*) has produced new fungal fruit bodies and decay in the trunk of the tree will be continuing (Figure 8). The weight of the crown will need to be controlled by reduction from time to time.

**Figure 8.** Fruit body of *Laetiporus sulphureus* on yew T1
