LAND AT  
ROUNDSTONE LANE  
ANGMERING  
WEST SUSSEX

TREE REPORT FOR  
ENGLISH OAK NO. T22

Prepared by  
ACD ARBORICULTURE

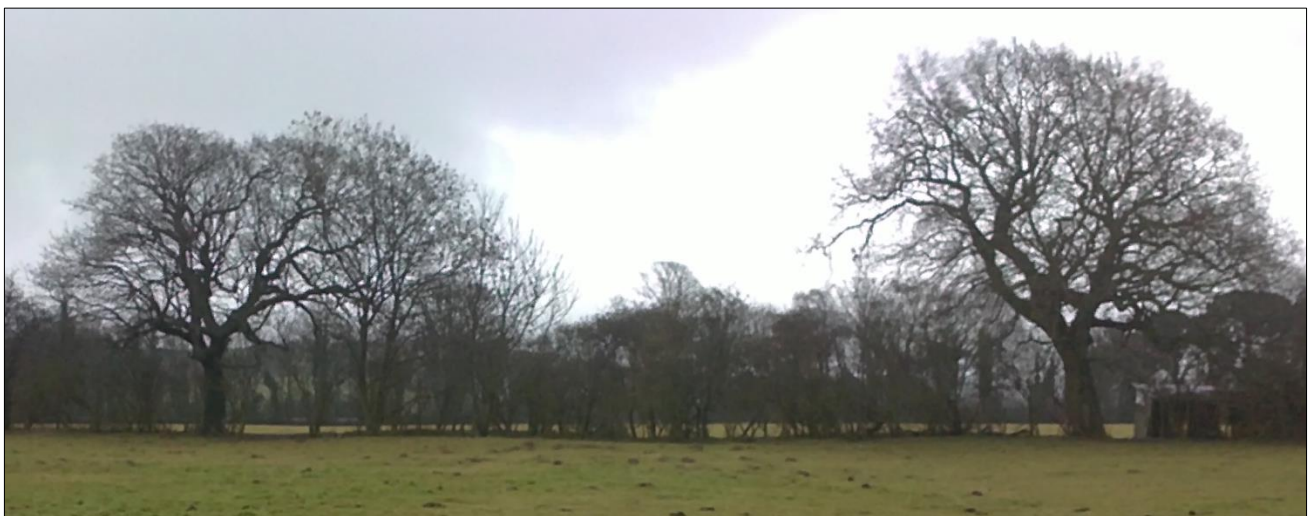
Figure 2: Showing historic photo of English oak tree no. T22 (right side).

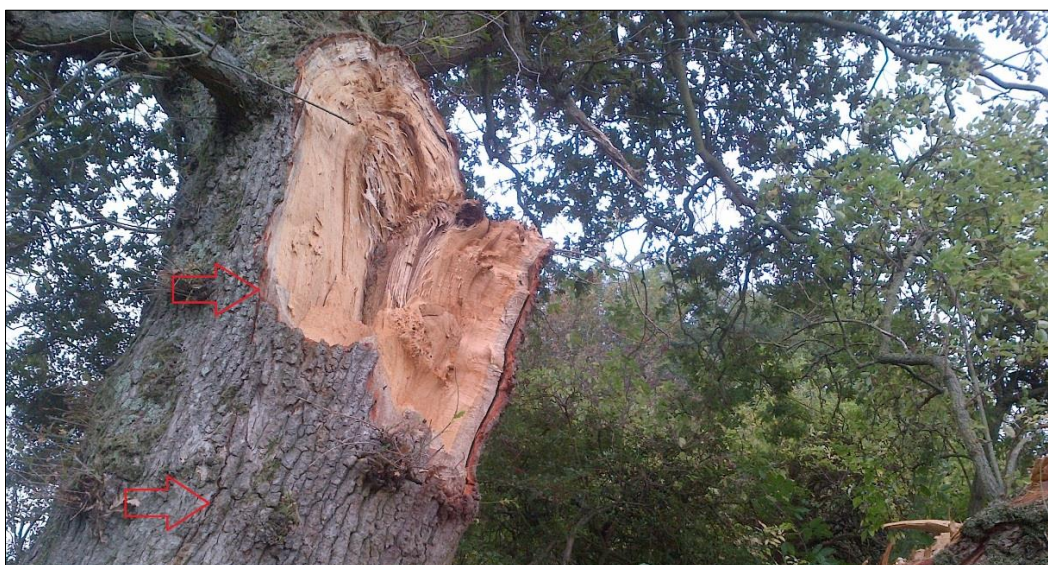
- 1.6. On inspection of the tree it is evident that the tree has failed at the bifurcation of the trunk. This has resulted in a significant trunk wound and longitudinal cracking running downwards from point of failure (figure 3). The tree has likely failed at this point due to the extent of the decay within the trunk bifurcation and wind loading through the tree crown. The tree is surrounded on both sides by open space.

- 1.7. Given the extent of incipient decay at the point of failure and the longitudinal cracking which has resulted it is reasoned that the retention of the tree is no longer suitable.

- 1.8. The tree is retained as an element of the Public Open Space and as such will be frequented by persons on a regular basis. If the tree was to fail further there is a high risk of personal injury and/or damage to proposed dwellings.

**Figure 3: Showing failure point of trunk bifurcation and longitudinal cracking of trunk.**

- 1.9. In conclusion the tree should be removed at the earliest opportunity and replaced with a suitable individual that will make a continued long term contribution to the local landscape.

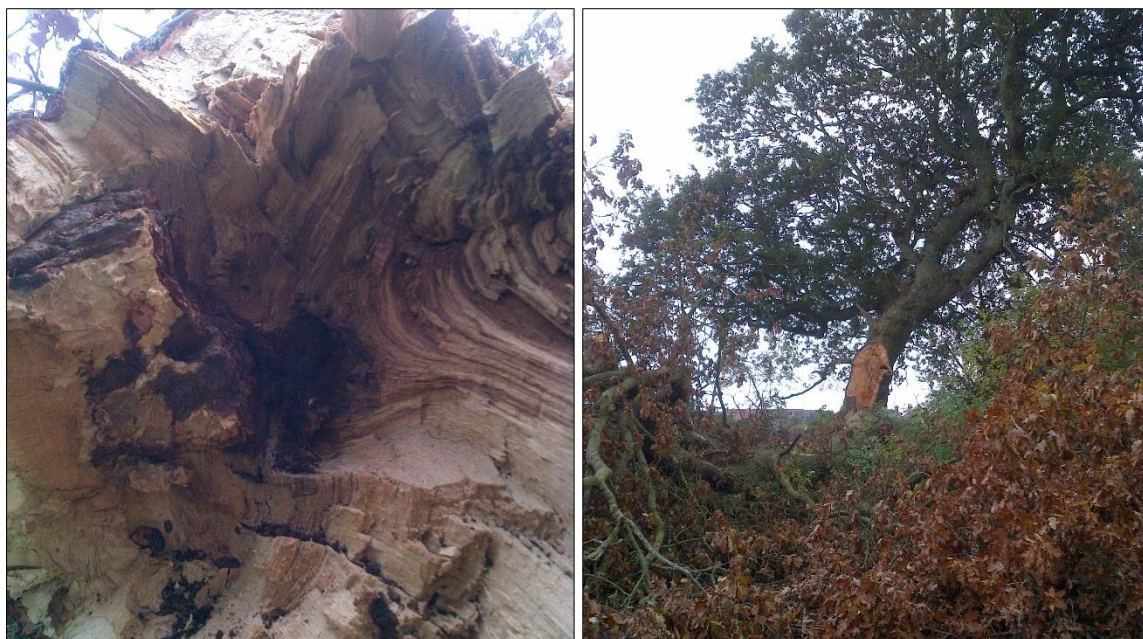
**Figure 4 & 5: Showing extent of decay with failed scaffold branch (l) & crown loss due to failure.**
