# ARBORICULTURAL ASSESSMENT REPORT

| | <b>Risk Address:</b> | North Lodge, North Drive, Angmering,<br>Littlehampton, West Sussex, BN16 4JJ |
| <b>Refs:</b> | <b>PRI Ref:</b> | 120172 |

| <b>Arborist Name:</b> | Ross Lane | <b>Date:</b> | 18/01/2019 |

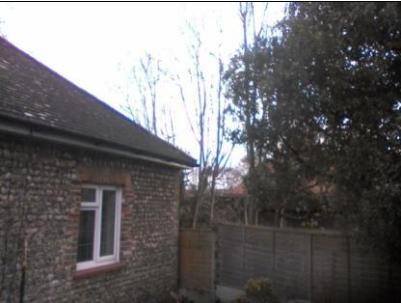
| TG1 - Mixed species group | STG1 - Unknown |

| Tree No | Common Name | Age Class | Condition | Height (m) | Crown Spread (m) | Stem diam. (mm) | Dist to bldg. (m) | Roots Implicated | Pruning history | Recommendation | Tree work constraints | Notes | Owner address | Owner |
|---|---|---|---|---|---|---|---|---|---|---|---|---|---|---|
| TG1 | Mixed species group | Early Mature | Fair | 9.5* | 3.0 | 135 | 1.3 | Y | Subject to past management. Mainly Ash species, but Horse Chestnut also present in group. | Fell and treat stumps. X8 trees | Adjacent to highway - traffic management required. | | District Land Registry search required | UKN |

| Tree No | Common Name | Age Class | Condition | Height (m) | Crown Spread (m) | Stem diam. (mm) | Dist to bldg. (m) | Roots Implicated | Pruning history | Recommendation | Tree work constraints | Notes | Owner address | Owner |
|---|---|---|---|---|---|---|---|---|---|---|---|---|---|---|
| | | | | | | | | | Group falls behind fence boundary on to apparent Local Authority land. | | | | | |

| Tree No: | Species | Works Required |
|---|---|---|
| TG1 | Mixed species group | Fell and treat stumps. X8 trees |

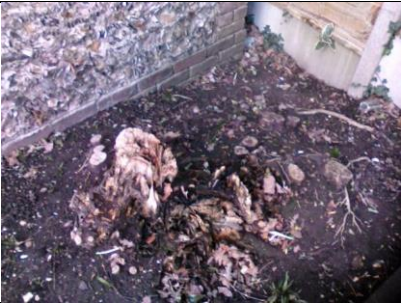
| Tree No | Common Name | Age Class | Condition | Height (m) | Crown Spread (m) | Stem diam. (mm) | Dist to bldg. (m) | Roots Implicated | Pruning history | Recommendation | Tree work constraints | Notes | Owner address | Owner |
|---|---|---|---|---|---|---|---|---|---|---|---|---|---|---|
| STG1 | Unknown | Mature | DDDD | 0.3 | 0 | 110* | 0.3 | N | Subject to past management.<br>Felled. | Treat stumps | | | North Lodge,<br>North Drive,<br>Angmering,<br>Littlehampton,<br>West Sussex<br>BN16 4JJ | PH |

| Tree No: | Species | Works Required |
|---|---|---|
| STG1 | Unknown | Treat stumps. |

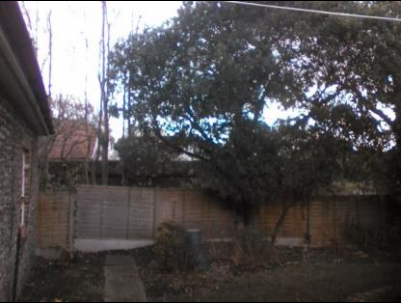
| T1 - Pittosporum | T2 - Oak |

| Tree No | Common Name | Age Class | Condition | Height (m) | Crown Spread (m) | Stem diam. (mm) | Dist to bldg. (m) | Roots Implicated | Pruning history | Recommendation | Tree work constraints | Notes | Owner address | Owner |
|---|---|---|---|---|---|---|---|---|---|---|---|---|---|---|
| T1 | Pittosporum | Mature | Fair | 6.3 | 7.0 | 240 | 4.4 | N | Subject to past management. | Fell and treat stump. | | Unidentified spp roots found underside foundations during Site Investigations. | North Lodge,<br>North Drive,<br>Angmering,<br>Littlehampton,<br>West Sussex<br>BN16 4JJ | PH |

| Tree No: | Species | Works Required |
|---|---|---|
| T1 | Pittosporum | Fell and treat stump. |

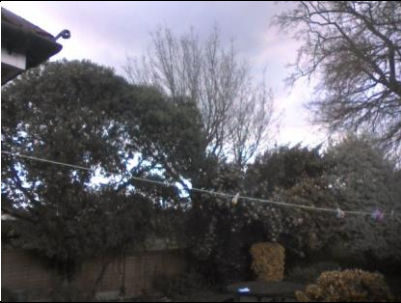
| Tree No | Common Name | Age Class | Condition | Height (m) | Crown Spread (m) | Stem diam. (mm) | Dist to bldg. (m) | Roots Implicated | Pruning history | Recommendation | Tree work constraints | Notes | Owner address | Owner |
|---|---|---|---|---|---|---|---|---|---|---|---|---|---|---|
| T2 | Oak | Mature | Fair | 8.5* | 6 | 280* | 9.2* | N | No significant recent management. | Fell and treat stump. | | | District Land Registry search required | UKN |

| Tree No: | Species | Works Required |
|---|---|---|
| T2 | Oak | Fell and treat stump. |

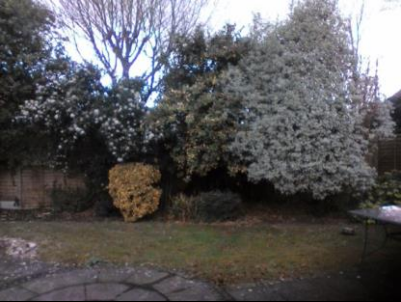
| SG1 - Mixed species shrubs | SG2 - Mixed species shrubs |

| Tree No | Common Name | Age Class | Condition | Height (m) | Crown Spread (m) | Stem diam. (mm) | Dist to bldg. (m) | Roots Implicated | Pruning history | Recommendation | Tree work constraints | Notes | Owner address | Owner |
|---|---|---|---|---|---|---|---|---|---|---|---|---|---|---|
| SG1 | Mixed species shrubs | Mature | Fair | 4.8 | 4 | 70* | 9 | N | Subject to recent management. | No work required. | | Species include Viburnum, Eleagnus | North Lodge, North Drive, Angmering, Littlehampton, West Sussex BN16 4JJ | PH |

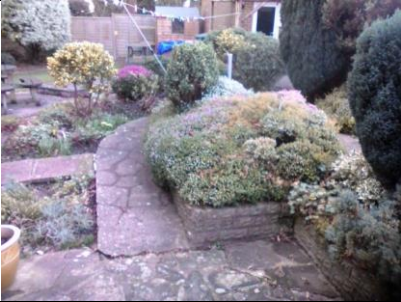
| Tree No | Common Name | Age Class | Condition | Height (m) | Crown Spread (m) | Stem diam. (mm) | Dist to bldg. (m) | Roots Implicated | Pruning history | Recommendation | Tree work constraints | Notes | Owner address | Owner |
|---|---|---|---|---|---|---|---|---|---|---|---|---|---|---|
| SG2 | Mixed species shrubs | Semi-Mature | Fair | 0.8 | 0.50 | 35* | 1.9 | N | Subject to recent management. | No work required. | | Species include Cypress, Heather | North Lodge, North Drive, Angmering, Littlehampton, West Sussex BN16 4JJ | PH |

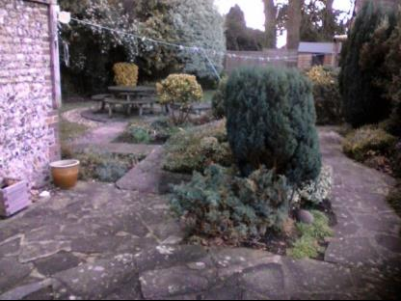
| S1 - Cypress | T3 - Oak |

| Tree No | Common Name | Age Class | Condition | Height (m) | Crown Spread (m) | Stem diam. (mm) | Dist to bldg. (m) | Roots Implicated | Pruning history | Recommendation | Tree work constraints | Notes | Owner address | Owner |
|---|---|---|---|---|---|---|---|---|---|---|---|---|---|---|
| S1 | Cypress | Semi-Mature | Fair | 1.4 | 0.6 | 30* | 3 | Y | Subject to recent management. | No work required. | | Minor tree despite identification of roots. Not near to area of damage. | North Lodge,<br>North Drive,<br>Angmering,<br>Littlehampton,<br>West Sussex<br>BN16 4JJ | PH |

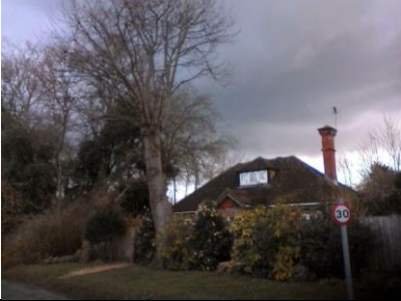
| Tree No | Common Name | Age Class | Condition | Height (m) | Crown Spread (m) | Stem diam. (mm) | Dist to bldg. (m) | Roots Implicated | Pruning history | Recommendation | Tree work constraints | Notes | Owner address | Owner |
|---|---|---|---|---|---|---|---|---|---|---|---|---|---|---|
| T3 | Oak | Mature | Fair | 15 | 8 | 680 | 6.6 | Y | Subject to recent management. | Fell and treat stump. | | Oak roots have been identified from below the foundation at the front right corner of the property. | District Land Registry search required | UKN |

| Tree No: | Species | Works Required |
|---|---|---|
| T3 | Oak | Fell and treat stump. |

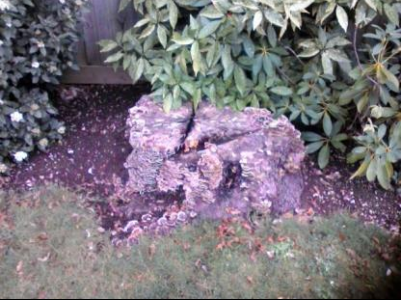
| ST1 - Unknown | T4 - Cherry |

| Tree No | Common Name | Age Class | Condition | Height (m) | Crown Spread (m) | Stem diam. (mm) | Dist to bldg. (m) | Roots Implicated | Pruning history | Recommendation | Tree work constraints | Notes | Owner address | Owner |
|---|---|---|---|---|---|---|---|---|---|---|---|---|---|---|
| ST1 | Oak stump | Mature | Fair | 0 | 0 | 900* | 8.3 | N | Felled since 2012.<br>Fungal bodies present on stump.<br>Turkey tail fungus | No work required. | | | District Land Registry search required | UKN |

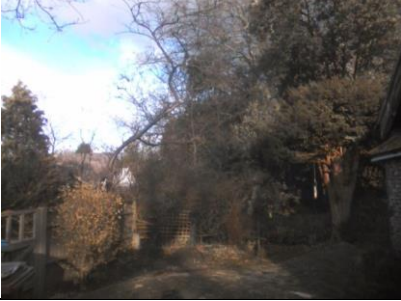
| Tree No | Common Name | Age Class | Condition | Height (m) | Crown Spread (m) | Stem diam. (mm) | Dist to bldg. (m) | Roots Implicated | Pruning history | Recommendation | Tree work constraints | Notes | Owner address | Owner |
|---|---|---|---|---|---|---|---|---|---|---|---|---|---|---|
| T4 | Cherry | Early Mature | Fair | 6 | 3.0 | 150 | 5 | N | Subject to recent management. | No work required. | | | North Lodge, North Drive, Angmering, Littlehampton, West Sussex BN16 4JJ | PH |

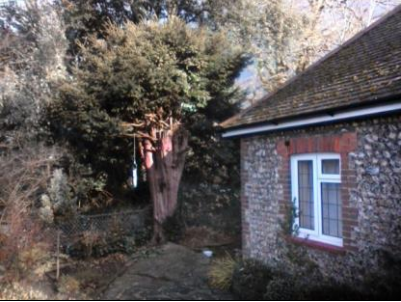
| T5 - Yew | H1 - Mixed species hedge |

| Tree No | Common Name | Age Class | Condition | Height (m) | Crown Spread (m) | Stem diam. (mm) | Dist to bldg. (m) | Roots Implicated | Pruning history | Recommendation | Tree work constraints | Notes | Owner address | Owner |
|---|---|---|---|---|---|---|---|---|---|---|---|---|---|---|
| T5 | Yew | Mature | Fair | 4.7 | 5.0 | 580 | 2.1 | N | Subject to recent management. Heavily reduced | No work required | | | North Lodge, North Drive, Angmering, Littlehampton, West Sussex BN16 4JJ | PH |

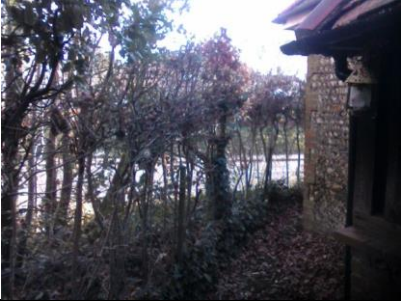
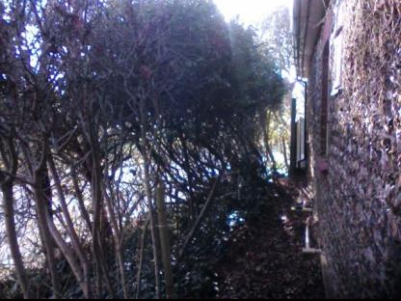
| Tree No | Common Name | Age Class | Condition | Height (m) | Crown Spread (m) | Stem diam. (mm) | Dist to bldg. (m) | Roots Implicated | Pruning history | Recommendation | Tree work constraints | Notes | Owner address | Owner |
|---|---|---|---|---|---|---|---|---|---|---|---|---|---|---|
| H1 | Mixed species hedge | Early Mature | Fair | 2.2 | 0.50 | 50* | 0.8 | Y | Subject to recent management. | Fell and treat stumps. Approx 14m in length for removal. | | Species include Hawthorn and Blackthorn | District Land Registry search required | UKN |

| Tree No: | Species | Works Required |
|---|---|---|
| H1 | Mixed species hedge | Fell and treat stumps. Approx 14m in length for removal. |

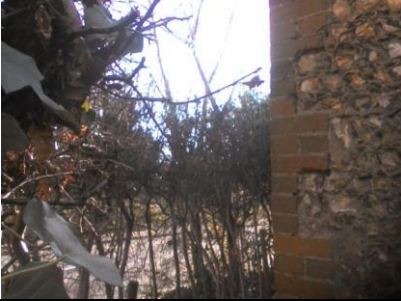
| H1 - Mixed species hedge | TG2 - Mixed species group |

| Tree No | Common Name | Age Class | Condition | Height (m) | Crown Spread (m) | Stem diam. (mm) | Dist to bldg. (m) | Roots Implicated | Pruning history | Recommendation | Tree work constraints | Notes | Owner address | Owner |
|---|---|---|---|---|---|---|---|---|---|---|---|---|---|---|
| TG2 | Mixed species group | Early Mature | Fair | 9* | 3.50 | 120* | 2.2 | Y | No significant recent management. | Fell and treat stumps. | | Species include Cherry, Maple. | District Land Registry search required | UKN |

| Tree No: | Species | Works Required |
|---|---|---|
| TG2 | Mixed species group | Fell and treat stumps. |

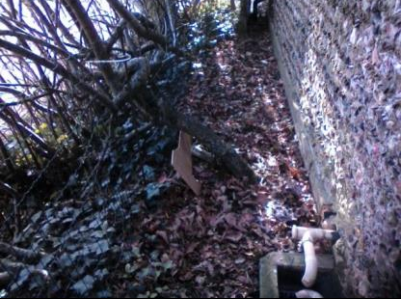
| S2 - Blackthorn | TG3 - Mixed species group |

| Tree No | Common Name | Age Class | Condition | Height (m) | Crown Spread (m) | Stem diam. (mm) | Dist to bldg. (m) | Roots Implicated | Pruning history | Recommendation | Tree work constraints | Notes | Owner address | Owner |
|---|---|---|---|---|---|---|---|---|---|---|---|---|---|---|
| S2 | Blackthorn | Mature | Fair | 2.5 | 0.6 | 50 | 0.3 | Y | Subject to past management. | Fell and treat stump. | | | North Lodge,<br>North Drive,<br>Angmering,<br>Littlehampton,<br>West Sussex<br>BN16 4JJ | PH |

| Tree No: | Species | Works Required |
|---|---|---|
| S2 | Blackthorn | Fell and treat stump. |

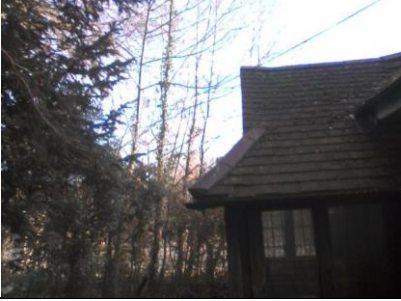
| Tree No | Common Name | Age Class | Condition | Height (m) | Crown Spread (m) | Stem diam. (mm) | Dist to bldg. (m) | Roots Implicated | Pruning history | Recommendation | Tree work constraints | Notes | Owner address | Owner |
|---|---|---|---|---|---|---|---|---|---|---|---|---|---|---|
| TG3 | Mixed species group | Early Mature | Fair | 12* | 5.0 | 120* | 2.6 | Y | No significant recent management. | Fell and treat stumps. X20 trees for removal approx (including occasional scrub growth), providing a 9m clearance from the rear left corner of the property. | | Species include Maple, Oak | District Land Registry search required | UKN |

| Tree No: | Species | Works Required |
|---|---|---|
| TG3 | Mixed species group | Fell and treat stumps. X20 trees for removal approx (including occasional scrub growth), providing a 9m clearance from the rear left corner of the property. |

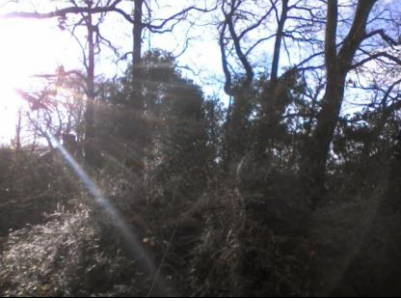
| TG4 - Mixed species group | |

| Tree No | Common Name | Age Class | Condition | Height (m) | Crown Spread (m) | Stem diam. (mm) | Dist to bldg. (m) | Roots Implicated | Pruning history | Recommendation | Tree work constraints | Notes | Owner address | Owner |
|---|---|---|---|---|---|---|---|---|---|---|---|---|---|---|
| TG4 | Mixed species group | Mature | Fair | 20* | 9.0 | 500* | 10* | N | Subject to past management. | No work required. | | Species include Oak, Pine, Lime | District Land Registry search required | UKN |
