**D.D. BENTLEY TREE SERVICES**

Tree survey carried out on an Ilex Oak November 2014 at

Kalyvaki

Ham Manor

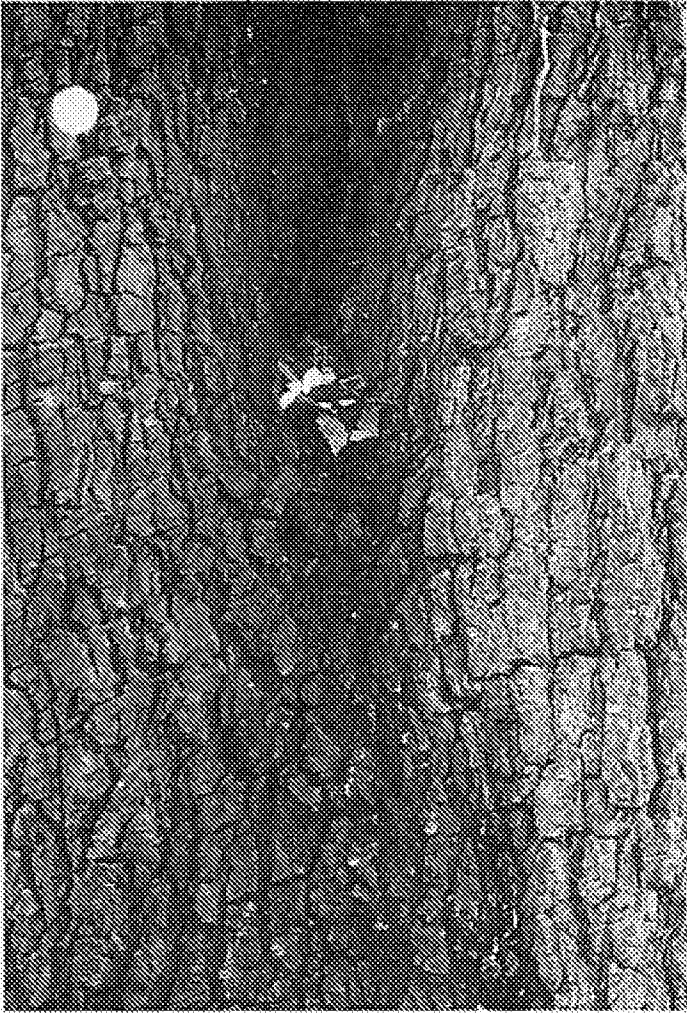
FIG 1

Generally good condition with no epicormic growth present. A dark sticky liquid oozes from two points on the trunk (fig 1 and fig 2).

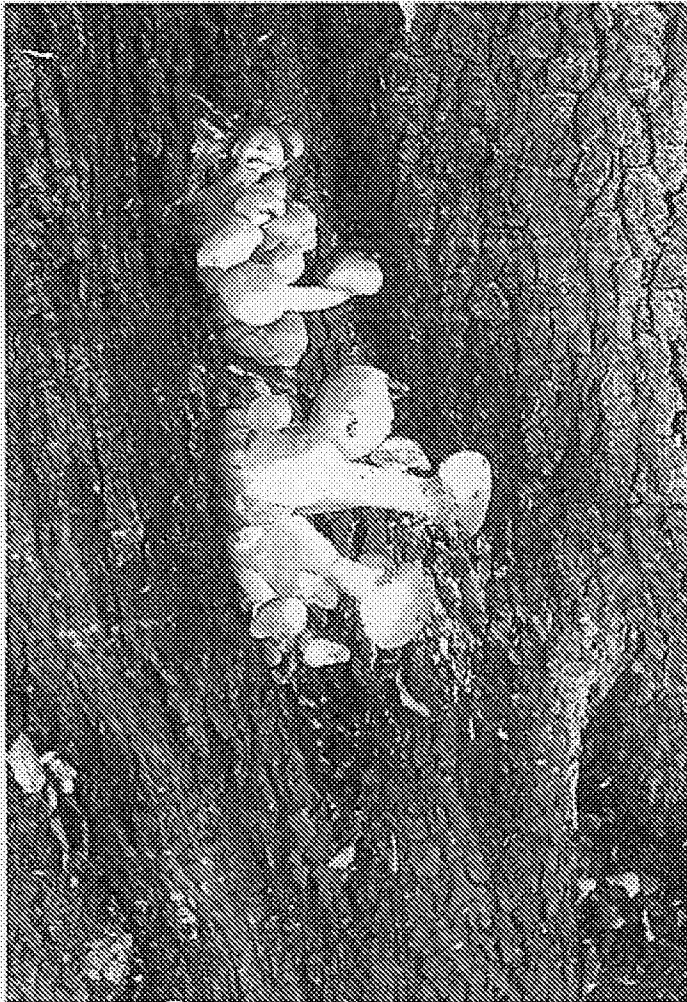
FIG 3

Fungi found on the trunk just above ground level, *Collybia fusipes* commonly known as spindle shank (fig 3 and fig 4). This fungus is a biotrophic parasite which is associated with simultaneous white rot of the root system.

This tree is starting to become hazardous and with the fungal growth found present is highly likely to suffer from extensive root rot which is likely to lead to susceptibility to wind throw. Damage would be sustained in any direction this tree would fail in. This tree has outgrown it's environment and casts a significant shadow over the whole garden. Further reductions would likely prove to be terminal for this tree.

My recommendation is to remove this tree before it becomes structurally unsound. Three Olive trees have already been planted to replace the oak.

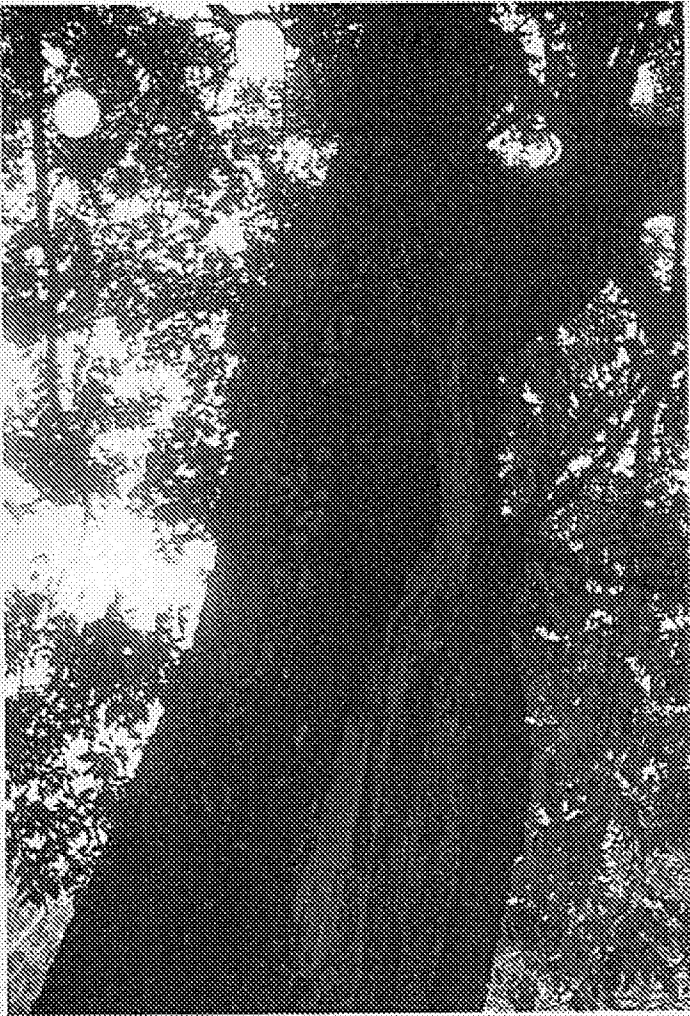
Fig 5

Canopy density is average with healthy looking leaves with little evidence of infestation. The stem condition shows extensive bark shedding with large areas of white rot and decay. There are six major stems and all are affected by either rot, necrosis and bark shedding with numerous holes and cavities present. (figs 5-13).
