SUPPLEMENTARY SITE INVESTIGATION  
MOTORSPORTS CENTRE, LAND NORTH OF WATER LANE  
ANGMERING, WEST SUSSEX  
GLEESON STRATEGIC LAND / RYDON HOMES  
SI-19495-21-62  
FEBRUARY 2021

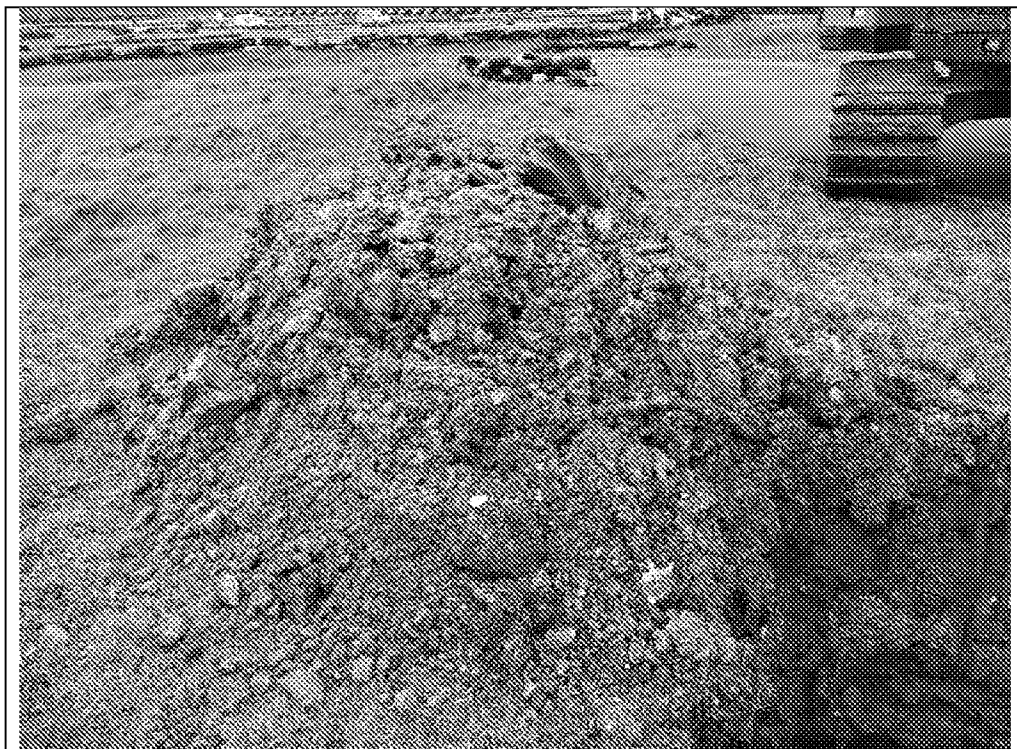
3.2.3.2 The general made ground encountered in the raceway comprised reworked orangish brown gravelly clays with inclusions of asphalt planings, brick, some concrete, metal and wood up to 1.3 m below ground level (bgl). At MTP301 a small piece of fragmented asbestos cement was identified 0.4 m bgl. Analysis of a bulk sample of the material confirms that it contains chrysotile asbestos.

MTP302: Made ground arisings in the raceway area.

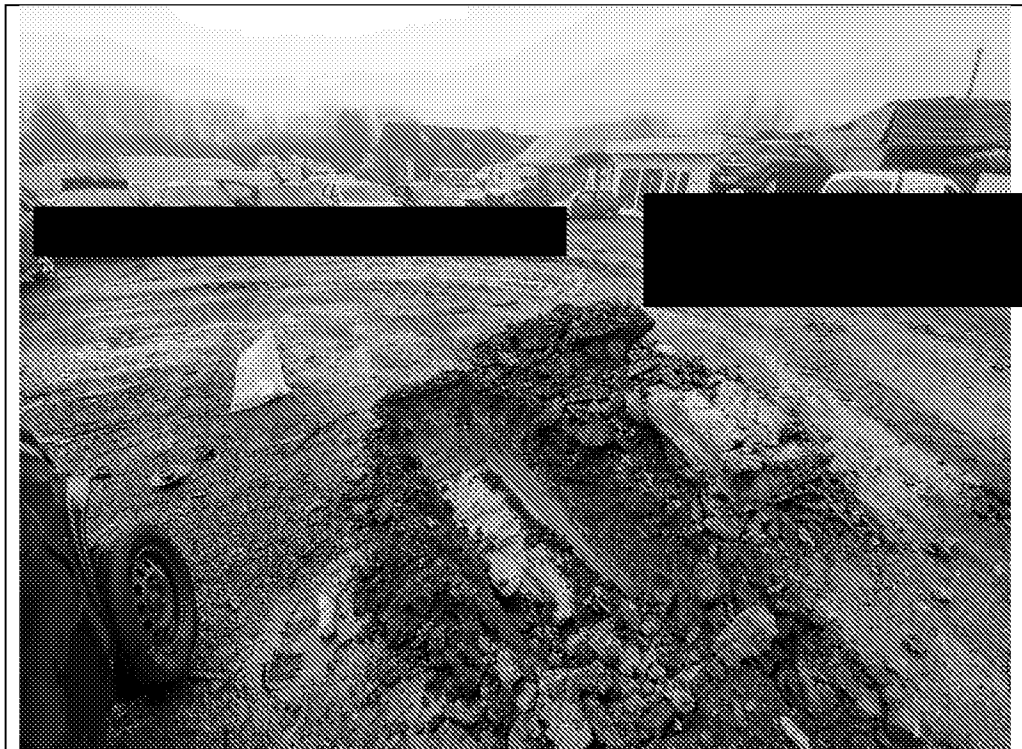
MTP343: Showing trial hole location and arisings.

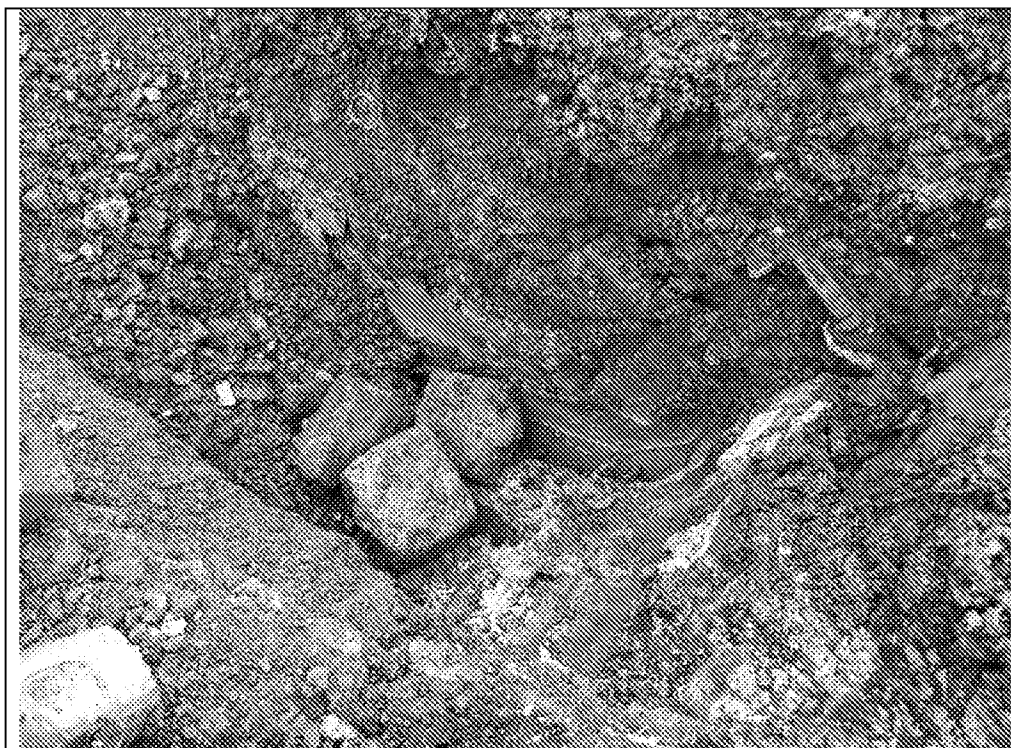
and 318 were advanced through asphalt hardstanding underlain by mixed made ground gravels with inclusions of concrete and brick. MTP318, MWS315 and MWS316 were identified to have a hydrocarbon odour beneath the asphalt. Location MTP319, (close to workshop) also identified a hydrocarbon odour in the upper strata overlying successive concrete slab boulders. Made ground encountered in these areas was shallow.

MTP318: Trial hole.

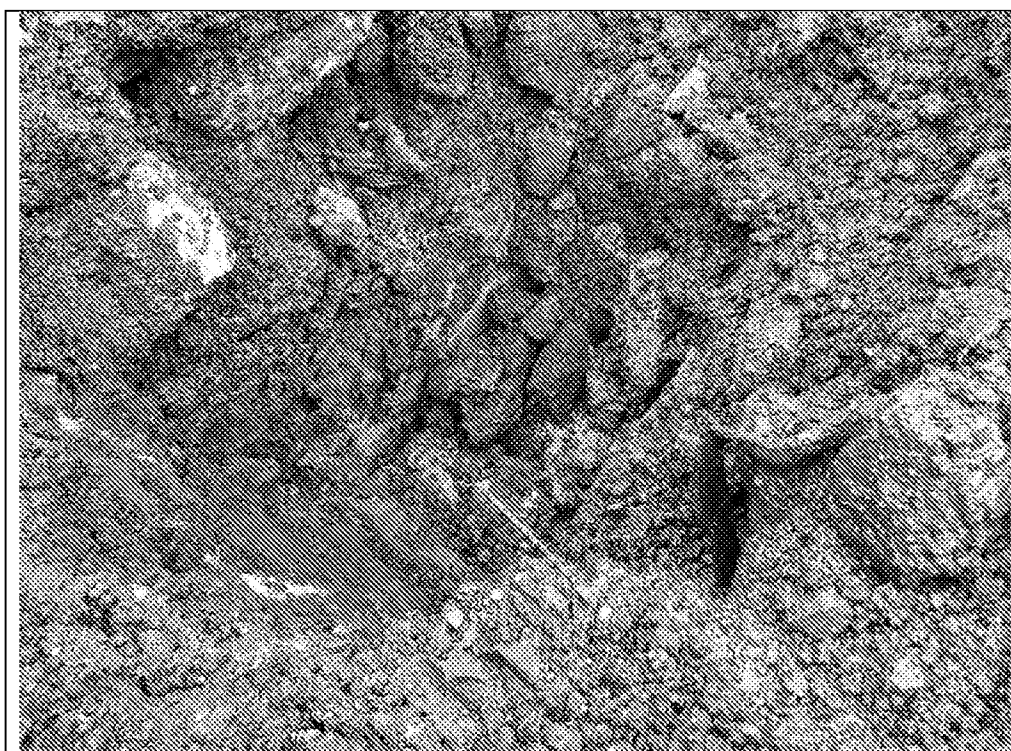
MTP319: Trial hole.

| LOCATION | DEPTH<br>(m bgl) | FIELD OBSERVATIONS | BENZO(A)PYRENE<br>(mg/kg) |
|---|---|---|---|
| MTP319 | 0.1 | Black stained clayey gravel. Strong hydrocarbon odour. | 16.0 |

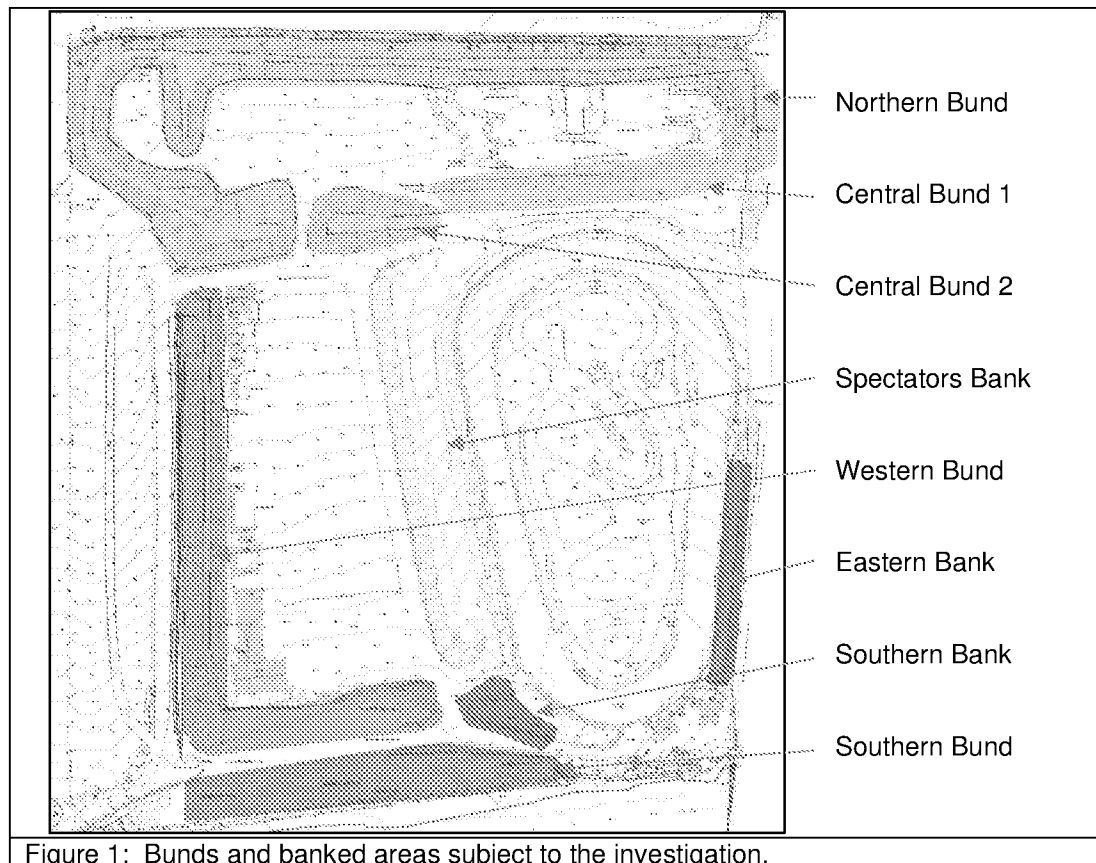
3.2.3.4 25 No. of the trial holes were advanced through banked/bunded areas. The depth and extent of these bunds was not achieved in all locations due to machine

Figure 1: Bunds and banked areas subject to the investigation.

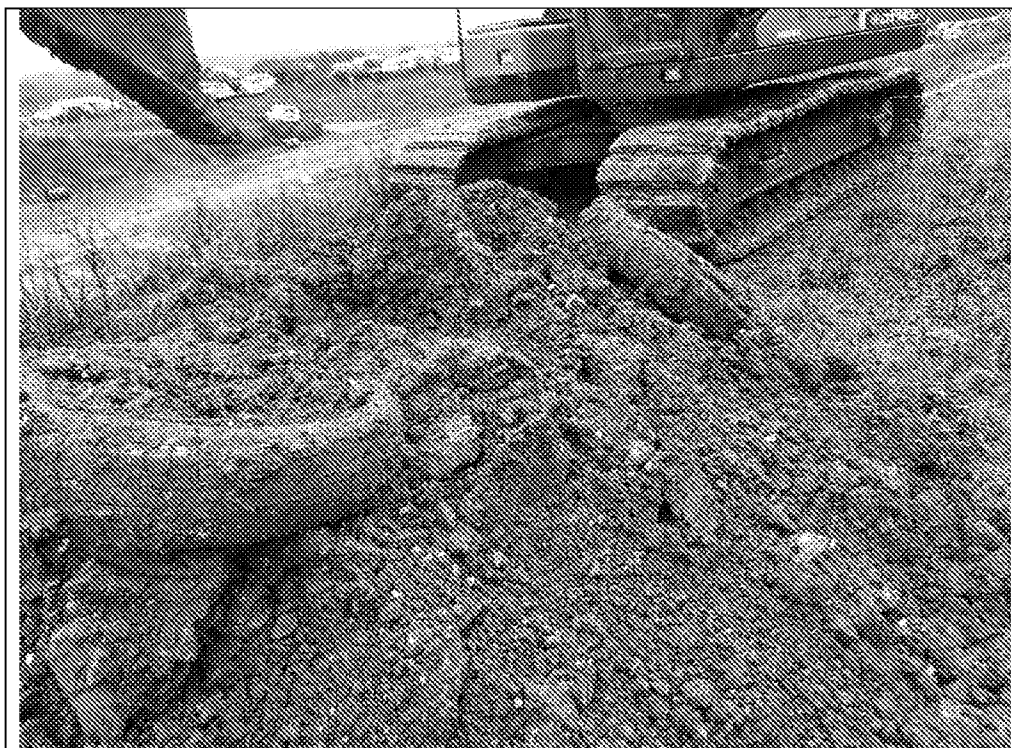
MTP329: Arisings (including tyres).

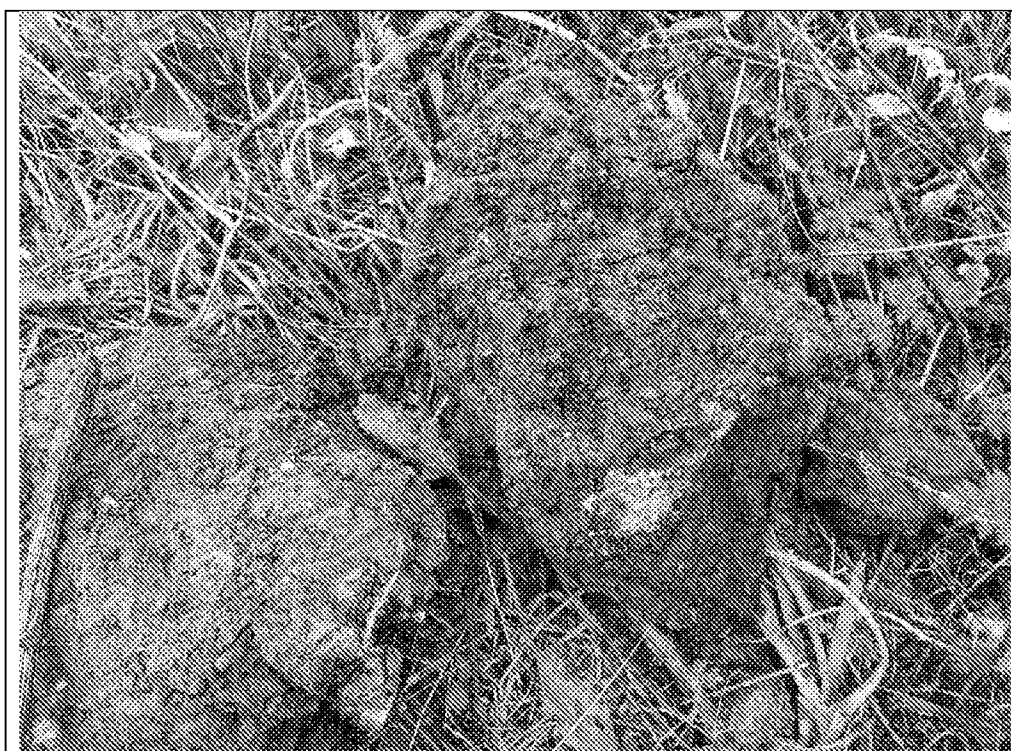
MTP322: Dark stained clay arisings.

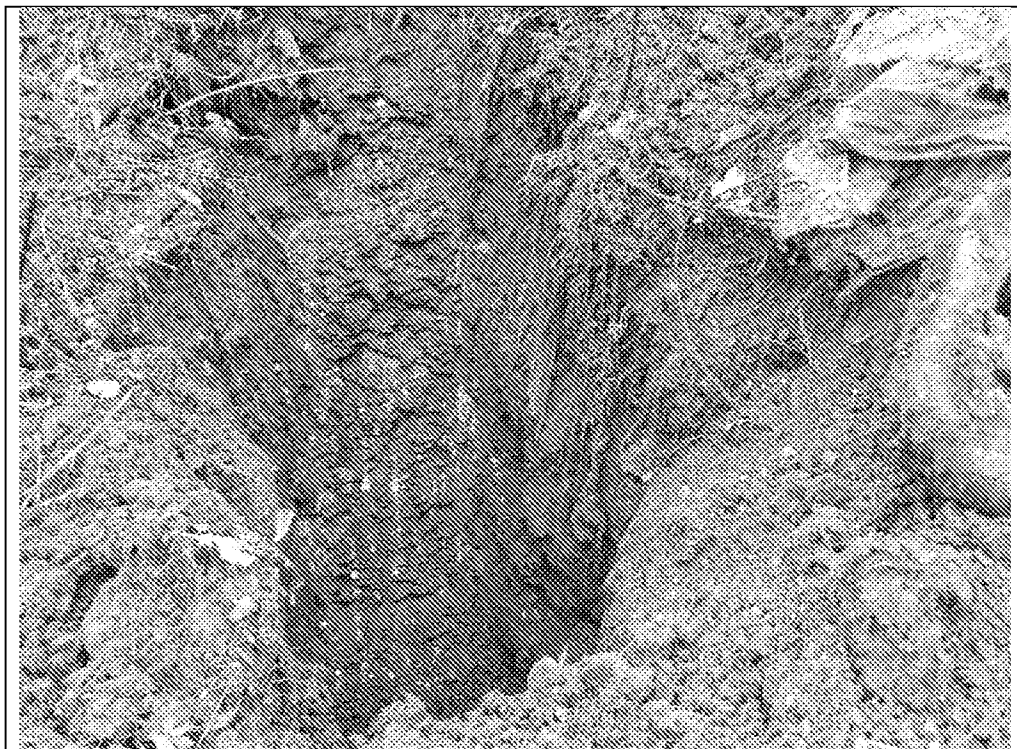
3.2.5.1 Generally comprised mixed reworked gravelly clays combined with topsoil with regular inclusions of brick and concrete. Tyres were found in MTP325 into the embankment and a tyre wall within the bund cannot be discounted due to the location of former racing track.

MTP325: Trial hole including edge of excavated tyre (right).

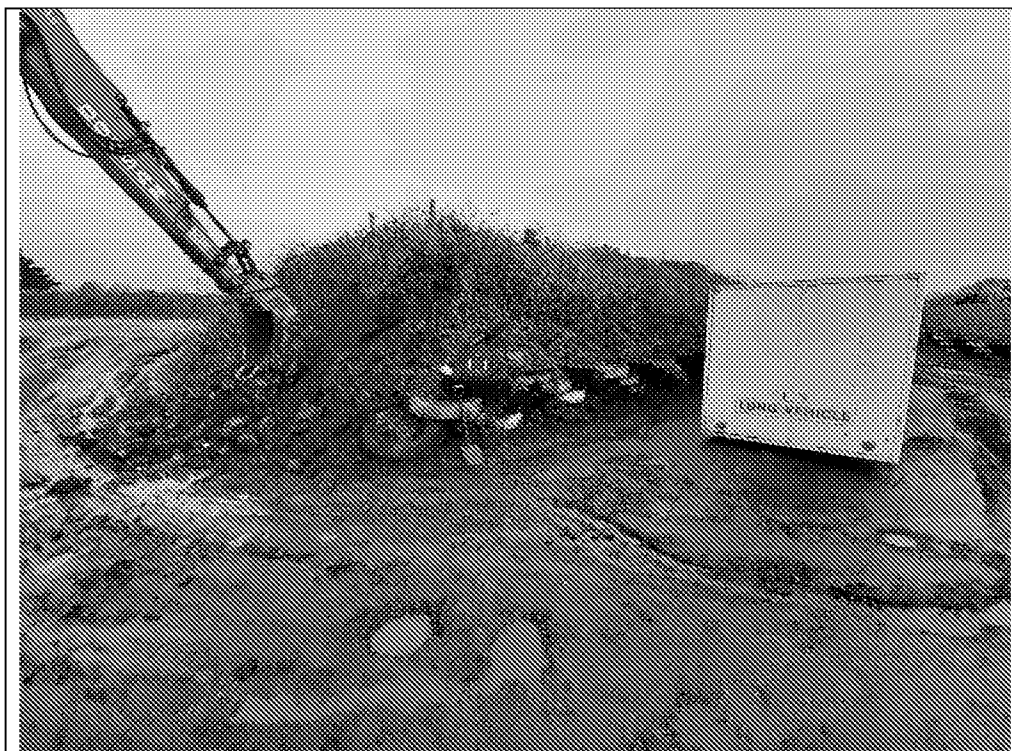
3.2.6.1 Surrounded by walled tyres. Made ground comprises reworked orangish brown gravelly clays with inclusions of brick, concrete (boulders/slabs) and asphalt.

MTP323: Showing trial hole location (into bund).

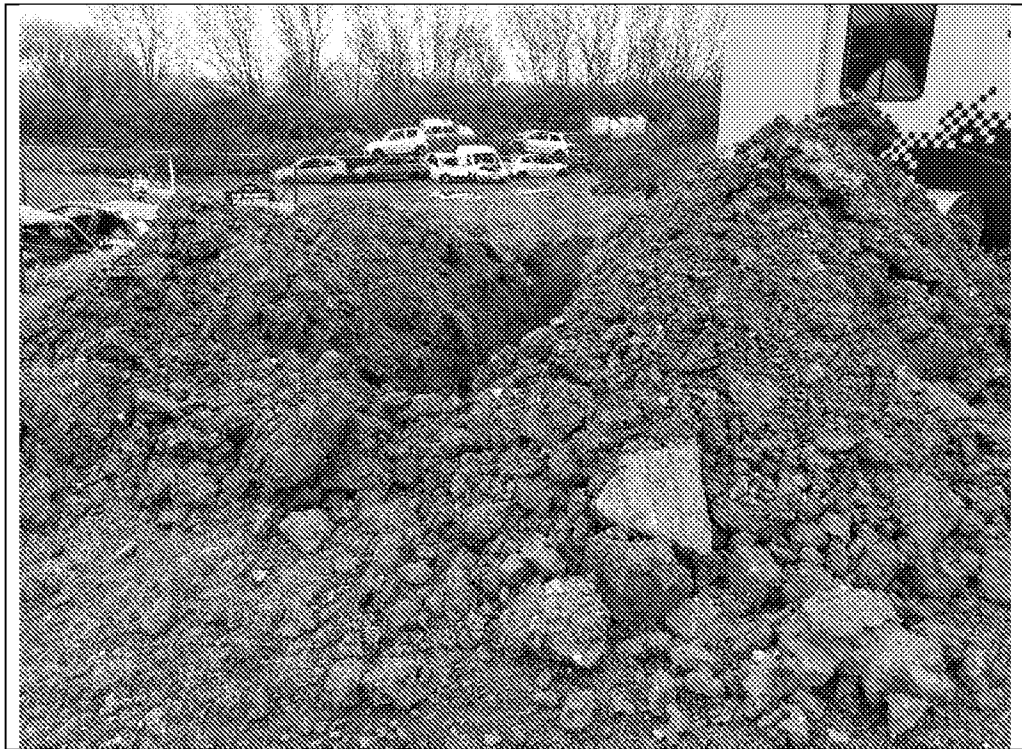
MTP316: Arisings.

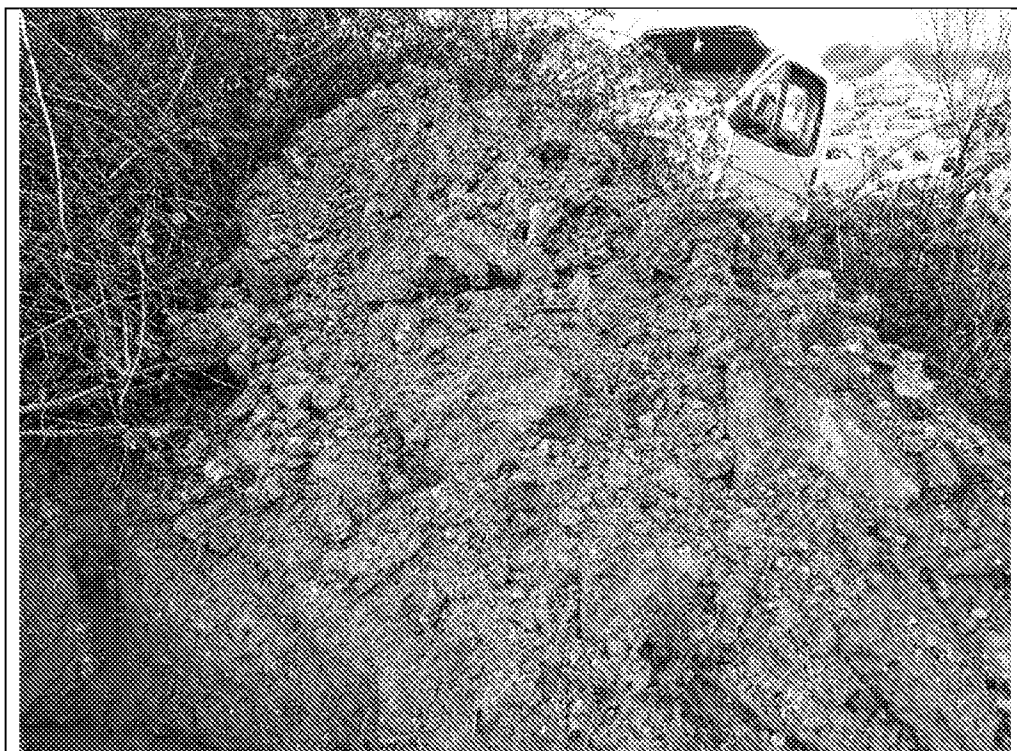
- 3.2.8.1 The L-shaped bund on the west of site consisted generally of the same reworked orangish brown gravelly clay with made ground inclusions more frequent in the southern spur section. Made ground elements included concrete (boulders/slabs and cobbles), brick, asphalt, old timber, plastic and metal rebar and wire. Tyres support one side of the embankment of the southern section. Asphalt hardstanding was encountered 2.5 m into the bund (at the base) at location MTP315.

MTP315: Arisings.

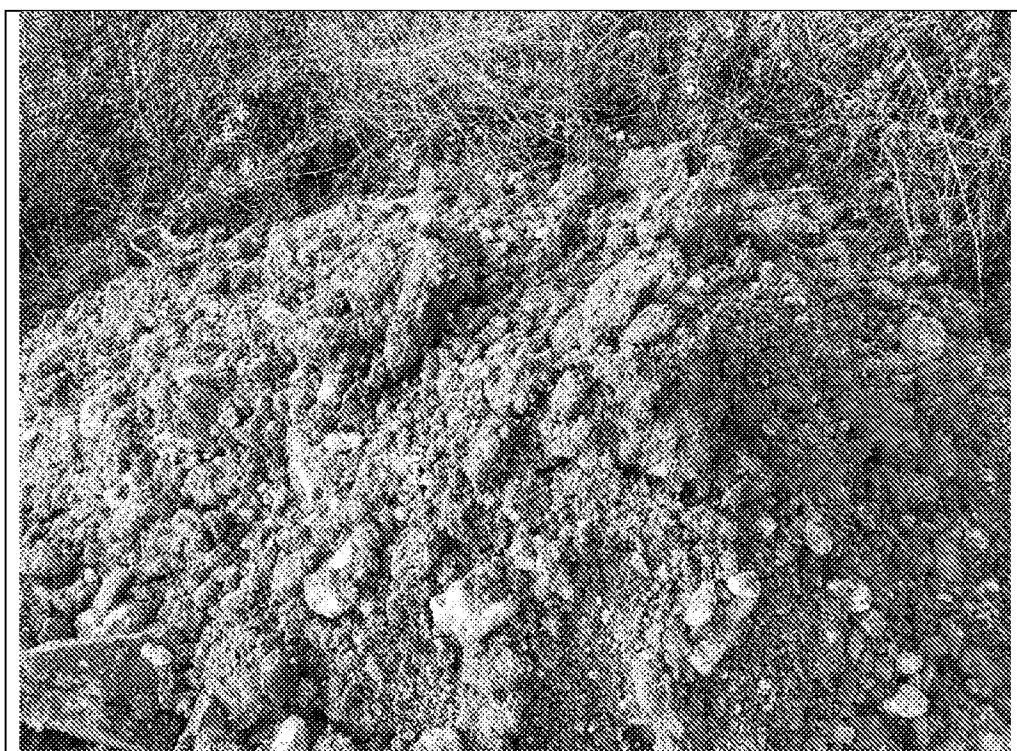
MTP322: Arisings.

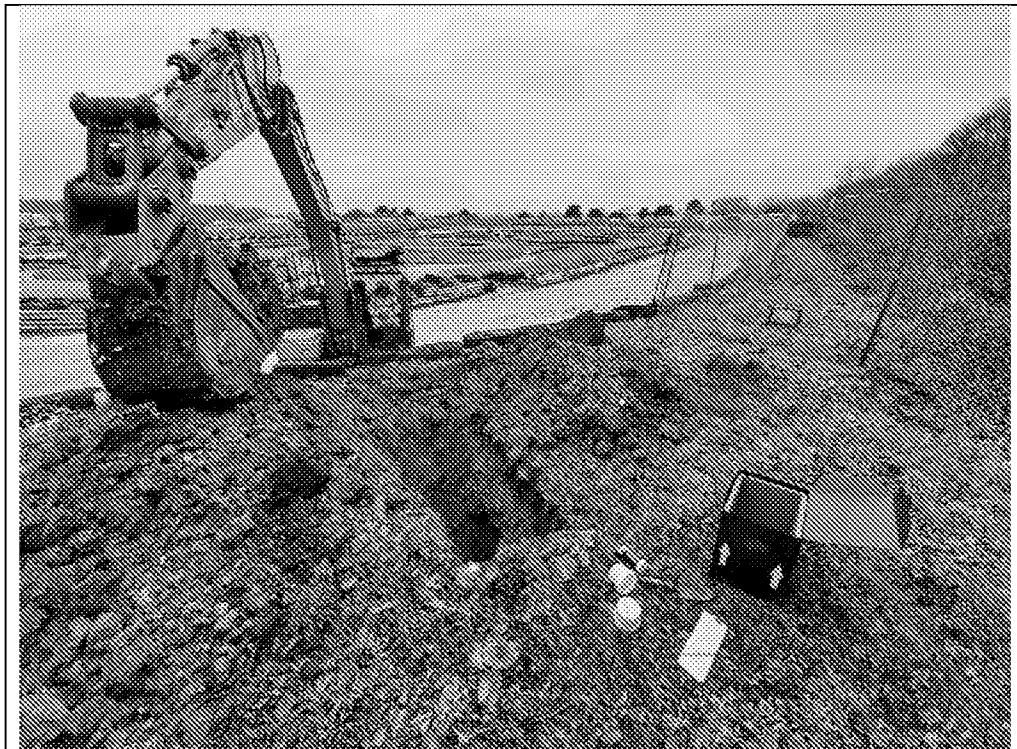
MTP306: Showing the eastern bank.

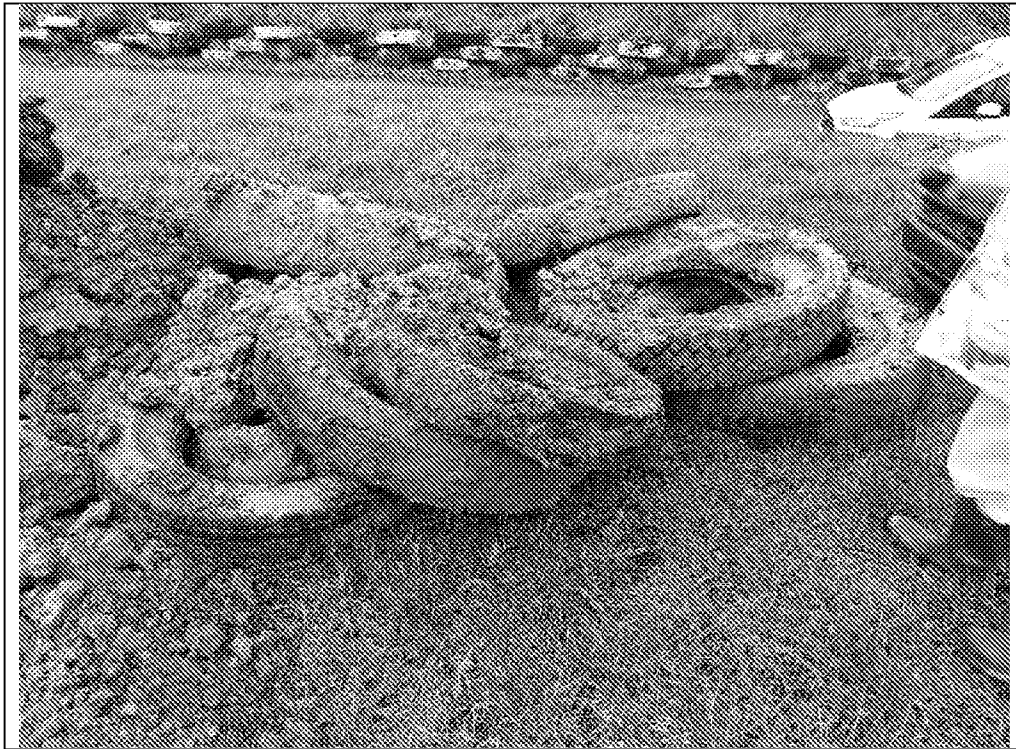
- 3.2.10 Southern Bank
- 3.2.10.1 Made ground was encountered up to 1.7 m bgl. This made ground includes successive tyres, concrete (boulders and cobbles) and regular brick. A degraded metal barrel lid was encountered 1.0 m bgl. The surrounding soil comprised a matrix of orangish brown gravelly clay.

- 3.2.10.2 Asbestos cement debris was encountered within MTP308 at 0.4 m bgl. Analysis of a bulk sample of the material confirms that it contains chrysotile asbestos.

MTP308: Buried tyres.

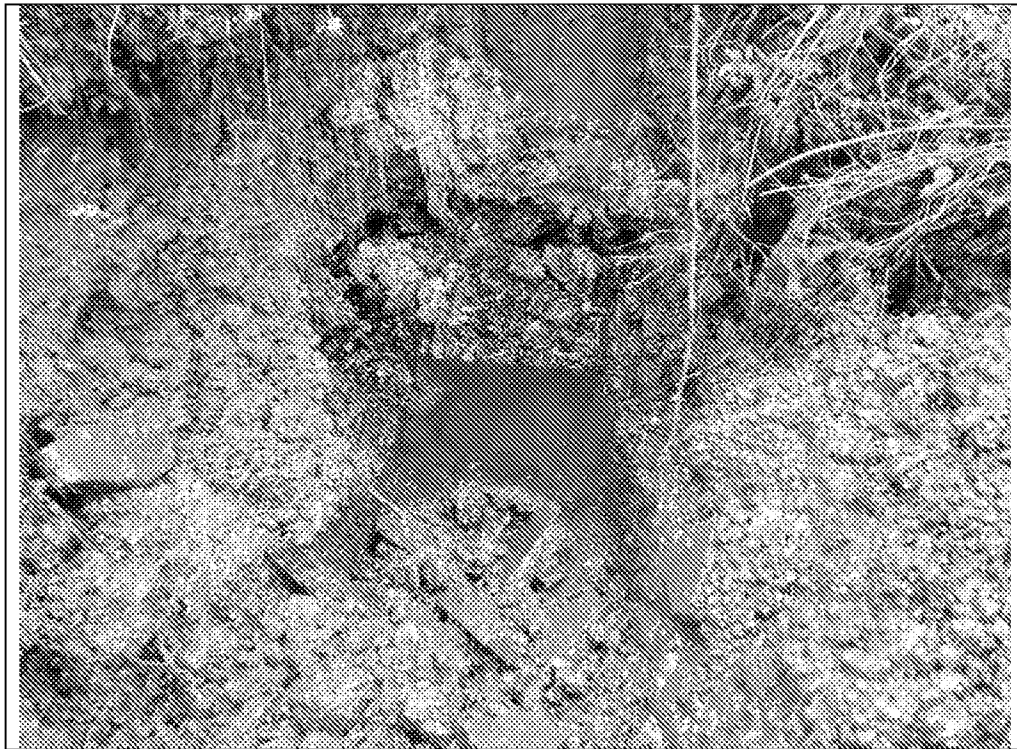
- 3.2.11.1 The southern bund was excavated into from the base. The whole of the northern embankment of the bund was supported by tyre wall. The soil encountered in the bund comprised orangish brown reworked sandy gravelly clay with inclusions of brick, concrete, asphalt, wood, metal, and geotextile pieces. Both locations MTP311 and MTP312 within the southern bund encountered black stained gravels with strong hydrocarbon odour. Oily globules were evident at MTP311.

MTP311: Dark stained oily strata.

| LOCATION | DEPTH<br>(m bgl) | FIELD OBSERVATIONS | BENZO(A)PYRENE<br>(mg/kg) |
|---|---|---|---|
| MTP311<br>(southern bund) | 0.6 | Black stained gravel with oily globules and a strong hydrocarbon odour. | 3.1 |

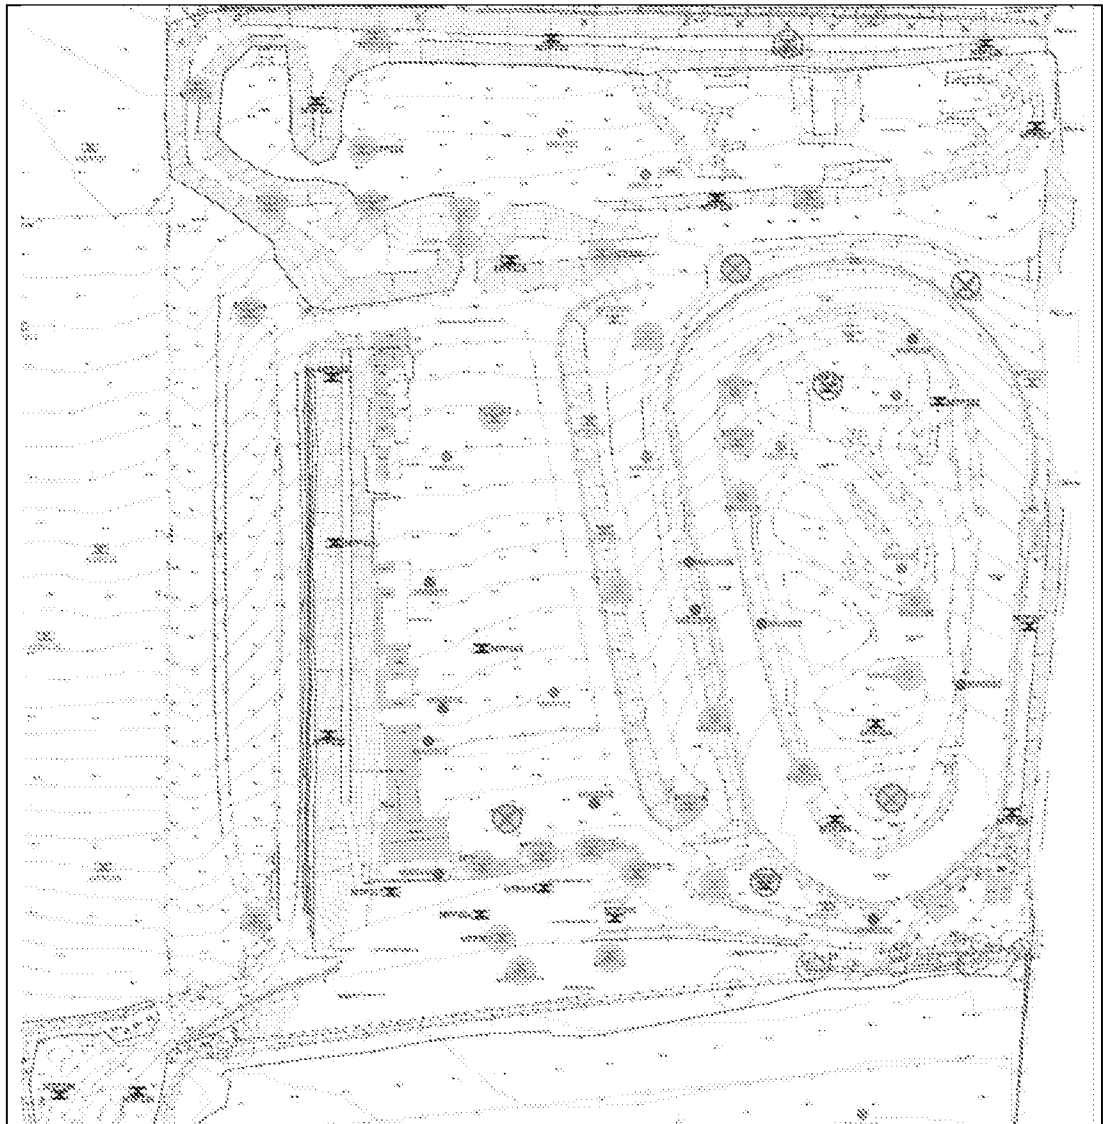
- 5.2.1 The contamination encountered to date is mainly in the form of occurrences of PAH (and in some cases associated TPH) in made ground likely associated with anthropogenic inclusions. PAH is a product with incomplete combustion and can be found where there are inclusions of tarmac, ash, clinker *etc.* This type of contamination is not particularly mobile in the environment. Exploratory holes with soils impacted by PAH and asbestos are displayed in Figure 2 below.

Figure 2: Exploratory holes impacted with hydrocarbon contamination (PAH) including from previous IDOM investigations = ● Asbestos impacted locations = ⊗

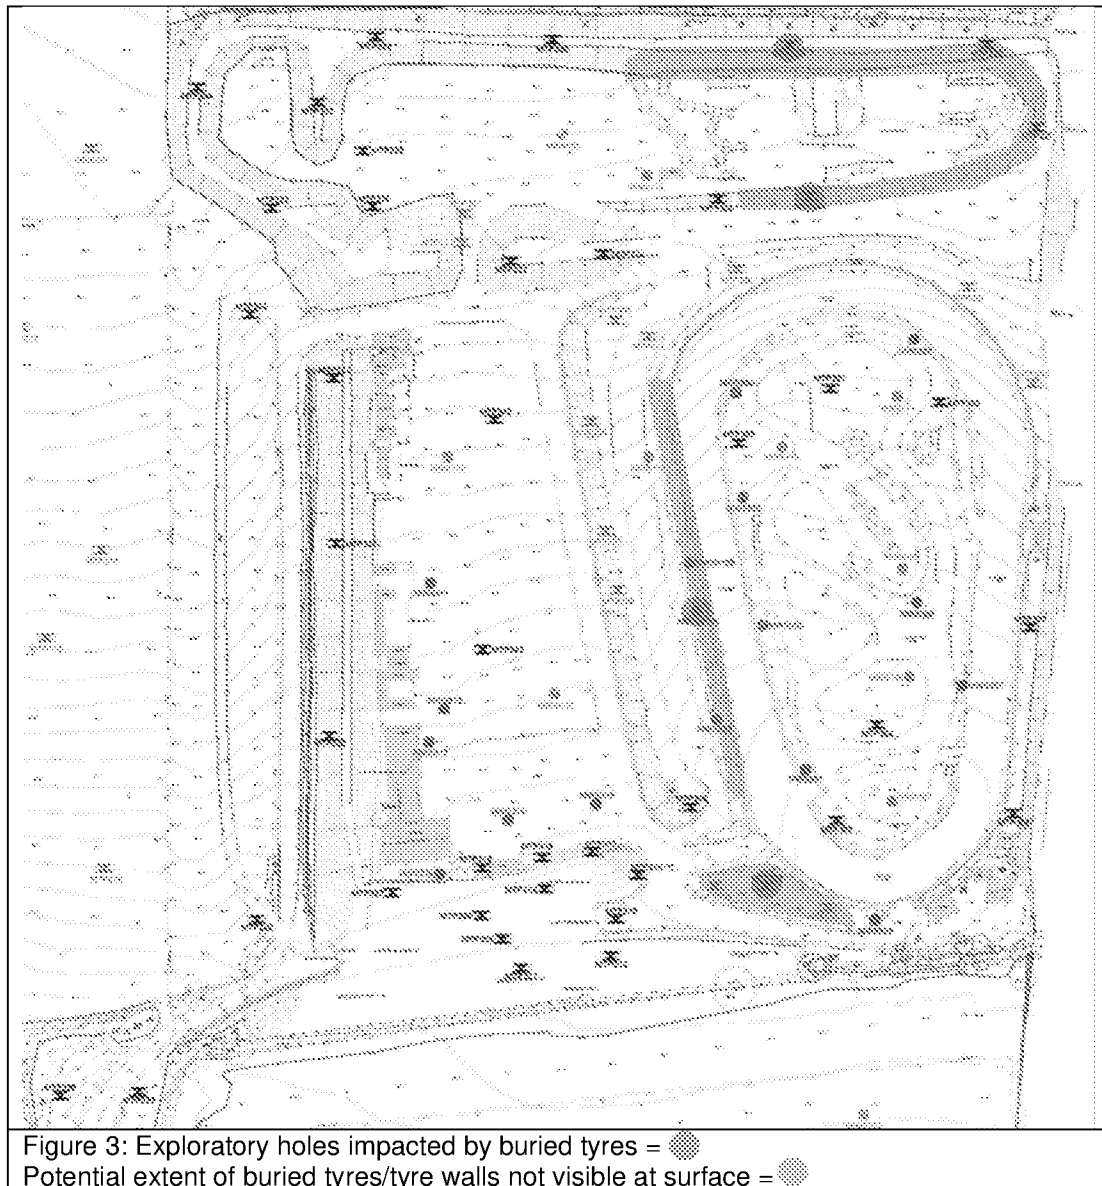
- 5.3.1 Buried tyres were found in some trial holes during the investigation which will require clearance as part of the site preparation works. Throughout the site, tyre walls are present supporting banks/bunds, however discovery of tyres buried in exploratory hole locations MTP308, MTP325, MTP329 and MWS10A provides evidence of buried tyres within bunds/banks. Figure 3 indicates the locations affected by buried tyres and the potential extent.

5.5.2 There are numerous bunds present on site which will require reprofiling. In addition, several areas of the site have been found to contain buried tyres which will require removal as part of the reprocessing and preparation of the site for development. If the made ground materials are to remain on site, it is vital that this work is carried out under a Materials Management Plan under the CL:AIRE Code of Practice on the Definition of Waste.

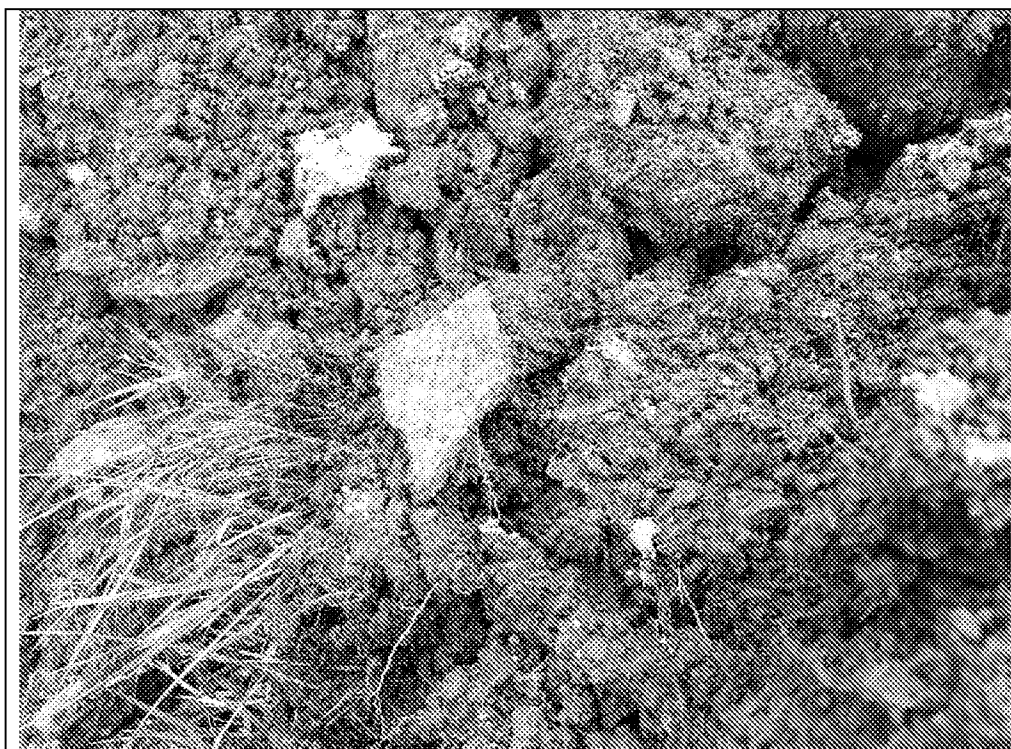
4.2.4 Visible fragments of asbestos-containing material have also been observed in soil in two locations (MTP301 and MTP308) which would also trigger a hazardous classification. Site clearance should also be cognisant of the presence of asbestos-containing materials on the surface on the northern bund and behind the workshop.

MTP301: Fragment of asbestos (chrysotile) cement.

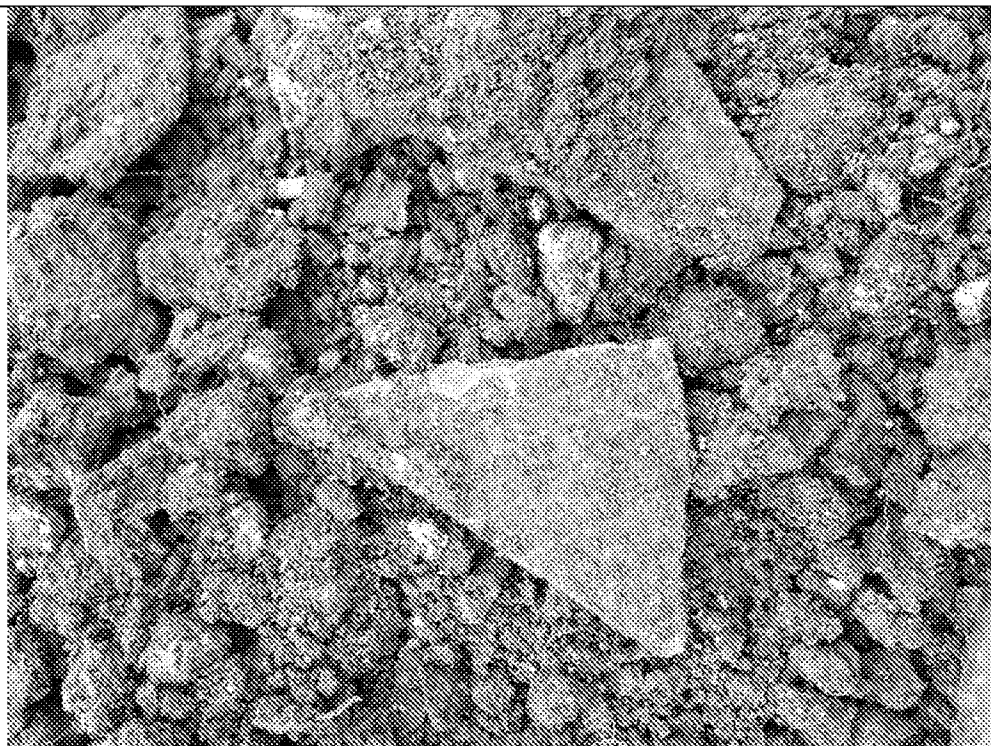
MTP308: Fragment of asbestos (chrysotile) cement.

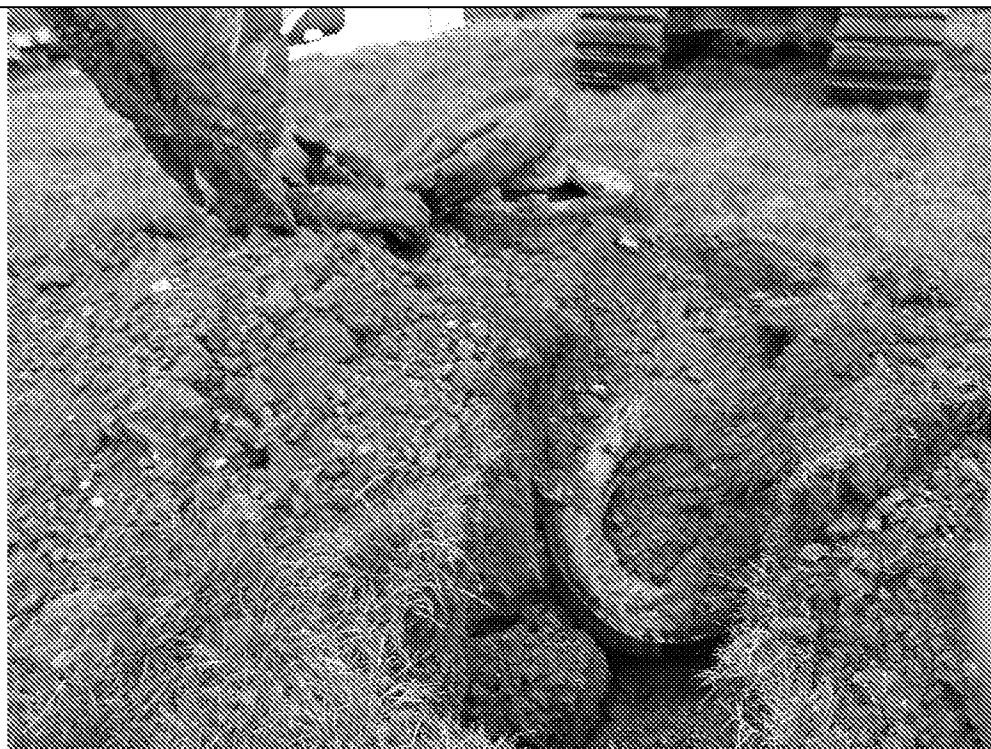
MTP308: Arisings with tyres.

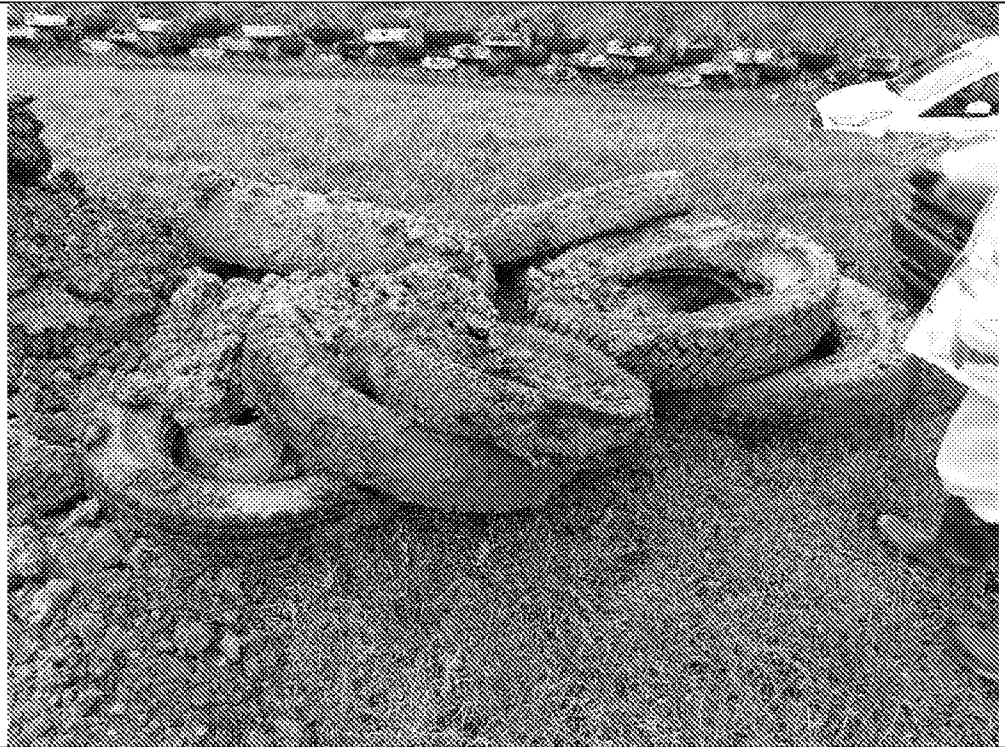
MTP308: Buried tyres.
