**Project Name:** Mackoy Ltd - Langmead Place Angmering

**Project Date:** 04/11/2025

**Inspection Standard:** MSCC5 Sewers & Drainage GB (SRM5 Scoring)

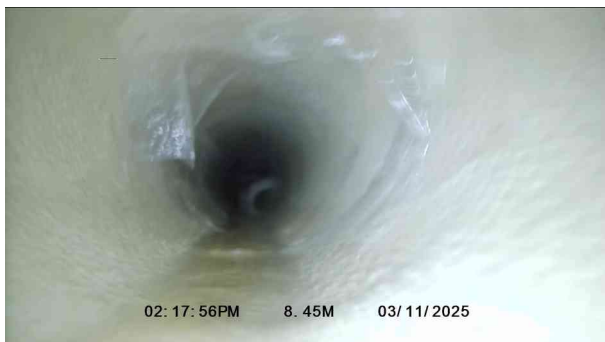
2, 00:00:18, 1.53 m  
Point repair, localised lining from 12 o'clock to 11 o'clock, start

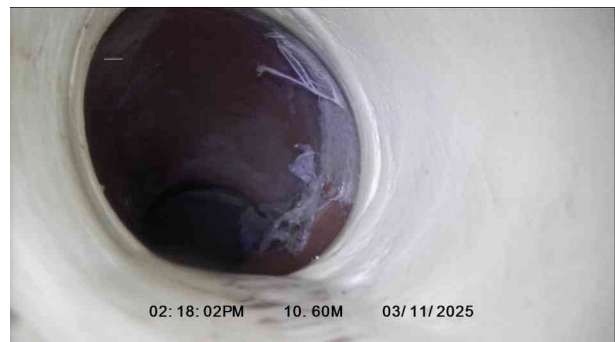
3, 00:00:29, 8.45 m  
Point repair, localised lining from 12 o'clock to 11 o'clock, start

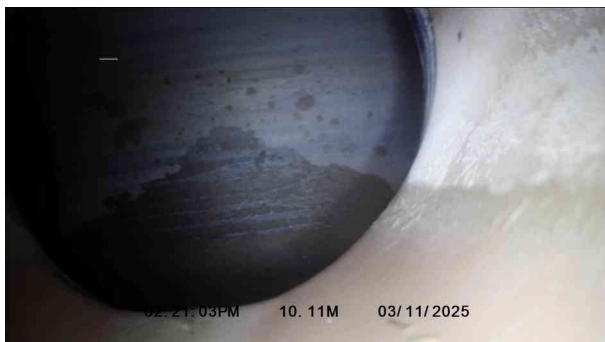
2, 00:00:11, 2.97 m  
Point repair, localised lining from 12 o'clock to 11 o'clock, start

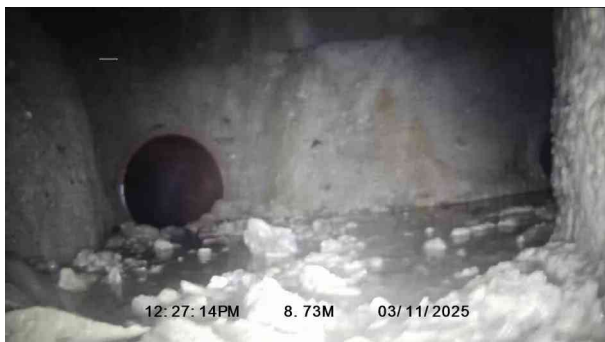
2, 00:00:15, 0.76 m  
Point repair, localised lining from 12 o'clock to 11 o'clock, start

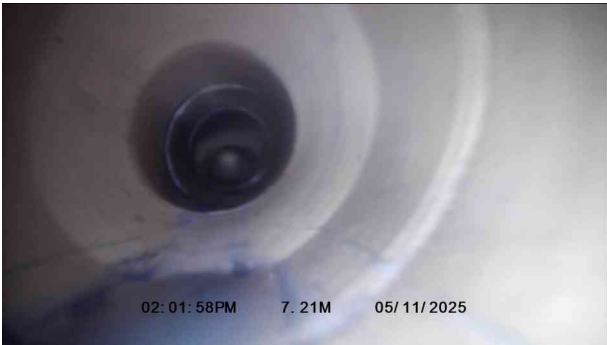
2, 00:00:07, 0.00 m  
Point repair, localised lining from 12 o'clock to 11 o'clock, start

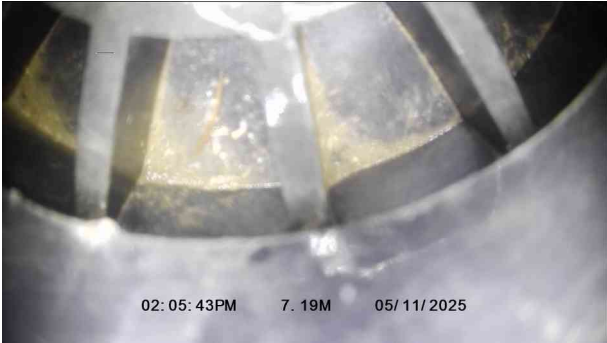
2, 00:00:08, 0.00 m  
Point repair, localised lining from 12 o'clock to 11 o'clock, start

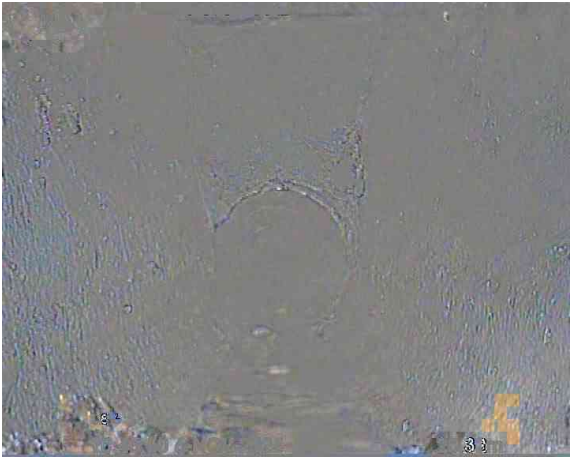
2, 00:00:08, 0.00 m  
Point repair, localised lining from 12 o'clock to 11 o'clock, start
