# Road Safety Audit – A29 Shripney Road

**Stage:** 1

**Location:** A29 Shripney Road, Shripney, West Sussex

**Site:** Proposed right turn lane and new site access

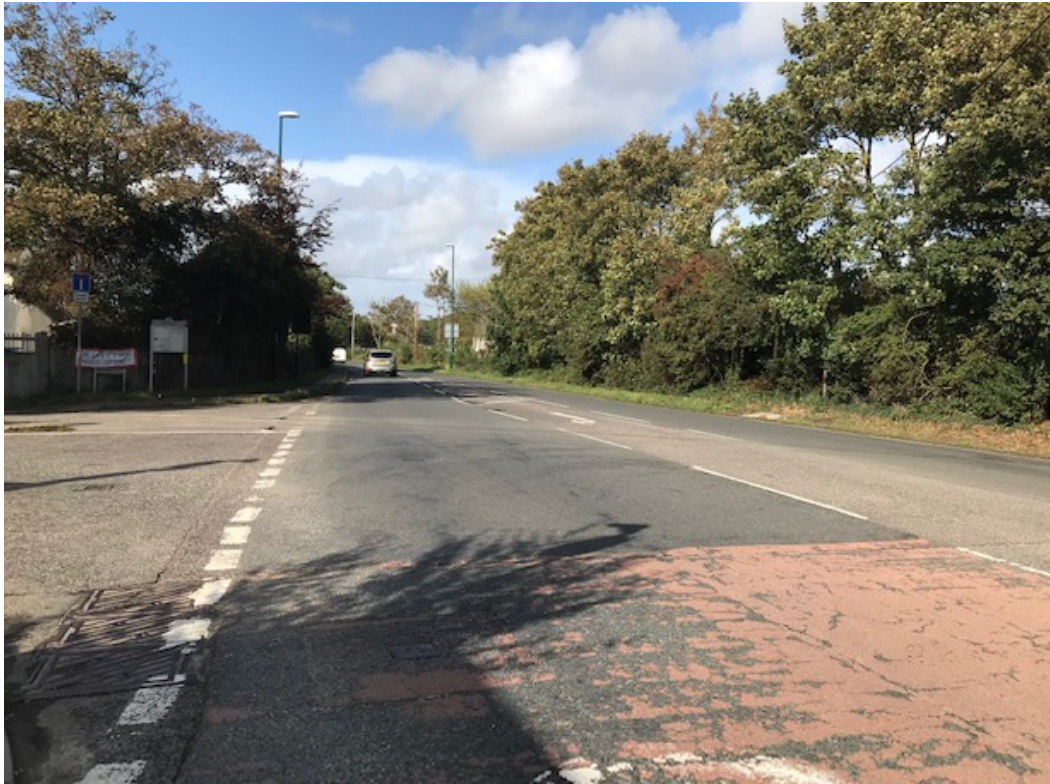
*Northbound approach to the proposed junction (to be located on the right) and right turn lane*

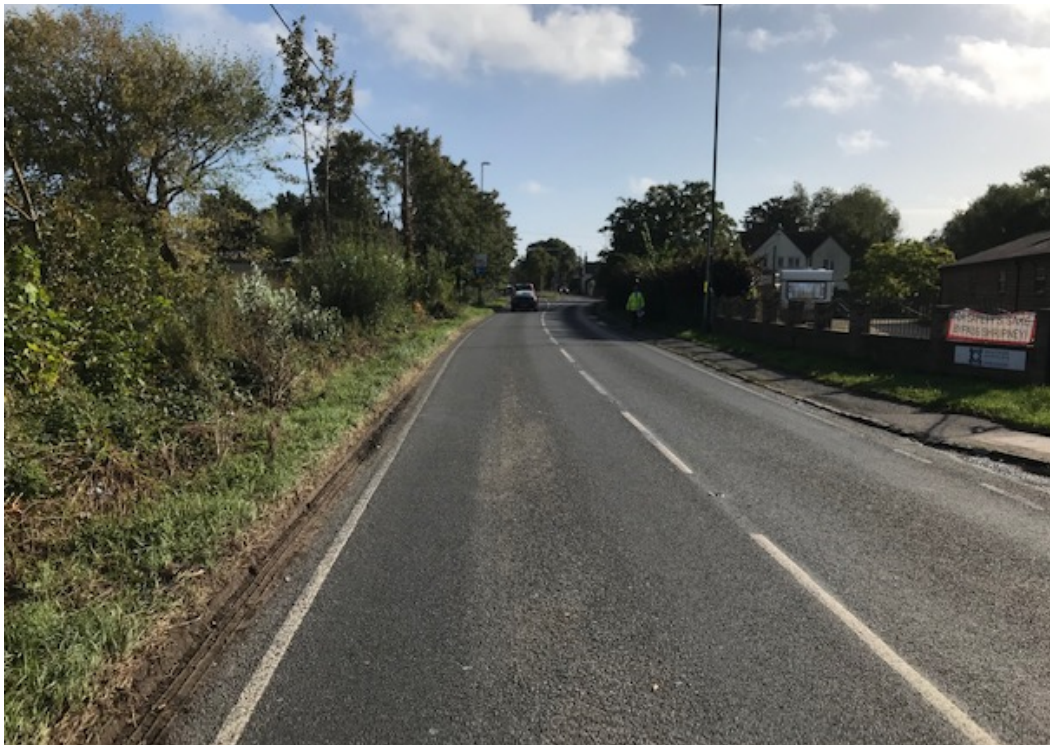
*Southbound approach to the proposed junction (to be located on the left)*

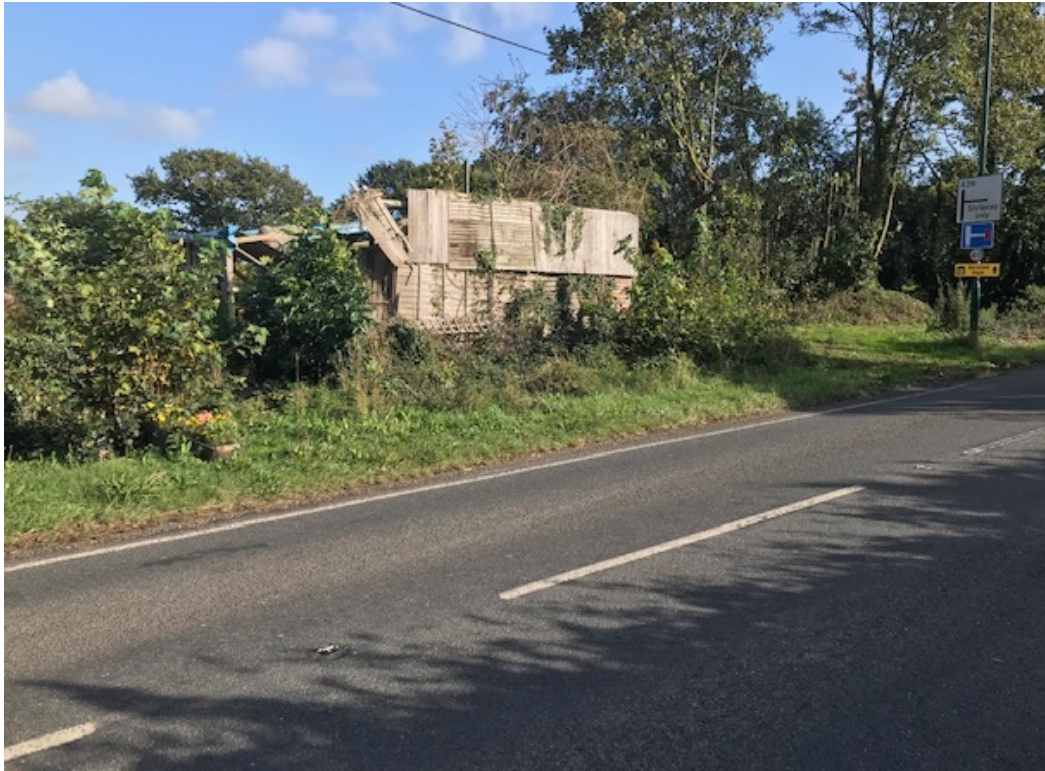
*Proposed junction site*

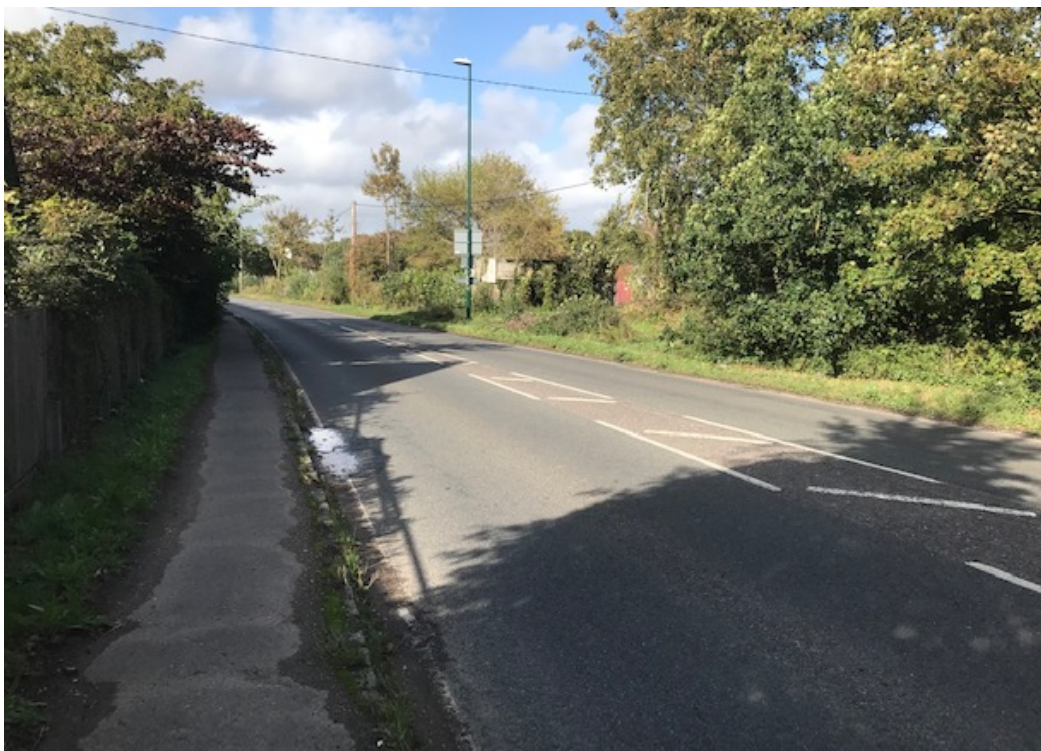
*Proposed junction (on right) and right turn lane location*

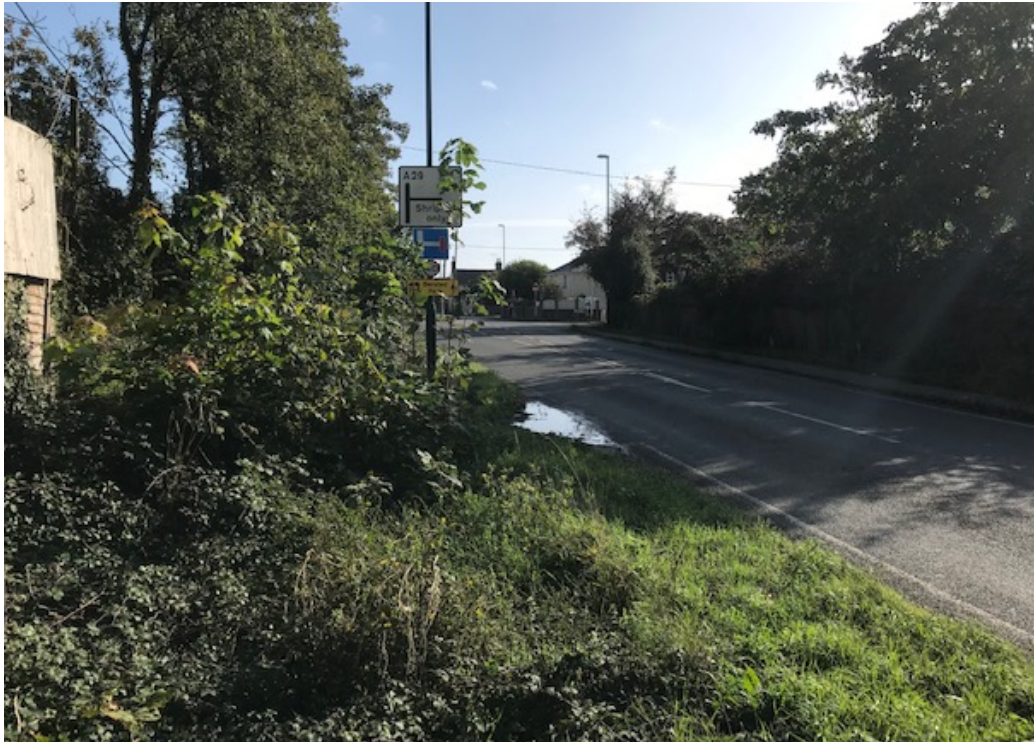
Vehicles exiting the proposed junction onto the A29 have obscured visibility in both directions due to the presence of foliage. This will increase the risk of junction collisions, an issue exacerbated by high speeds of approaching vehicles (see photos 2.1a and 2.1b).

*Photo 2.1a Visibility to the south of the proposed junction is obscured by vegetation*

**Recommendation** – Remove the foliage/hedgerow and ensure sight lines are unobstructed and maintained.

**Designer's response** – Foliage within the visibility splays to be cut back as part of access highway works and maintained by appropriate parties

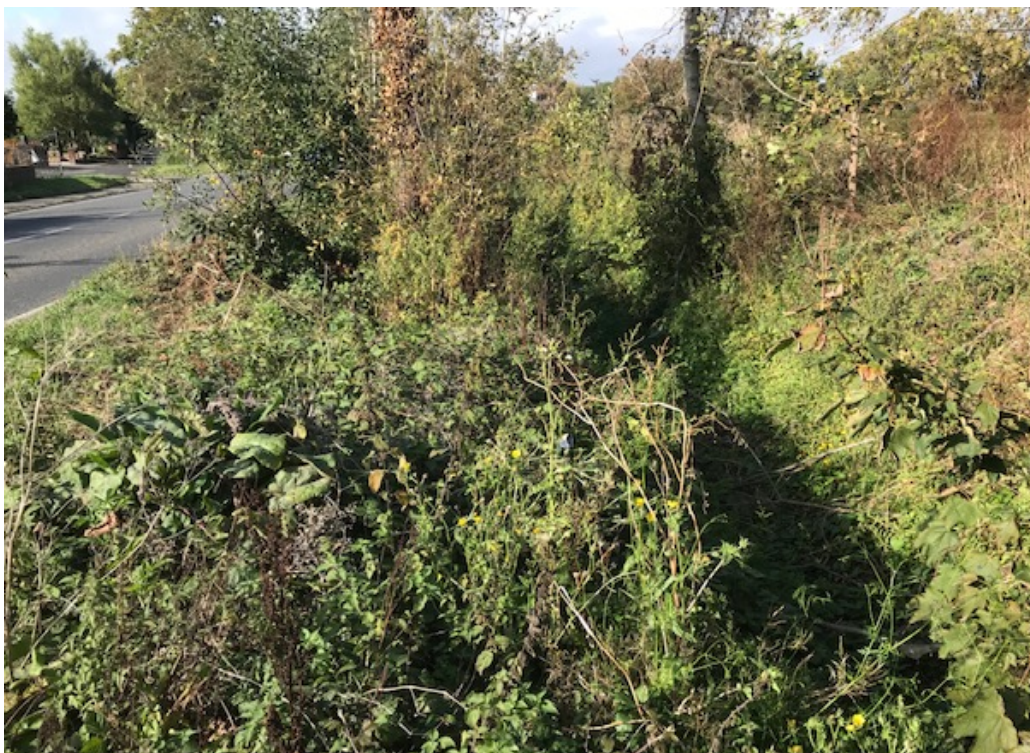
A ditch is currently present on the east side of the existing carriageway. The proposed realignment will move road users closer to this ditch which will increase the risk of vehicles ending up in the ditch following loss of control collisions (see Photo 2.1b).

As mention in Problem 2.3, the road realignment will lead road users closer to the ditch that currently runs parallel to the southbound carriageway. If left unprotected, pedestrians using the proposed new footway on the east of the A29 are at risk of falling into the ditch (see Photo 2.1b).

*Photo 2.1b - Visibility to the north from the proposed junction. Also Problem 2.4 & Problem 2.8 - The ditch that is present will present a danger to footway users and increase severity of those involved in loss of control collisions.*

**Recommendation** – Provide a road restraint system to protect road users from falling into the ditch.

**Designer's response** – The ditch will be culverted as part of the access highway works, in line with an appropriate drainage strategy. As part of the Works Agreement with the LHA the need for restraint systems will be discussed.

**Recommendation** – Provide appropriate protection for pedestrians to prevent them from falling in the ditch.

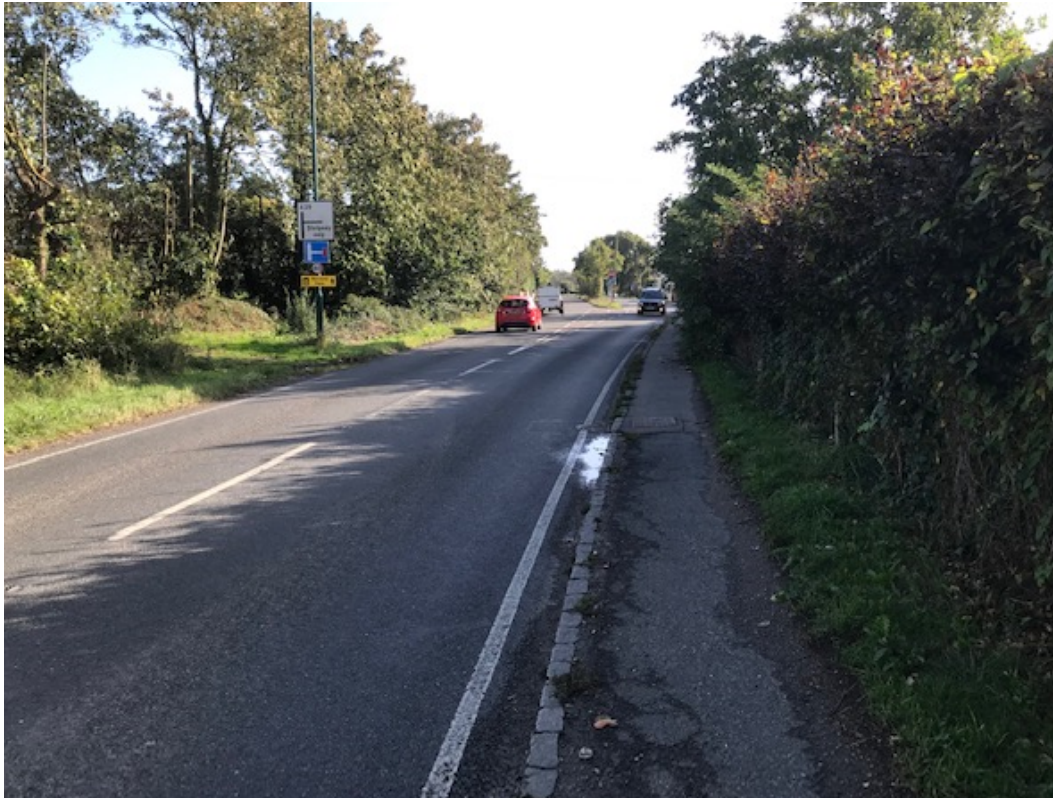
When crossing west to east at the proposed informal crossing point, foliage is currently obscuring the visibility of approaching vehicles from the south, increasing the likelihood of pedestrian/vehicle conflict (see Photo 2.4).

*Photo 2.4 - Visibility for pedestrians using the proposed crossing facilities will become obscured if vegetation is not maintained*

**Recommendation** – Remove the existing foliage and establish methods to permanently maintain required sight lines.

**Designer's response** – Any vegetation obscuring visibility in this location is as a direct result of encroachment onto the public highway. Such vegetation is regularly cut back and maintained as part of the public highway. It is within the powers of the LHA to serve notice on properties where vegetation is overhanging the public highway. The developer can ensure that any vegetation overhanging the public highway on the approaches to the proposed pedestrian crossing is cut back as part of the access highway works.

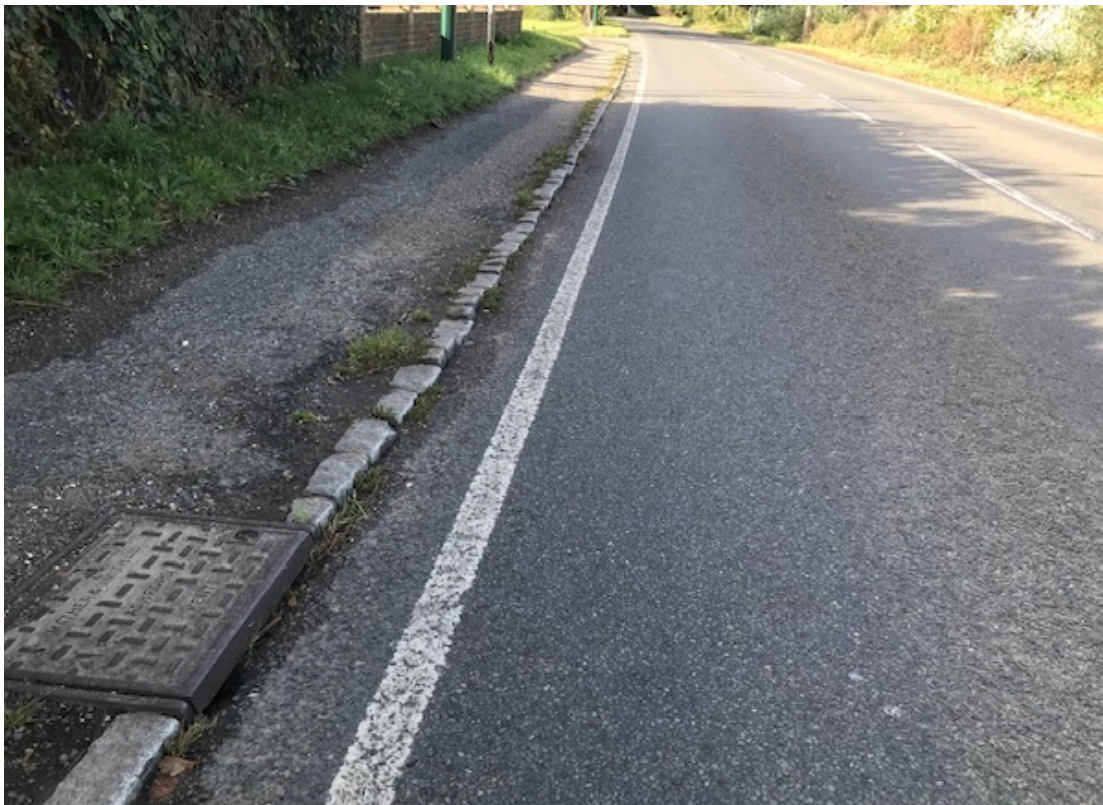
The proposed pedestrian crossing point is located in a position where the upstand of the existing footway is insufficient. This increases the risk of vehicles mounting the footway in a location where pedestrians are encouraged to cross the road (see Photo 2.5).

*Photo 2.5 - Low upstand at the proposed west side crossing point allows vehicles to easily run over, which creates potential conflict between vehicles and pedestrians*

**Recommendation** – Reconstruct the existing footway on the west side to provide a sufficient upstand which will give the carriageway greater delineation and provide protection for pedestrians.

**Designer's response** – It is considered that works to the kerb line on the western side of the carriageway, along the length of the site frontage, can be encompassed within the detailed design.
