# Surface Water Drainage Verification Report

Former Bartons Infant School, North Bersted Bognor  
Regis PO22 9BD

Lovell Partnerships

Ref: 11642

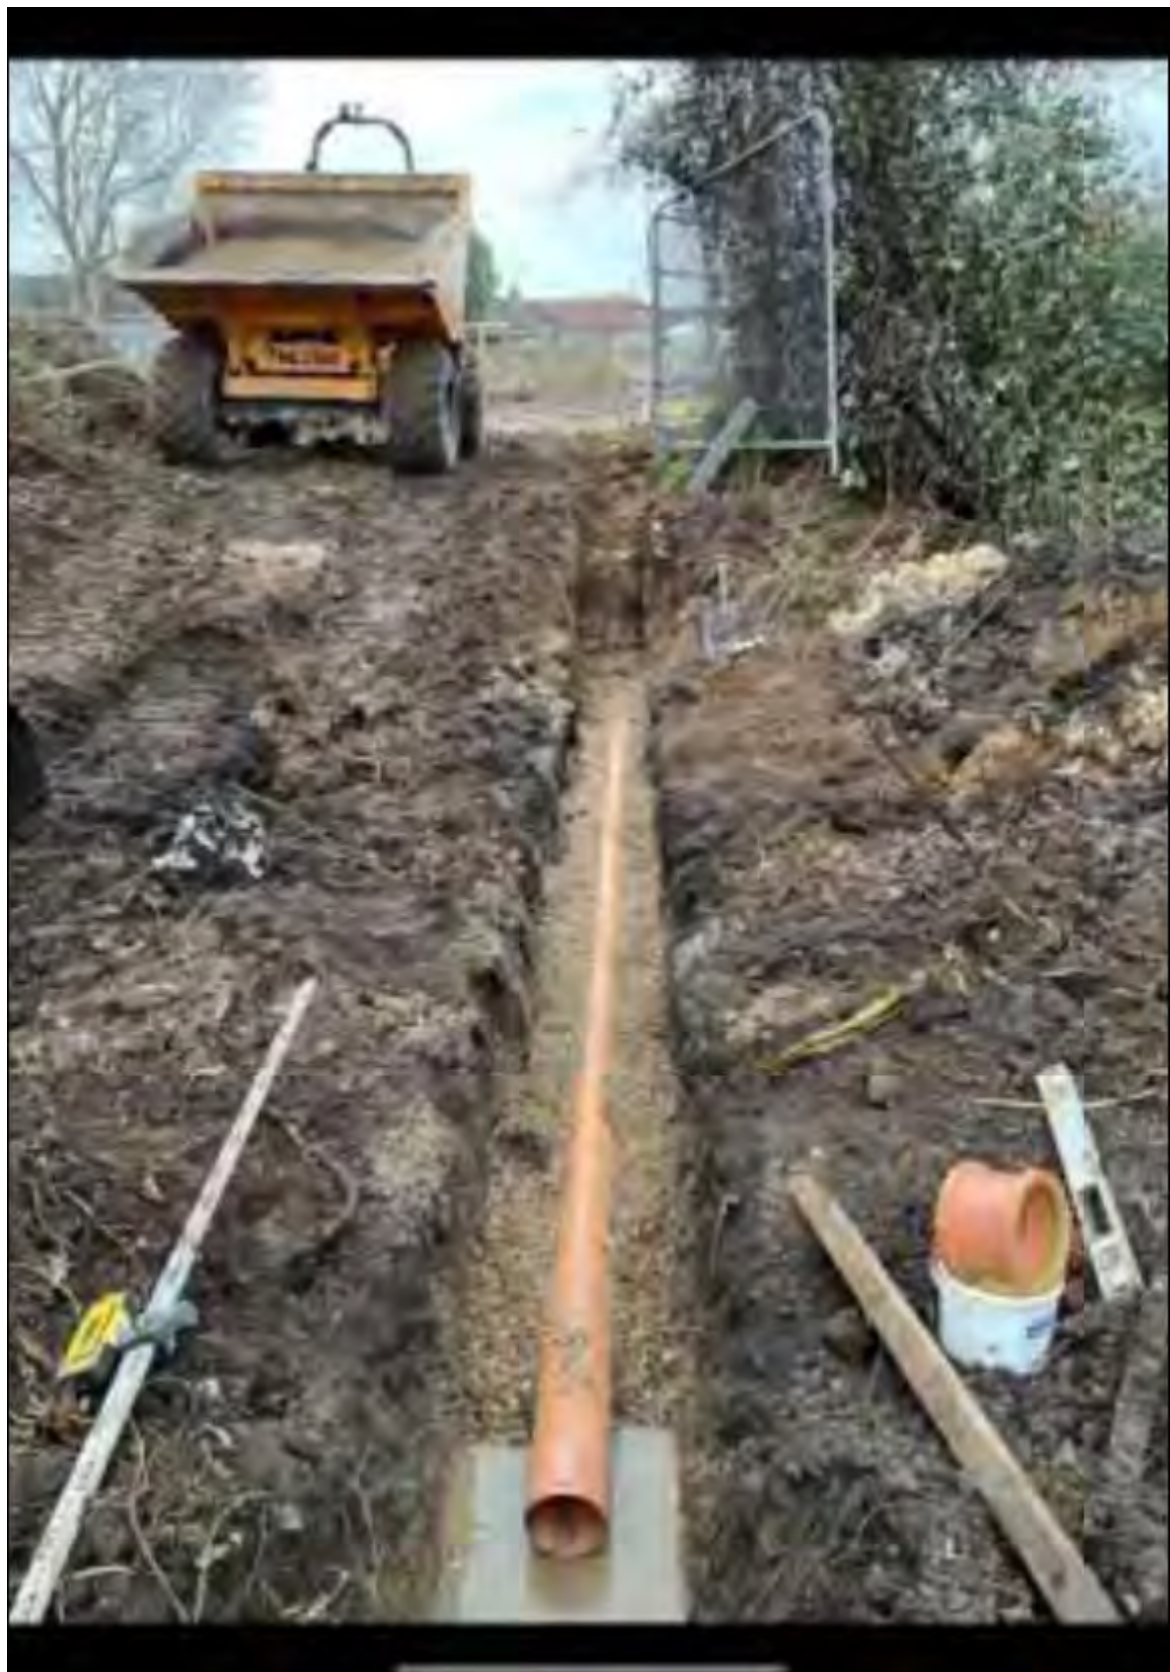
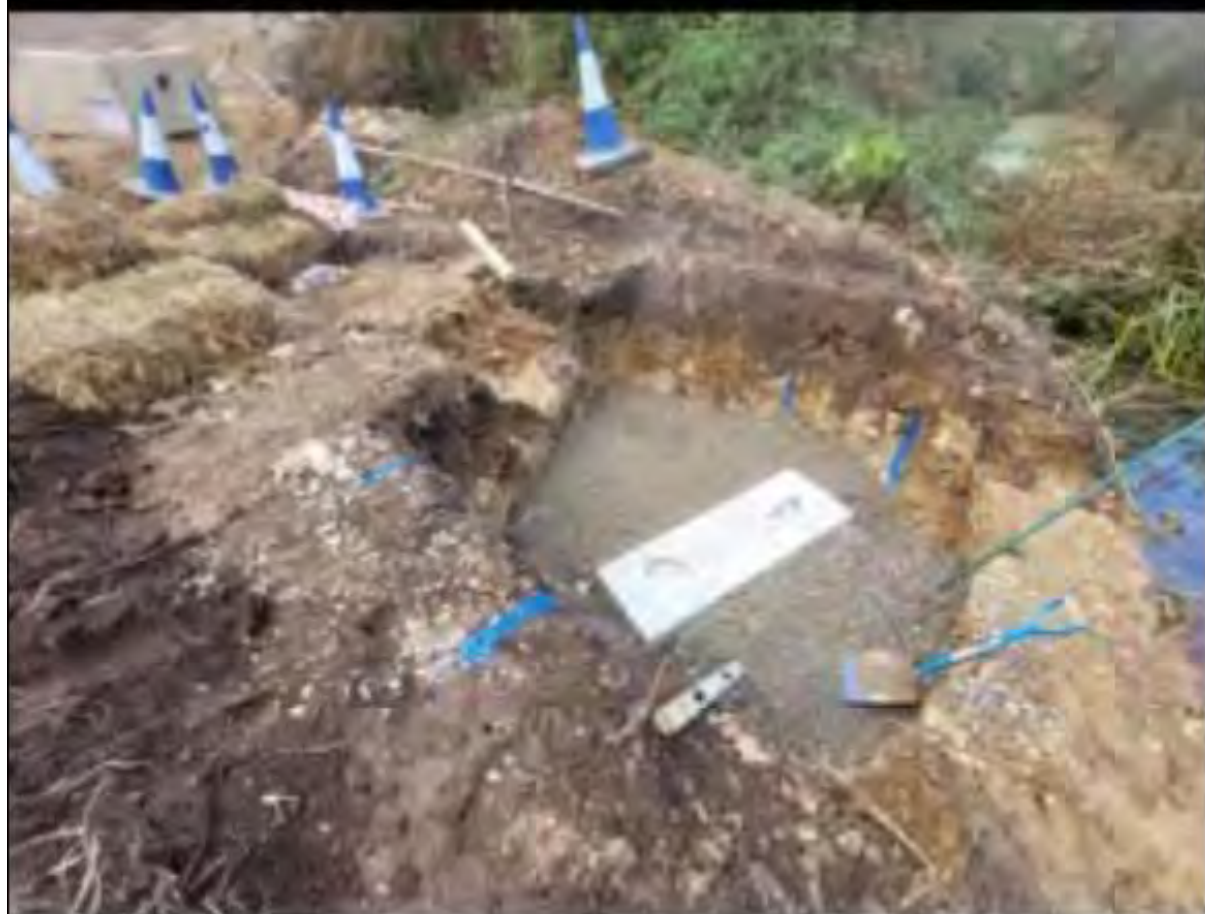
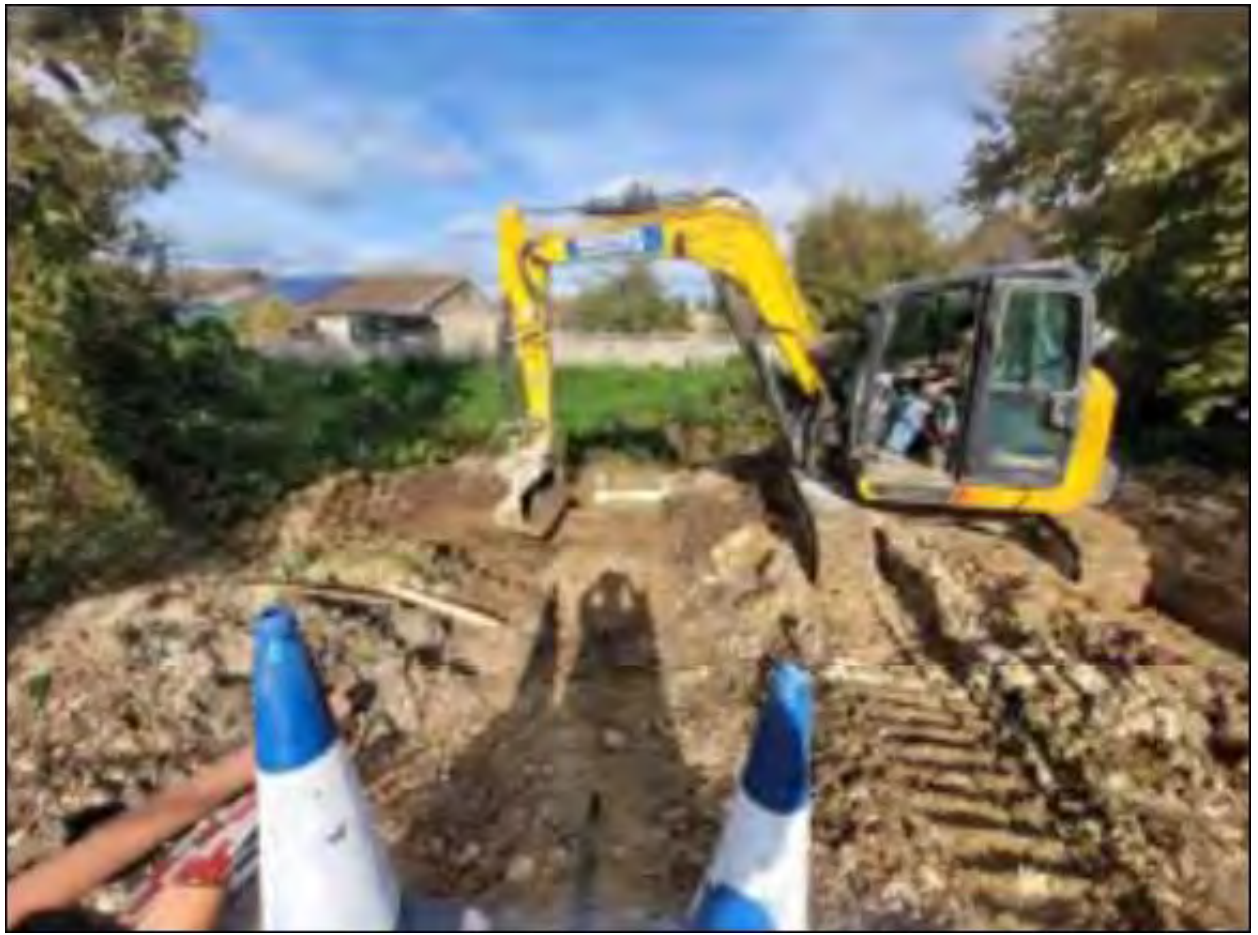
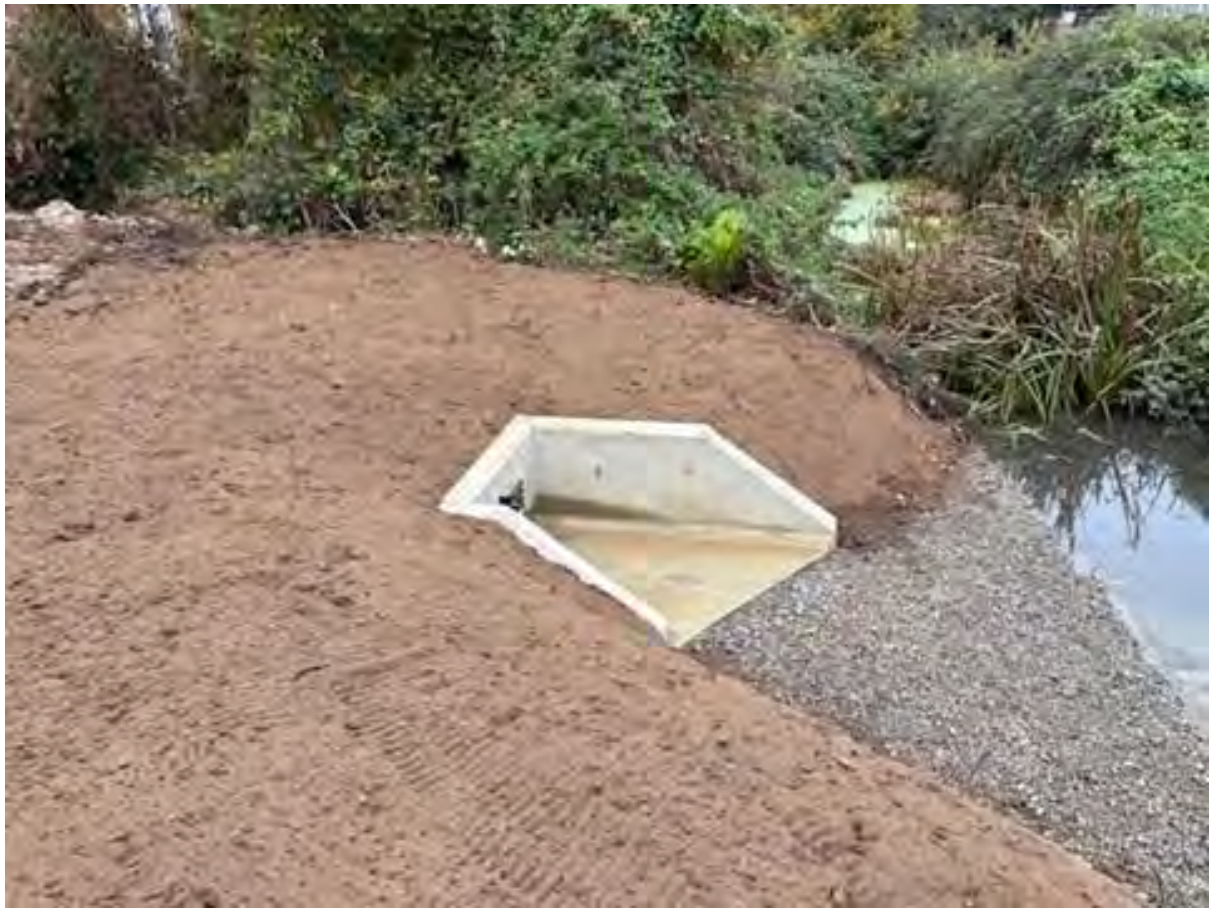
## **HEADWALL COMPLETE AND THE STREAM CLEANED OUT**

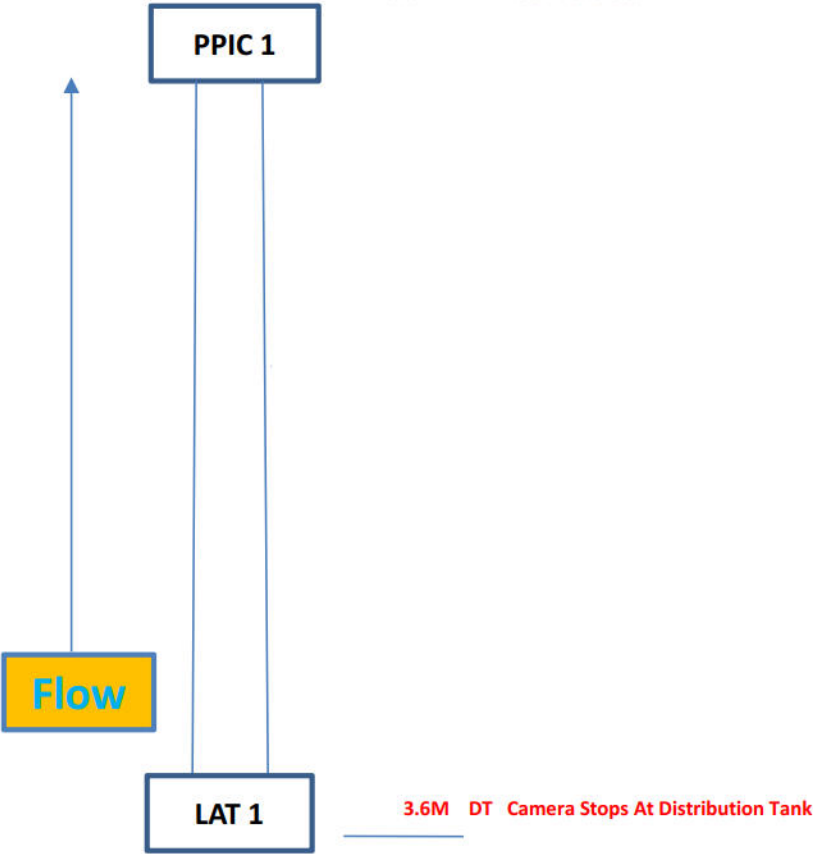
REM ; THERE ARE NO MAJOR DEFECTS WITH THIS SECTION OF PIPE

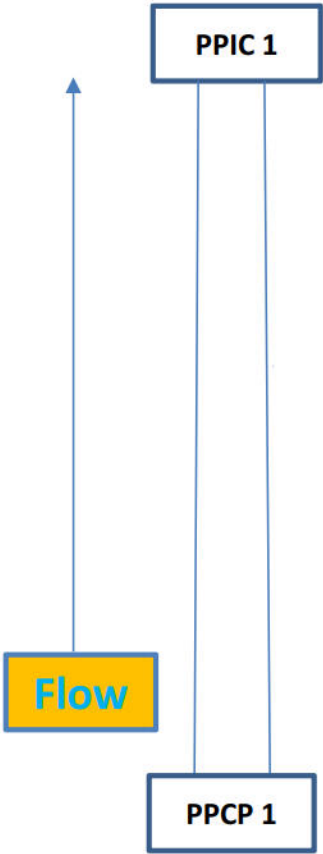
REM ; THERE ARE NO MAJOR DEFECTS WITH THIS SECTION OF PIPE

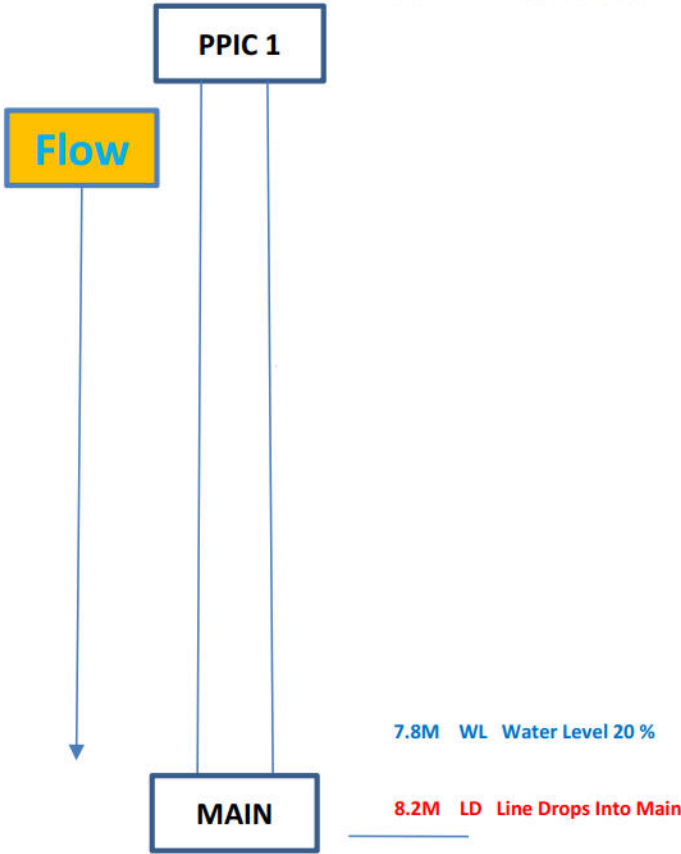
REM ; THE MAIN LINE NEEDS CLEANING FURTHER DOWN

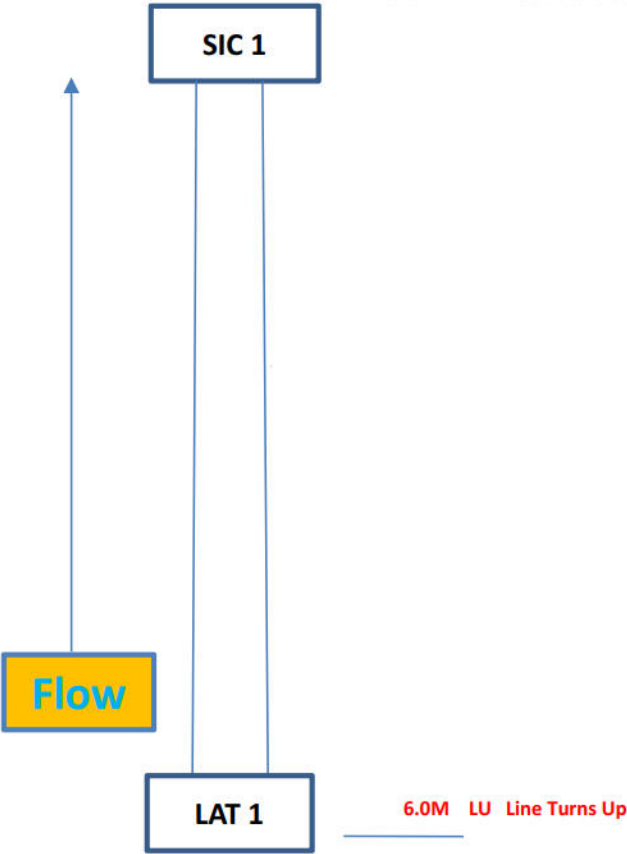
REM ; THERE ARE NO MAJOR DEFECTS WITH THIS SECTION OF PIPE

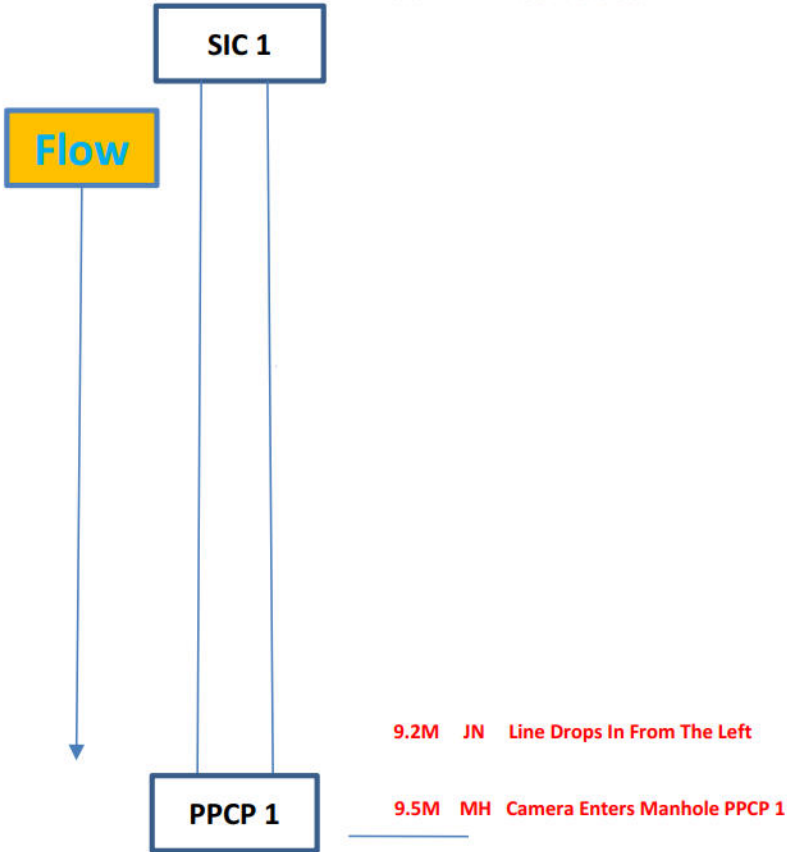
REM ; THE MAIN LINE NEEDS CLEANING FURTHER DOWN

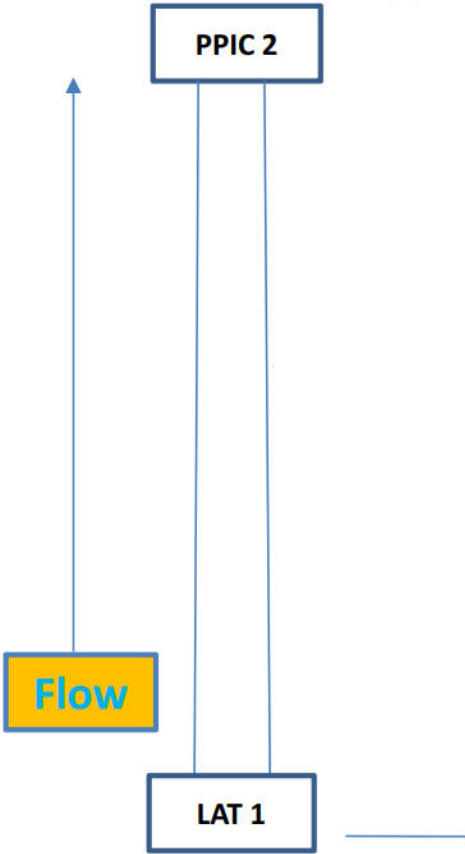
REM ; THERE ARE NO MAJOR DEFECTS WITH THIS SECTION OF PIPE

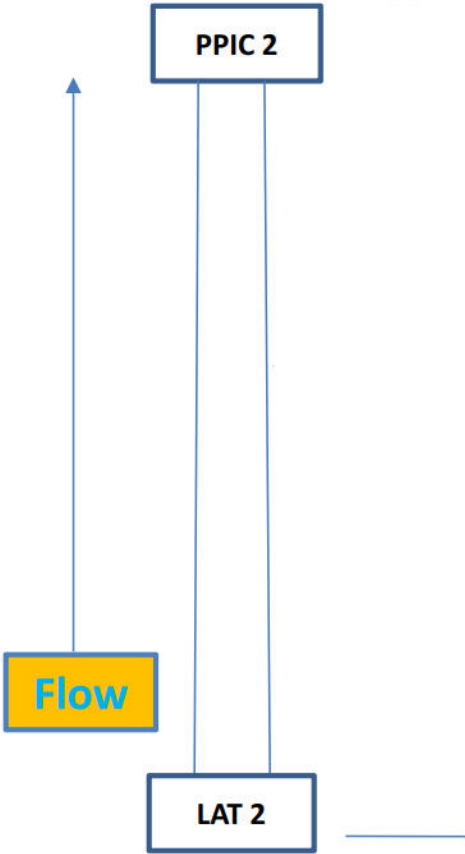
REM ; THERE ARE NO MAJOR DEFECTS WITH THIS SECTION OF PIPE

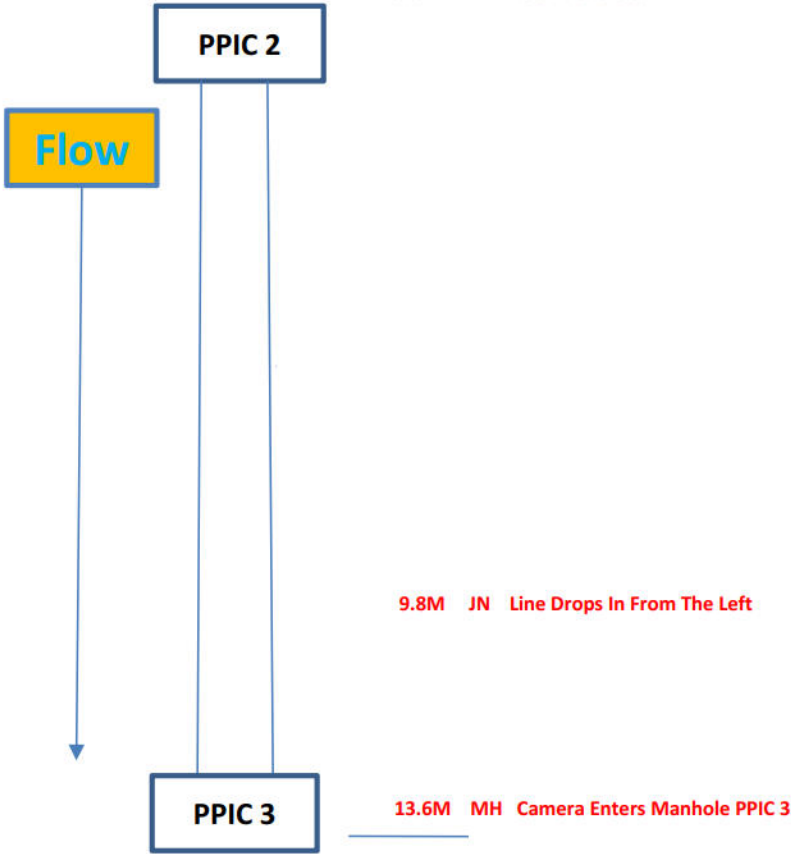
REM ; THERE ARE NO MAJOR DEFECTS WITH THIS SECTION OF PIPE

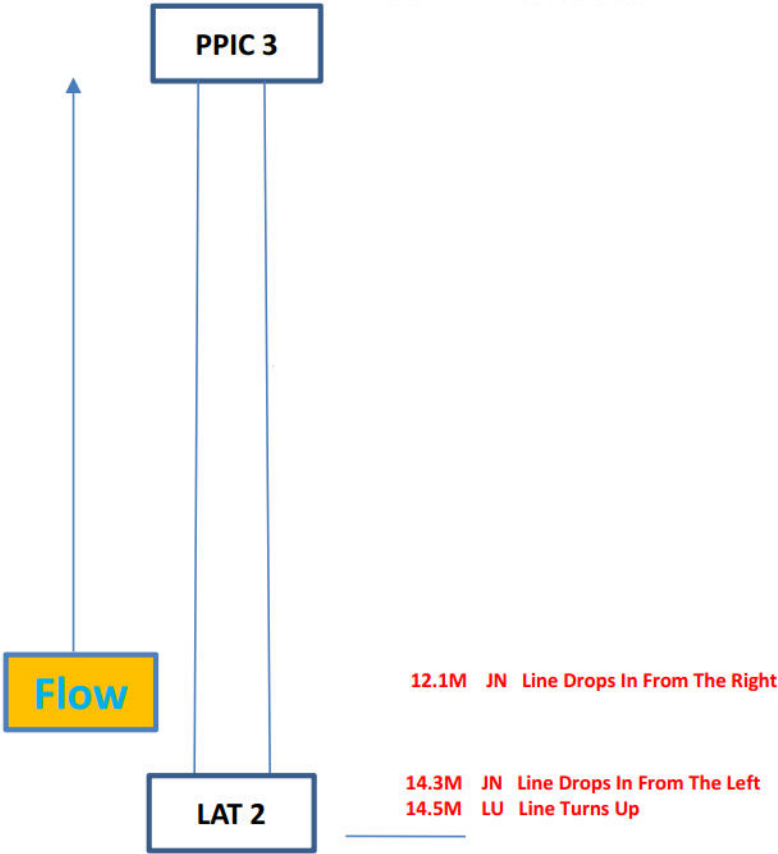
REM ; THERE ARE NO MAJOR DEFECTS WITH THIS SECTION OF PIPE

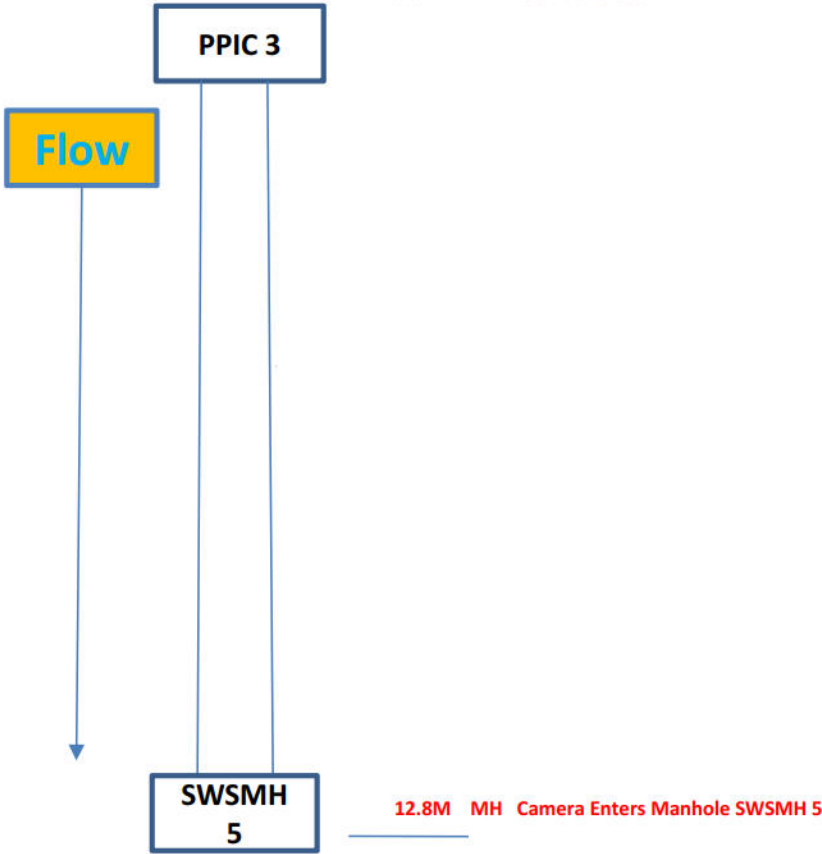
REM ; THERE ARE NO MAJOR DEFECTS WITH THIS SECTION OF PIPE

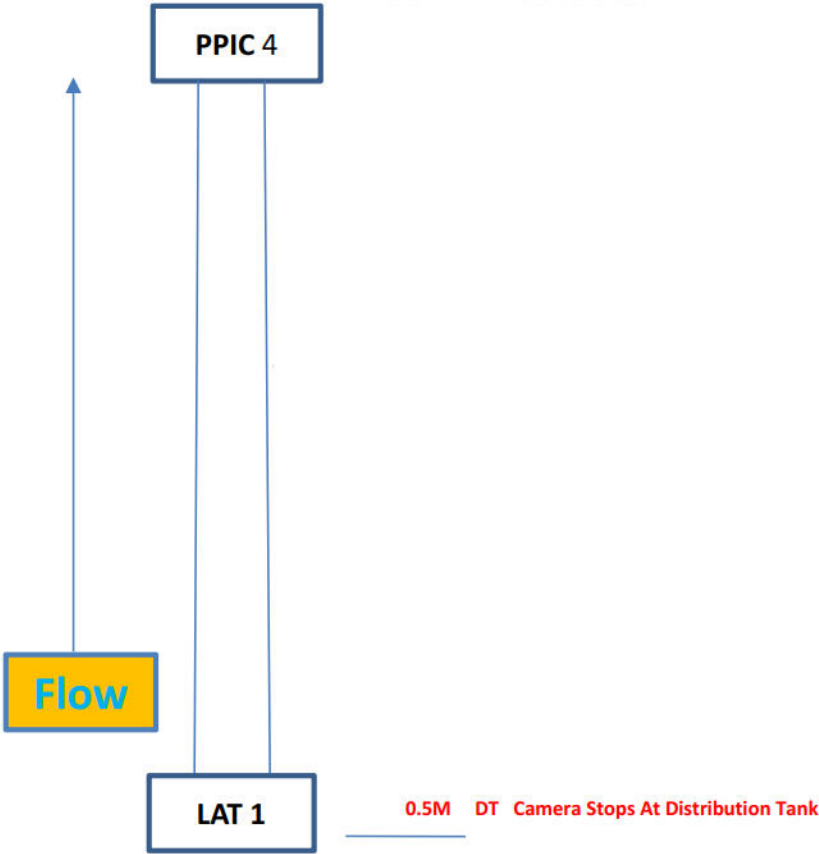
REM ; THERE ARE NO MAJOR DEFECTS WITH THIS SECTION OF PIPE

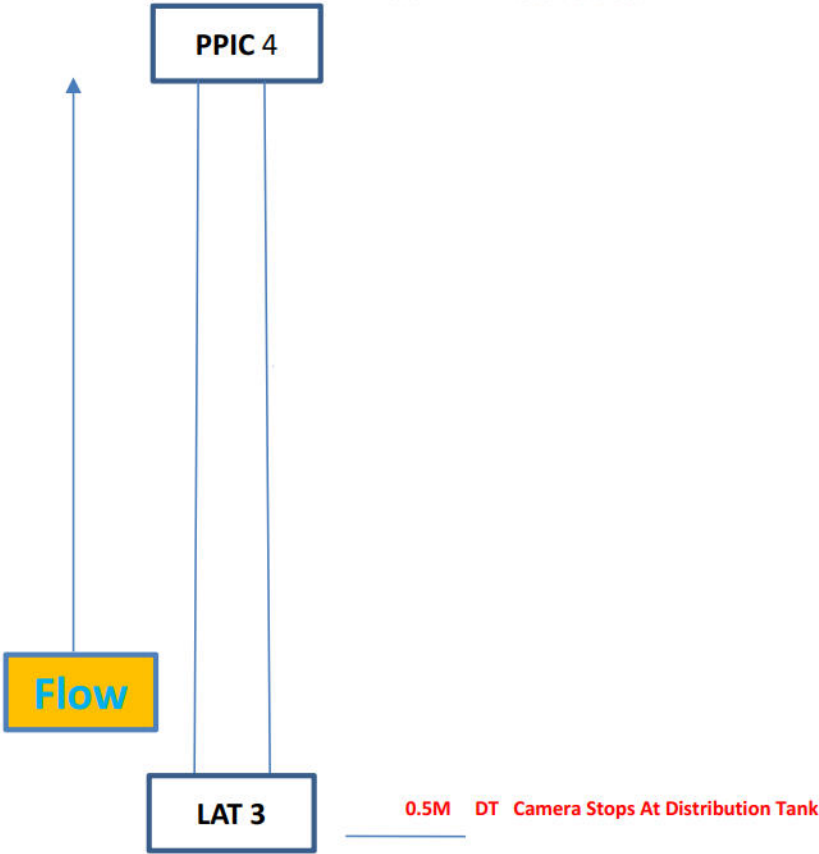
REM ; THERE ARE NO MAJOR DEFECTS WITH THIS SECTION OF PIPE

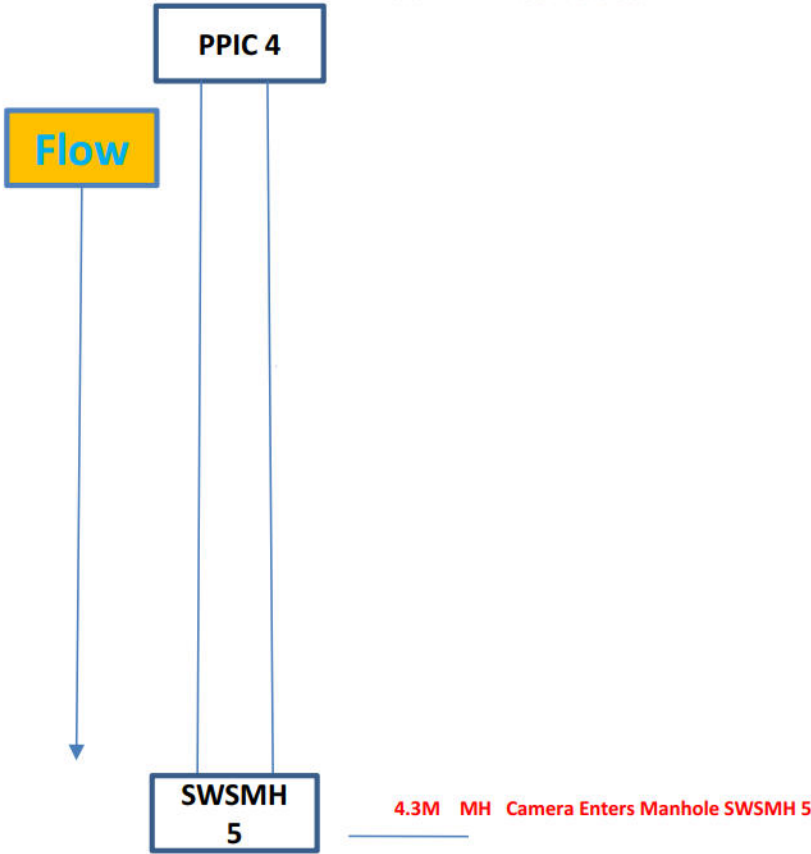
REM ; THERE ARE NO MAJOR DEFECTS WITH THIS SECTION OF PIPE

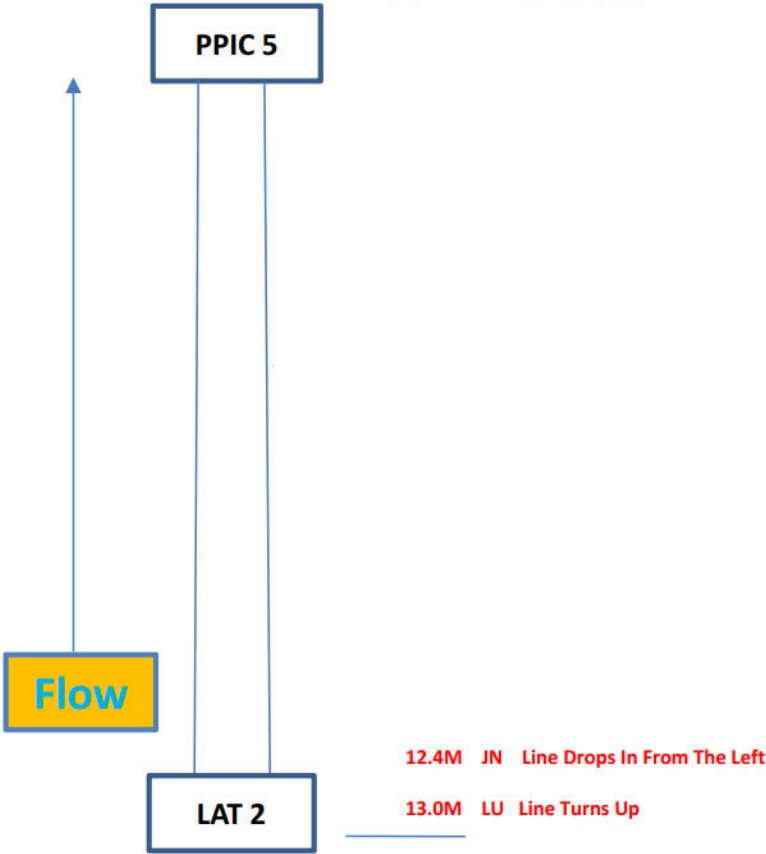
REM ; THERE ARE NO MAJOR DEFECTS WITH THIS SECTION OF PIPE

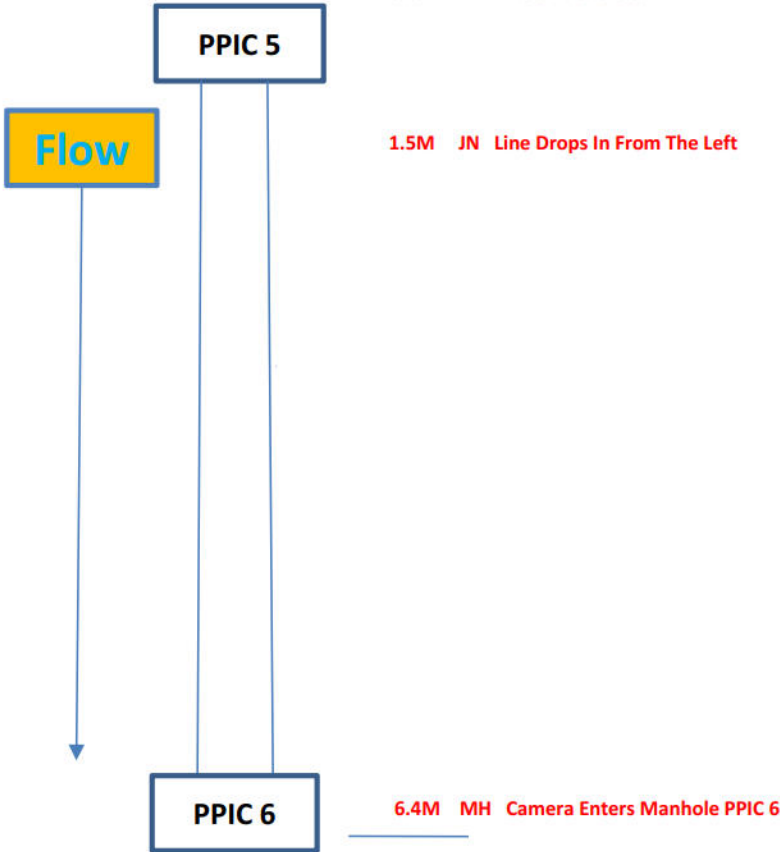
REM ; THERE ARE NO MAJOR DEFECTS WITH THIS SECTION OF PIPE

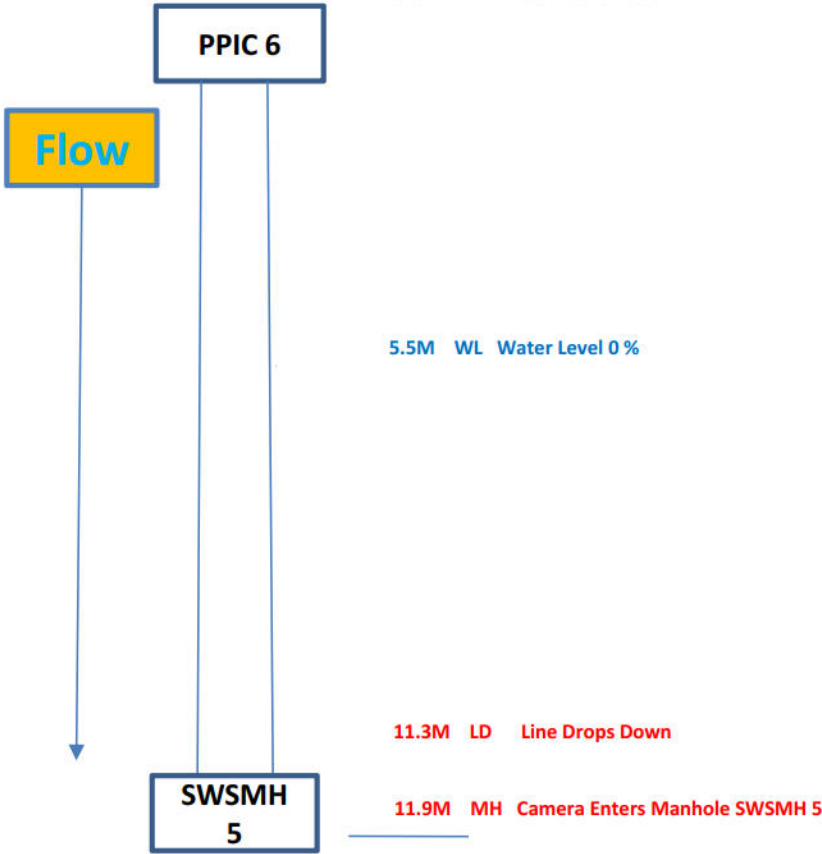
REM ; THERE ARE NO MAJOR DEFECTS WITH THIS SECTION OF PIPE
