## 11. APPENDIX E - COMPLETION REPORT

| Project name | C-13319 - Saltbox, Bognor Regis | | |
| Design note title | Site Completion Report | | |
| Document reference | SAL-HYD-XX-XX-RP-C-0005 | | |

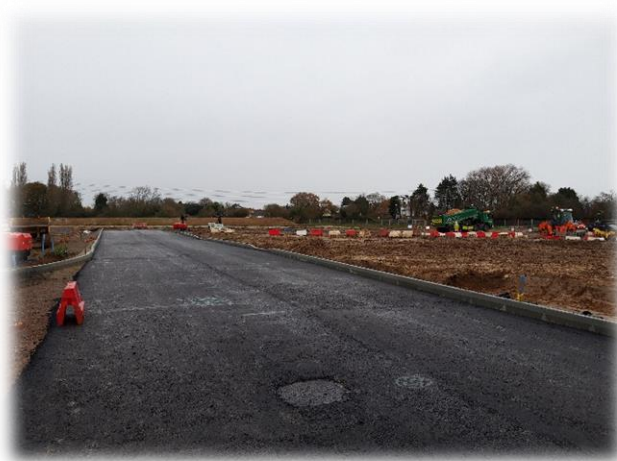
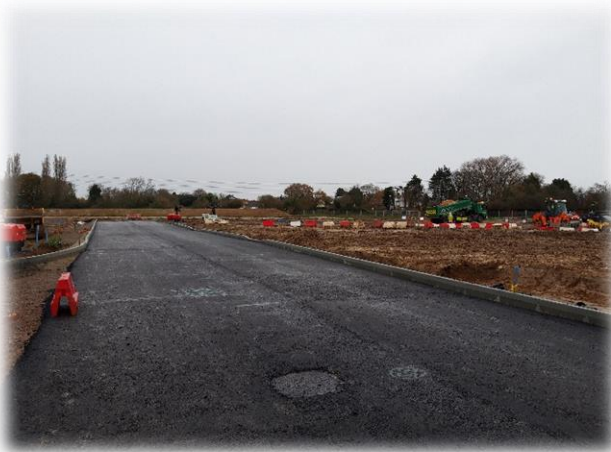
Photo 1. Photo taken November 20<sup>th</sup> 2020

- Photo 1: Sub-base placed and compacted, with base course laid on top. HB2 kerbs installed.
- Photo 2: Manhole PC ring, cover slab and cover installed to SW507.
- Photo 3: Kerb haunching and tie in to site. Installation of base course to access road.
- Photo 4: Formation of Unit 2 site.
- Photo 5: Phase 2 foundations installed (began works)

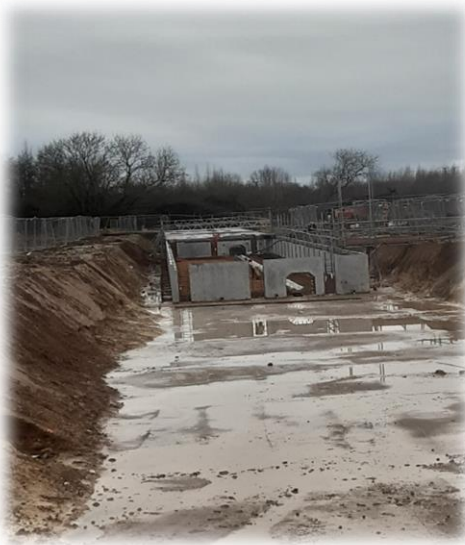
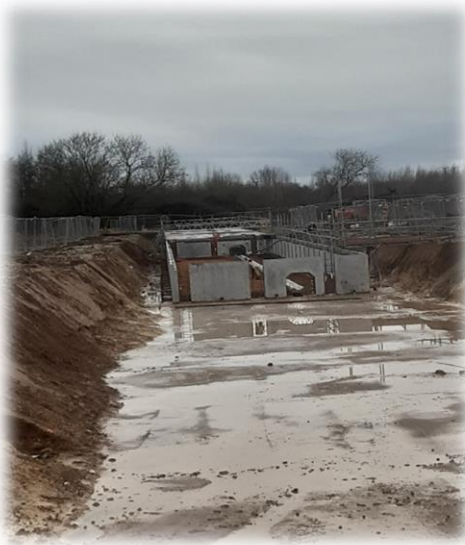
Photo 6. Photo taken December 10<sup>th</sup> 2020

- Photo 6: Formation of road cut and culvert being constructed.
- Photo 7: Construction of FW-205 with benching. Constructed in accordance with Hydrock drawing C-7100.
- Photo 8: Construction of pipe run with Class S bedding. In accordance with Hydrock drawing C-7101.
- Photo 9: Partial construction of SW-201 with benching. In accordance with Hydrock drawing C-7100.
- Photo 10: Unit 8 (ALDI) Frame is constructed

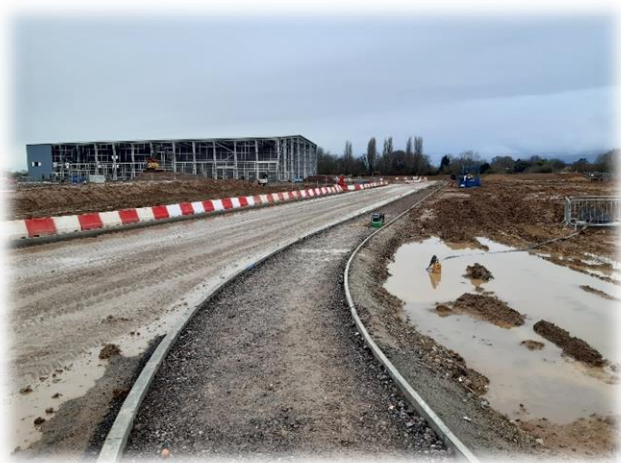
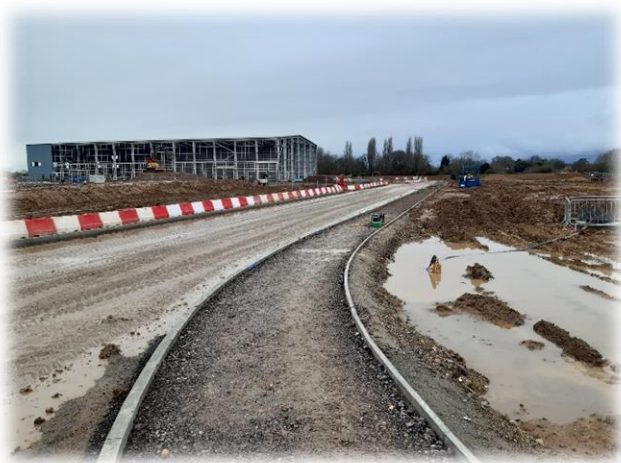
Photo 11. Photo taken January 12<sup>th</sup> 2021

- Photo 11: Edging and HB2 installed with haunching visible. Footway installed to top of sub-base.
- Photo 12: Klargestor NSFA200 as per Hydrock drawing ready to install downstream of FC-501.
- Photo 13: Channel of attenuation tank (CA-501). Constructed in accordance with Hydrock drawing C-7020.
- Photo 14: Unit 2 site at formation, kerbs installed prior to sub-base being laid.

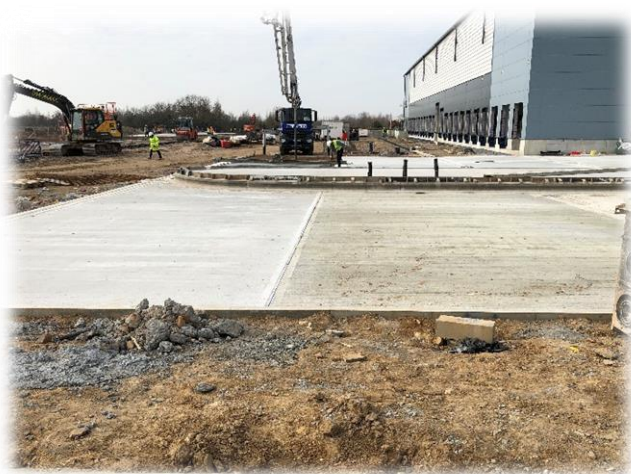
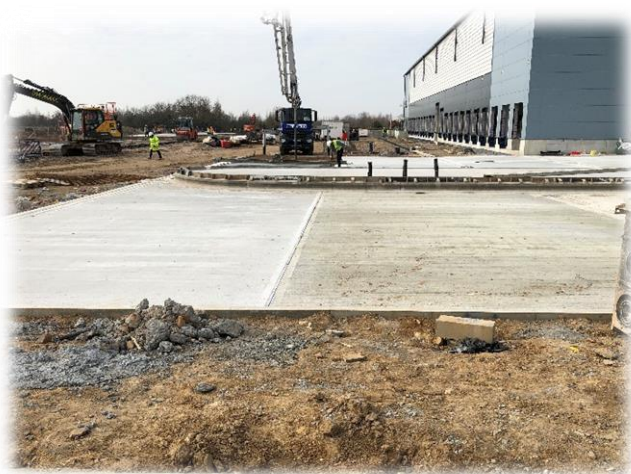
Photo 15. Photo taken March 10<sup>th</sup> 2021

- Photo 15: External slab installed east of Unit 2. Constructed in accordance with Hydrock drawing C-7300.
- Photo 16: Kerbs of Weybridge installed east of Unit 2.
- Photo 17: Currently constructing external slab south of Unit 2 - Rebar exposed.
- Photo 18: Cover of culvert and FC-501 up to cover slab installed.

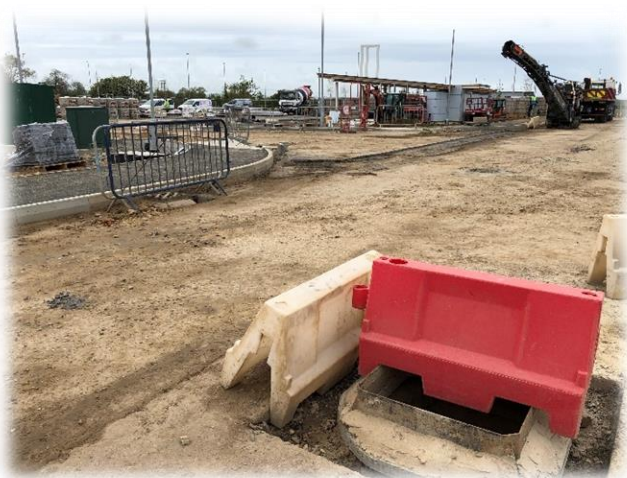
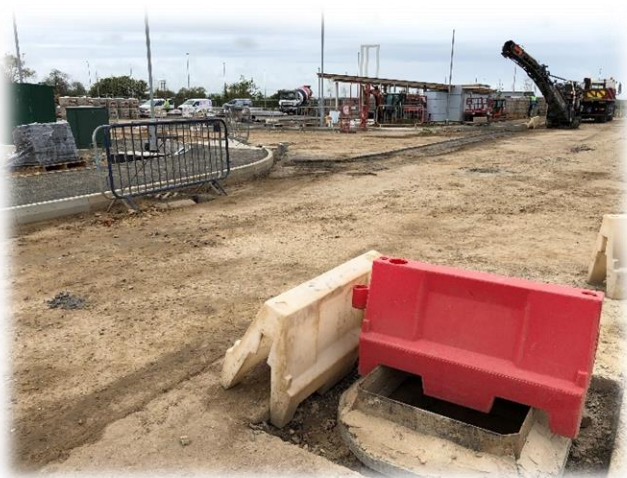
Photo 19. Photo taken March 28<sup>th</sup> 2021

- Photo 19: Access Road installed up to base course. Bellmouth installed.
- Photo 20: Kerbs installed with adjacent footway installed up to surface course.
- Photo 21: Unit 2 Permeable paving bays (P-B2 (P)) installed. in accordance with Hydrock drawing C-7200.
- Photo 22: Double gullies installed near SW505a. Constructed in accordance with Hydrock drawing C-7300
- Photo 23: Phase 2 car park/porous block paving installed on site

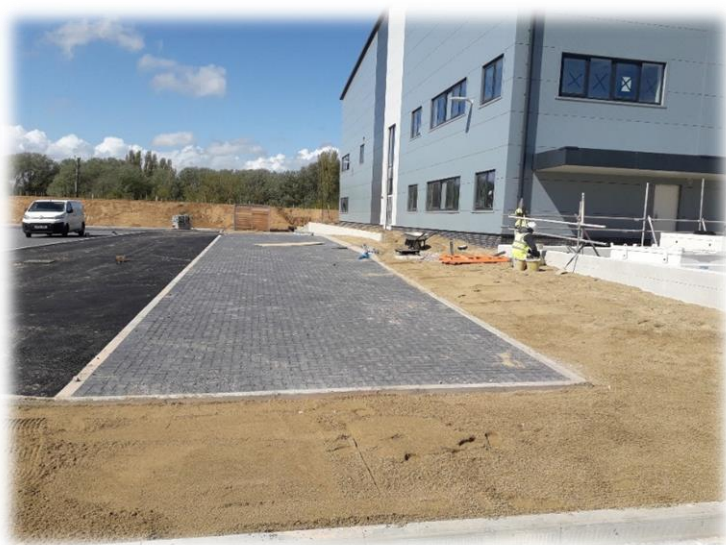
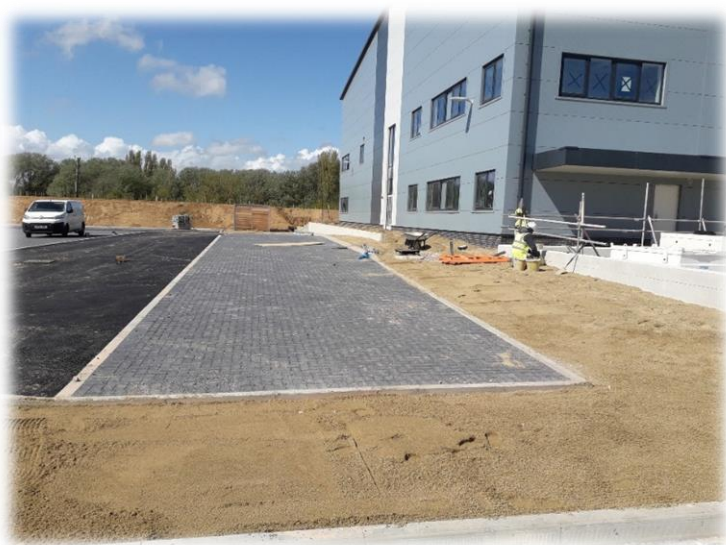
Photo 24. Photo taken June 01<sup>st</sup> 2021

- Photo 24: Permeable paving bays (P-B2 (P)) and asphalt (A3) aisles installed; sand bedding visible prior to blocks (P-B1) being laid. Constructed in accordance with Hydrock drawing C-7210 and drawing 7200 (PH1 & PH2)
- Photo 25: Phase Permeable paving bays (P-B2 (P)) and asphalt (A3) aisles installed; sand bedding visible prior to blocks (P-B1) being laid. Constructed in accordance with Hydrock drawing C-7210 and drawing 7200 (PH1 & PH2)
