## Arun Retail Park | Survey & Inspection Documents

# Arboricultural Report

## Q161 - Visual Tree Assessment Report

Arun Retail Park,  
Shripney Road,  
Bersted,  
Arun,  
West Sussex

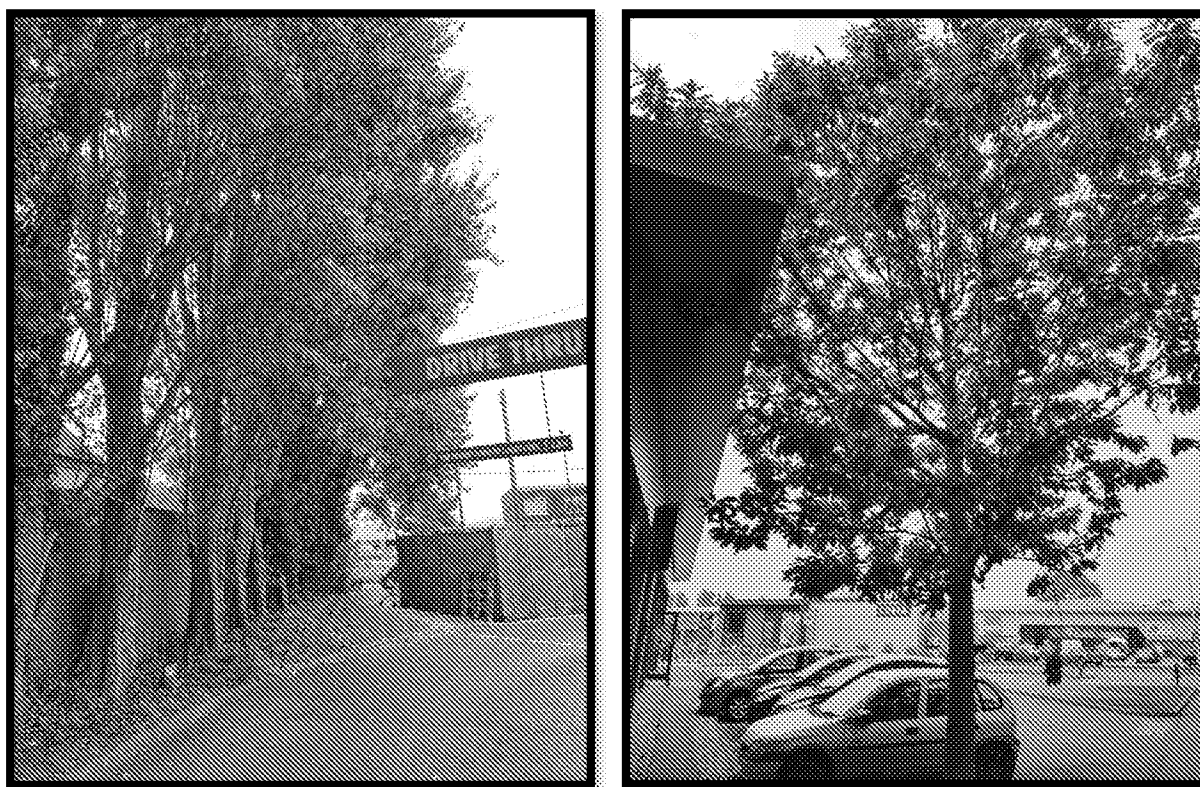
Plate 2: Tree and structures.

**4.1.3** Where trees overhang the retail park properties and boundary features the land-owners should ensure that any encroaching vegetation is crown lifted from these man-made features to avoid a nuisance. It is particularly important to note that the tree owners have a Duty of Care under the Occupiers Liabilities' Act to ensure that their trees do not cause harm to person or property. During the survey it was noted that a number of trees rest on boundary features, buildings or other man-made structures as shown in Plate 2.

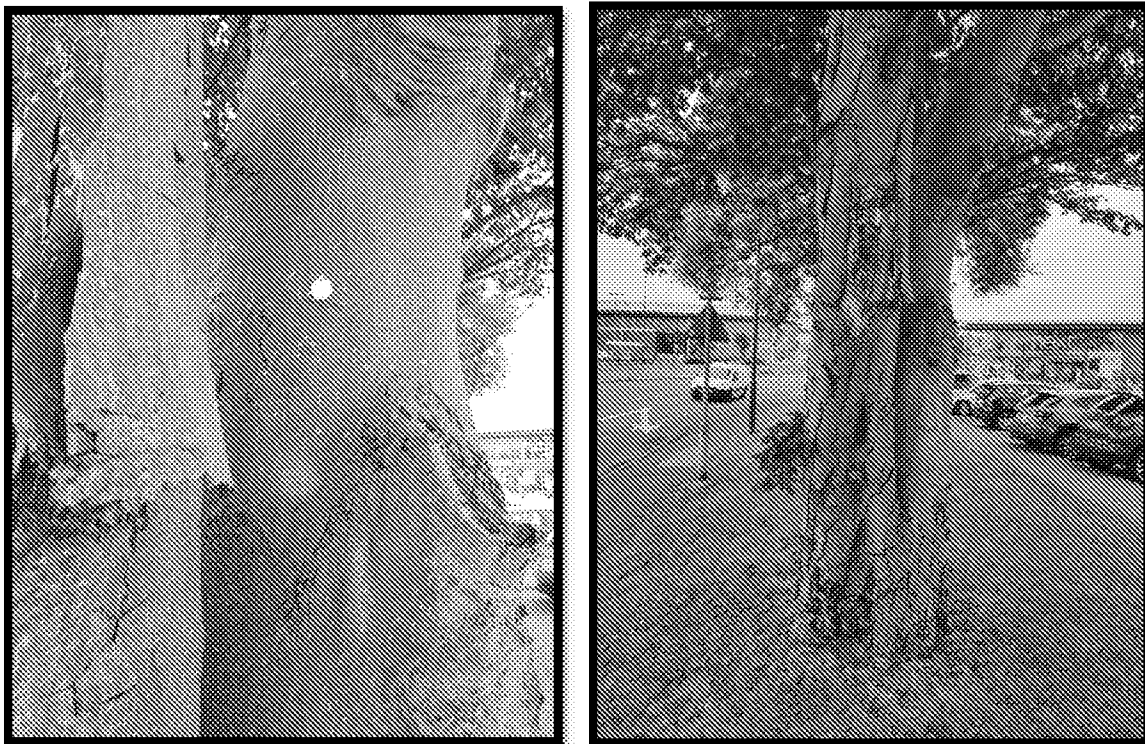
Plate 3: Bleeding Canker.

**4.1.8** Tree number 3 (tag 2823), Horse Chestnut, was observed to have advanced symptoms of bleeding canker and leaf minor. See Plate 3. If the tree were located in a position of low risk, it may be prudent to manage the tree to allow it to fight infection as an immune tree can pass on the DNA to combat these diseases and pests. However, due to the location and high risk involved the tree is to be felled.

Bleeding canker is a disease that affects European horse chestnut trees (*Aesculus hippocastanum*) in Great Britain. It is characterised by the appearance of 'bleeding cankers', or lesions, on the stems and branches.

These cankers ooze, or bleed, dark fluid. In most cases diagnosed since the year 2000 the cause has been the bacterium *Pseudomonas syringae pathovar aesculi*.

It can kill affected trees, although some do recover from infection, and some appear to be resistant to it.

| Survey Comment: Advanced symptoms of bleeding canker on stems and in crown. Bark plates shedding, decay and weak bifurcated stem union. Tree adjacent to major highway and parking bays. Replant space. | | | |
