**Road Safety Audit Stage 1**  
**Various Roads, Bognor Regis**  
**Retail Development**  
**Proposed Access Arrangements**

**Reference:RSC/MKG/7193/Bognor**

Project Title      Bognor Regis – Retail Development

Report Title      Road Safety Audit Stage 1

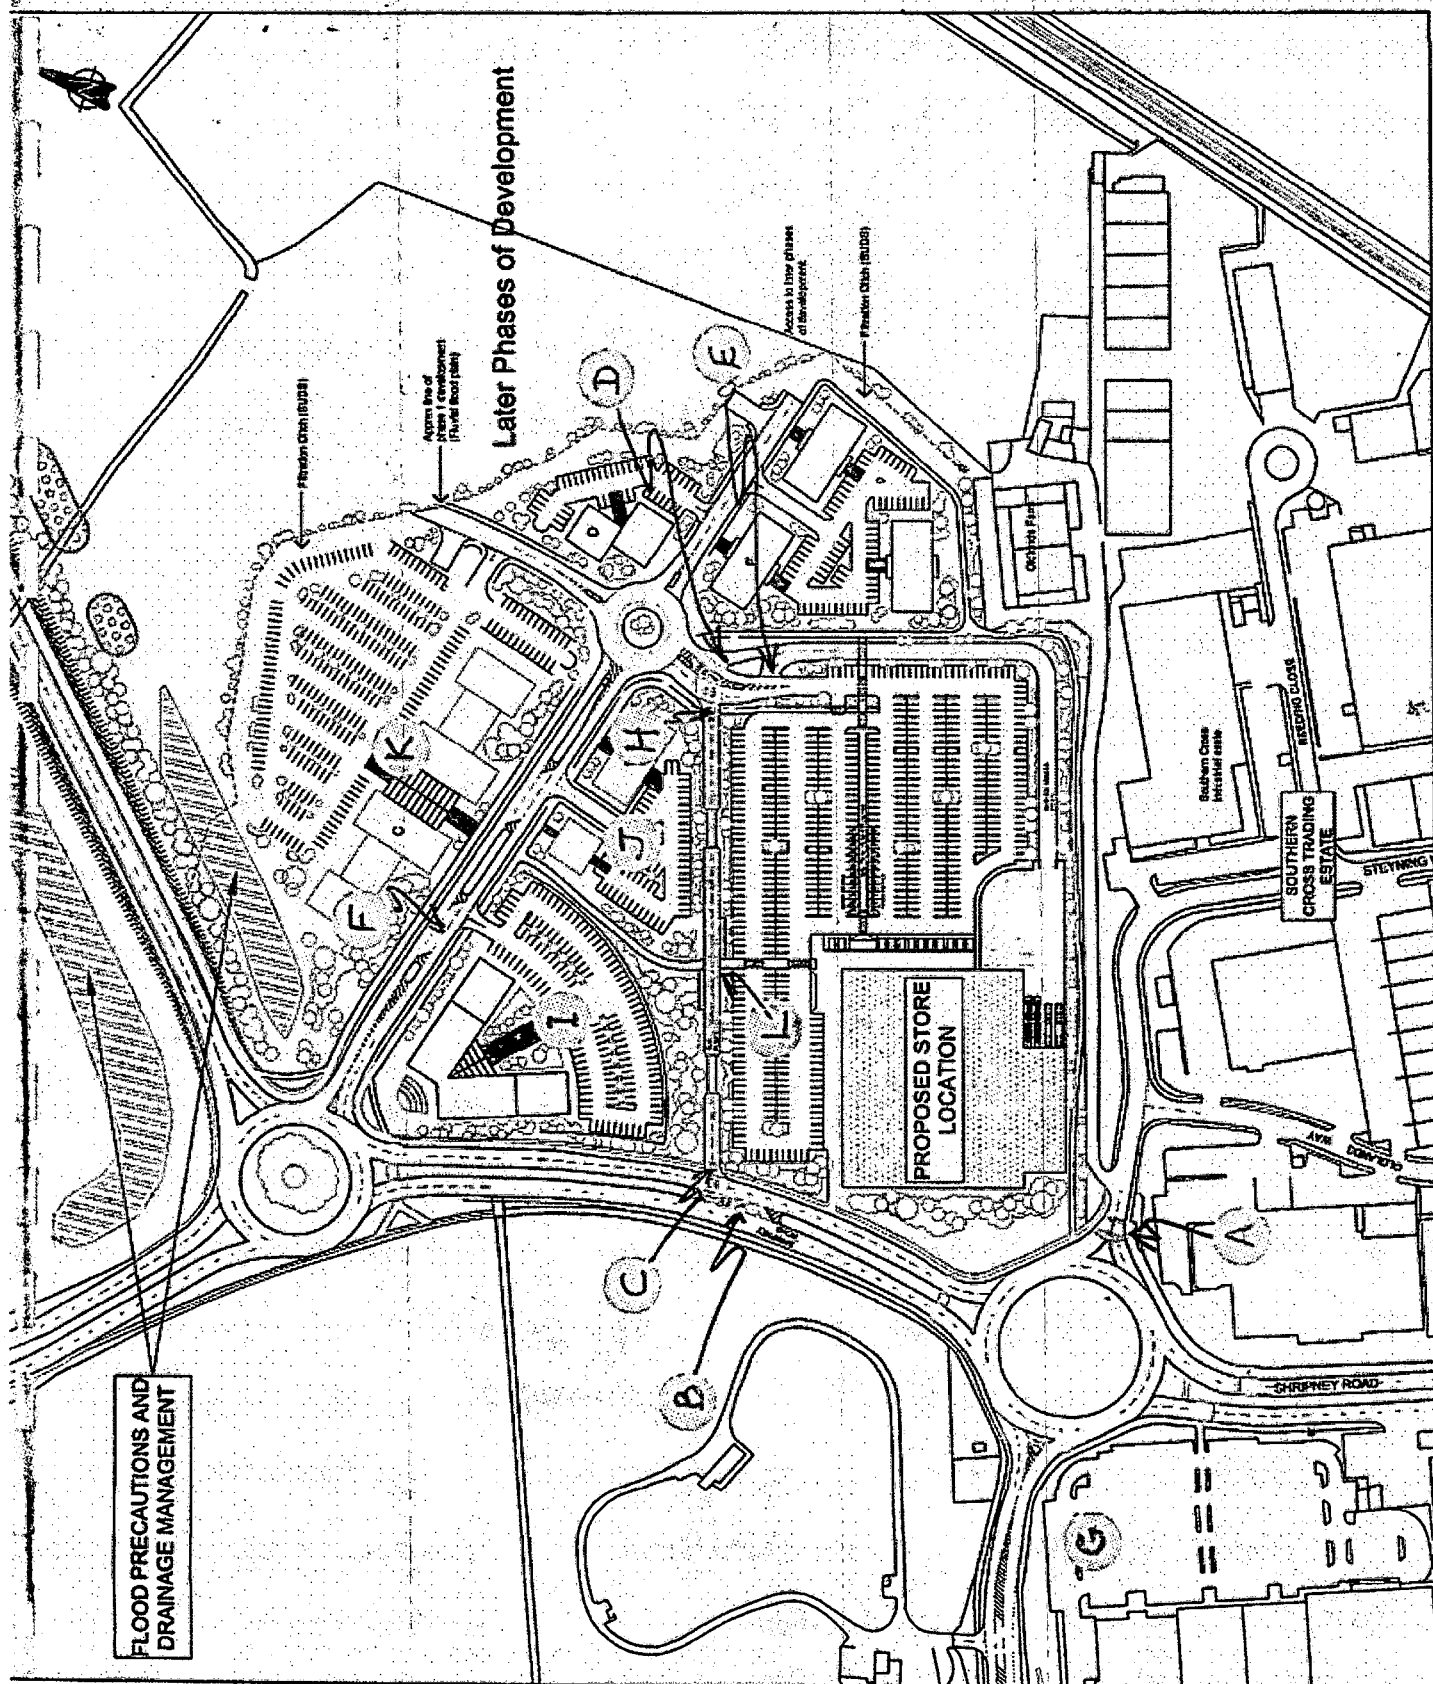
Drawing showing Problem Locations

Location – Rowan Way Roundabout (Steyning Way, eastern arm) – Marked A on the drawing

The ramps are sited close to the roundabout and would be negotiated by turning vehicles. This may cause particular problems for riders of two-wheeled vehicles. A vehicle exiting from the roundabout may slow suddenly and unexpectedly in the path of a circulating vehicle. There is a risk of nose-to-tail type collisions if a vehicle suddenly stops to afford precedence to a pedestrian.

Drivers of vehicles entering the roundabout may have control difficulties if still partly on a ramp when moving off.

Location – Shripney Road – Marked B on the drawing

There are concerns relating to the bus right turn lane facility and gap in the central reserve. The opening in the reserve and bus turning movements increase the risk of conflict and collision, particularly in darkness or in adverse weather conditions. There is no deceleration lane clear of other traffic, a short direct taper and minimal safety margin between a bus in the turning lane and opposing traffic in the outer lane. The opening allows the possibility of other vehicles making high risk 'U' turns.

Location – Shripney Road, access/egress for buses – Marked C on the drawing

Buses turning left from the site occupy the whole of the carriageway during the manoeuvre. The dimensions of the access road would not accommodate a bus turning in whilst another was waiting or turning out, or vice versa. There is concern that in moderate to busy traffic conditions there may be minimal opportunities for buses to exit safely and without conflict with other traffic.

Location – Goods vehicle entry to the service yard – Marked D on the drawing

The entry is necessarily wide to accommodate large vehicles, however, the close proximity to the roundabout and horizontal alignment across the junction may result in non-goods vehicle drivers entering in error. There is a risk of vehicles colliding with the separator island as the guidance marking is likely to wear and the alignment may not be clear in darkness or in adverse weather conditions.

Location – Goods vehicle egress junction from the service yard – Marked E on the drawing

Drawing No. 0704/07E shows the track of an articulated vehicle exiting the service road. There is concern that the angle required for the vehicle to make the exit manoeuvre is such that a driver may not be able to see to his left at the junction.

Location – Access road from Shripley Road roundabout – Marked F on the drawing

Internal car park access points commence about 90m along the access road. There is some concern that delays for traffic entering the site along the access road may adversely affect the safe operation and free-flow at the roundabout.

Location – Rowan Way Roundabout (western arm) – Marked G on the drawing

The alignment results in long (9m) crossings for pedestrians. The risk for pedestrians increases as crossing width increases and it becomes more difficult for them to judge safe crossing opportunities. Pedestrians crossing from the southern side would have their backs to traffic.

There is no central refuge. Given the crossing width, available visibility of the roundabout and potential traffic speeds, there is the potential for conflict between pedestrians and vehicles. Pedestrians may come to rely on vehicles stopping for them. There is no tactile paving guidance shown.

Location – The eastern end of the internal bus lane – Marked H on the drawing

The footways on opposite sides of the bus lane do not align. Pedestrians crossing diagonally from the southern side would be facing away from buses turning in.

Location – Two Car Park areas – Marked I and J on the drawing

The footway links to and from the car parks lead northwards requiring pedestrians to make relatively long detours. It is more likely that pedestrians will attempt to take direct routes. This may result in pedestrians crossing internal roads at locations where visibility is poor.

Location – Car Park and area to the north of the access road from Shripley Road roundabout – Marked K on the drawing

There is a footway link and pedestrian crossing location sited at the eastern end close to the internal roundabout and a crossing location at the Shripley roundabout end. These crossings are about 180m apart. It is unclear whether or not there will be pedestrian desire line(s) at other locations along the route but there are no crossing facilities shown.

Location – Internal bus lane – Marked L on the drawing

When buses are occupying the stops it will not be possible for pedestrians to check for other traffic (other buses or illegal vehicle movements). It would be difficult for pedestrians to judge when buses are moving away. Drivers of buses have a limited view of pedestrians close to the vehicle. Pedestrians would be vulnerable.

The ramps should be sited further from the roundabout and vehicles should meet them in a straight alignment. (Problem 2.3.2 refers)

There should not be a central reserve opening.

The junction should be controlled by traffic signals.

In addition to appropriate signing, the service road should be given a contrasting colour surface from the junction for approximately 15m. The curved alignment of the junction mouth should be clearly shown with a line of granite setts (or similar) (0 to 6mm upstand).

The goods vehicle exit route and junction should allow vehicles to position squarely and should ensure clear visibility in each direction.

Anticipated traffic flows should be appraised to ensure that queuing can be accommodated within the site.

The crossings should be realigned (as per those shown on the site access roundabout) to take the shortest crossing routes and positioning pedestrians at an appropriate visibility angle.

The uncontrolled pedestrian crossings should utilize the traffic separator island. Tactile paving guidance and dropped kerbs should be provided. (Problem 2.1.3 refers).

The footways should be realigned to make a straight crossing alignment.

There should be lateral footways from the car linking with footways shown to the east and west.

There should be an assessment of potential pedestrian desire lines. Where justified crossing facilities should be provided.

The bus stops should be located at least 20m away from the crossing point. High visibility pedestrian guard rail should be provided between the crossing and the bus boarding/alighting points.
