### **DESIGNERS RESPONSE TO SAFETY AUDIT**

## **OLDLANDS BUSINESS PARK – BOGNOR REGIS**

### **STAGE ONE SAFETY AUDIT**

#### **Designers Response**

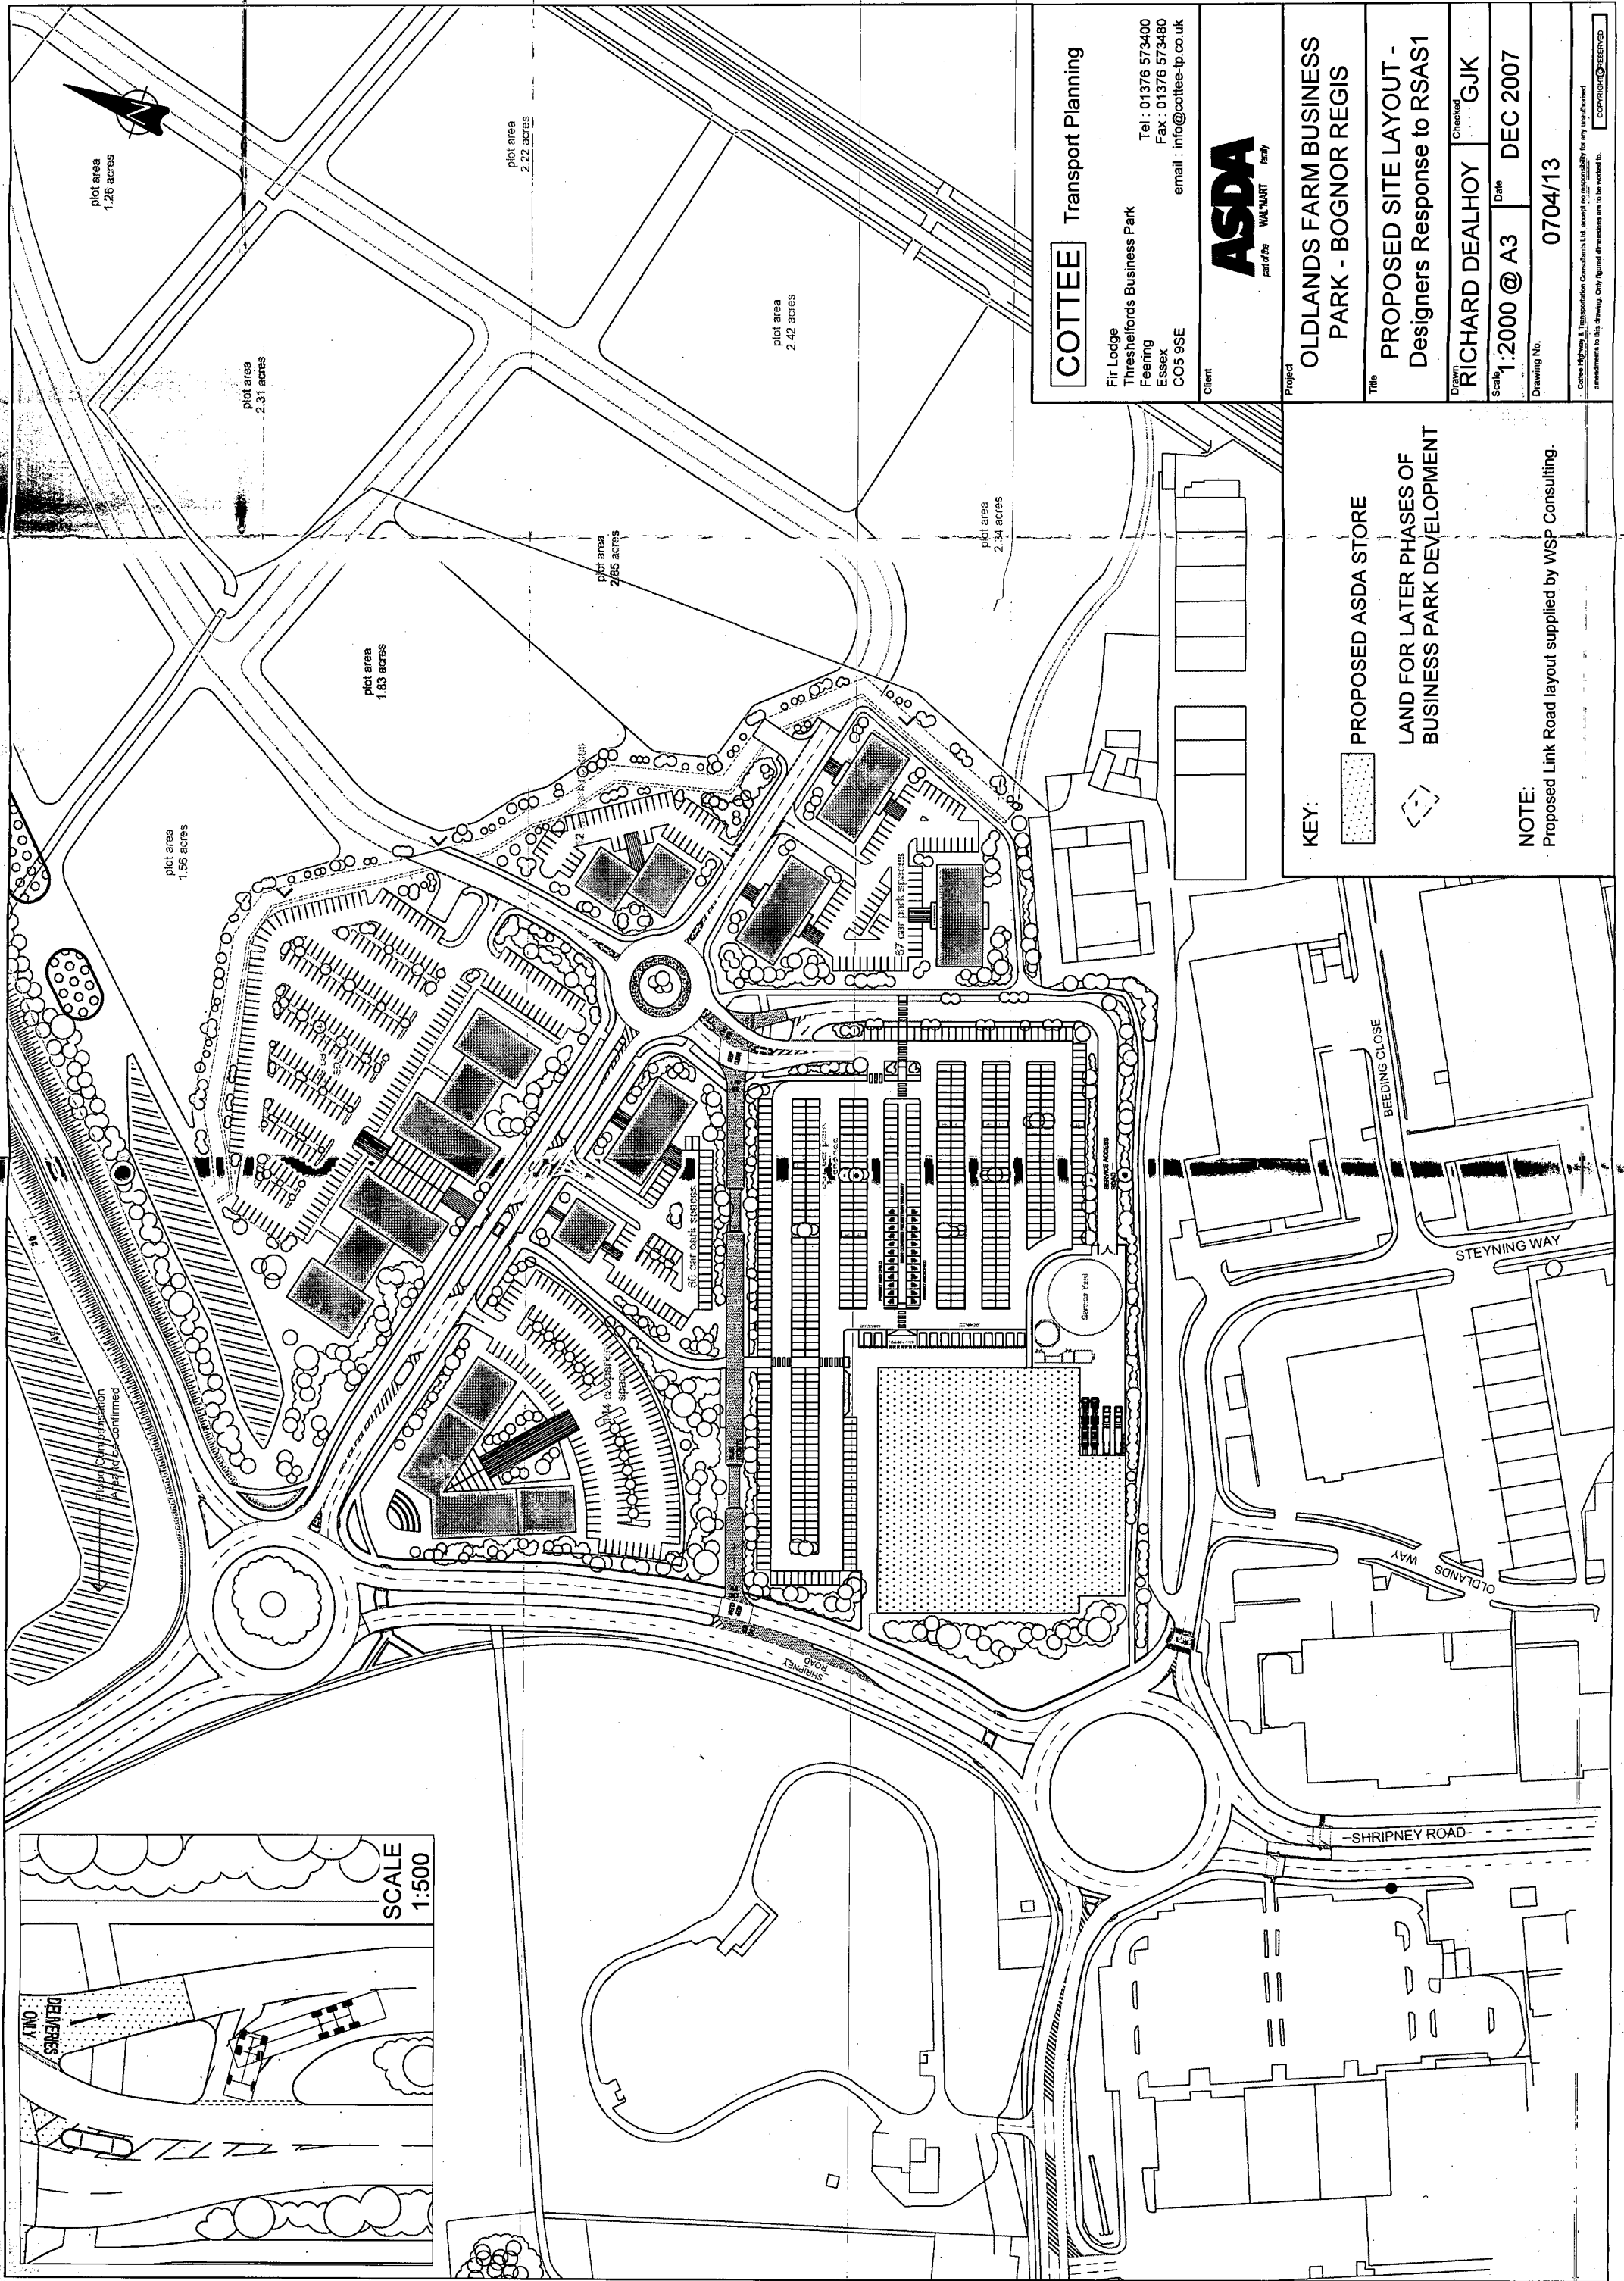
Visibility for exiting driver

As shown on drawing 0704/13 the vehicle cab is almost perpendicular to the giveway line when exiting the service road, which affords the driver the prescribed 90m visibility to the left and up to the roundabout access to the right.

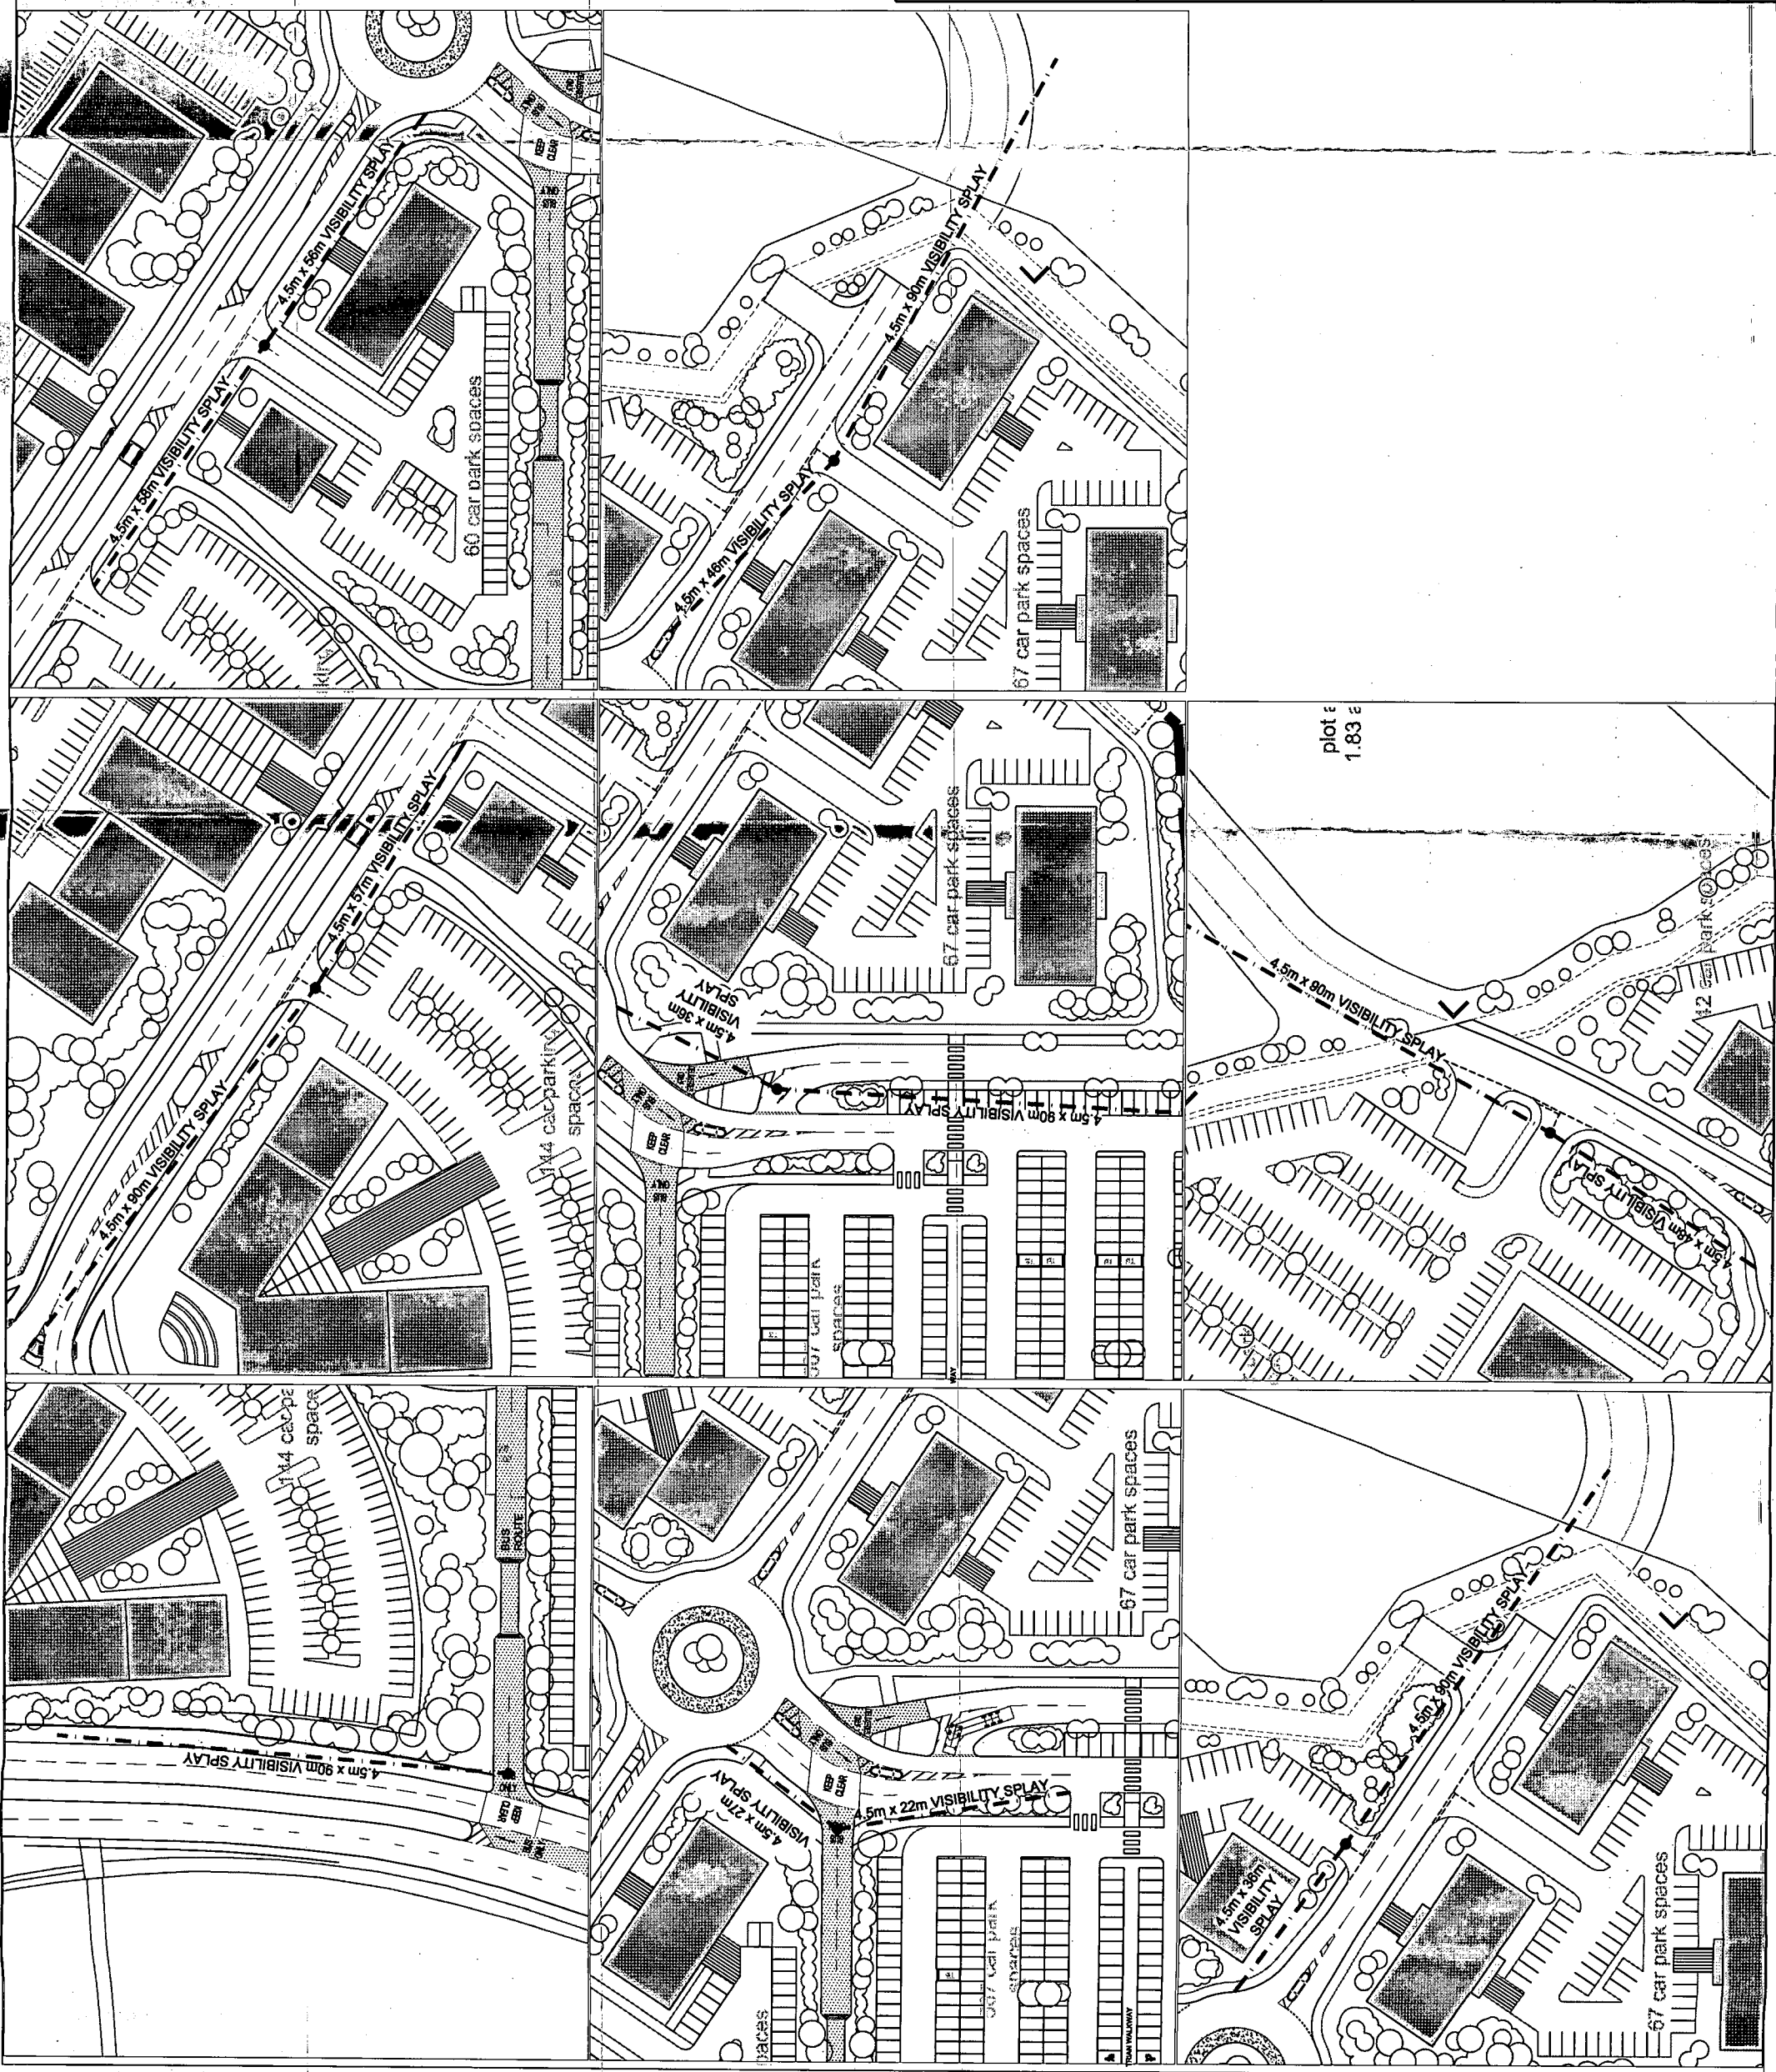
Drawing No.  
0704/13A

Title  
VISIBILITY SPLAYS -  
Designers Response to RSAS1
