### ARBORICULTURAL REPORT AND STATEMENT IN RELATION TO DEVELOPMENT PROPOSALS BS5837: 2012

Reference: NB/173/20

Location: Liseve Lodge, 84 North Bersted Street, Bognor Regis, West Sussex, PO22 9AQ.

Inspection date: 6<sup>th</sup> May 2020

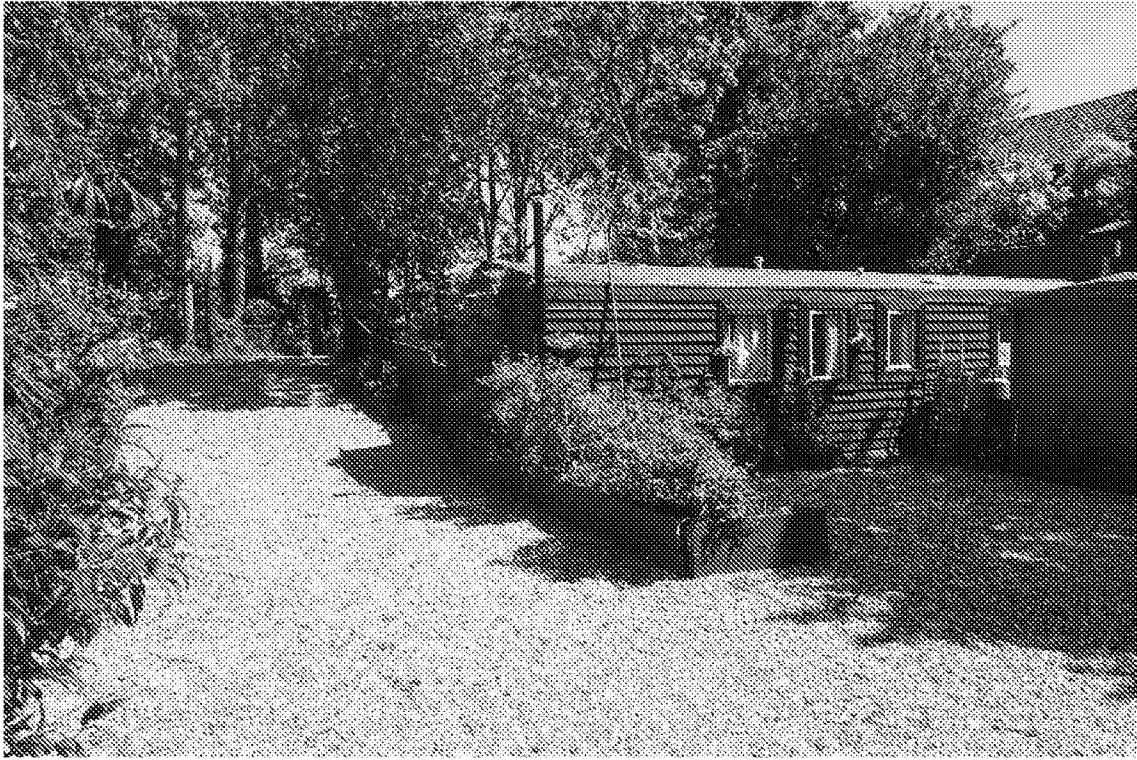
Area of proposed building

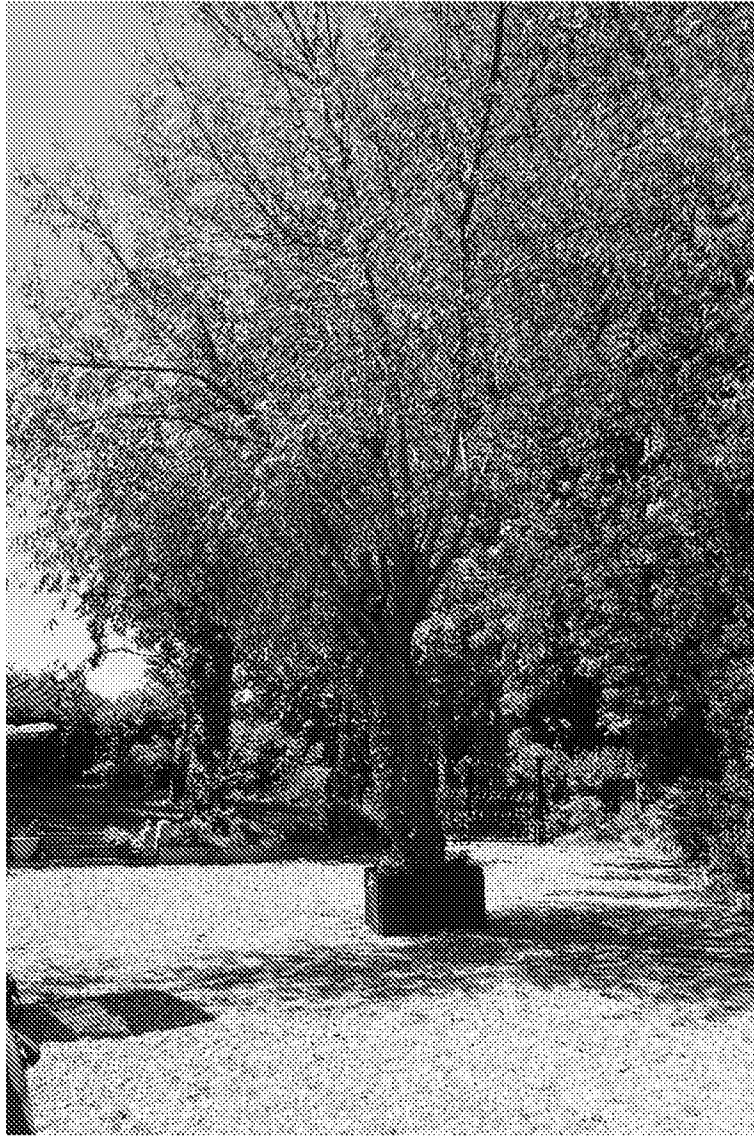
T1 Willow in middle of drive

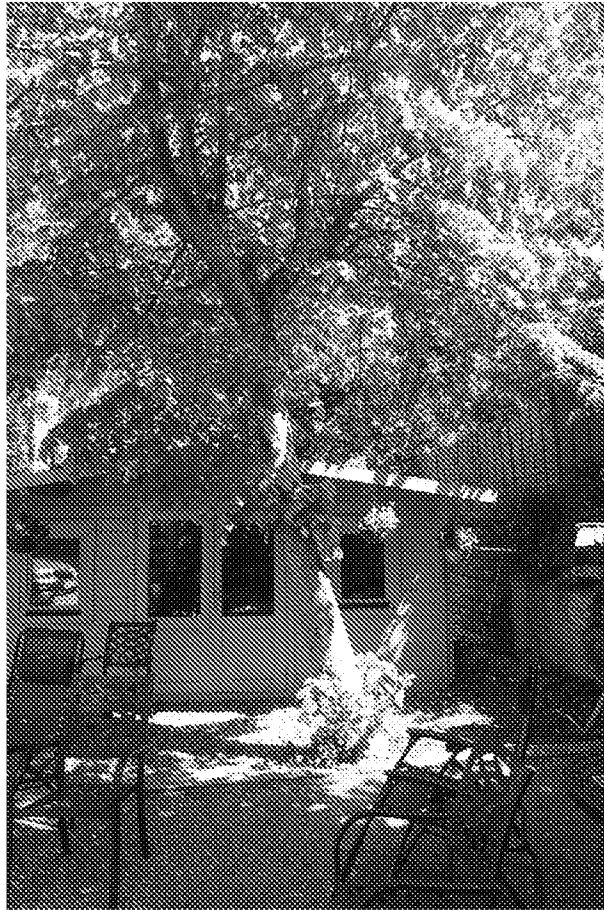
T2 Lime

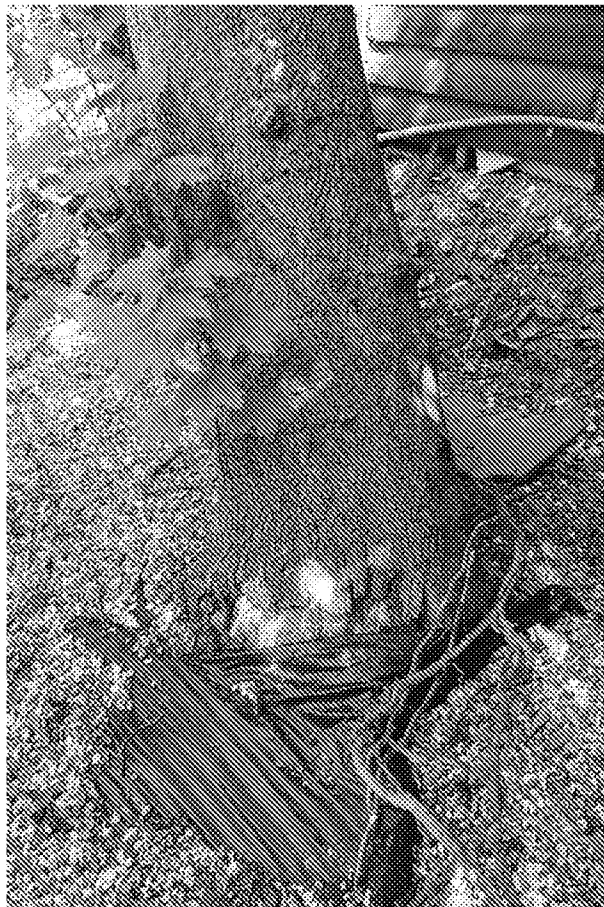
T4 Norway Maple showing damage at buttress  
12

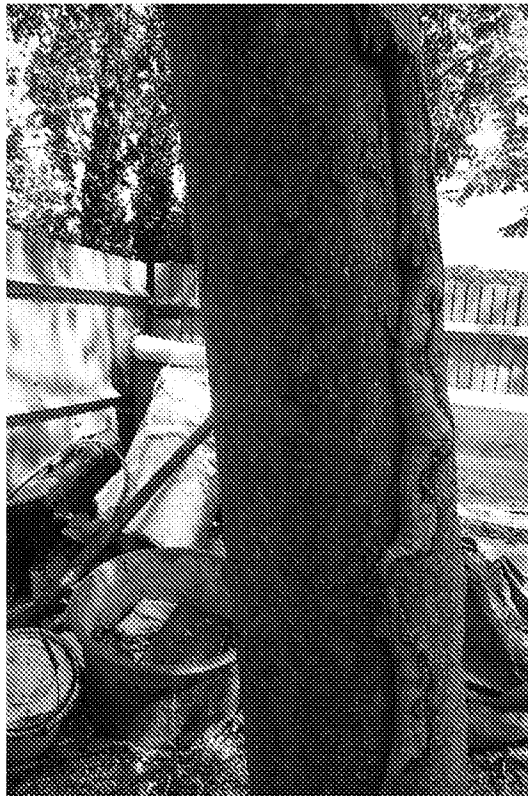
T6 Badly damaged bark occluding

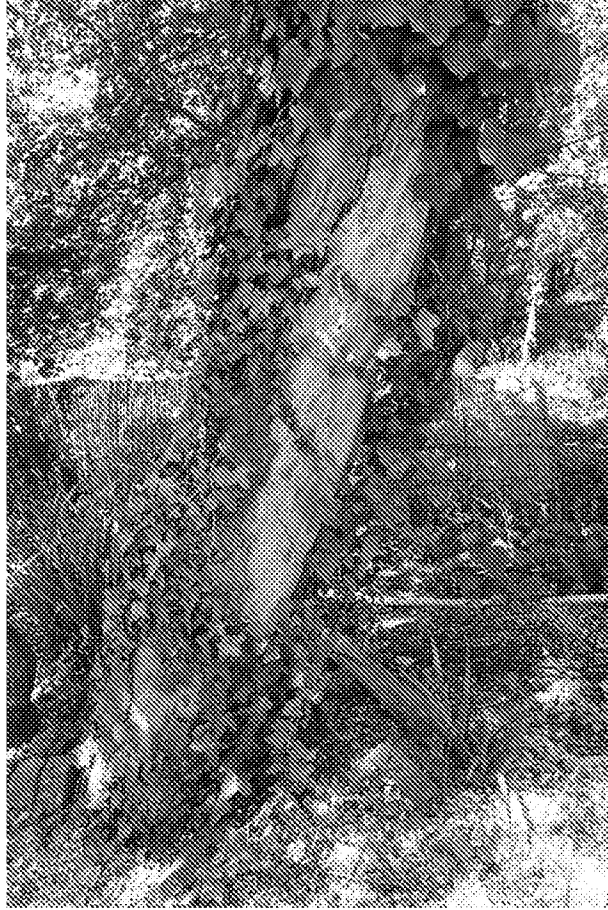
Damaged bark on Willow T11
