# **Phase 1 Land Contamination Risk Assessment**

## **Proposed Development of Industrial Units**

**Chalcroft Nurseries,  
Chalcroft Lane, Bersted,  
West Sussex PO21 5TS**

**Date: June 2025**

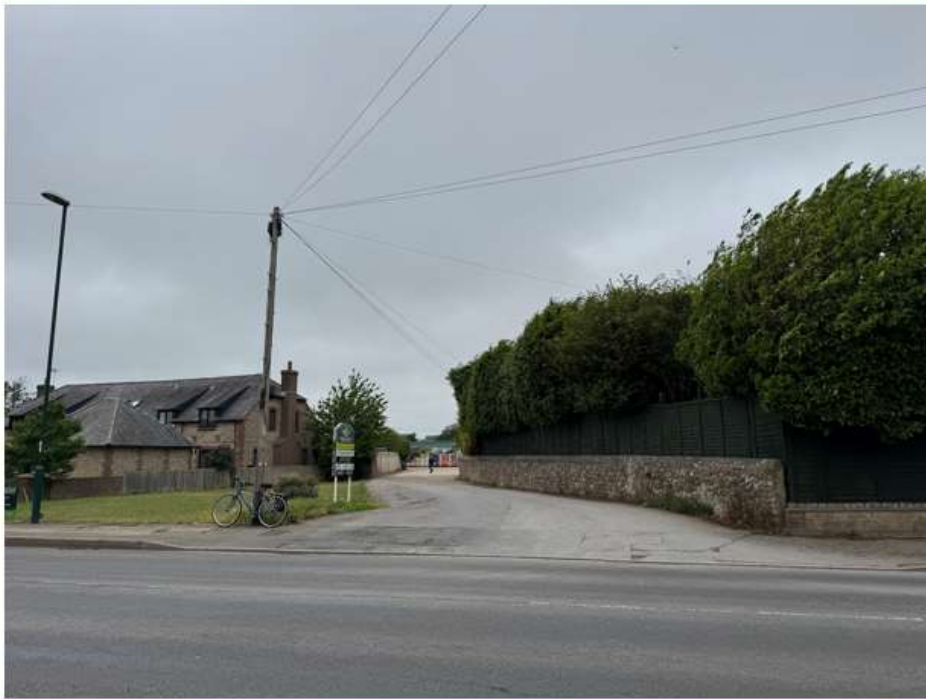
**Photo No.1: Facing west from Chalcraft Lane showing the site access (outside redline boundary)**

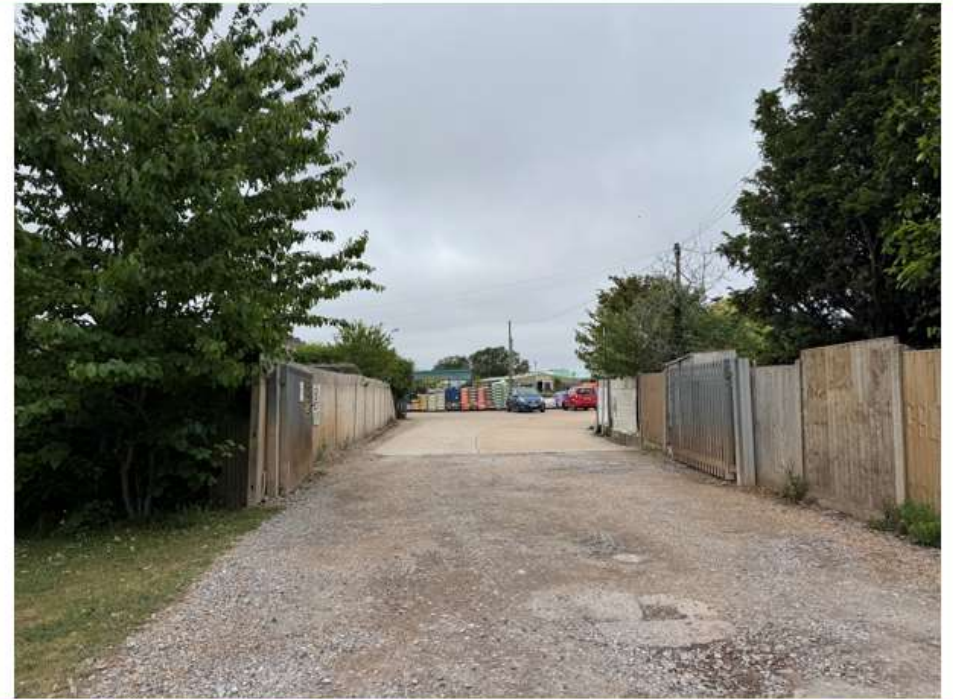
**Photo No.2: Facing west showing continuation of access route leading west off Chalcraft Lane**

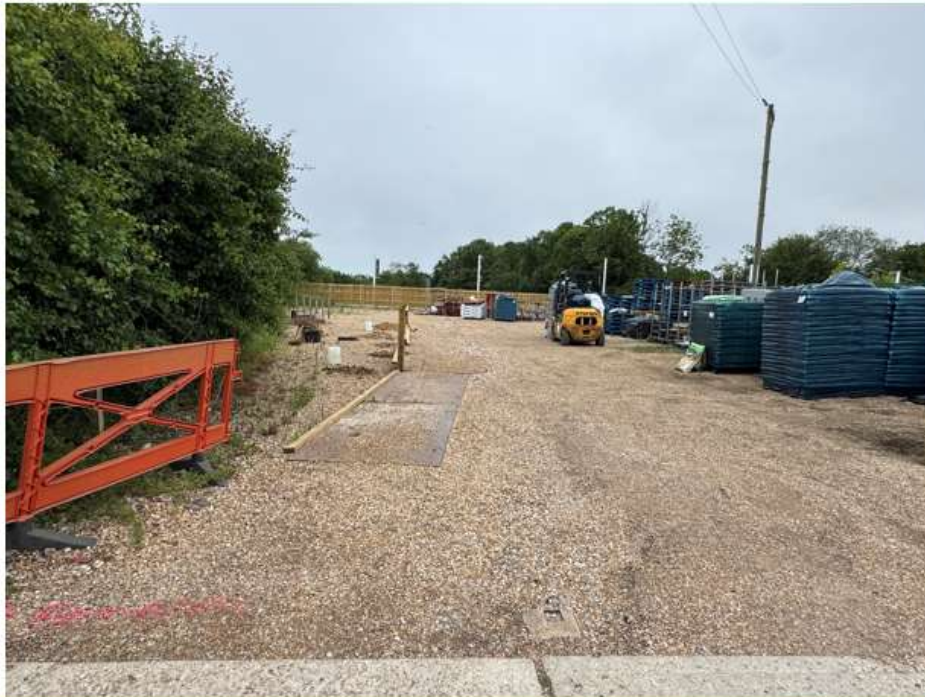
**Photo No.3: Facing southwest from the entrance to site showing car-parking and storage area**

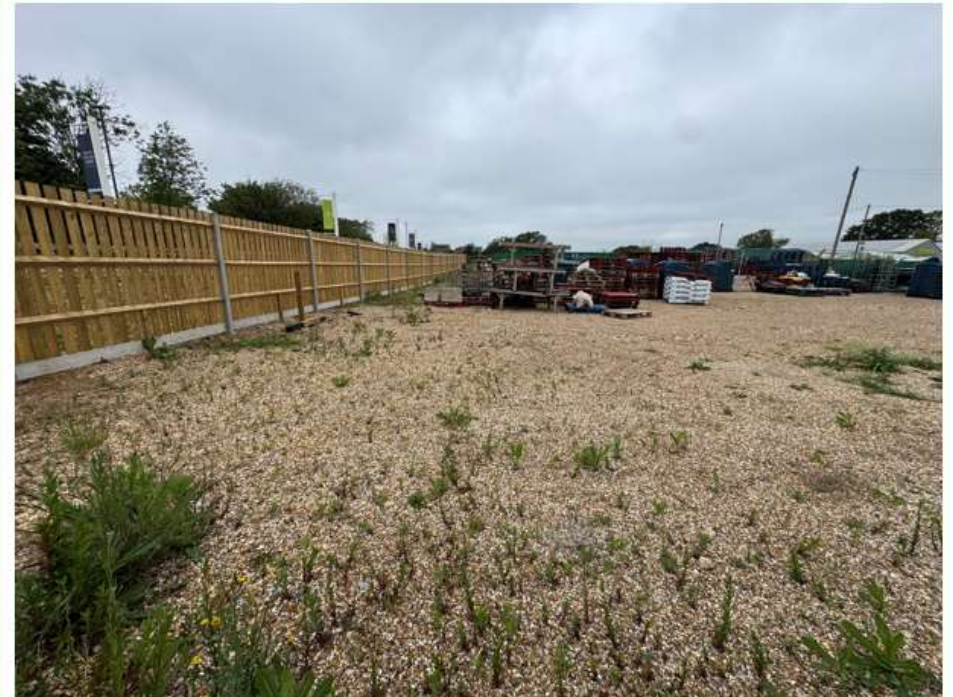
**Photo No.4: Facing northwest from the southeastern corner of site showing further storage areas**

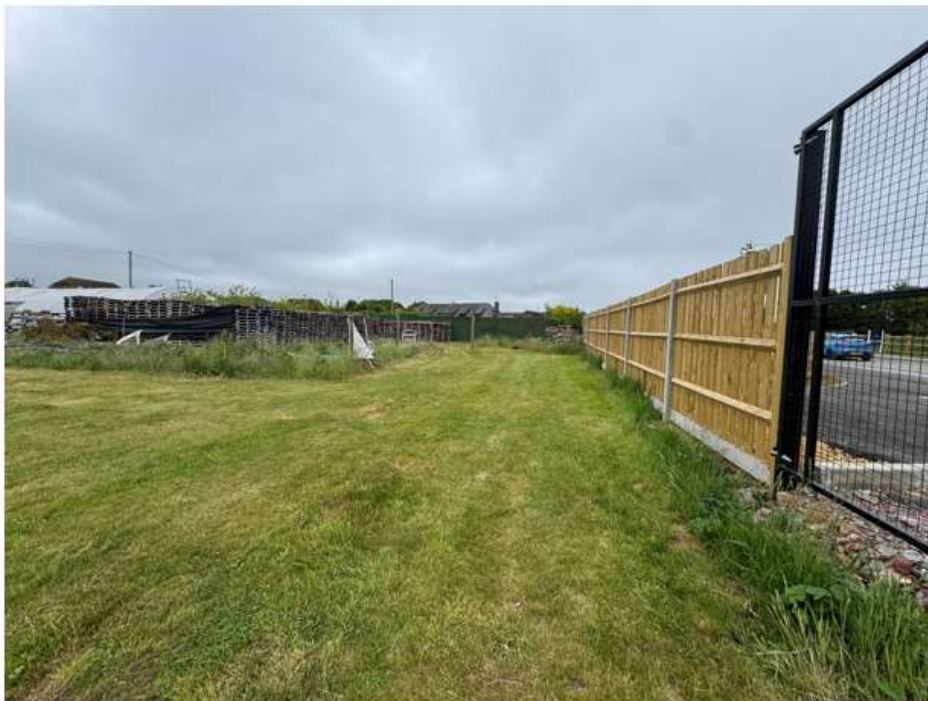
**Photo No.7: New site entrance to the right – facing southeast**

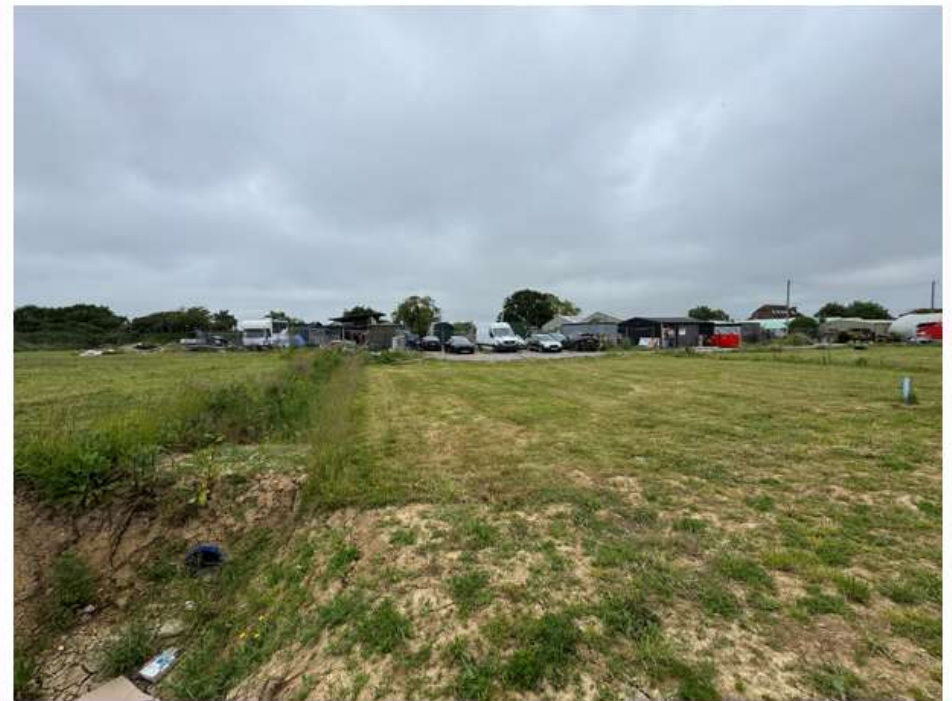
**Photo No.8: Facing north showing the western boundary of site (largely not demarcated beyond ditch)**

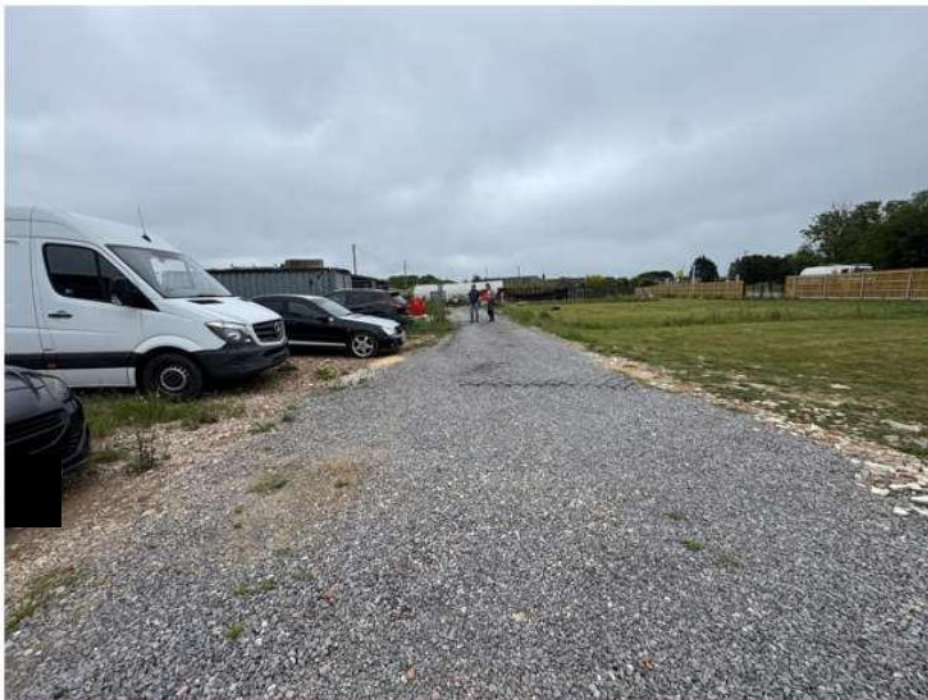
**Photo No.9: Facing east along the current site track in the central area of site with grassed areas south of this (right)**

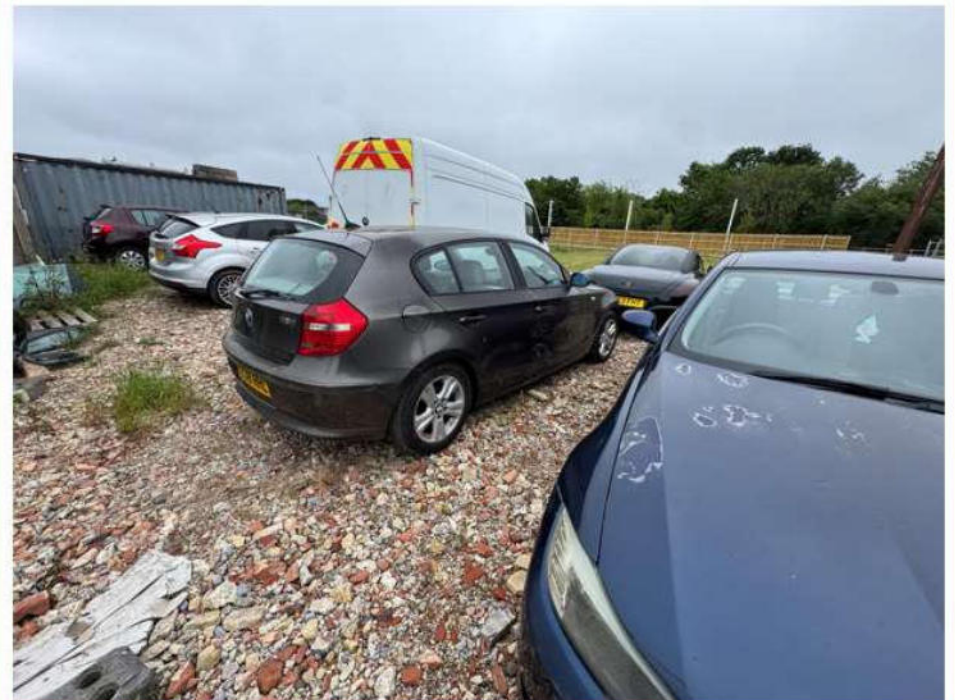
**Photo No.10: Facing southeast showing parking in the NW of site**

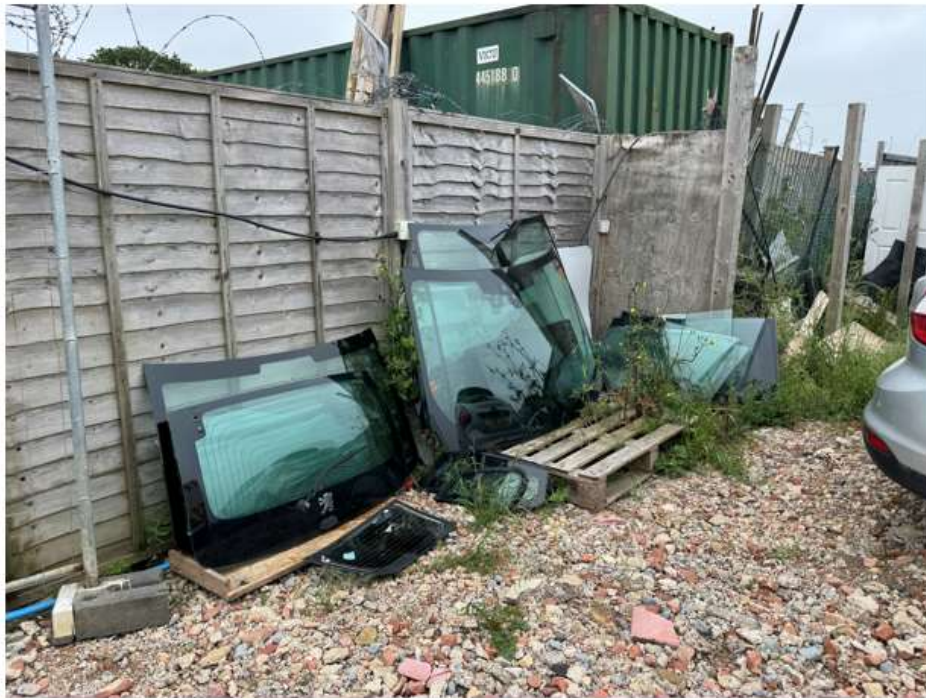
**Photo No.11: Facing northeast showing vehicle glass (no vehicle repair beyond glass replacement & repair here)**

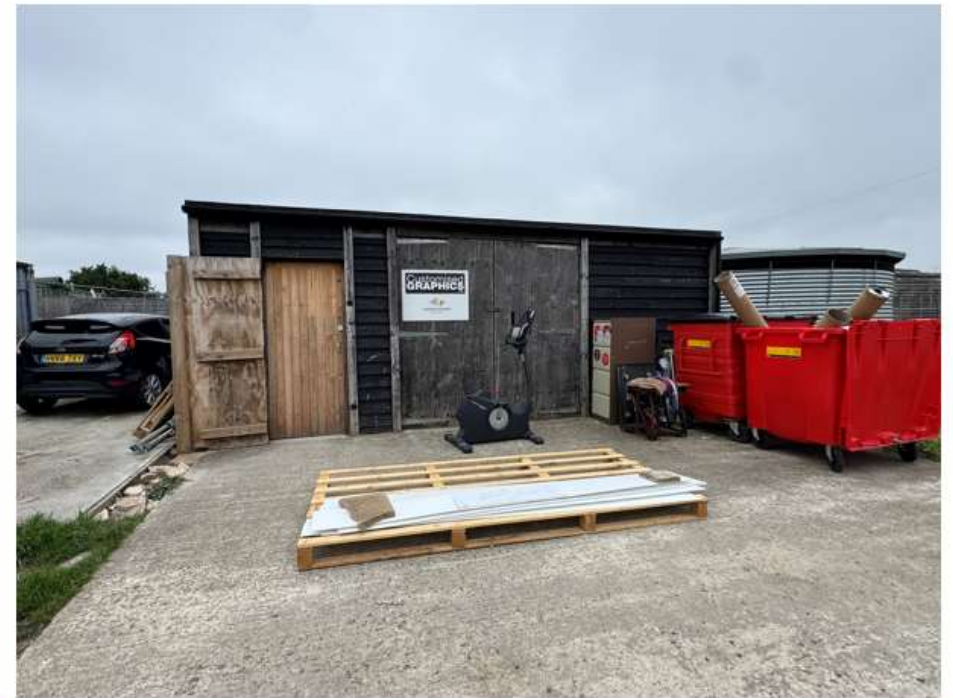
**Photo No.12: Facing north showing vehicle graphics and glass repair and replacement unit in the centre of site**

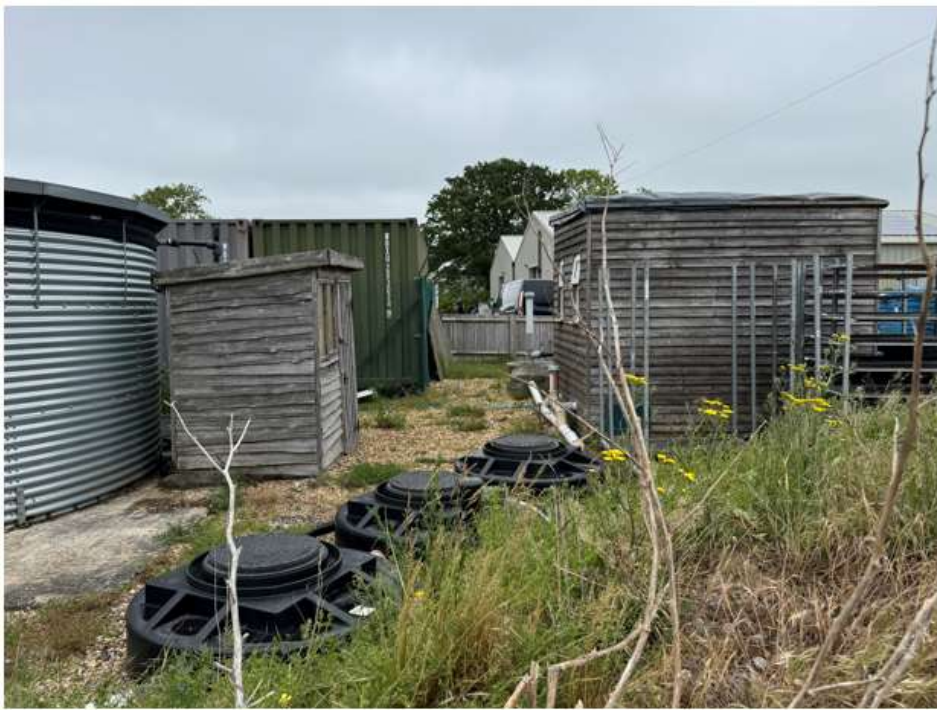
**Photo No.13: Facing north – water tank and sheds (storage)**

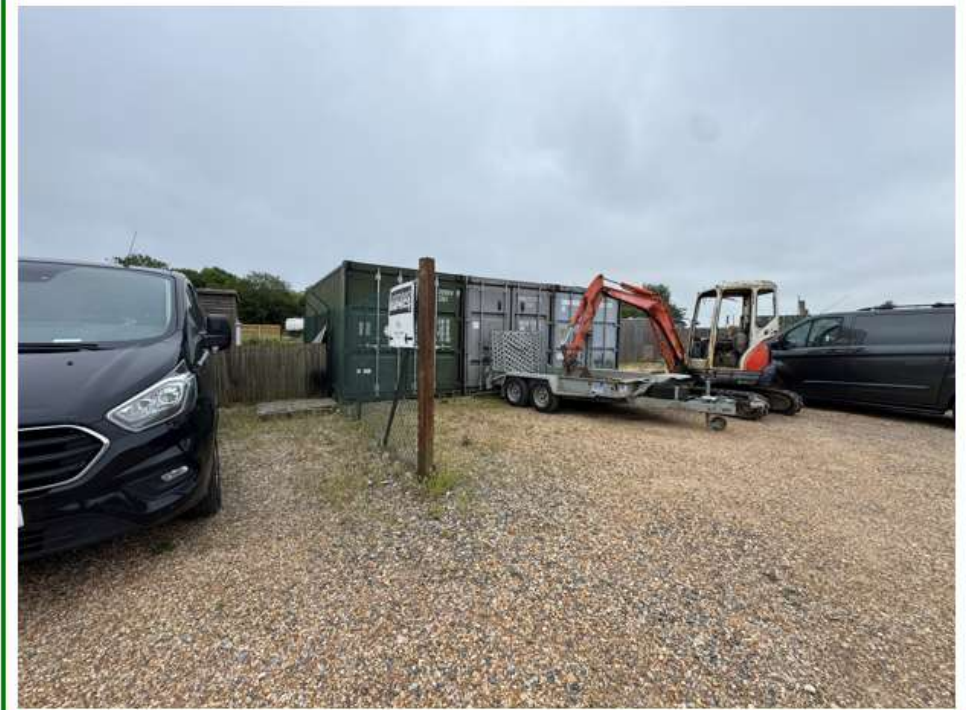
**Photo No.14: Facing south showing the central container, storage and parking areas on site**

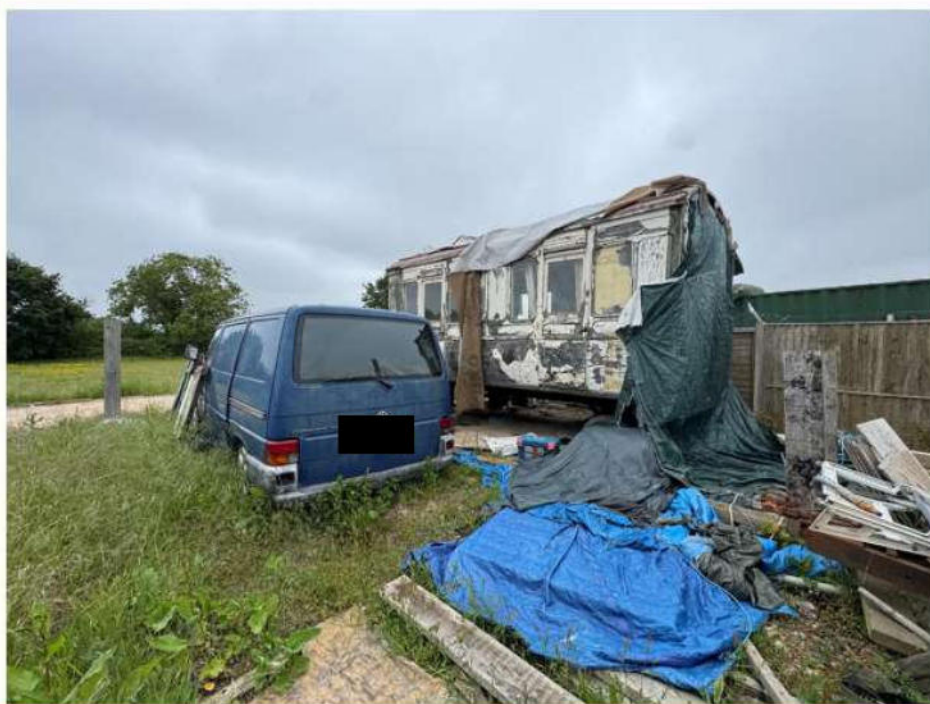
**Photo No.17: Facing northeast showing former train carriage (under renovation)**

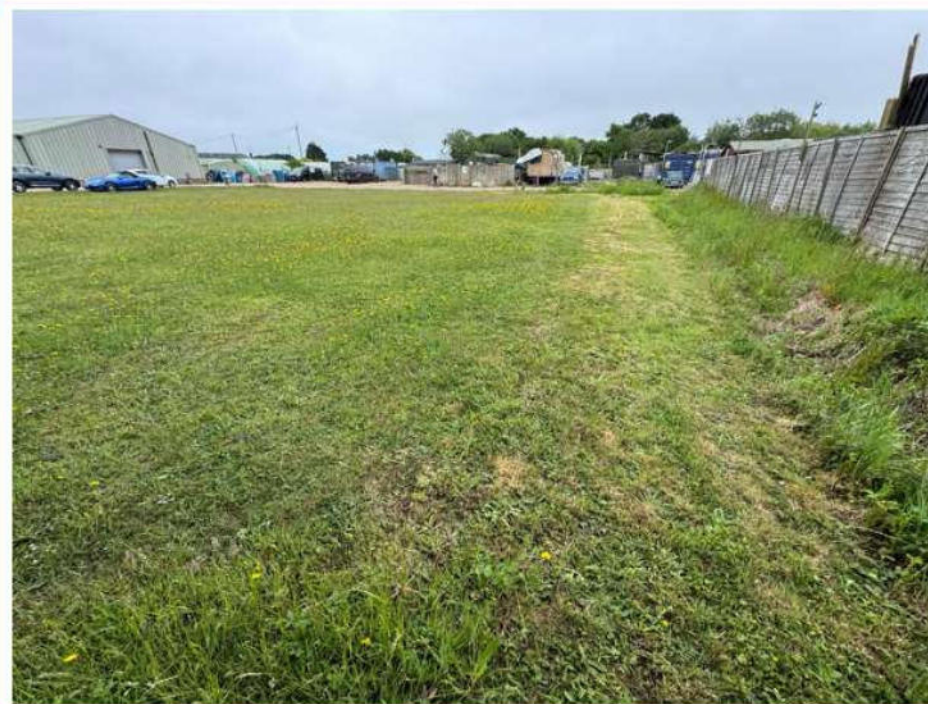
**Photo No.18: Facing slightly southwest showing the western border**

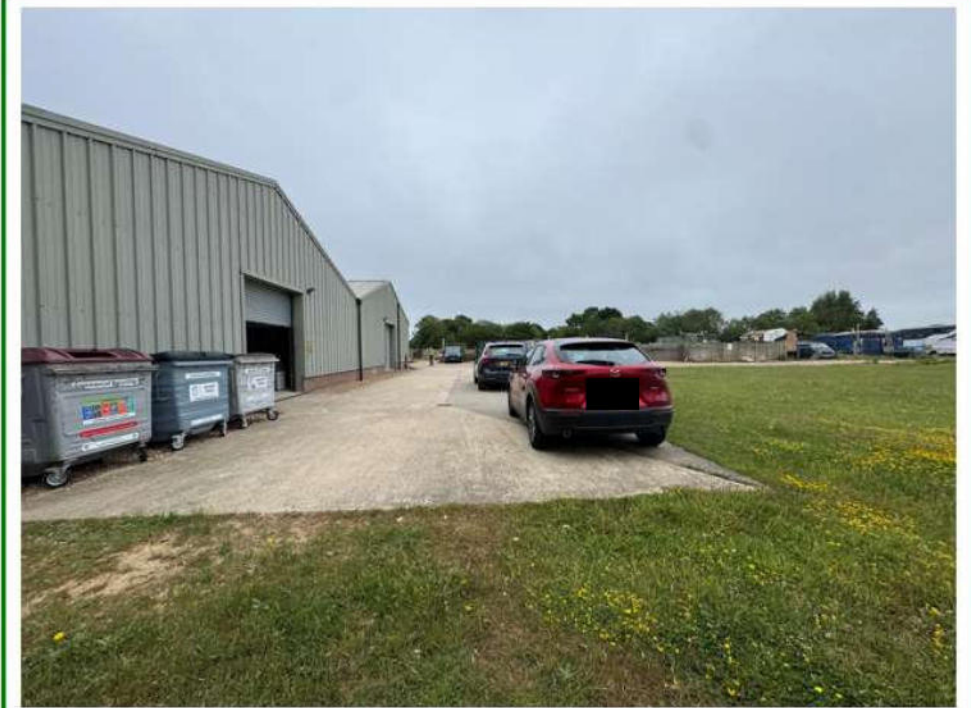
**Photo No.20: Facing south showing the western face of the offsite industrial units located north of centre of site**

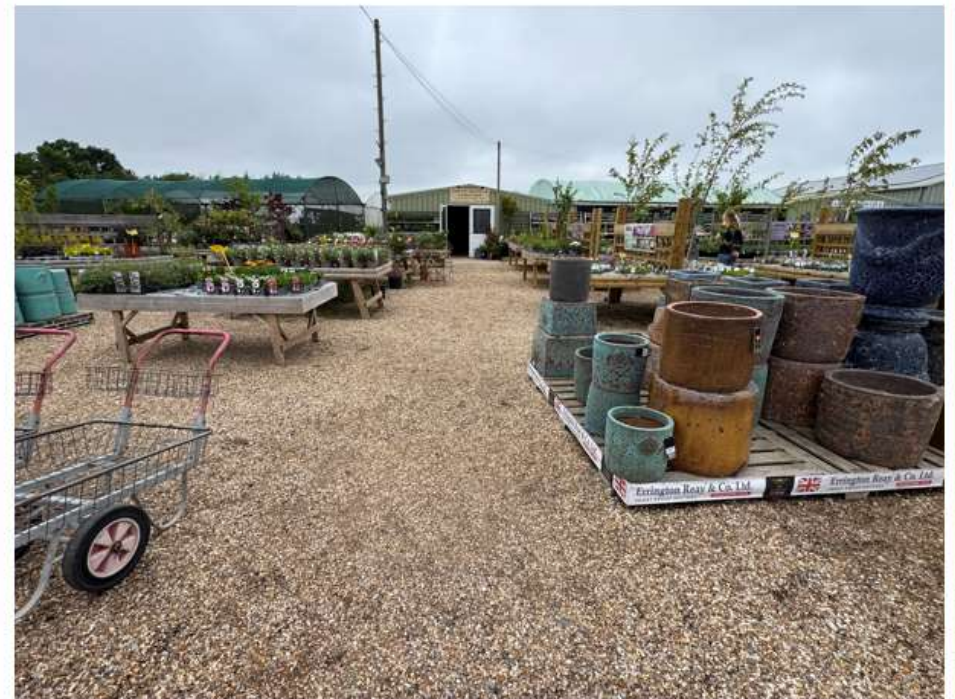
**Photo No.22: Shows the entrance to the garden centre facing west**

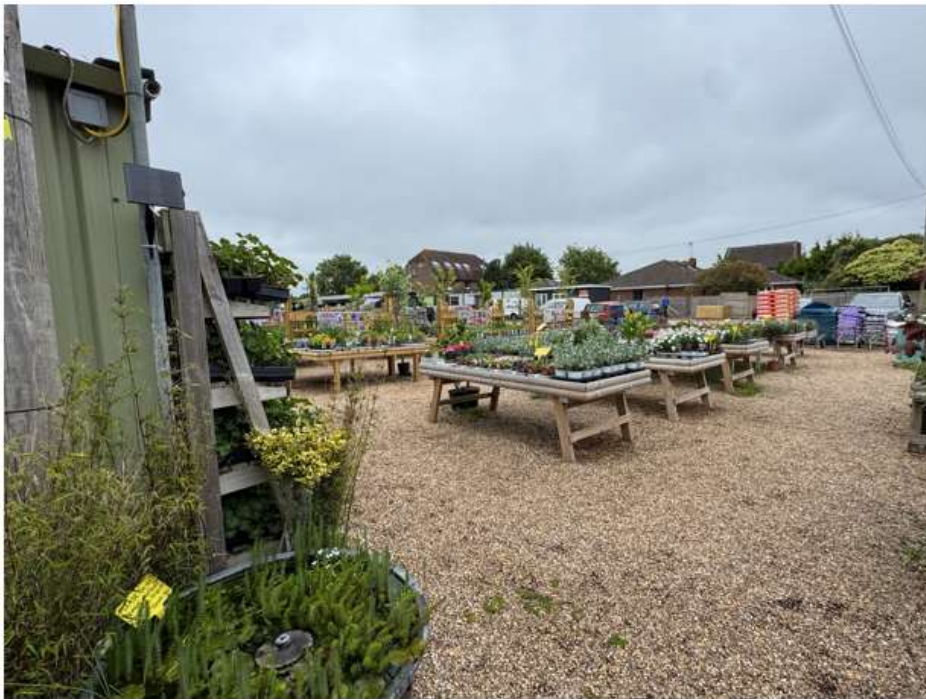
**Photo No.23: Facing northeast showing garden centre stock**

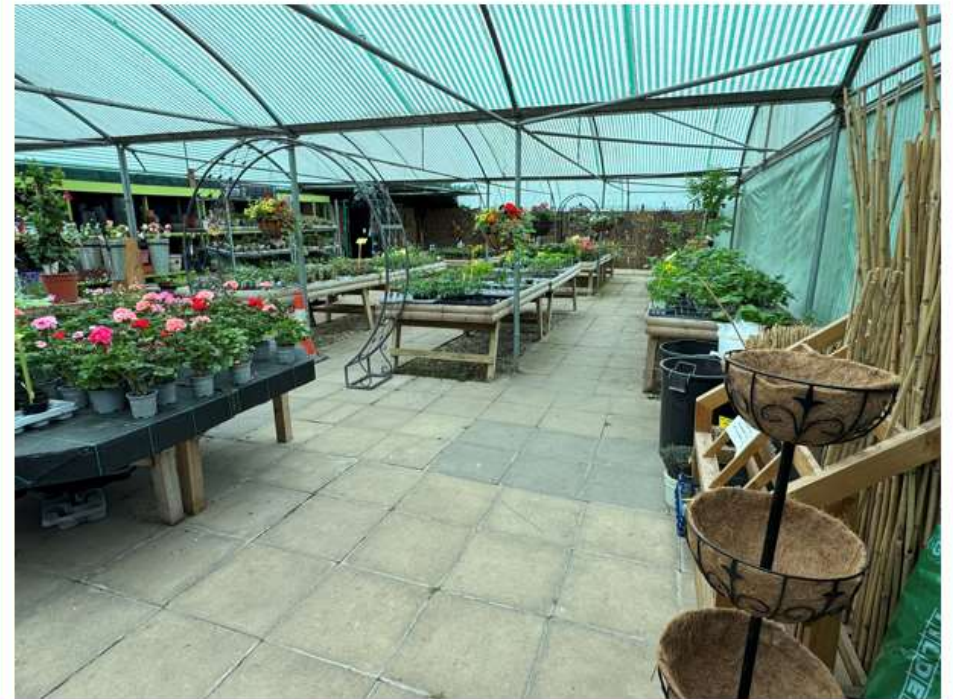
**Photo No.24: Inside the garden centre facing west**
