**WALNUT TREE COTTAGE, SHRIPNEY LANE,  
SHRIPNEY, WEST SUSSEX**

**TREE SURVEY, ARBORICULTURAL IMPACT ASSESSMENT  
AND TREE CONSTRAINTS PLAN**

**May 2019**

**REF: 19.890**

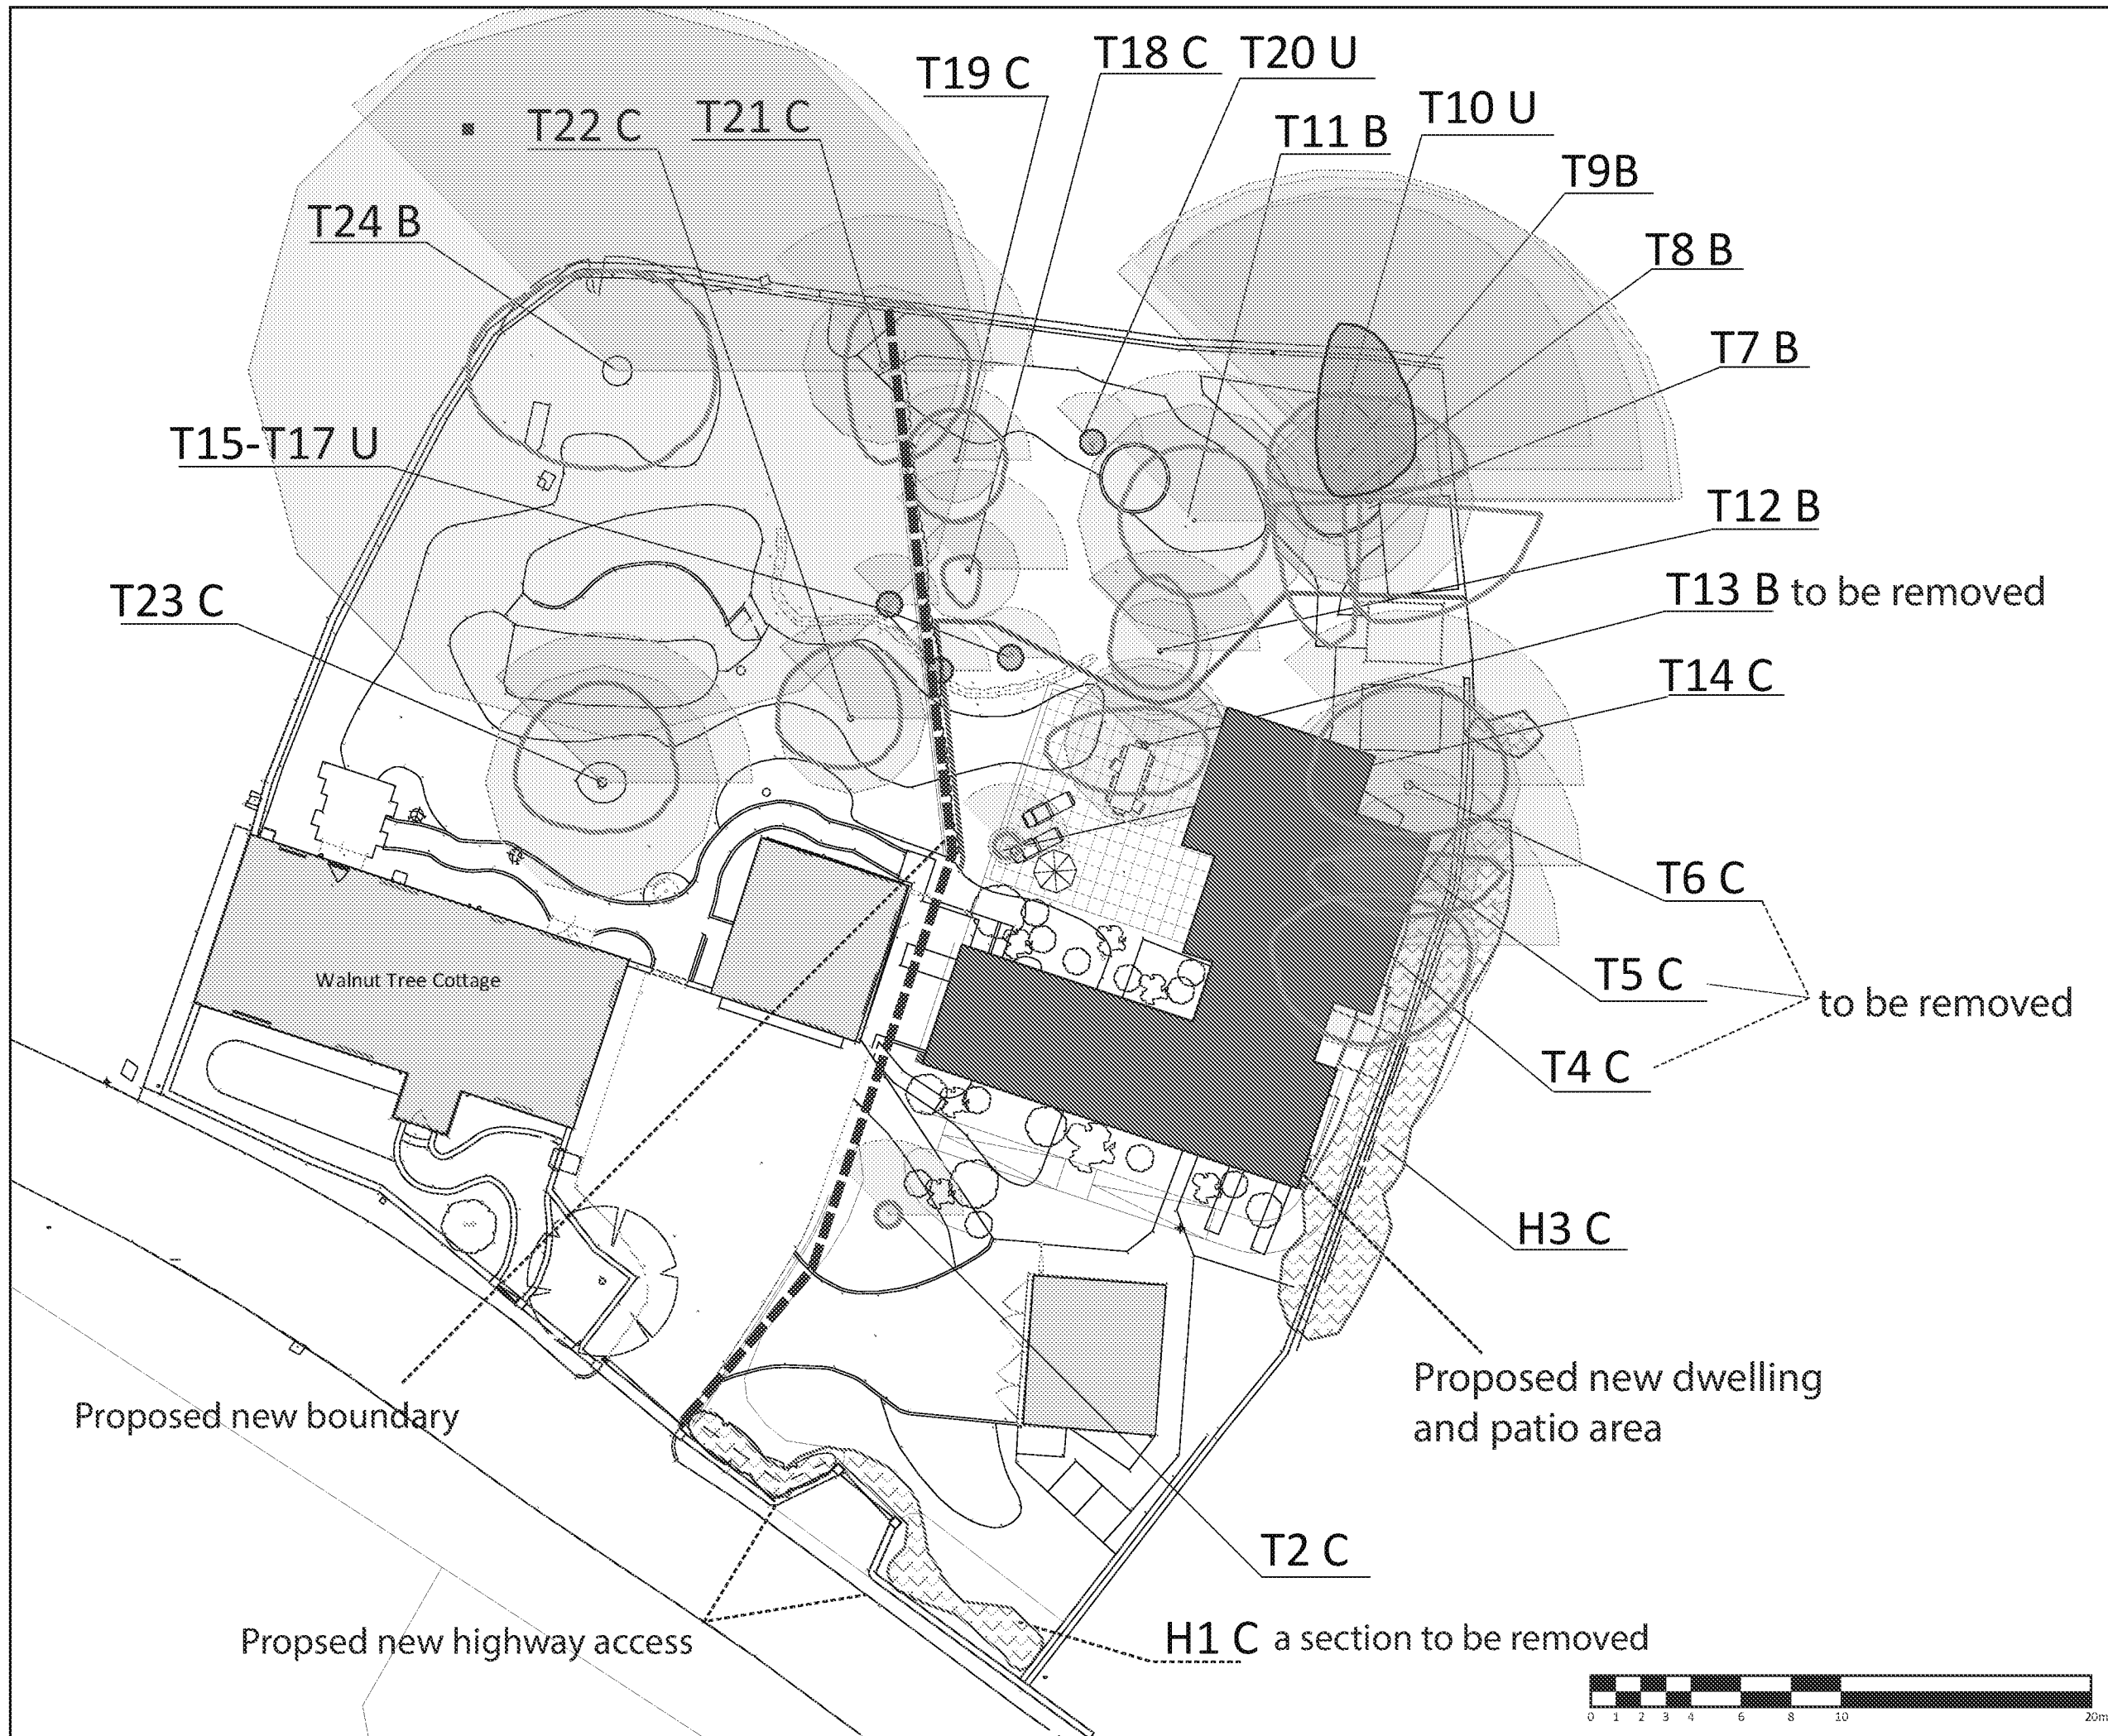
FIGURE 1 - TREE CONSTRAINTS PLAN

**4.3** The birch (T10) in the north-east corner of the site has previously been managed as a pollard. Several young and healthy appearing stems rise to 8m from an aging and heavily decayed main stem that stands at 1.5m and is in very poor structural condition. The extensive re-growth from the stem has a high potential to fail towards the adjacent property to the north and this tree has been categorised as U grade (unsuitable for retention).

**4.4** The majority of the apple trees assessed in the garden area are in declining condition due to age and many have cushion fungus brackets (*Phellinus pomaceus*) colonising their stems, largely visible on deadwood. This fungal pathogen, commonly found on veteran orchard species, causes a heartwood decay that can contribute to structural failure as the declining physiological condition of the aging tree is less able to respond to the advance of decay. Many of these trees have been heavily pruned to approximately 2m removing all their branching crown structure, they are now attempting to re-grow crowns from epicormic growth (growth emerging from dormant buds). In several cases they have been categorised as U grade as they are unlikely to contribute to the amenity of the site beyond ten years. These U grade trees include T15-T17 and T20.

**4.10** The apple tree (T23) which stands to the rear of the existing dwelling is aging but appears to be in good physiological form. It does however have several extended lateral limbs that could be prone to failure particularly if they become heavy with fruit.

**4.11** The large crack willow (T24) on the rear boundary is a heavy limbed over-mature specimen showing several large branch wound cavities on its stem, which is likely to be subject to some significant internal decay. The tree has been managed as a pollard and shows good, healthy, regrowth following being pruned within the last growing season. Following the recent pruning work the structural condition of the tree overall is considered as acceptable even with the element of decay identified within the main stem.

**5.1** The trees assessed that are to be retained are largely in a satisfactory structural and physiological condition and suitable for retention, with the exception of several U grade apple trees (T15-T17 and T20) which are recommended for removal although they do not currently pose a structural risk. They could be retained in the short term if desired.

**5.2** The birch (T10) is also graded as U grade due to the poor structural condition of its stem. It is recommended that the limbs emerging from the stem are removed to remove the risk of their failure into the adjacent property. The decayed stem could be retained as a conservation feature as it will be providing habitat for insect species.

**5.5** It is recommended that the extended lateral limbs of the apple (T23) are reduced by 1-2m in order to lower the risk of complete limb failure that may ruin the form of this tree.

**5.6** Although the structural condition of the crack willow is currently assessed as acceptable, this will diminish as the tree continues to regrow its crown following recent pruning work. It is therefore recommended that the tree is re-pollarded within 4-5 growing seasons in order to maintain acceptable structural condition of its main stem.
