# Phase I Desk Study and Site Reconnaissance

at 47 South Way, Bognor  
Regis, West Sussex, PO21  
5EY

Report Reference: LP2331/DS/1

Report Date: 7<sup>th</sup> October 2020

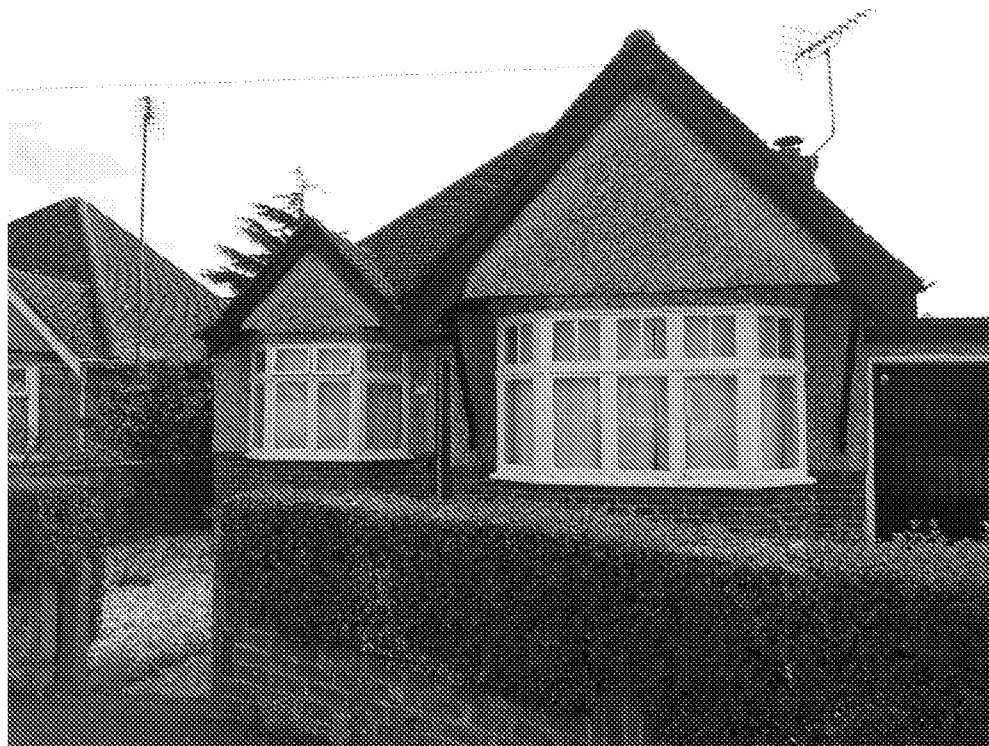
Front of the bungalow (facing east)

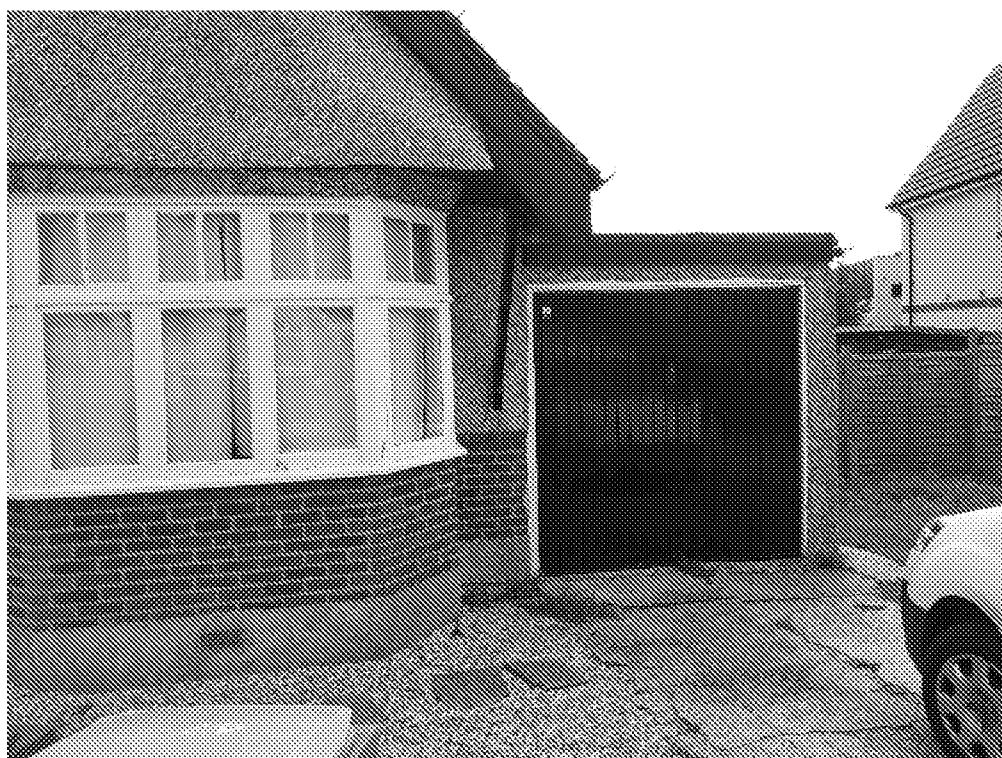
Front of the bungalow, garage and front driveway (facing east-southeast)

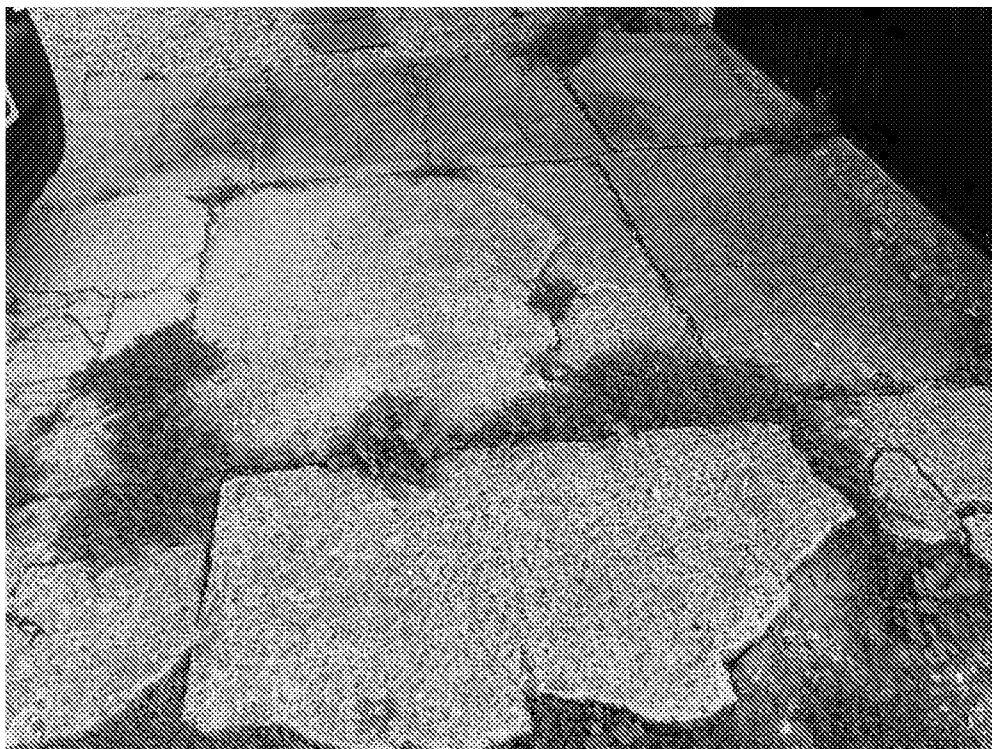
of oil or fuel from vehicles of various owners parked on site over the years. Though the main drive in front of the garage is concrete it was damaged at the time of the site walkover, and may have been for several years, which creates a pathway for hydrocarbons to more easily reach the soils beneath. Leakages from cars parked on the grass on the front drive will also result in a higher likelihood of hydrocarbons contaminating the soils. In both cases the leakages are likely to be small and localised.

Broken slabs on driveway

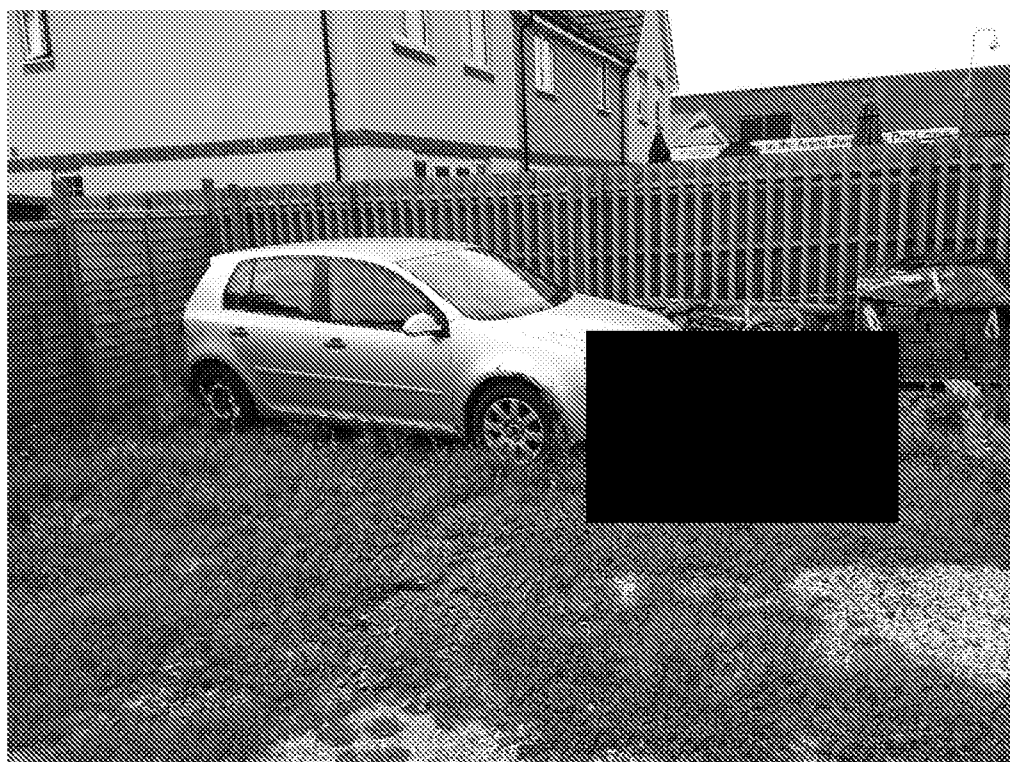
The car currently being stored on site could be a possible source of contamination, however there was no evidence of oil or fuel leaks or spillages. There were no other observed features on site that were considered to be possible sources of contamination.

Car and bricks stored on grass portion of the front garden (facing south)

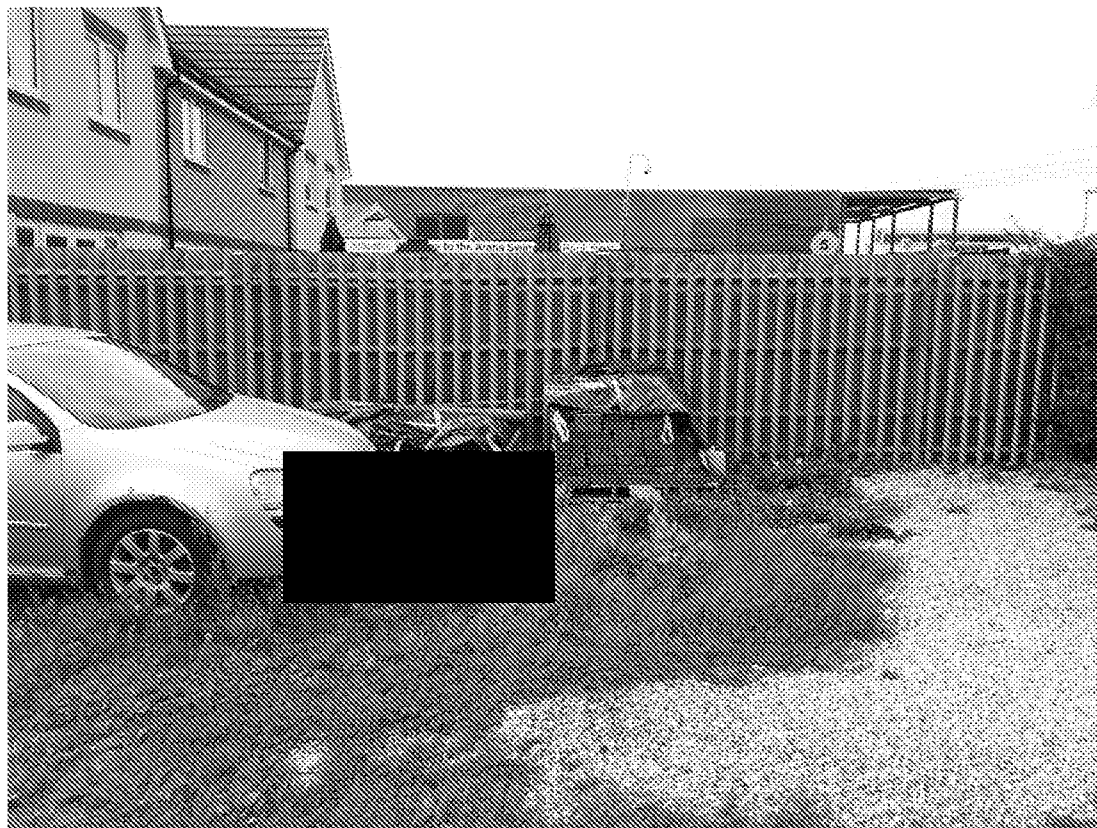
Grass portion of the front garden (facing southwest)

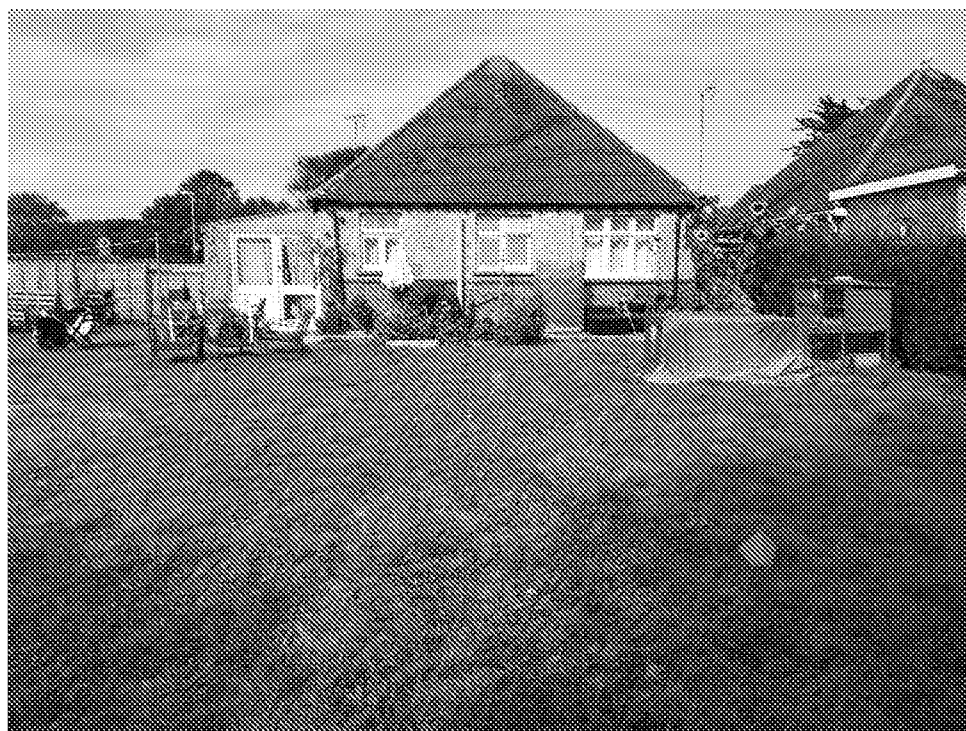
Back of house and back garden (facing west-northwest)
