## CCTV Inspection Report

**UNIT 2  
Saltbox  
Shripney Way  
Bognor Regis  
PO22 9NW**

**03/06/2021**

**Job Number: 432**

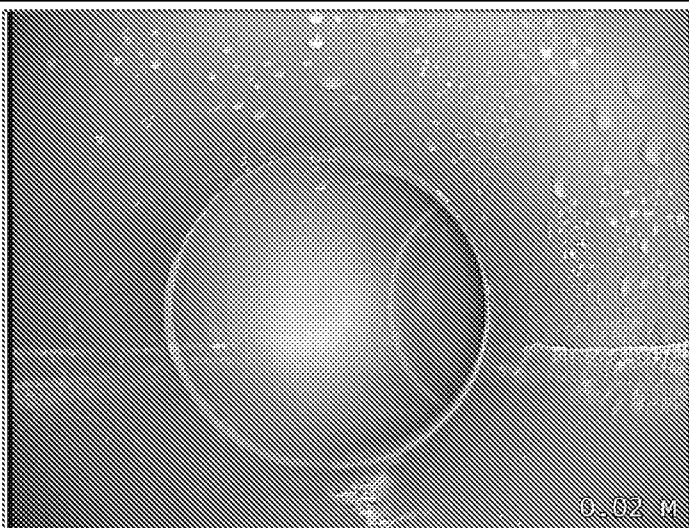
Start of Survey Length, Start node type, inspection chamber, reference  
FW-200, Water level 0% height/diameter

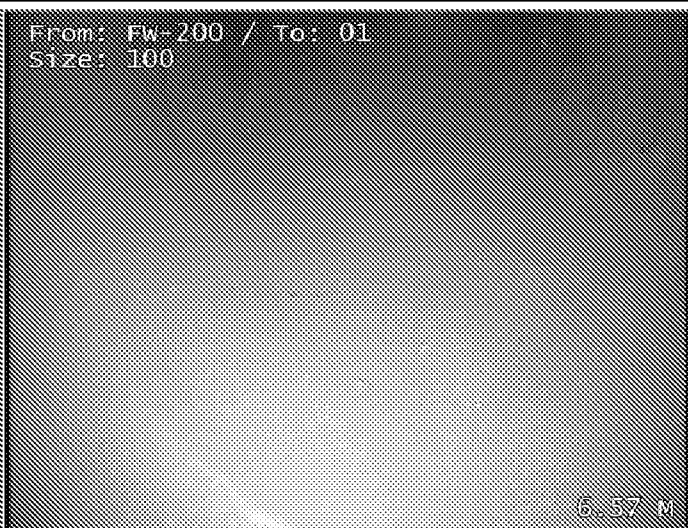
Finish survey length

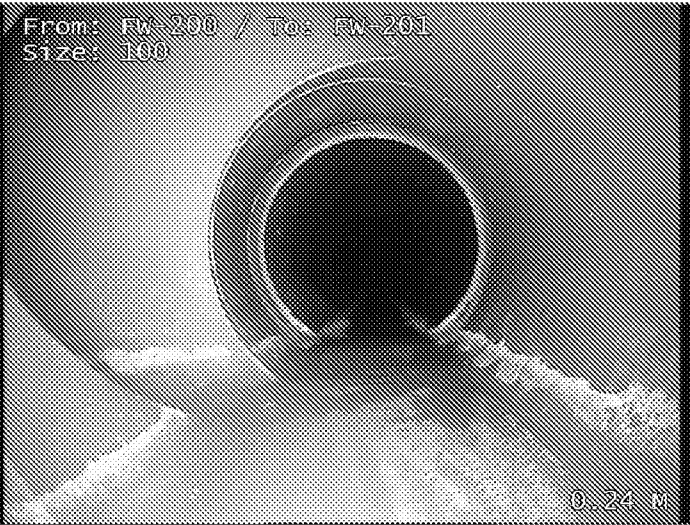
| Job Number<br>432 | Surveyed by (Operator)<br>Luke Clayton | Base Unit<br>8J5R2AEYKL | Date<br>03/06/2021 |
|---|---|---|---|
| <p>0.00 M</p> <p>Start of Survey Length, Start node type, inspection chamber, reference FW-200, Water level 0% height/diameter</p> | | <p>From: FW-200 / To: FW-201<br/>Size: 100</p> <p>0.24 M</p> <p>Junction at 11 o'clock, diameter 100mm - Remark: FW-200/01</p> | |

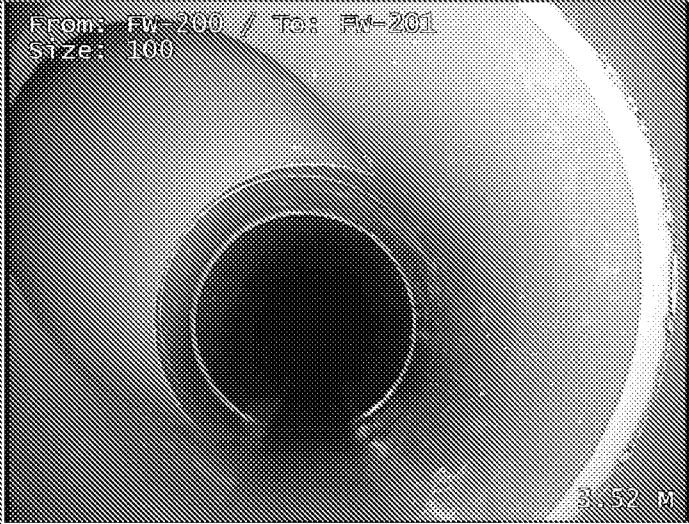
| Job Number<br>432 | Surveyed by (Operator)<br>Luke Clayton | Base Unit<br>8J5R2AEYKL | Date<br>03/06/2021 |
|---|---|---|---|
| <p>From: FW-200 / To: FW-201<br/>Size: 100</p> <p>3.52 M</p> <p>Junction at 11 o'clock, diameter 100mm - Remark: FW-200/02</p> | | <p>From: FW-200 / To: FW-201<br/>Size: 100</p> <p>16.38 M</p> <p>Junction at 11 o'clock, diameter 100mm - Remark: UNKNOWN</p> | |

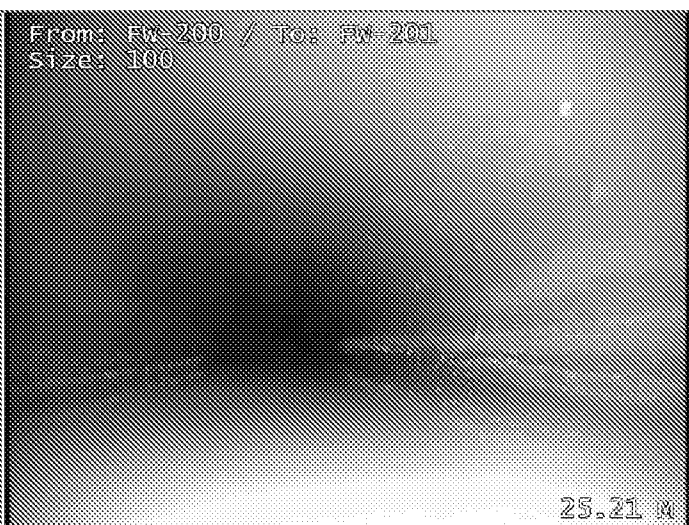
| Job Number<br>432 | Surveyed by (Operator)<br>Luke Clayton | Base Unit<br>8J5R2AEYKL | Date<br>03/06/2021 |
|---|---|---|---|
| <p>From: FW-200 / To: FW-201<br/>Size: 100</p> <p>25.21 M</p> <p>Water level 10% height/diameter</p> | | <p>From: FW-200 / To: FW-201<br/>Size: 100</p> <p>27.79 M</p> <p>Line of sewer deviates down</p> | |

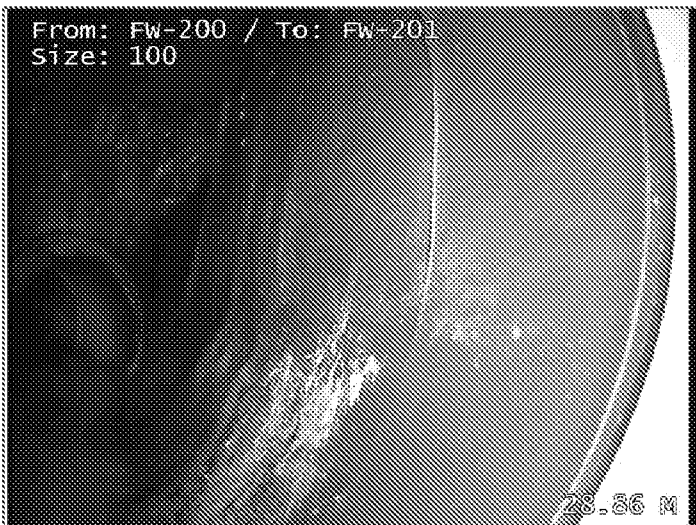
From: Fw-200 / To: Fw-201  
Size: 100

Finish survey length

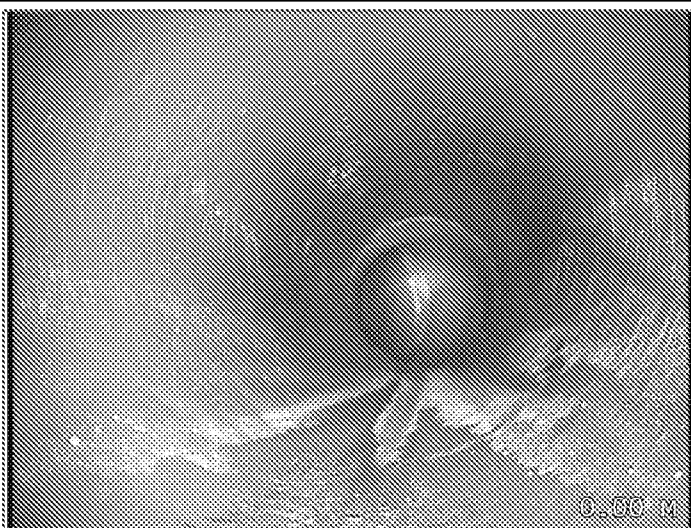
Start of Survey Length, Start node type, manhole, reference FW-205,  
Water level 0% height/diameter
