## Windmill Views, Yapton SuDS Installation Report

Prepared for Redrow Homes Southern Counties  
By Technical & Development Services  
(Southern) Ltd

| Document Ref | SuDS Report-01 |

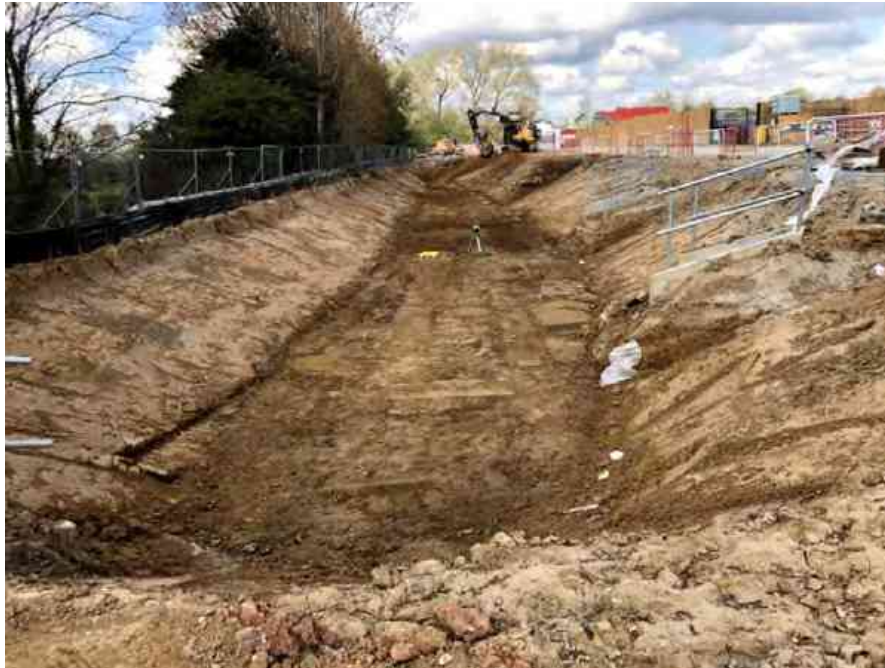
Photo 1 - Excavation of pond looking from east to west

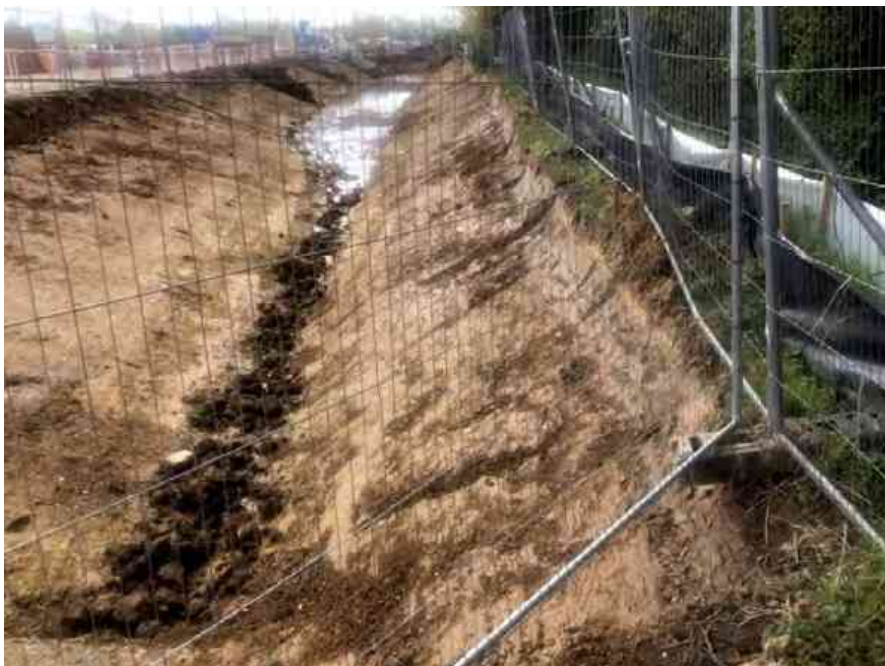
Appendix 2 Photos 1 & 2 show the excavation of the pond box, note Photo 2 the southern bank profile is too steep, this was later regraded with the clay liner.

Photo 2 - Excavation of pond looking from west to east, note slope of southern bank too steep, corrected later with clay liner

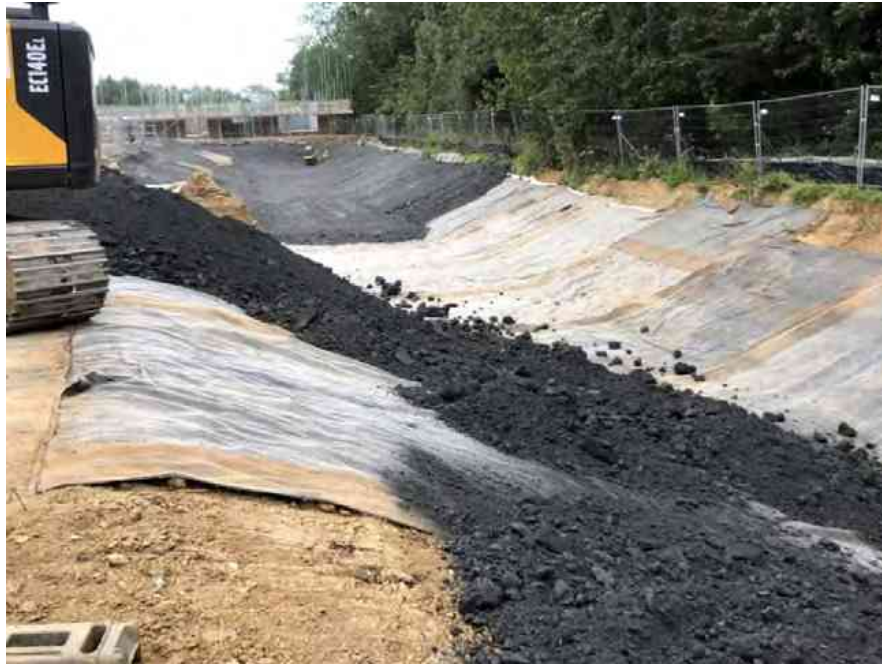
Photo 3 - Installation of bentonite liner and placement of blue clay pond liner

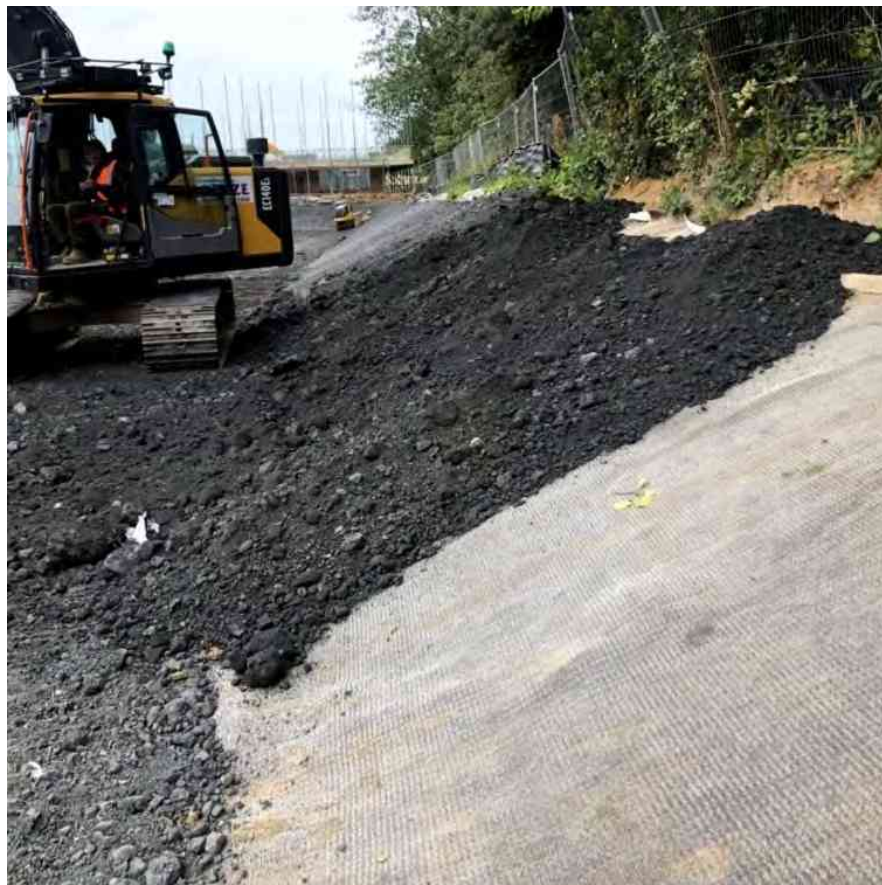
Photo 4 - Shaping southern bank to achieve 1 in 3 slope

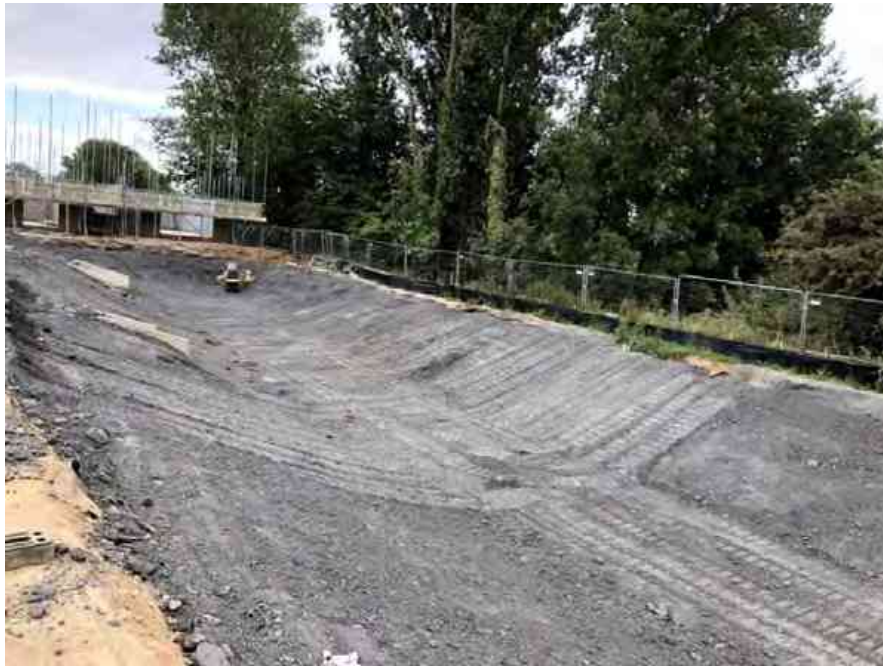
Photo 5 - Compaction of blue clay liner

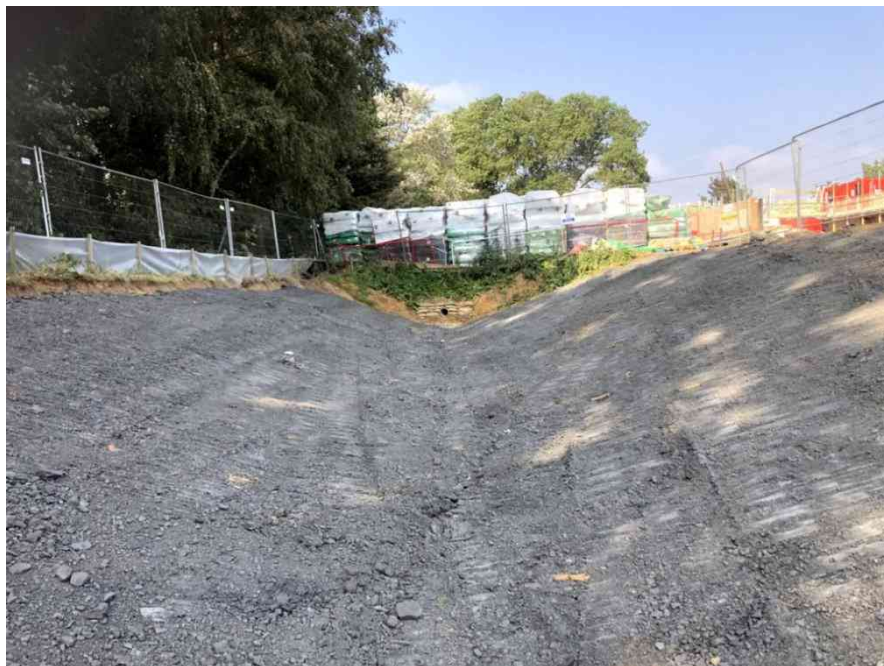
Photo 6 - Blue clay liner looking west towards inlet pipe

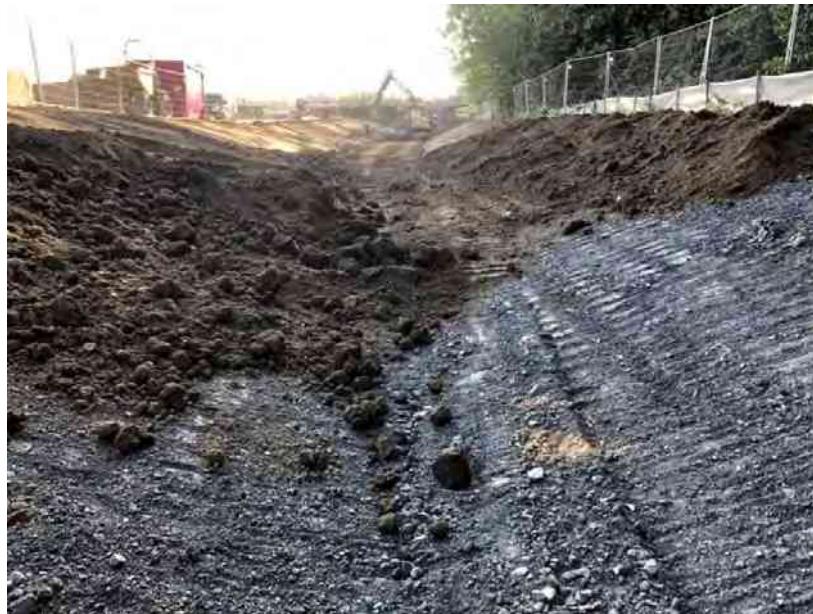
Photo 7 - Placing 150mm topsoil layer over clay

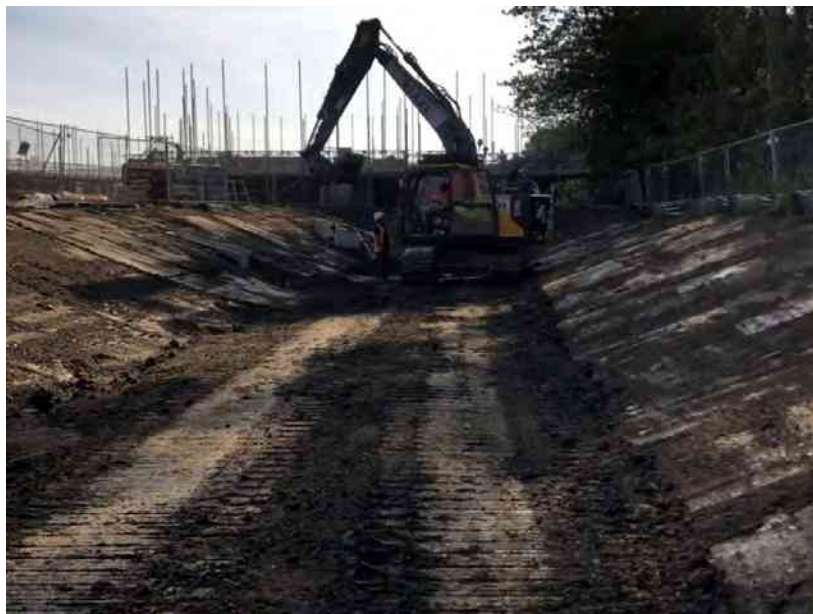
Photo 8 - Top soil layer looking east, trimmed and compacted

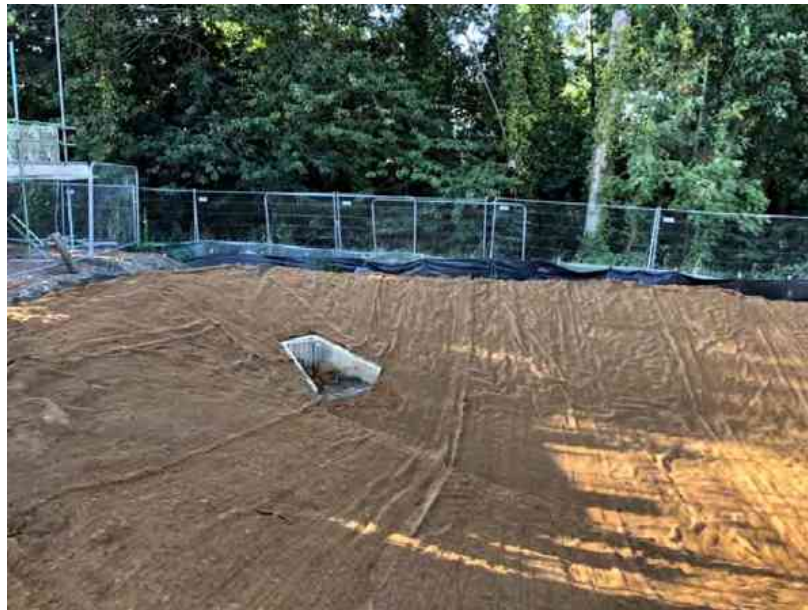
Photo 9 - Installation of bio-degradable erosion mat, east end looking at outfall

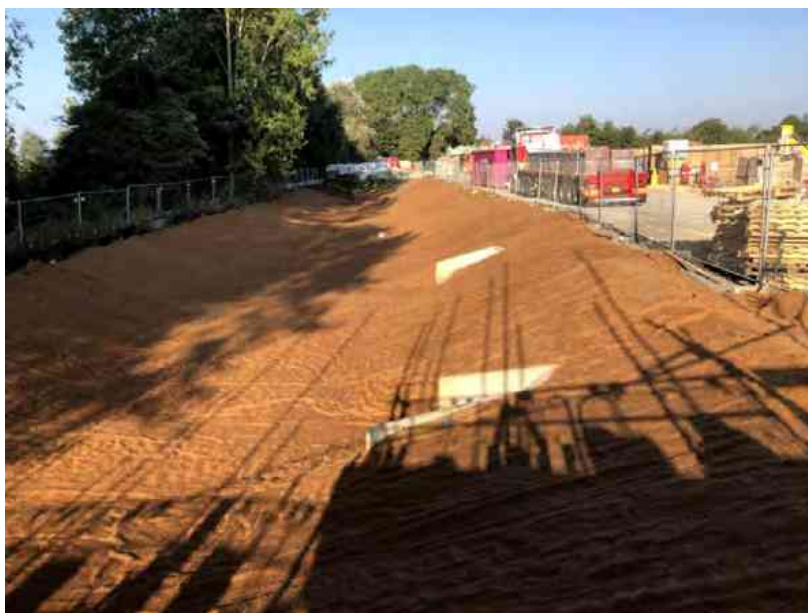
Photo 10 - Finished bio-degradable erosion mat looking west

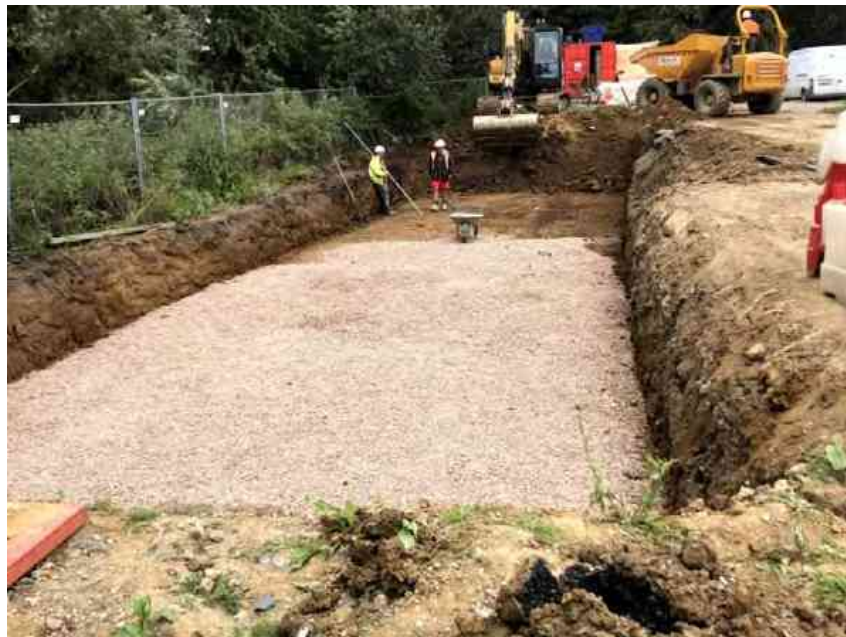
Photo 11 - Excavation for attenuation tank, note level control, and fines free shingle backfill

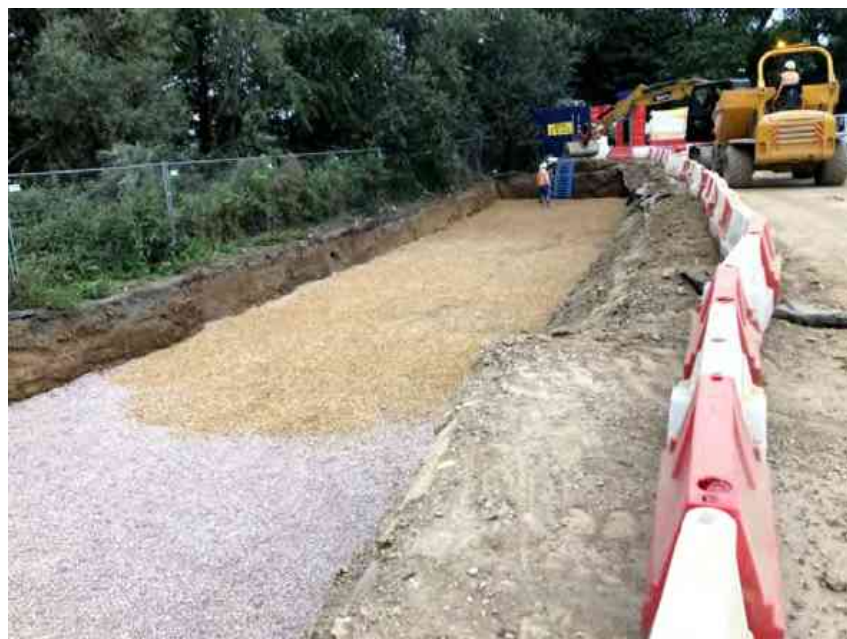
Photo 12 - Shingle base complete

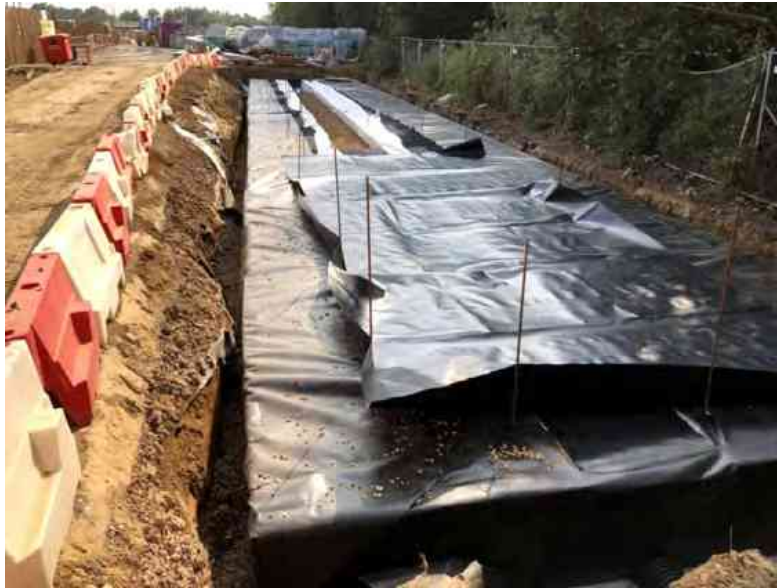
Box 13 - Shows central perforated pipe wrapped in geotextile back filled with fines free shingle crates both sides looking east

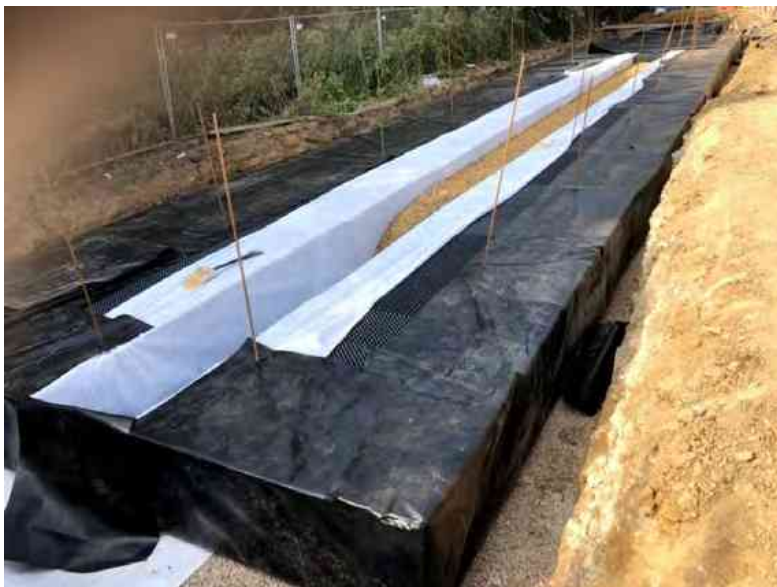
Box 14 - Shows central perforated pipe wrapped in geotextile back filled with fines free shingle crates both sides looking west

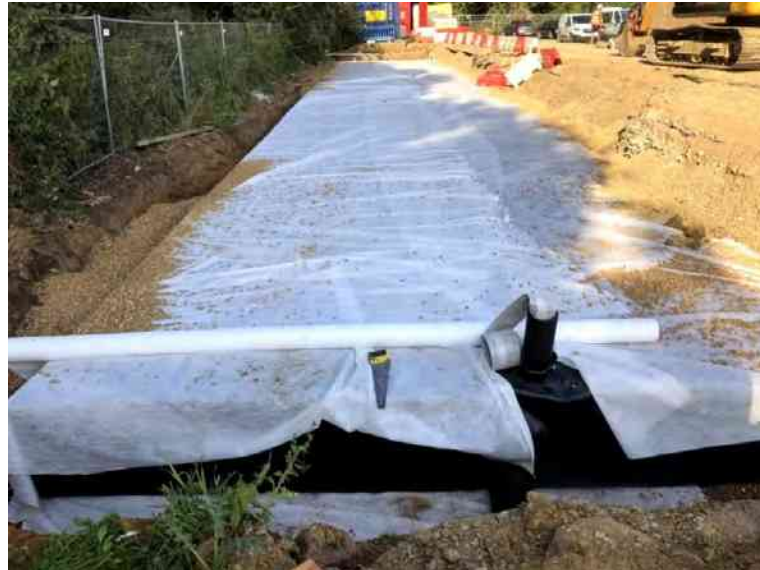
Photo 15 - Drainage crates wrapped in geo-membrane (seen here black), welded joints and wrapped in a geotextile (seen here white)

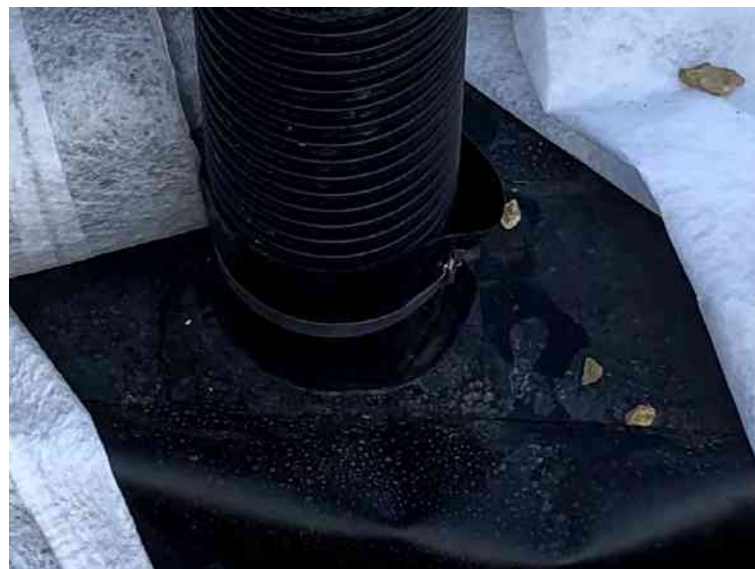
Photo 16 - Shows welded geo-membrane around air vent

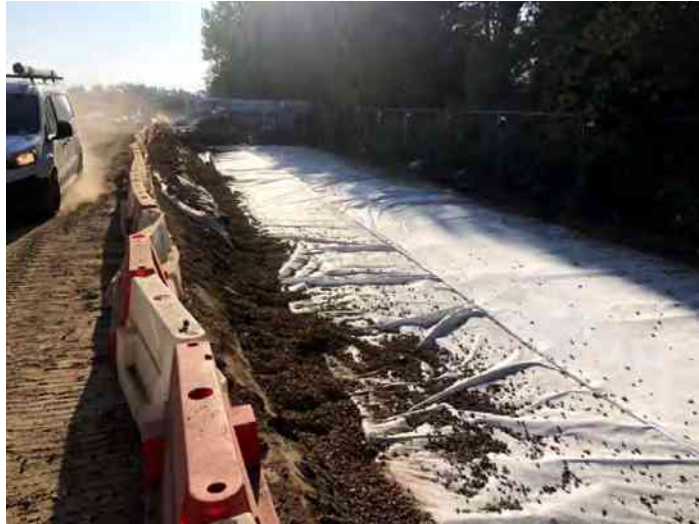
Photo 17 - Backfill of attenuation tank looking east

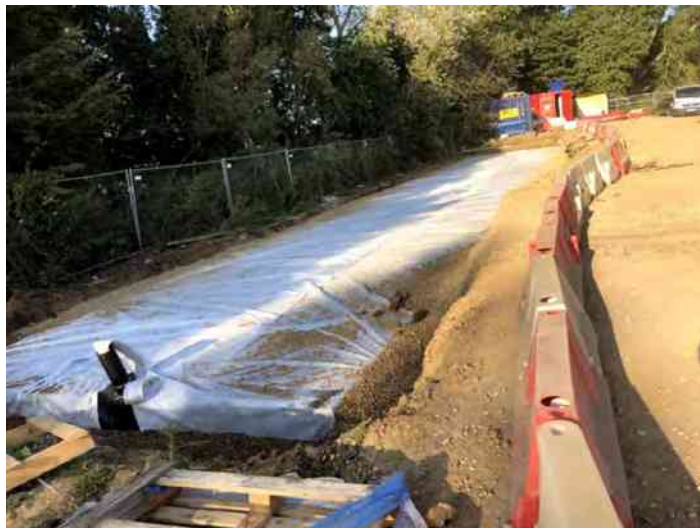
Photo 18- Backfill of attenuation tank looking west
