DOMUSEA DEVELOPMENTS  
PROPOSED RESIDENTIAL DEVELOPMENT  
THE BOWERIES, BARNHAM ROAD,  
EASTERGATE

REPEAT STAGE 1 - ROAD SAFETY  
AUDIT

APRIL 2021

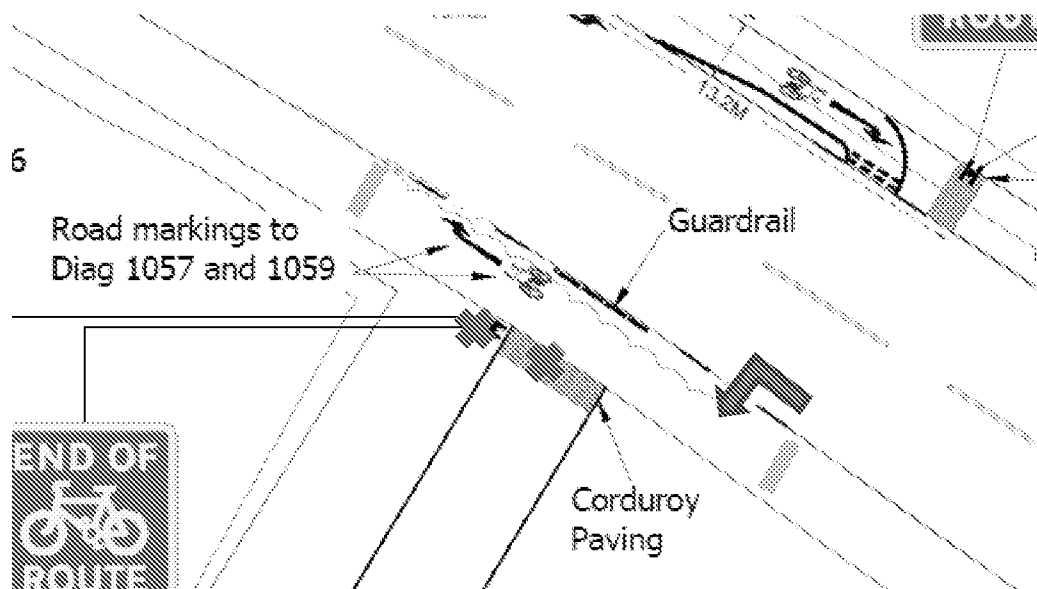
**Location:** Barnham Road, south side, adjacent to proposed shared use pedestrian/cycle facility.

**Summary:** Cycle route continuity unclear.

Whilst a dropped kerb has been provided for westbound cyclists on Barnham Road to leave the carriageway and join the shared use pedestrian/cycle facility on the northern side of the development site, no cycle markings have been provided to ensure that westbound cyclists are able to identify this facility.

Furthermore, whilst 'end of route' signing is provided at the northern end of the shared use pedestrian/cycle facility, it is considered that in practice, cyclists will not stop and dismount at this point, but continue across the footway and join the carriageway. Similarly, westbound cyclists are highly unlikely to dismount immediately when they leave the carriageway and enter the footway. It will be important that pedestrians travelling east-west on the southern footway are aware that they might be sharing the facility with faster moving cyclists.

It is recommended that:

- i. A short section of the footway on the southern side of Barnham Road, adjacent to the north-south shared use pedestrian/cycle facility, should be designated a shared use facility.

- ii. Cycle logos and direction arrows are provided adjacent to the dropped kerb to the east of the 'greenway'.
- iii. Corduroy paving should be provided to the west of the western dropped kerb provided for cycles to rejoin the carriageway, and to the east of the eastern dropped kerb provided for westbound cyclists to leave the carriageway, to ensure vision impaired pedestrians are aware when they step onto/into the cycle facility.
- iv. Appropriate cycle signing should be provided.
- v. Remove the corduroy paving and signing at the northern end of the proposed shared use pedestrian/cycle facility.

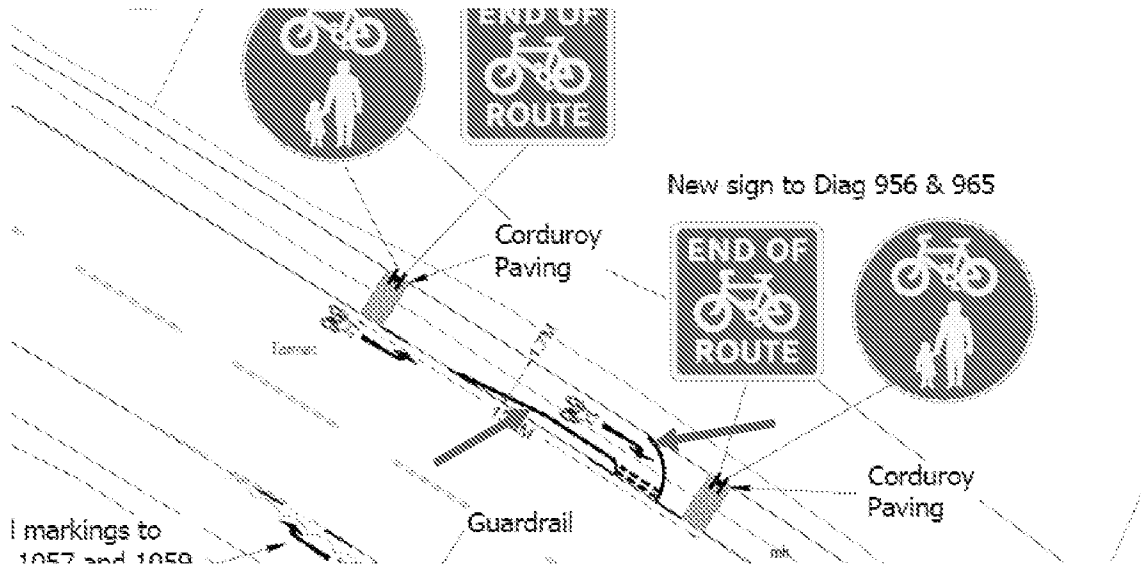
**Location:** Barnham Road, north side, adjacent to proposed shared use pedestrian/cycle facility (please refer to reference point 3.3 in **Appendix B**).

**Summary:** Excessive road markings may result in unclear priority for road users.

A short 13m shared use facility has been provided on the northern side of Barnham Road to enable eastbound cyclists to leave the carriageway and stop to wait for a break in the general traffic flow before crossing Barnham Road to join the 'greenway' adjacent to the development site.

However, there is concern that the cycle delineation markings, may indicate to cyclists that this section is for pedal cycles only. This could result in cyclists entering this section, potentially at speed, resulting in conflict and/or pedestrian/cycle collisions.

It is recommended that the cycle symbol and direction arrow are retained, but the delineation markings are removed.

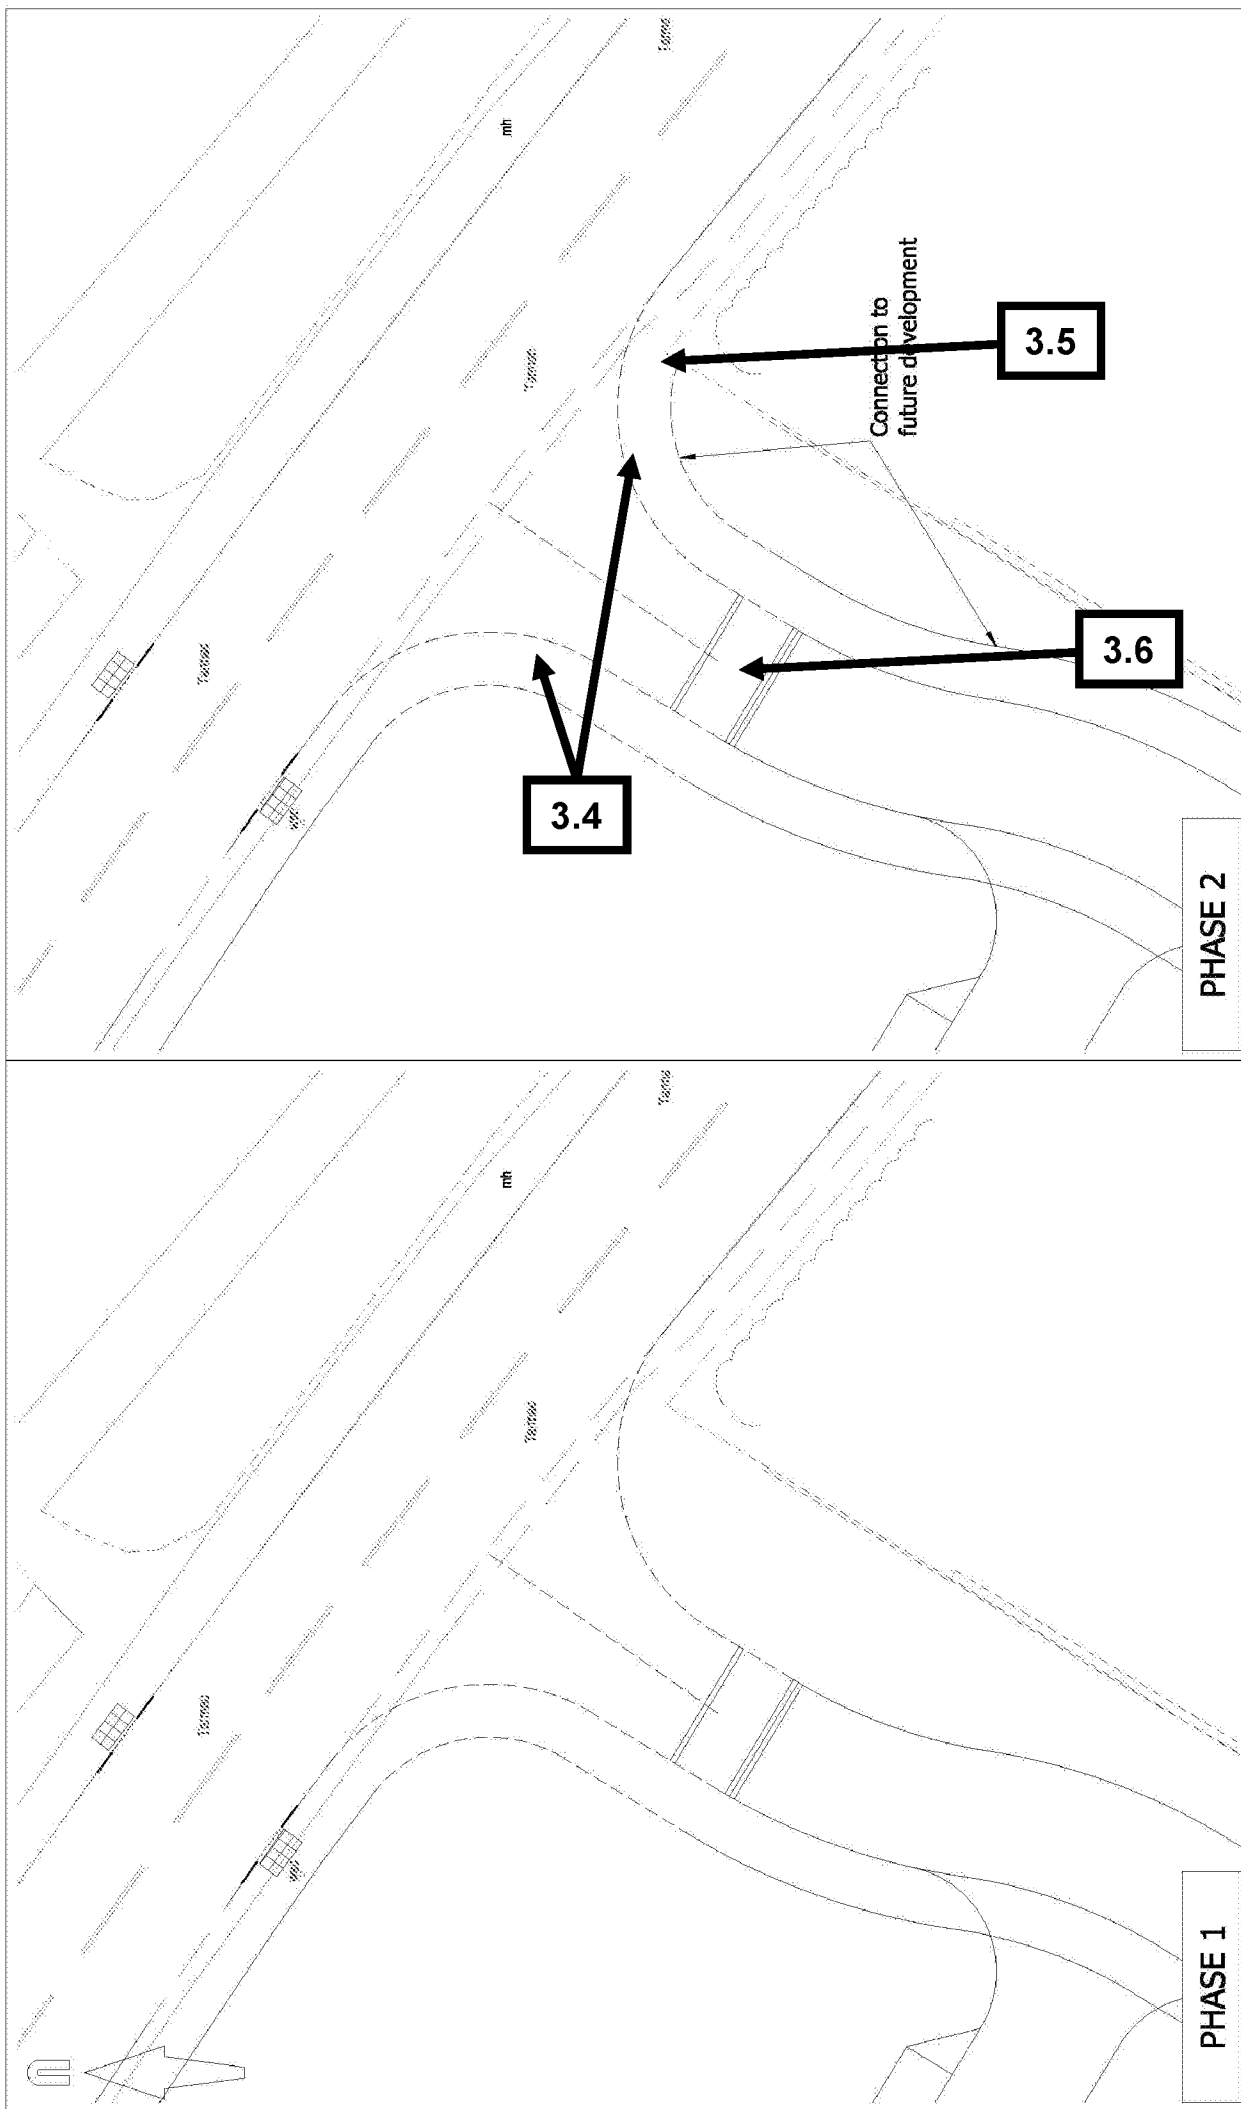
drawing number **MBSK210326/02** rev. **-**

**Location:** Site access (please refer to reference point 3.1 in **Appendix B**).

**Summary:** Pedestrian/cycle inter-visibility splays.

It will be important to ensure that appropriate inter-visibility splays are provided to reduce the risk of pedestrians and/or cyclists emerging from the shared pedestrian/cycle facility into the path of pedestrians travelling east-west on the southern footway.

**Location:** Site access, 'Phase 2' only (please refer to reference points 3.4 in **Appendix B**).

**Summary:** No pedestrian crossing point on desire line.

It will be important to provide dropped kerbs and tactile paving on all pedestrian desire lines to ensure continuity of the pedestrian route. Failure to do so may result in pedestrians, especially the vision and mobility impaired, tripping on kerbs, or unable to cross the carriageway.

**Location:** Site access, 'Phase 2' only (please refer to reference point 3.5 in **Appendix B**).

**Summary:** Pedestrian route continuity and pedestrian facilities.

A footway has been provided on the eastern side of the site access, however there is no footway currently on the southern side of Barnham Road near the development site. An existing footway is provided on the southern side of the Barnham Road circa 250m from

the site access. This could lead to pedestrians walking in the carriageway, with subsequent risk of being struck by a moving vehicle.

**Location:** Site access (please refer to reference point 3.6 in **Appendix B**).

**Summary:** Transition ramps/ramp warning triangles.

There appears to be a raised table provided on the site access road. If this is a raised table, then it will be important that approaching drivers/riders are able to identify the transition ramps on approach so that they can adjust their speed/riding position as appropriate to reduce the risk of losing control.

It will also be important to ensure that the gradient of the transition ramps is appropriate for anticipated vehicle speeds. Ramps that are too short/steep may increase the risk of vehicles/powered two wheelers losing control and/or damaging the vehicles.

It is recommended that appropriate inter-visibility splays are provided at the northern end of the shared pedestrian/cycle facility.

It is recommended that dropped kerbs and tactile paving are provided in accordance with relevant design standards on the pedestrian desire line.

It is recommended that either:

- i. A footway is provided on the southern side of Barnham Road linking the proposed footway on the eastern side of the site access and the existing footway located 250m to the east. If it is not possible to link the proposed footway with the existing footway, then a pedestrian crossing point should be provided at the termination point of the footway or
- ii. Remove the footway on the eastern side of the site access.

It is recommended that white warning triangles (Diag 1062) are provided on the speed reducing ramps. Ensure appropriate gradients are provided on both of the transition ramps.
