## Windmill Views Adoptable Surface Water Drainage

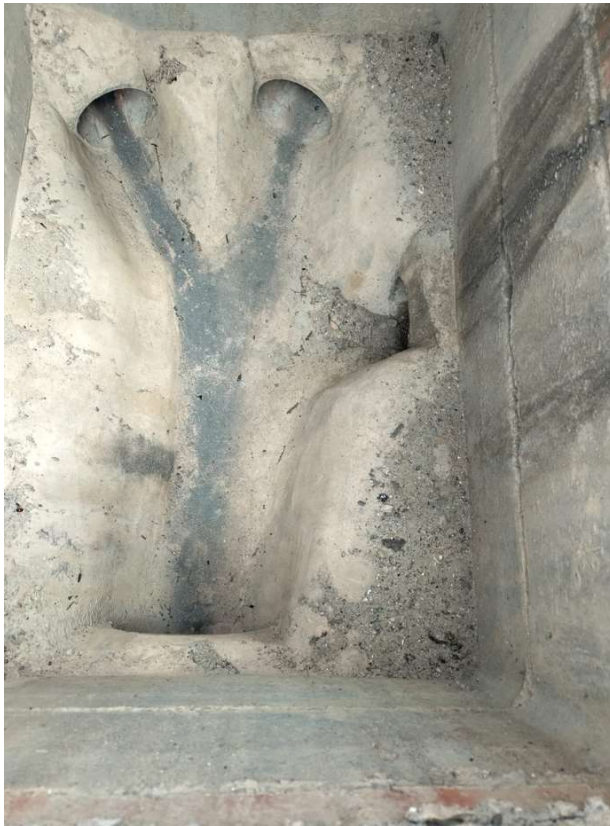
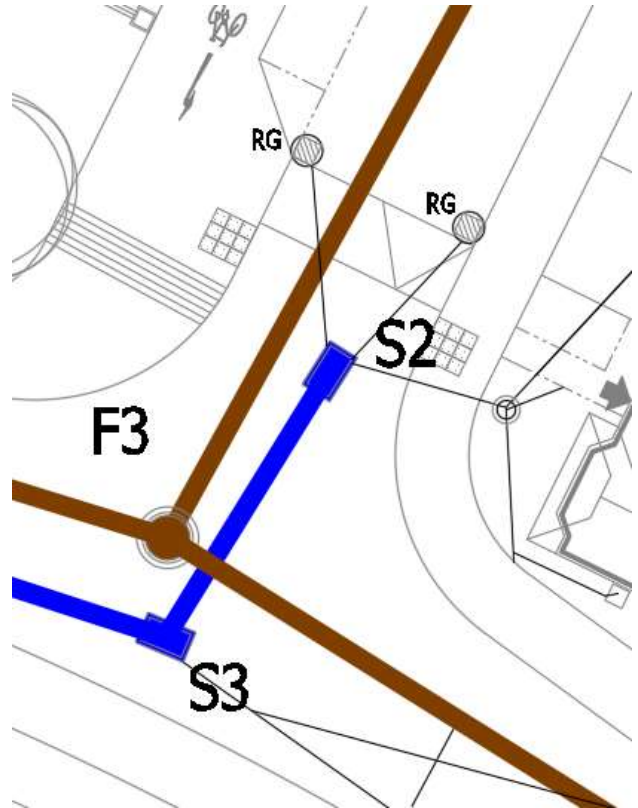
28/01/2021 – S2 - Completed and in operation.

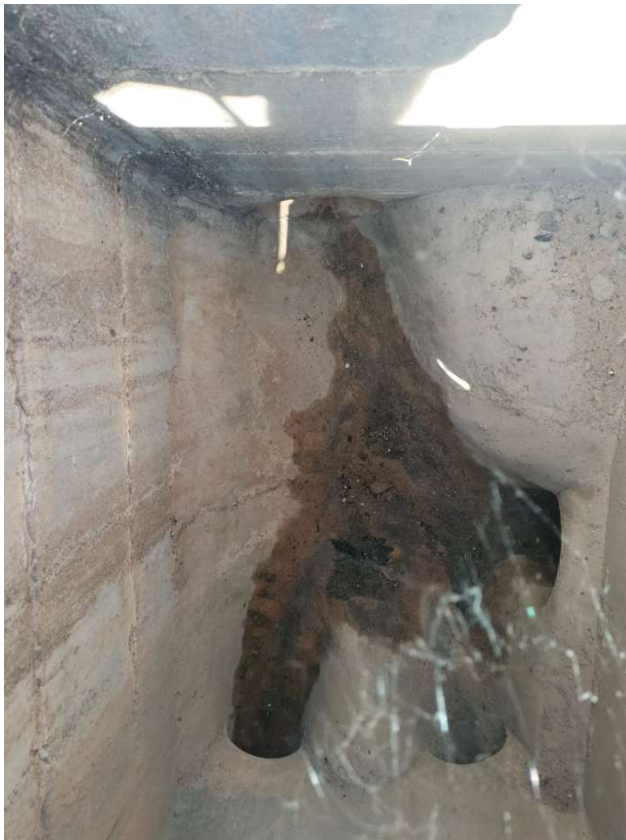
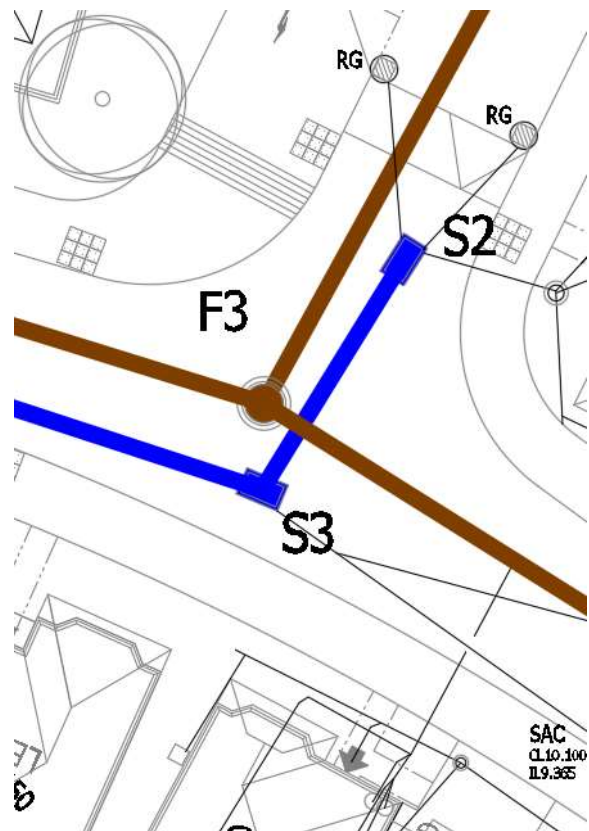
28/01/2021 – S3 – Completed and in operation.

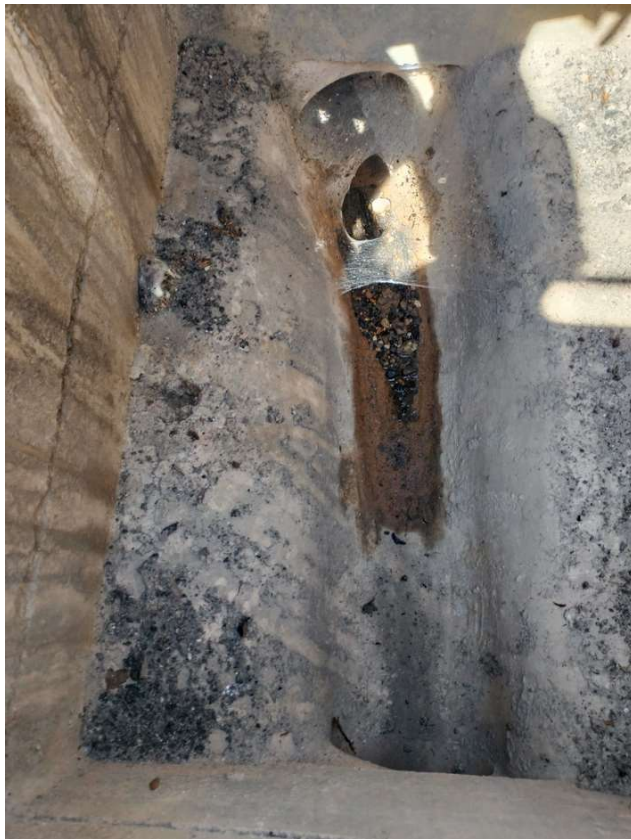
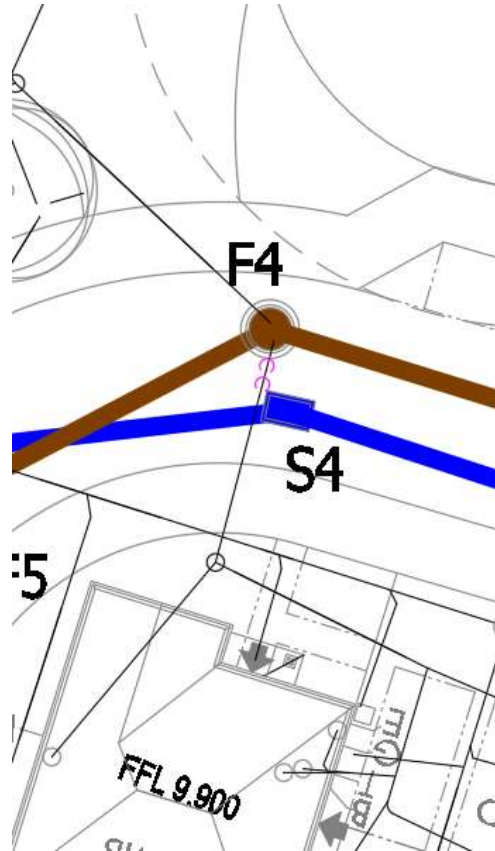
28-01-2021 – **S4** – Completed and in operation.

Stones to be removed to allow water to flow more freely.

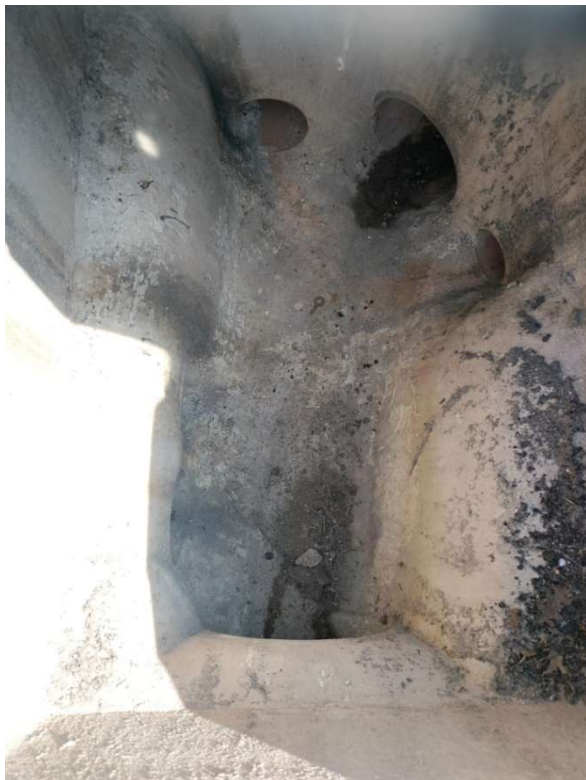
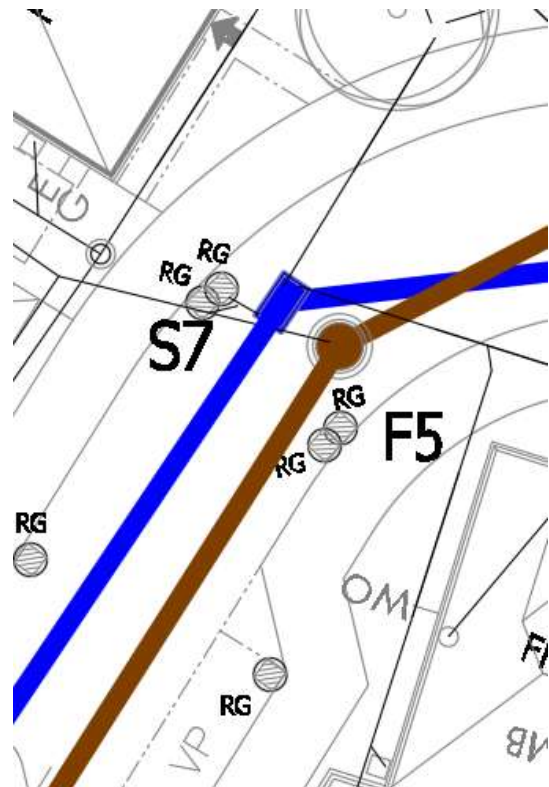
28-01-2021 – **S7** – Completed and in operation

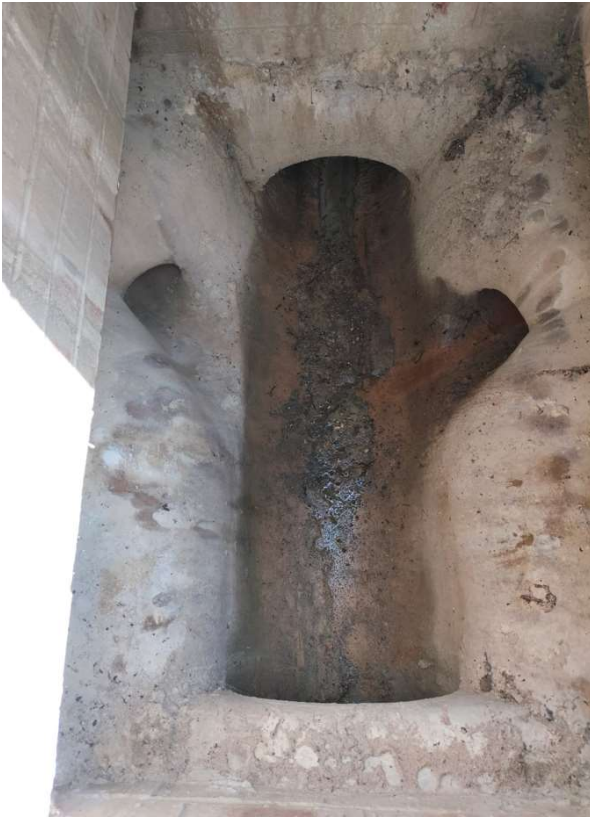
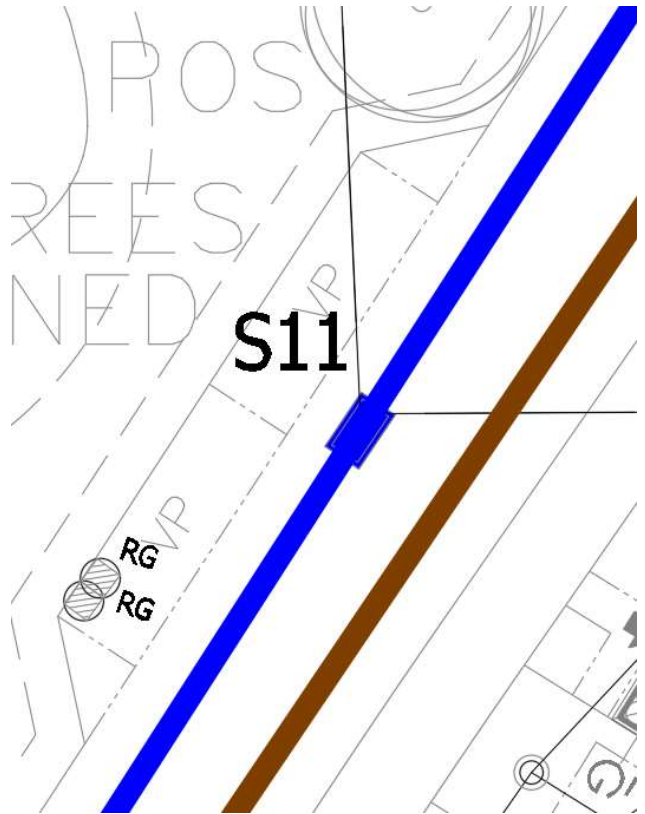
28-01-2021 – **S11** – Completed and in operation.

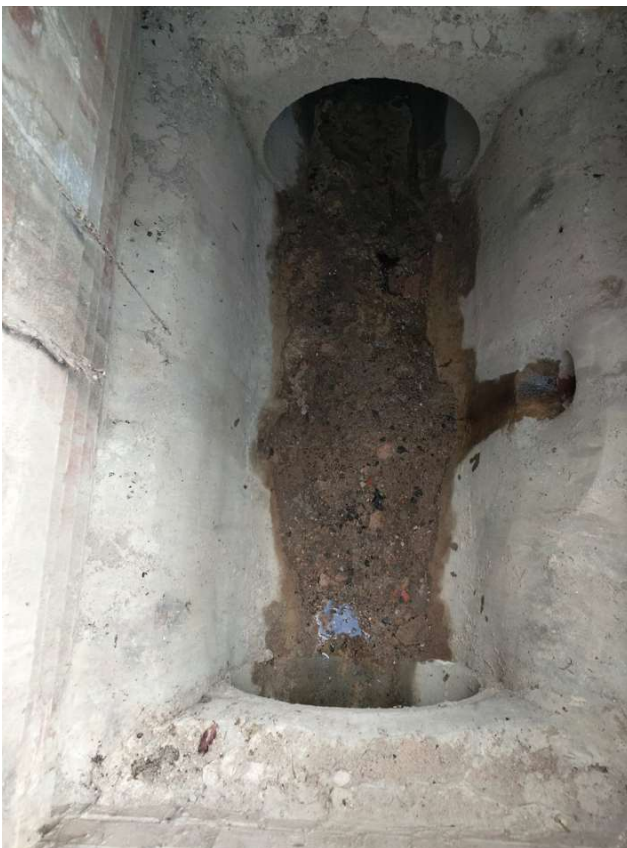
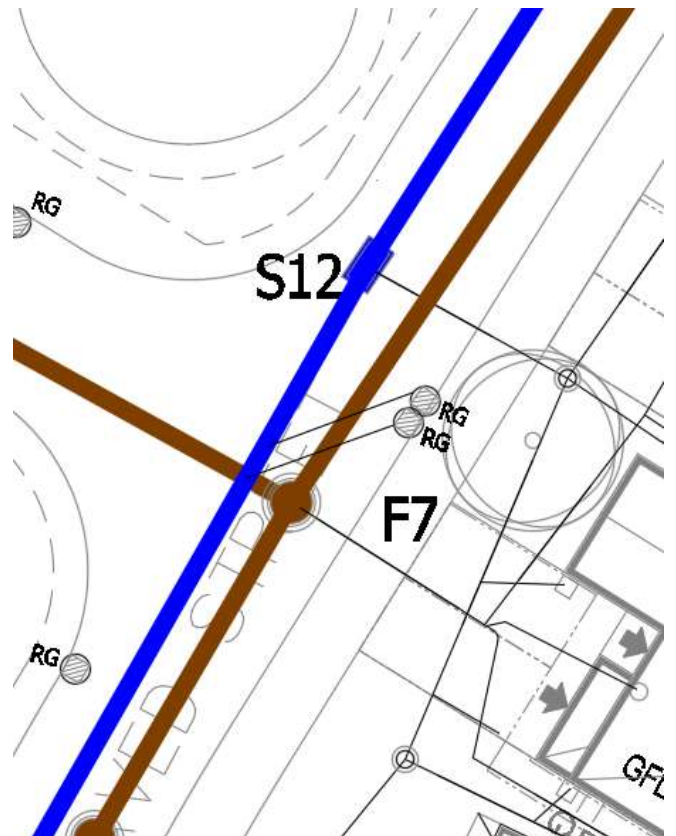
28-01-2021 – **S12** - Completed and in operation.

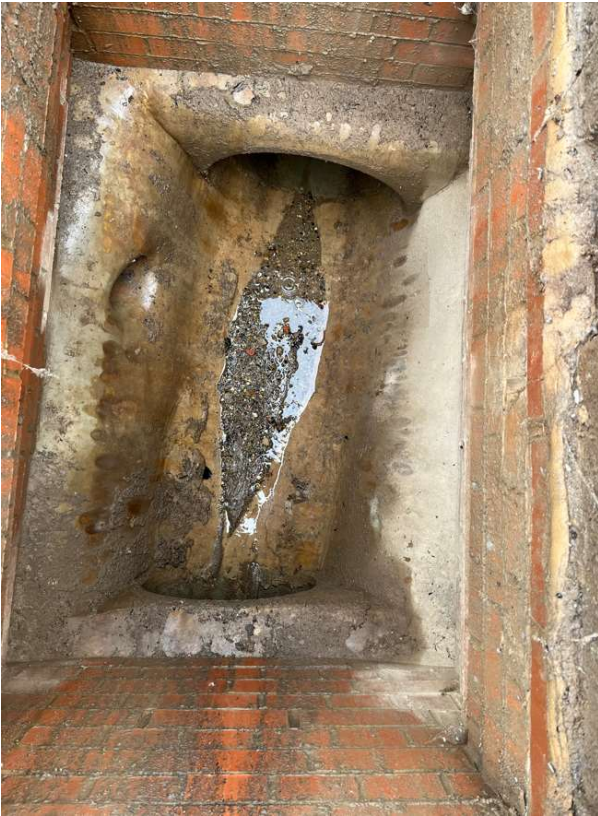
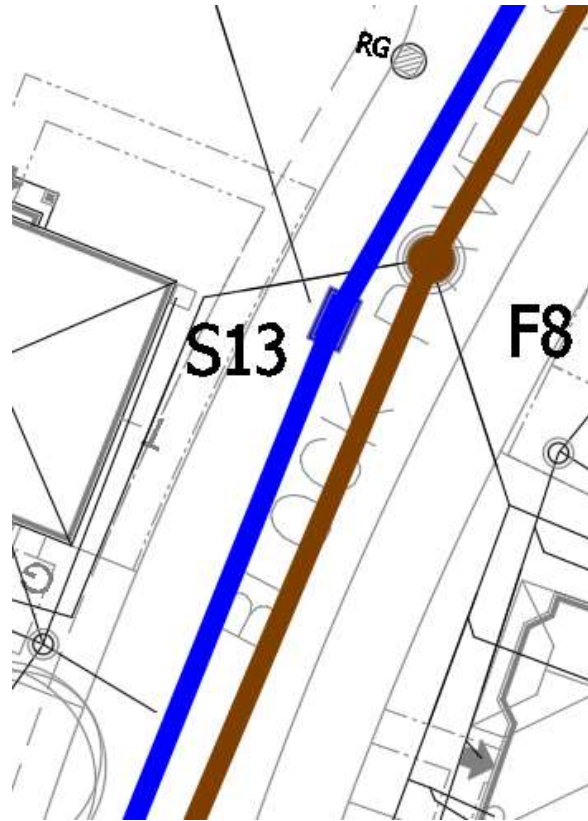
28-01-2021 – **S13** – Completed and in operation.

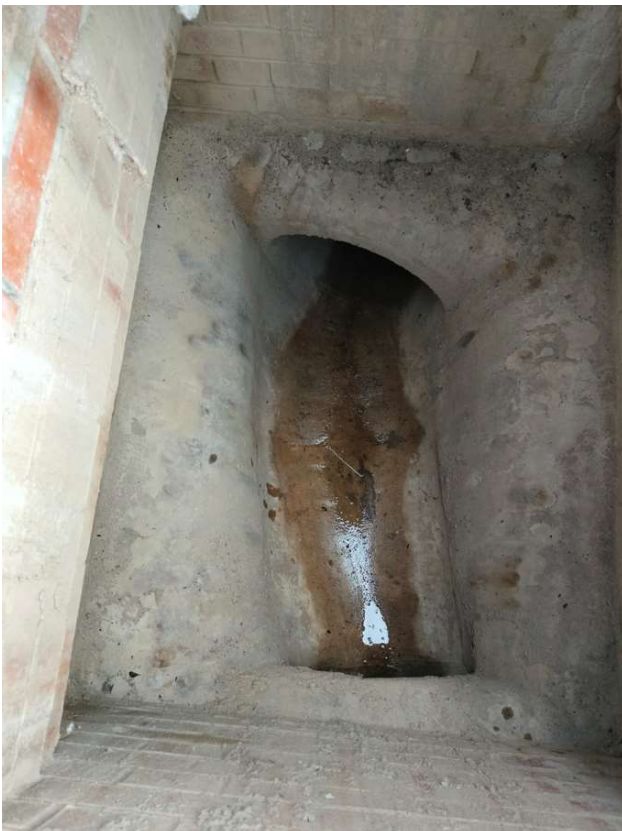
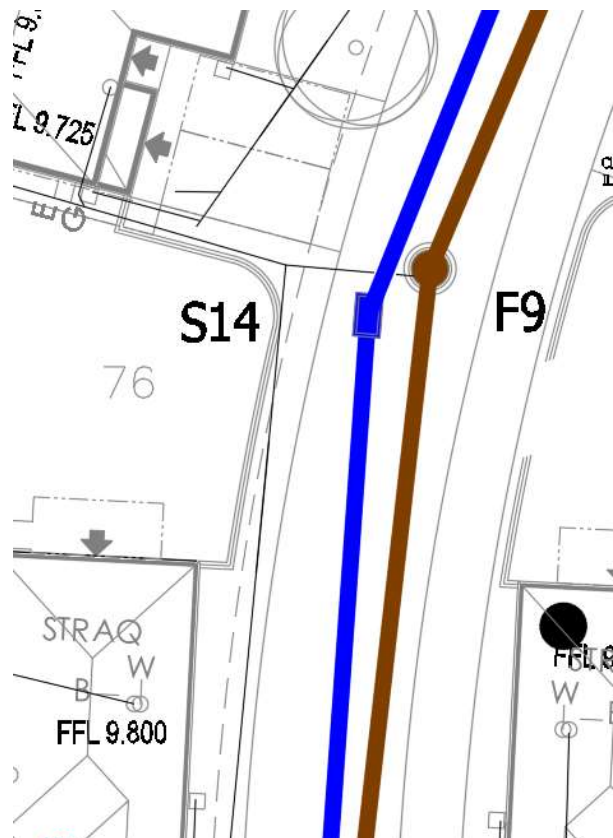
28-01-2021 – **S14** - Completed and in operation.

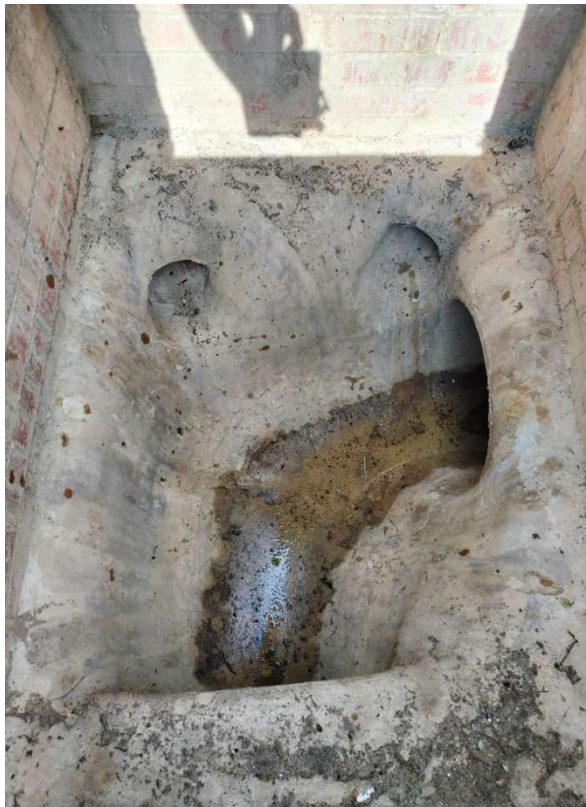
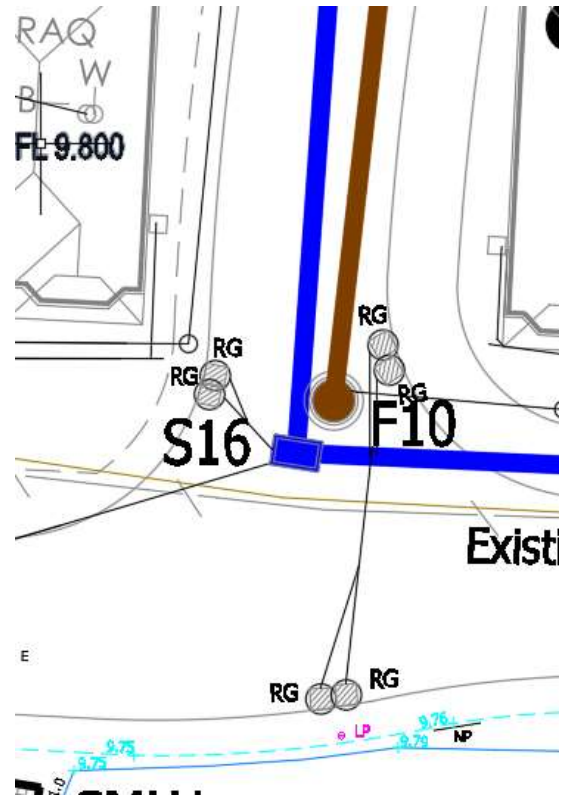
28-01-2021 - **S16** - Completed and in operation

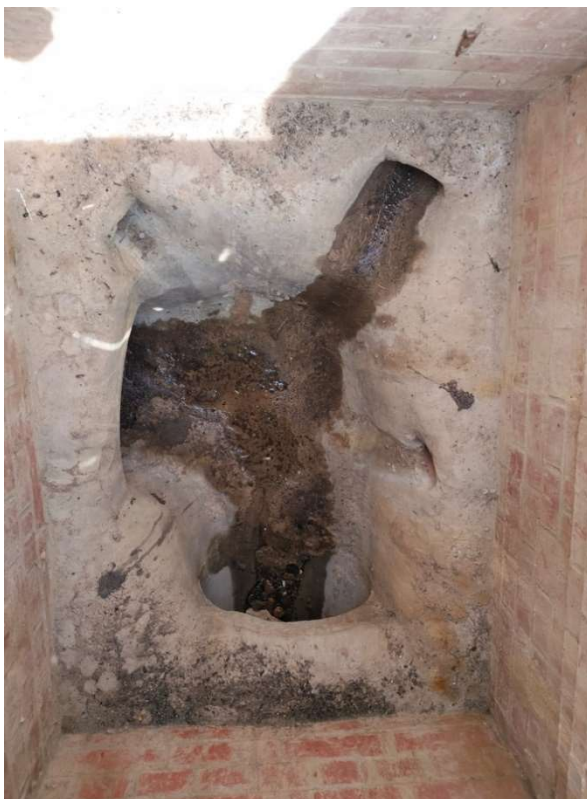
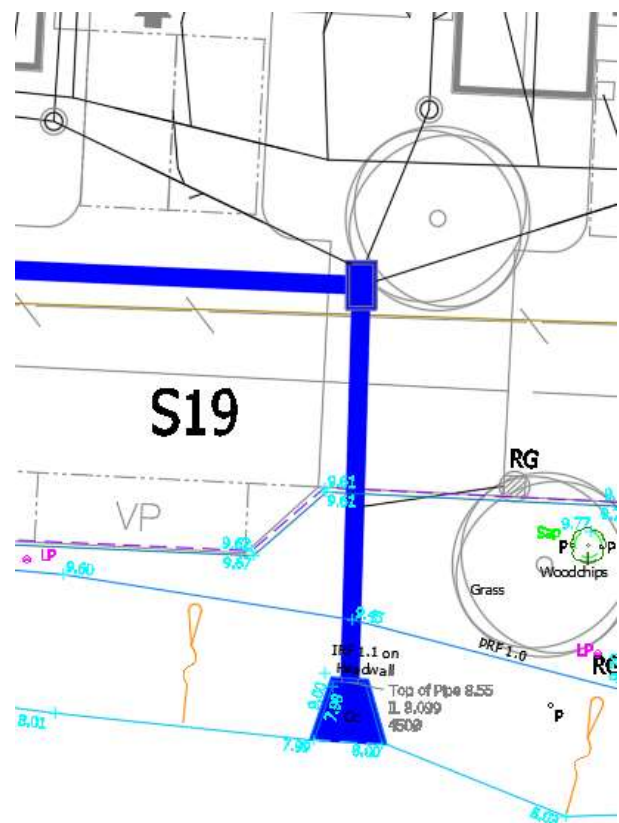
28-01-2021 – **S19** - Completed and in operation

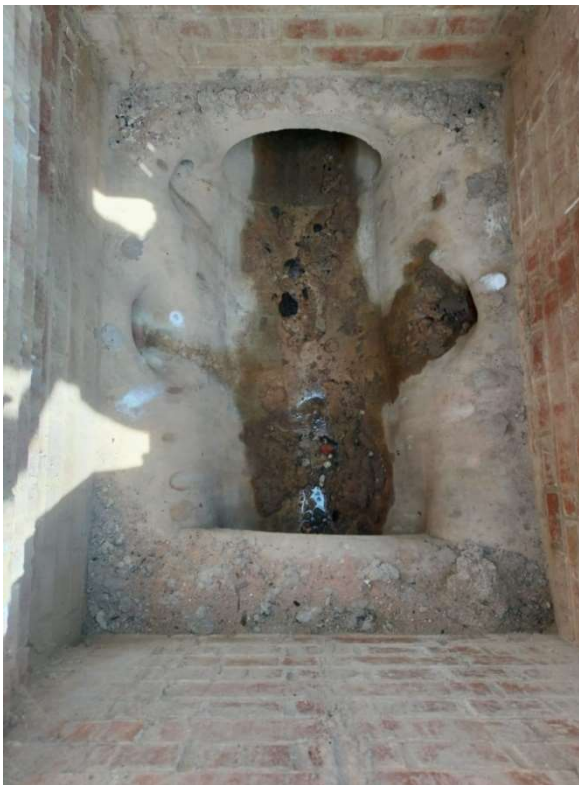
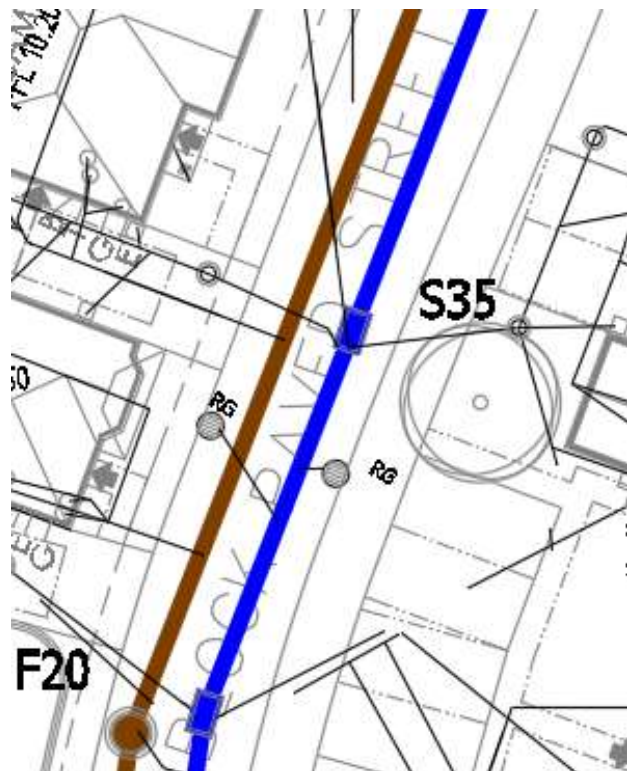
28-01-2021 – **S35** – Completed and in operation.

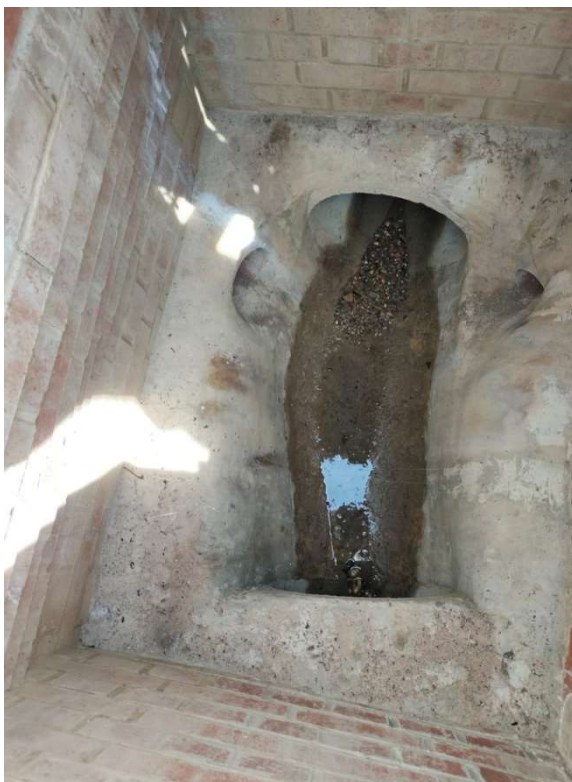
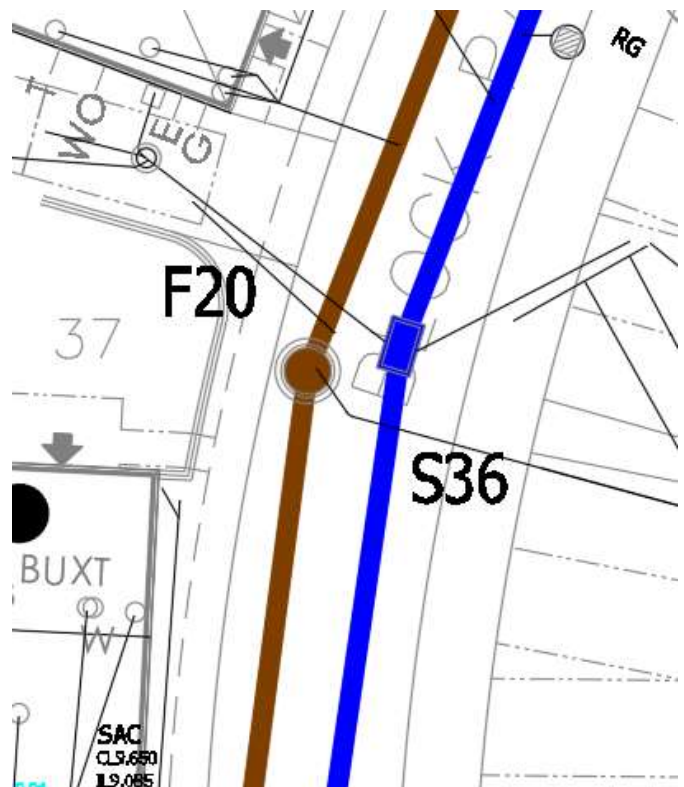
28-01-2024 – **S36** – Completed and in operation.

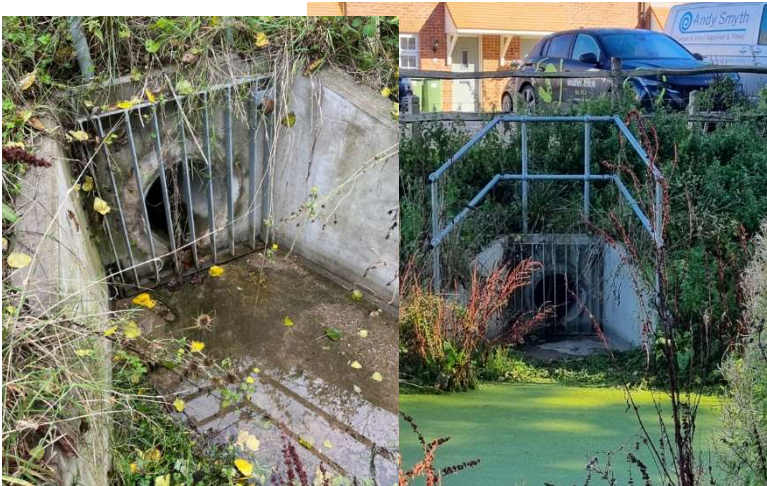
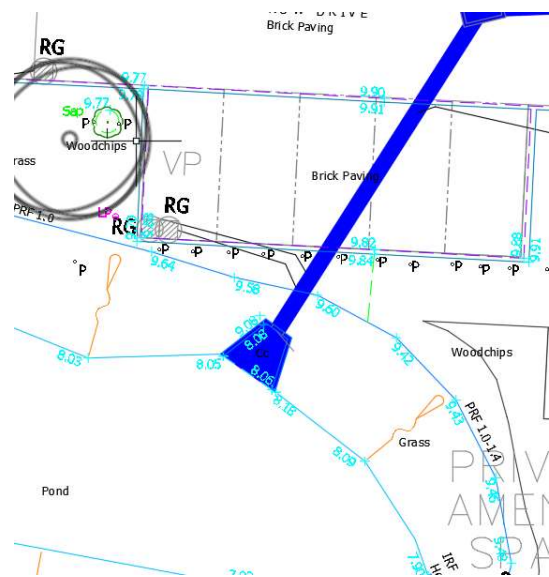
28-09-2024 – Headwall from S40 – Completed in accordance with specification

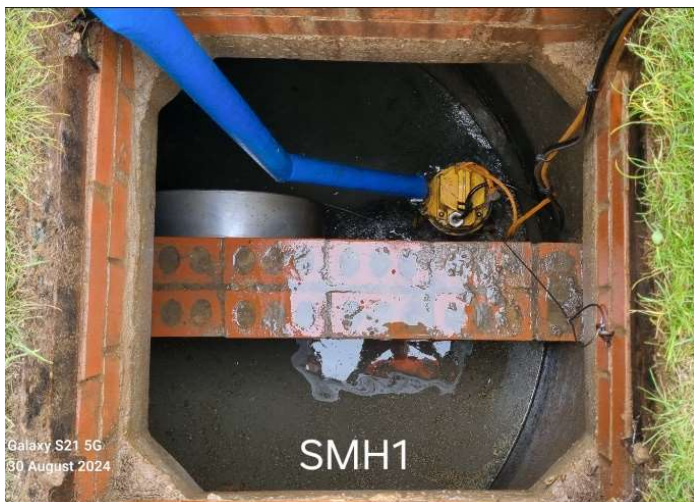
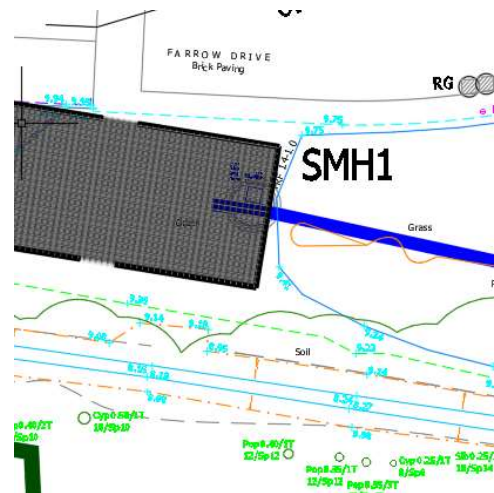
30-08-2024 SMH1 – **incorrectly installed hydrobrake. This does not match the design.**

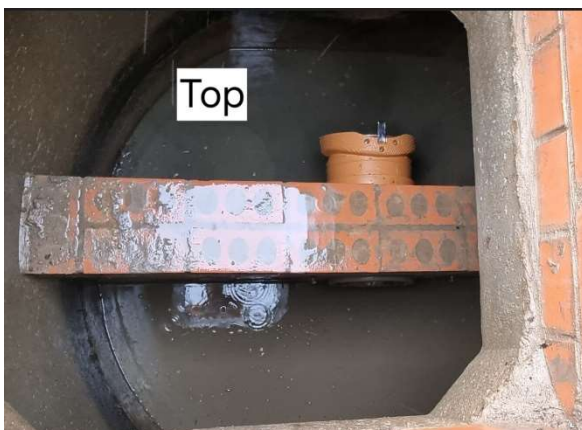
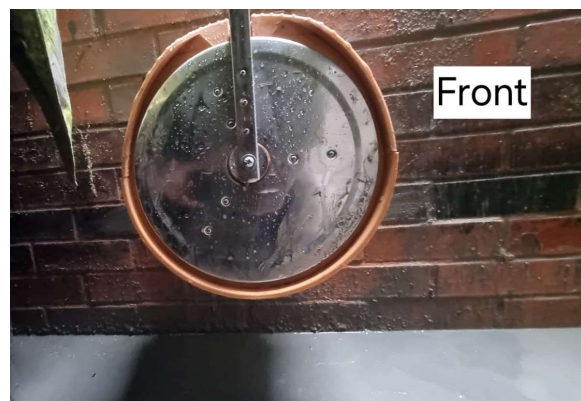
12-10-2024 – SMH1 **Non-return valve now installed as per design**

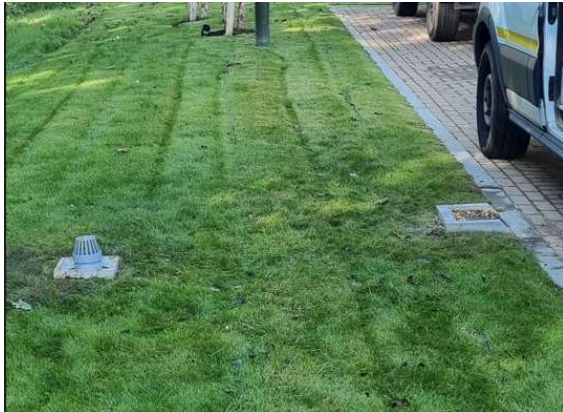
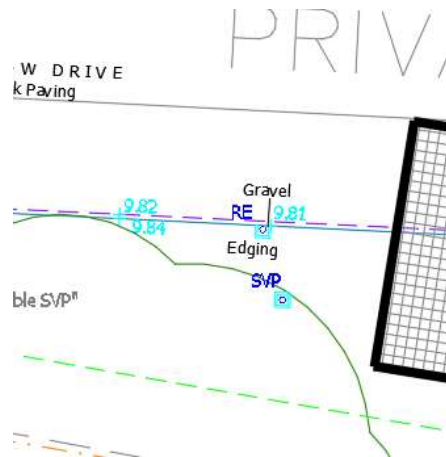
28-09-2024 Vent pipe and rodding eye from attenuation tank.

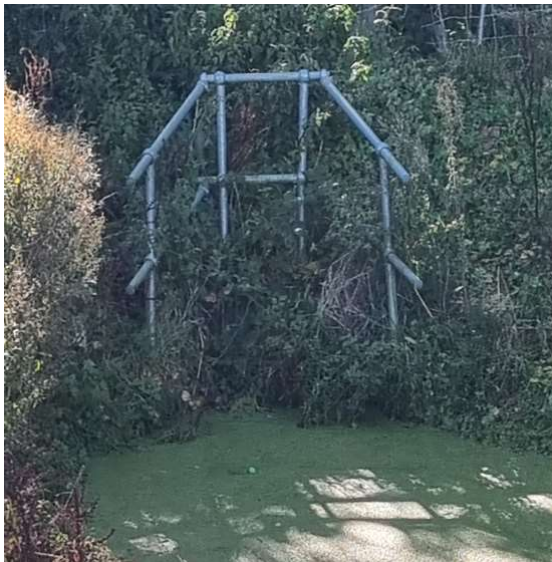
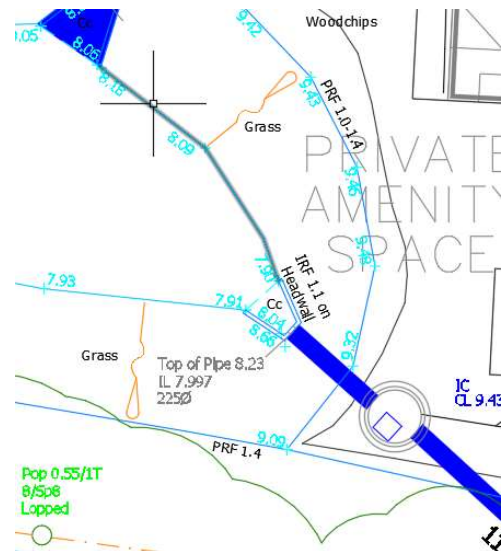
28-09-2024 Headwall leading to SMH2

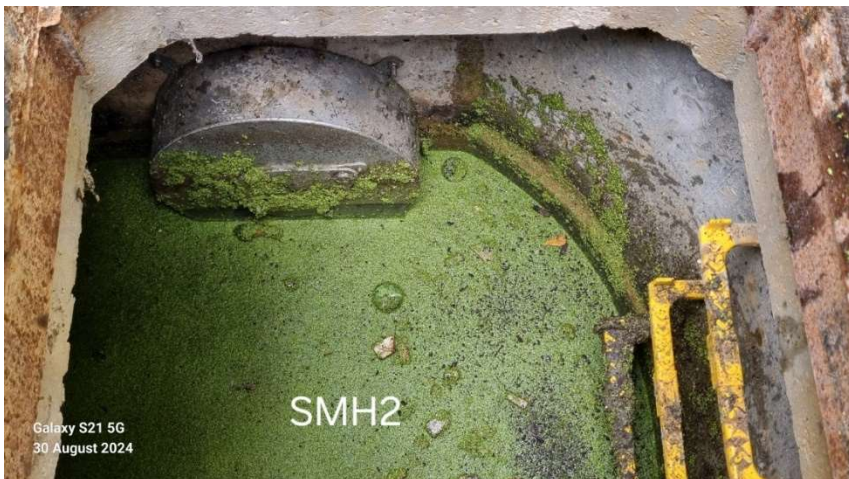
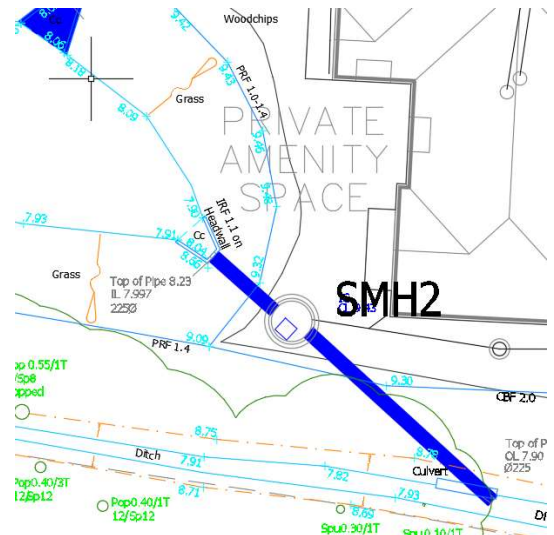
30-08-2024 SMH2 - Completed and in operation.

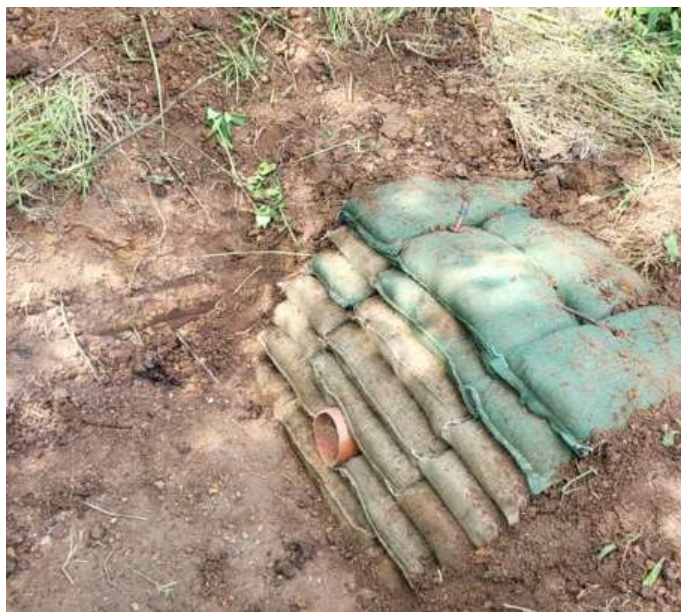
30-05 2024 – Culvert for ditch to the North
