Tree Survey

The Lillies Caravan Park.  
Yapton Road, Barnham

Prepared  
For Mr Hartrick  
February 2010

ARBORTECH (Consultancy)

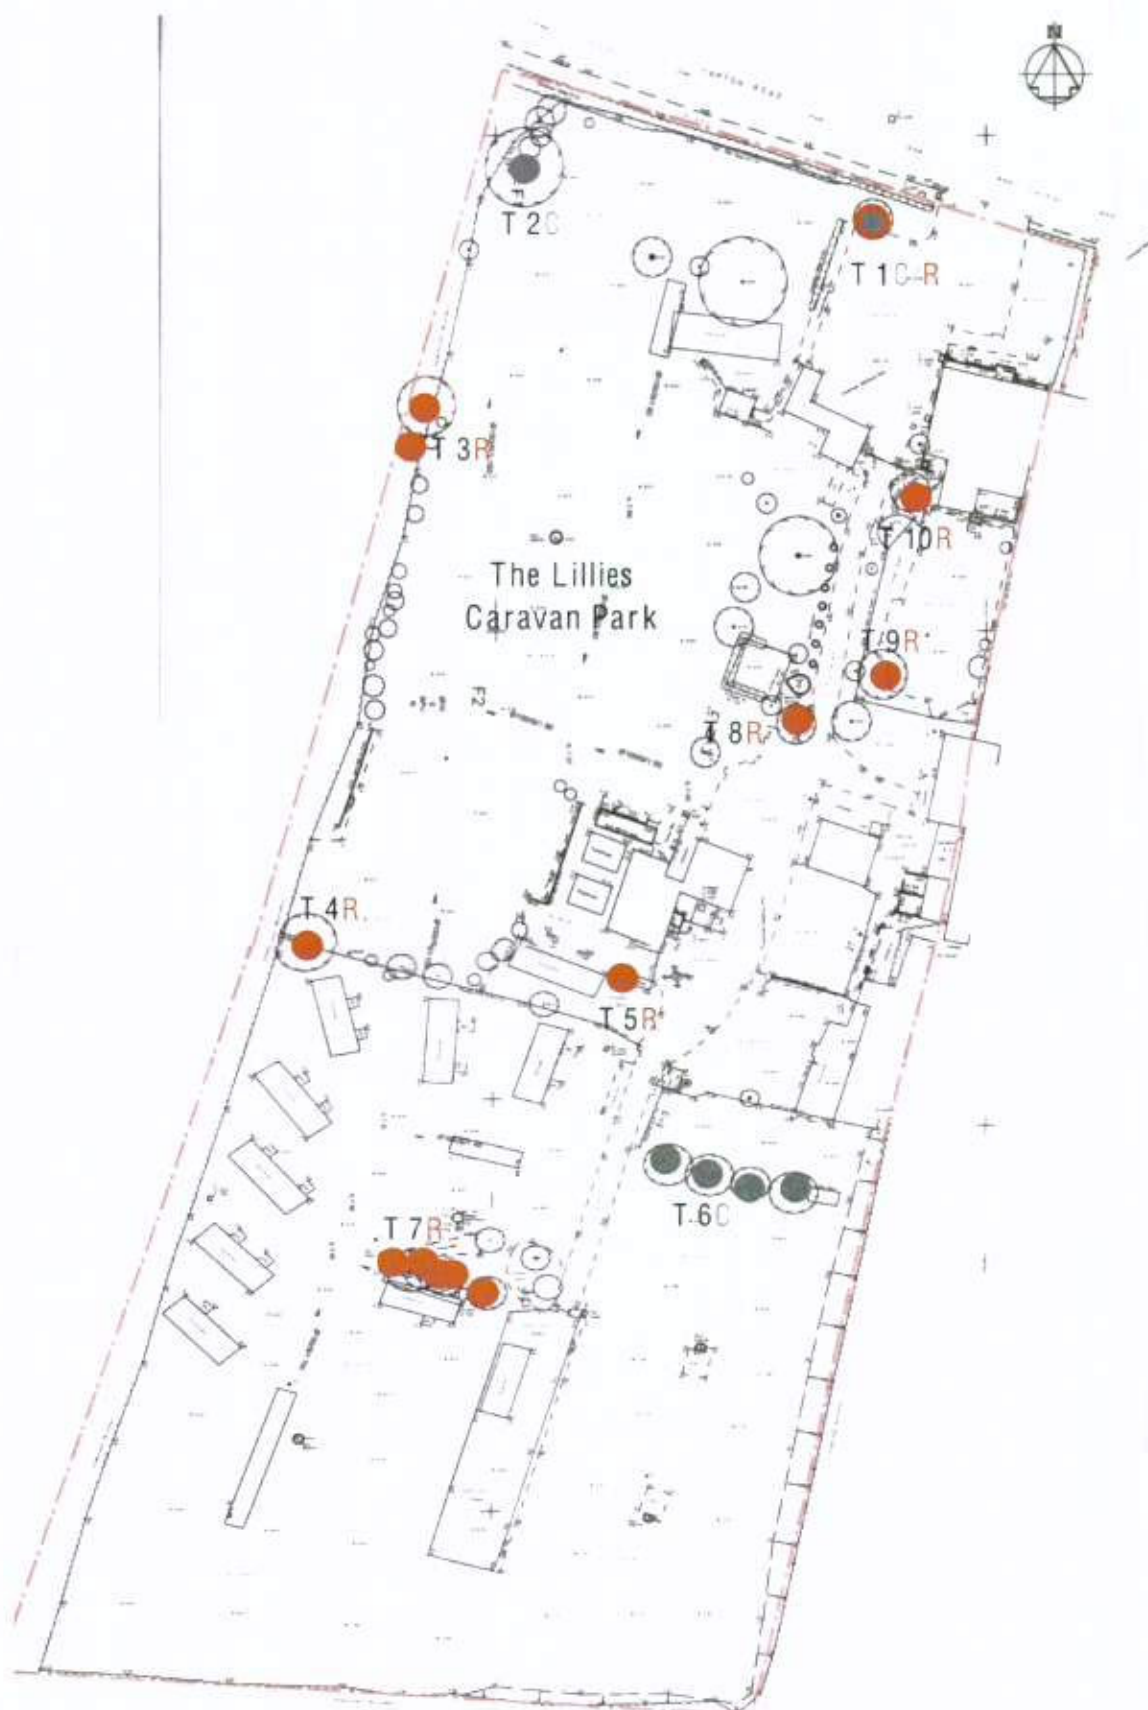
APPENDIX 1  
Tree Survey Plan  
*To be read in conjunction with Tree Survey Notes*

The individual trees can be identified at Appendix 1. '*Tree Survey Plan*' by way of a tree number.
