**Project Name:** FLAMSTEED

**Inspection Standard:** MSCC3 Sewers & Drainage GB (SRM4 Scoring)

**Company:** CHRIS SCOTT  
**Description:** CCTV DRAINAGE SURVEY

## Section Inspection - 25/07/2020 - IC2X

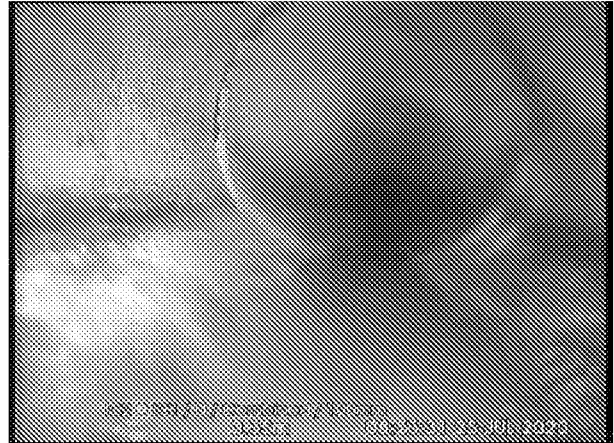
| Scale: 1:106 | Position [m] | Code | Observation | Grade |
|---|---|---|---|---|
| | 0.35 | MC | Sewer material changes at this point | |

2, 00:02:26, 0.35 m  
Sewer material changes at this point

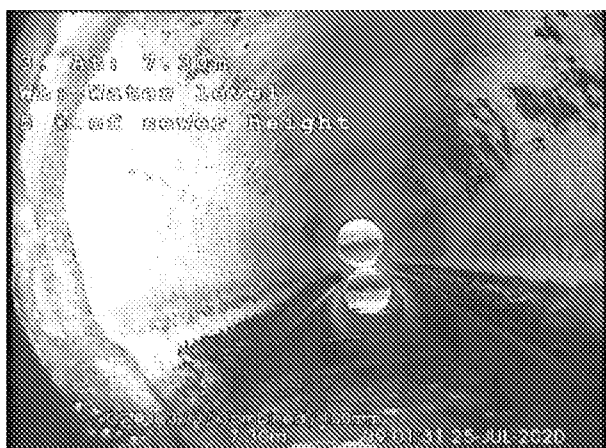
3, 00:01:39, 7.30 m  
Water level, 5% of sewer height

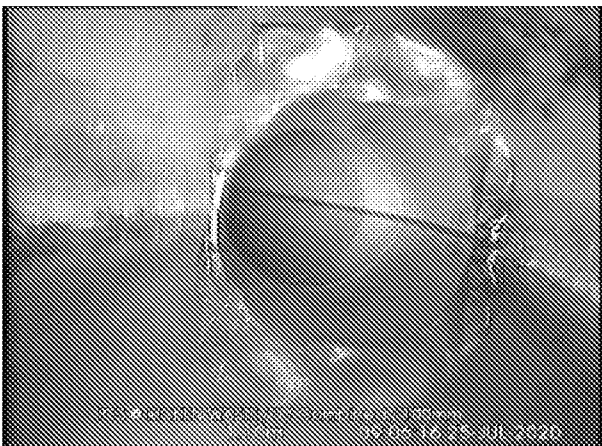
| Scale: 1:50 | Position [m] | Code | Observation | Grade |
|---|---|---|---|---|
| | 1.10 | WL | Water level, 45% of sewer height | |

3, 00:00:37, 1.10 m  
Water level, 45% of sewer height

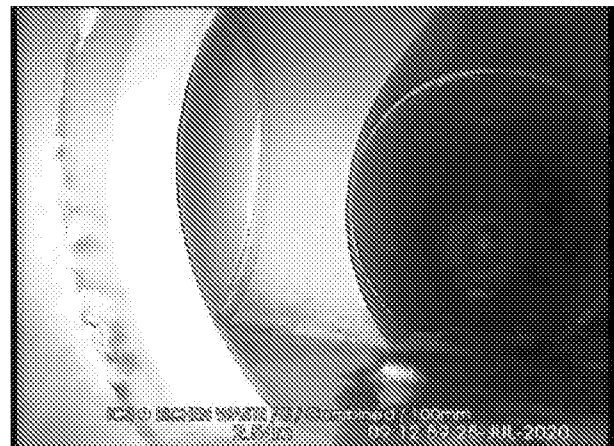
| Scale: 1:50 | Position [m] | Code | Observation | Grade |
|---|---|---|---|---|
| | 2.54 | CN | Connection at 10 o'clock, 100mm diameter | |

4, 00:02:02, 2.54 m  
Connection at 10 o'clock, 100mm diameter

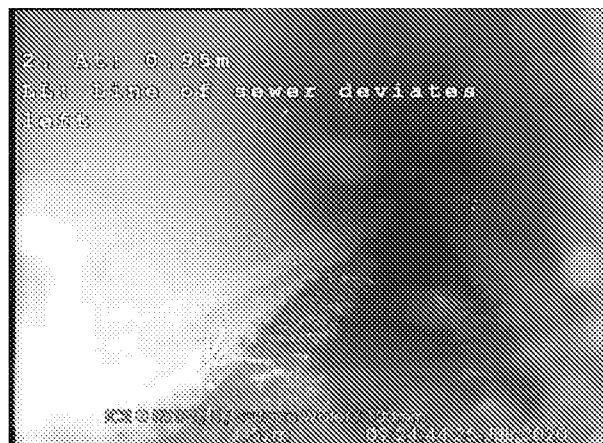
2, 00:00:14, 0.95 m  
Line of sewer deviates left

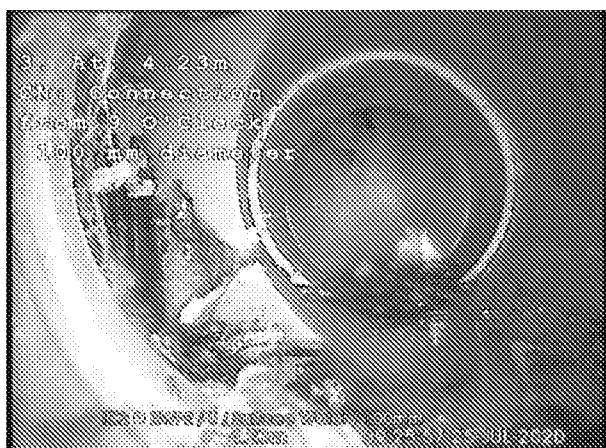
3, 00:01:19, 4.23 m  
Connection at 9 o'clock, 100mm diameter

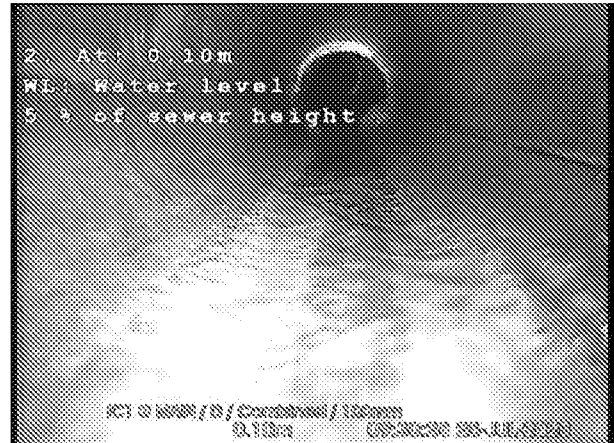
| Scale: 1:50 | Position [m] | Code | Observation | Grade |
|---|---|---|---|---|
| | 0.10 | WL | Water level, 5% of sewer height | WL @ 0.10 m |

2, 00:00:16, 0.10 m  
Water level, 5% of sewer height

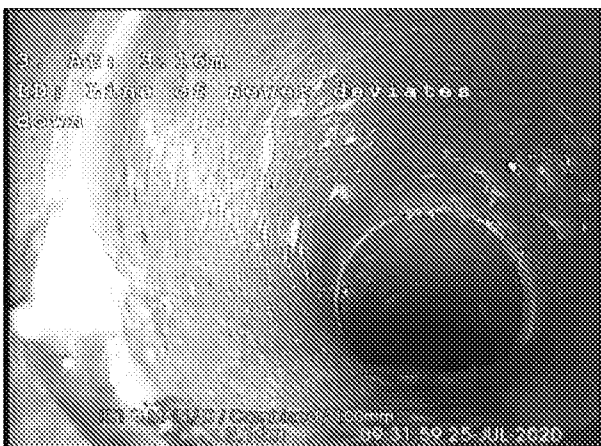
| Scale: 1:50 | Position [m] | Code | Observation | Grade |
|---|---|---|---|---|
| | 3.16 | LD | Line of sewer deviates down | LD @ 3.16 m |

3, 00:01:43, 3.16 m  
Line of sewer deviates down
