**STRUCTURAL ENGINEERS REPORT**

**13 NORMANTON AVENUE**

**BOGNOR REGIS**

Ref 2620/MJG  
1 May 2026

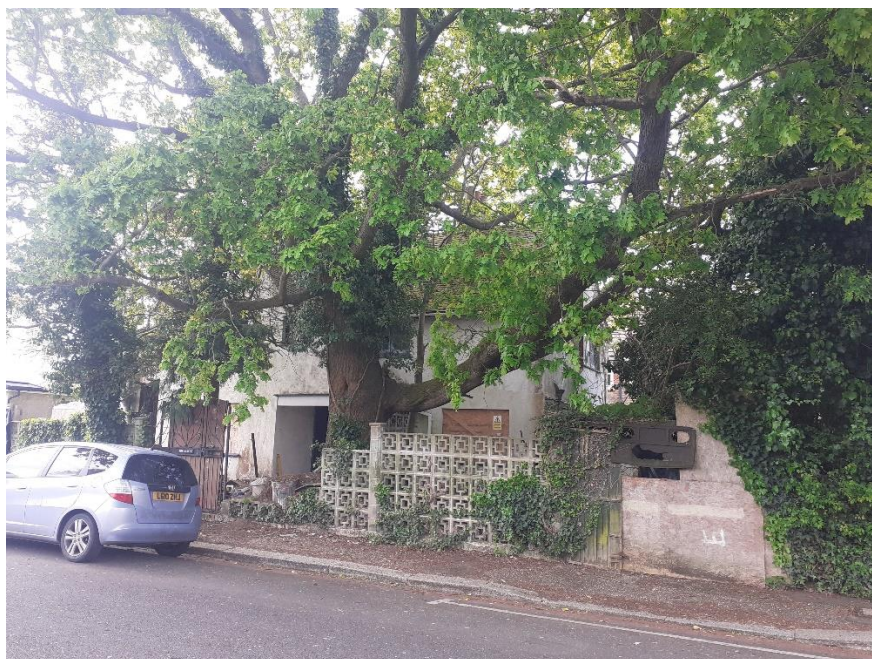
- 7.1 The Oak tree envelopes the house with the crown above the roof and spreading across to the rear garden. Some of the smaller trees noted are completely beneath the canopy of the Oak.
- 7.2 The branches of the oak tree lay onto the roof in several places and damage has occurred as a result to the ridge line running N-S, with ridge tiles broken and lost and other tiles damaged/dislodged.
- 7.3 The branches appear to have penetrated through the roof felting in places. Damage has also occurred to guttering.

**Front Elevation, mostly obscured by Oak**

- 13.8 The input of an Arboriculturist may be helpful. I would recommend that the tree should be taken down gradually. The overhanging crown should be reduced as soon as possible to prevent further roof damage etc and the bulk of the tree should be reduced by say one third during the months of Jan – Mar when the water demand will be at it slowest.

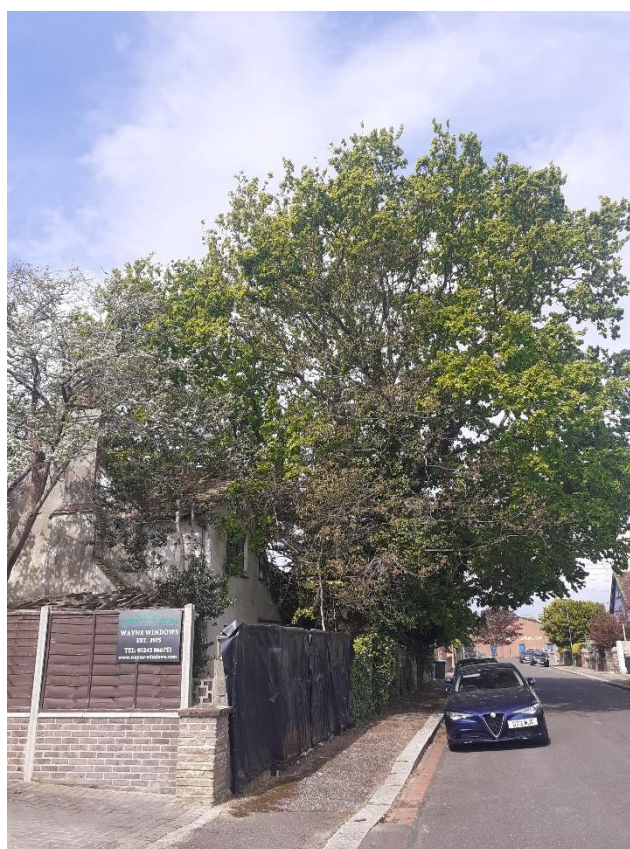
**View looking West**

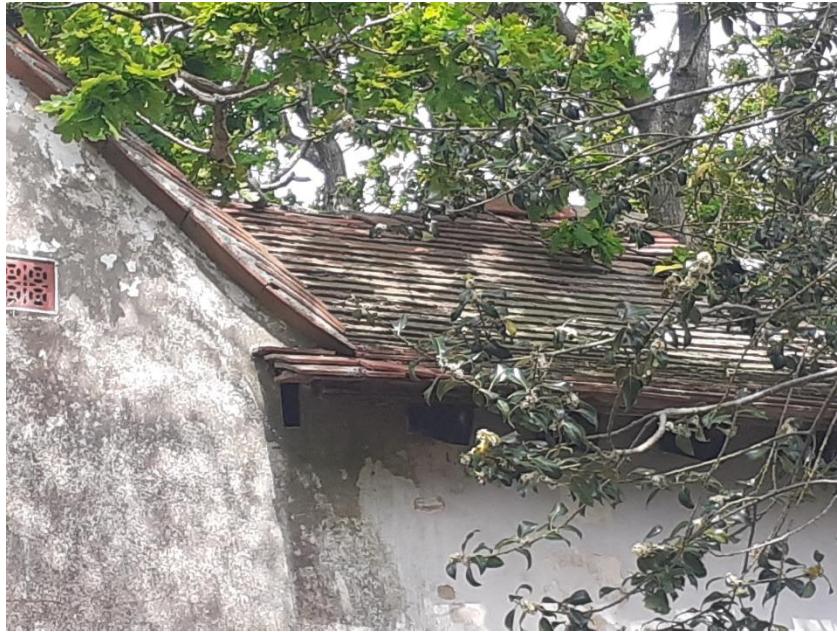
- 13.2 The Oak tree at the front is extremely large and engulfs the entire house. It has damaged the roof by the overhanging branches. It has also damaged the garage and possibly the house internal walls also.

**Roof damage from Oak**

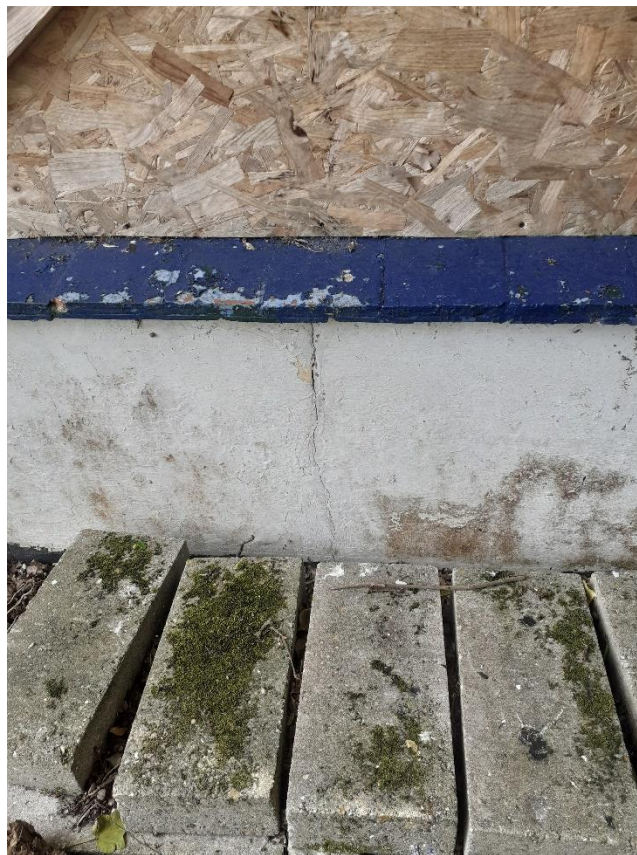
- 8.1 There are numerous cracks in the front elevations including

- 13.1 There are numerous cracks present throughout the building. The house is in a dilapidated condition and is currently at the beginning of a refurbishment process. This makes it difficult to analyse which cracks are caused by foundation movement or age/deterioration.

- 13.3 Trees in general represent a risk to foundations where the soil is clay. Here the soil may be clay or clayey and if so, the Oak tree particularly represents a significant risk of further foundation movement/ damage.

**Crack in front elevation**

- 13.6 I recommend that all trees very close to the house should be removed. The approval of the Local Authority will be required for any trees subject to TPO's

- 13.7 For the large Oak this should be done over a period of several years in order to minimise risk of heave (swelling) of the soil. When a tree is removed the soil will recover moisture causing the clay element to swell and this could damage the house.

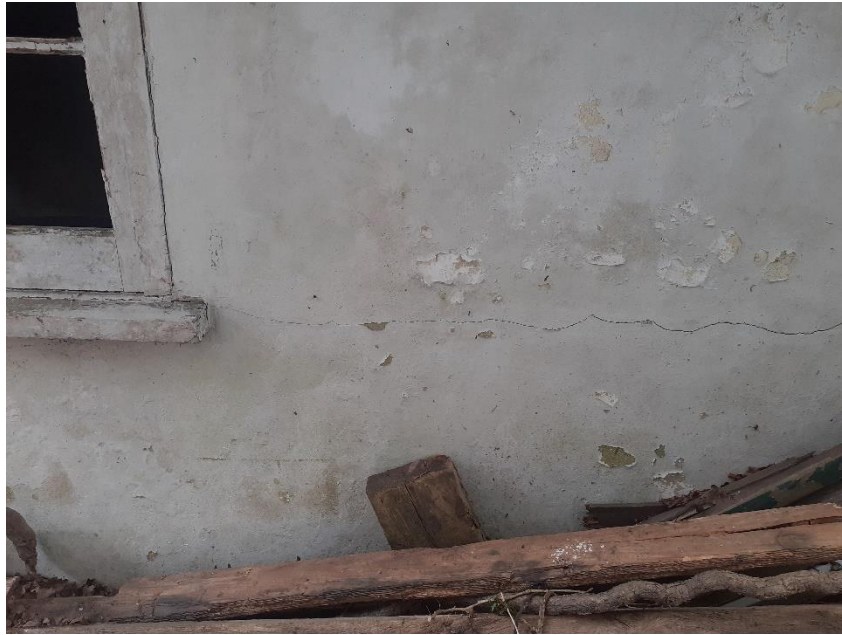
- 12.1 It was not possible to enter the garage, and external observations were very limited by overgrown shrubbery and debris.
- 12.2 The construction is of single brickwork with a tiled pitched roof.
- 12.3 Damage is evident to the roof from the overhanging branches of the oak and other trees with tiles broken and dislodged.
- 12.4 Cracking to the East flank wall was visible to the LC RH, this is H across to the front corner, est at 3-4mm
- 12.5 Also, a V/diag crack from the front corner V /diag 3-4mm.

- 13.5 The cracking of the garage appears to have been caused probably by the action of the tree roots, possibly causing shrinkage of clay or by direct growth effects causing movement of the sub-soil and foundations.

**Cracking in garage East Elevation**

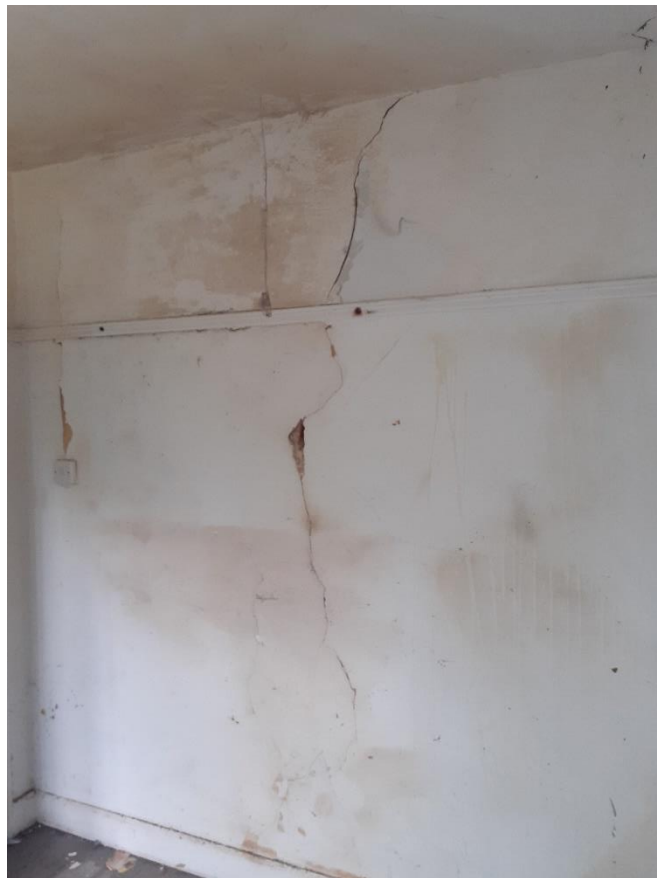
- 11.1 The internal walls at first floor appear to be mostly of solid masonry construction.
- 11.2 The internal face of the front external wall has numerous fine cracks present.
- 11.3 There is a larger V crack at the LC RH of the window over the stairs and also V cracks over doorways from the landing into the bedrooms
- 11.4 In both the rear bedrooms there are V full height cracks of 6mm width tapering to 0, to the S side of the chimney breast.
- 11.5 The door head of the rear SW bedroom dips out of level.

**Cracking in rear bedroom**
