Our Ref: **16835 - Let 2**

20 February 2018

**RE: TREE ISSUES AT 'VILLA MARIA', CAMPBELL ROAD, BOGNOR REGIS**

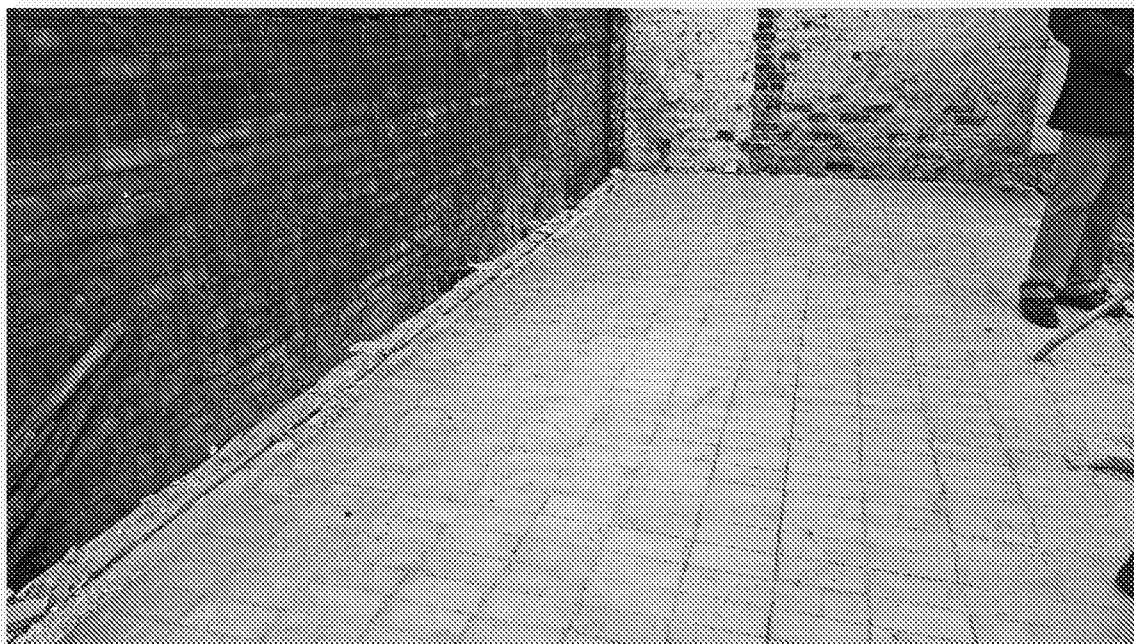
The floor slab of the existing building (photograph 1) in the north western corner of the site (and closest to the offsite trees) was carefully removed. It was noted that the boundary wall positioned between the trees and the site extended well below ground level and this was seated on an existing deep footing. The existing building foundation was located immediately adjacent to this and internally to the east and south of the wall. I can confirm that our exploratory investigations found no tree root activity (photographs 2, 3 and 4) to a depth of approximately 500mm in the vicinity of where the new studio accommodation was to be constructed. We determined that the position of the wall, the existing building foundations and the depth of their construction was the likely cause of the lack of root growth from the nearby trees into the site.

**Photograph 1** – Floor slab of existing building

As a precautionary measure, we agreed that the existing building foundations were to be left in place, with the slab removed and replaced with beam and block flooring with a clear void beneath. Any new foundations

were to be cast outside the perimeter of the old, so as to avoid unnecessary ground disturbance internal to the existing perimeter building foundation.

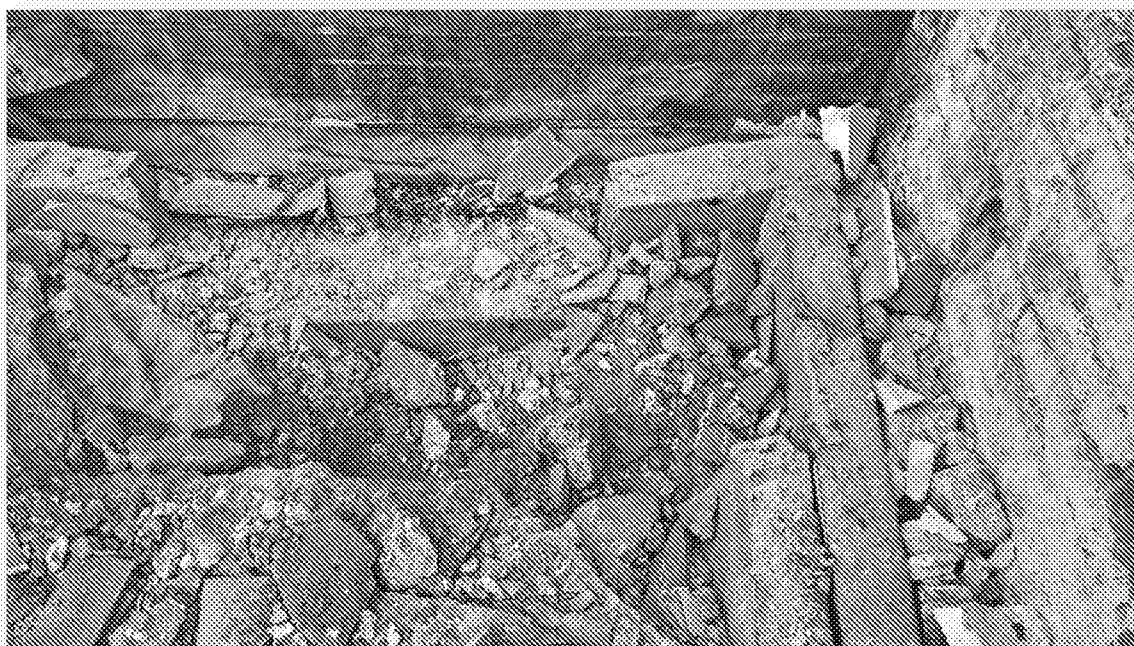
**Photograph 2** – Partial removal of floor slab with building foundation evident

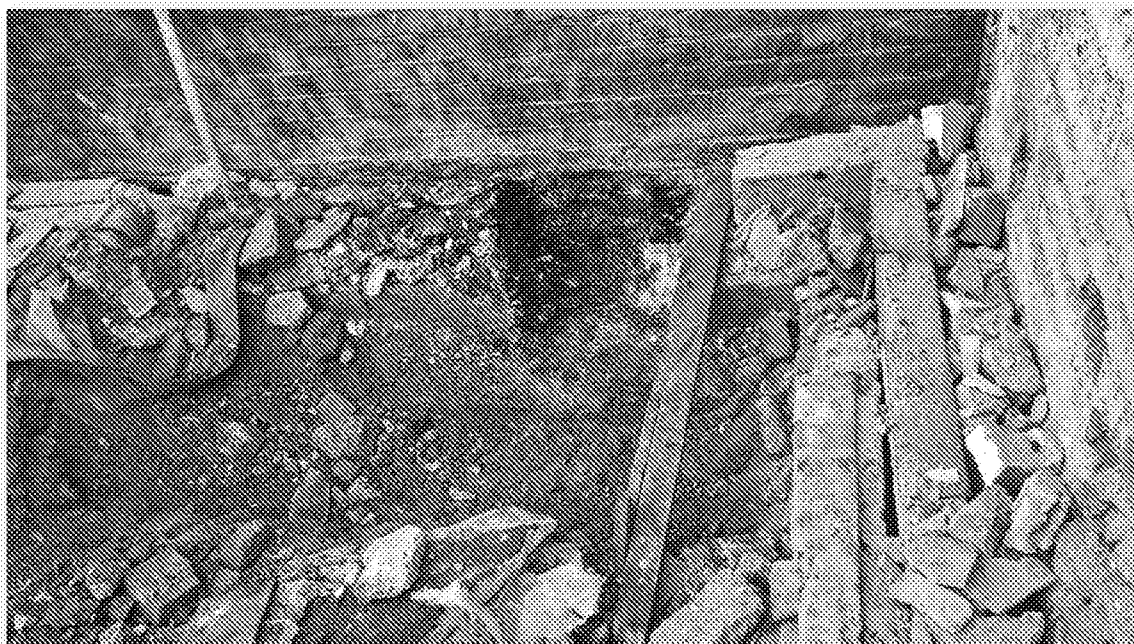
**Photograph 3** – More complete removal of floor slab and exposure of building foundation

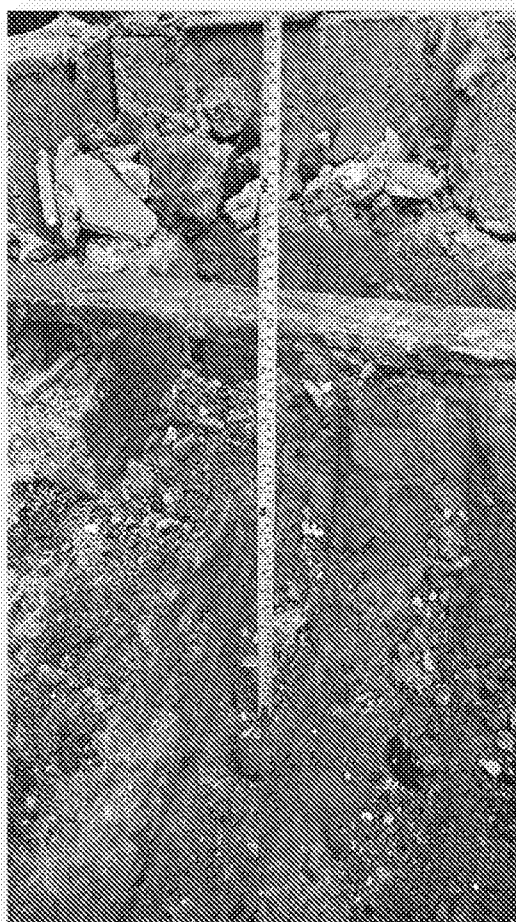
**Photograph 4** – Complete removal of floor slab and exploratory investigations to a depth of 500mm
