**PROPOSED WORKS :**     **Conversion of existing property into 3 x No. self-contained apartments.**

**ADDRESS :**               **23 Mead Lane, Bognor Regis, PO22 8AP.**

### **Garage Infill Wall**

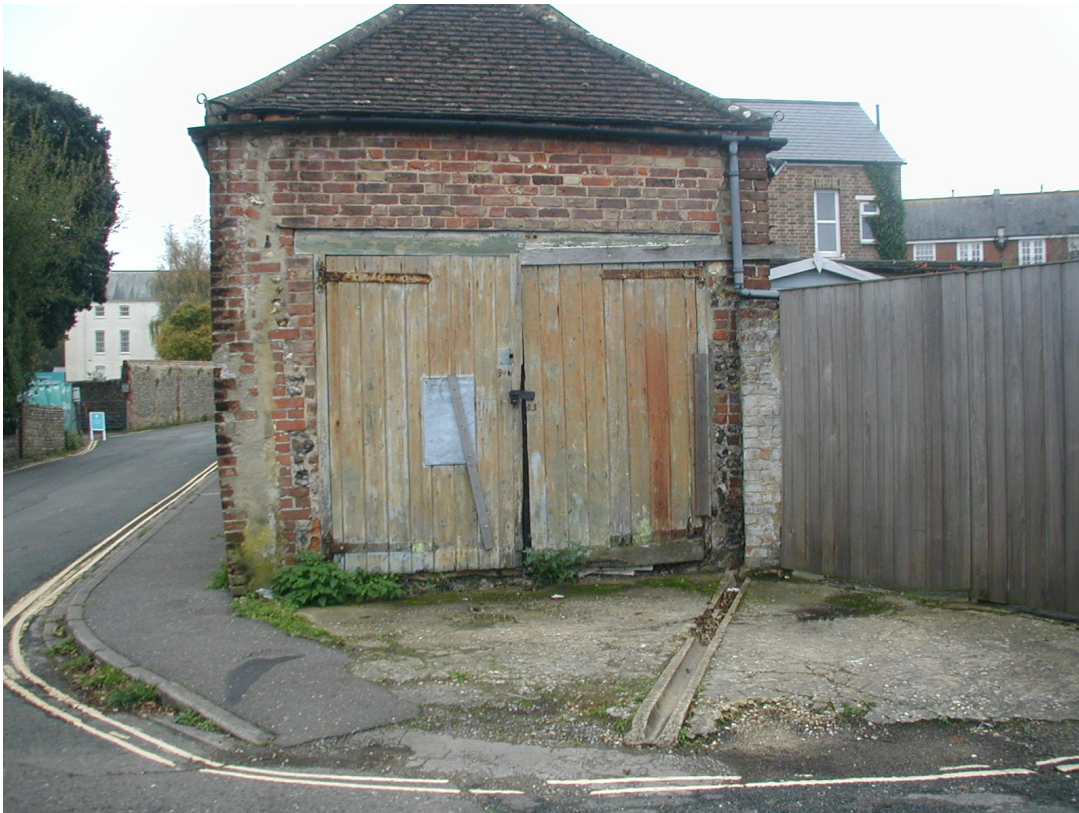
Photo – Existing garage wall elevation.

- 1.3 Since the original report the internal space and structure of the garage has been cleared out and fully exposed, the situation regarding the state of repair of the rear facing garage wall and in turn the lateral stability of the flint wall facing Mead Lane has been found to be more critical than originally thought.
- 1.4 The site was inspected by Mr Jim Henn of Arun Building Control recently where he raised concerns and asked for further investigation following the exposure of the structure.
- 1.5 The structural engineer visited the site and called for more extensive remedial work, not only to ensure the stability of the infill portion of the wall but also the long-term stability of the existing flank wall which has also moved over the years.

- 1.12 The proposal is therefore to re-build this portion of the wall in its entirety to safeguard the long-term stability of the structure and provide a more robust form which will reduce the need for medium term repair which it would otherwise need.

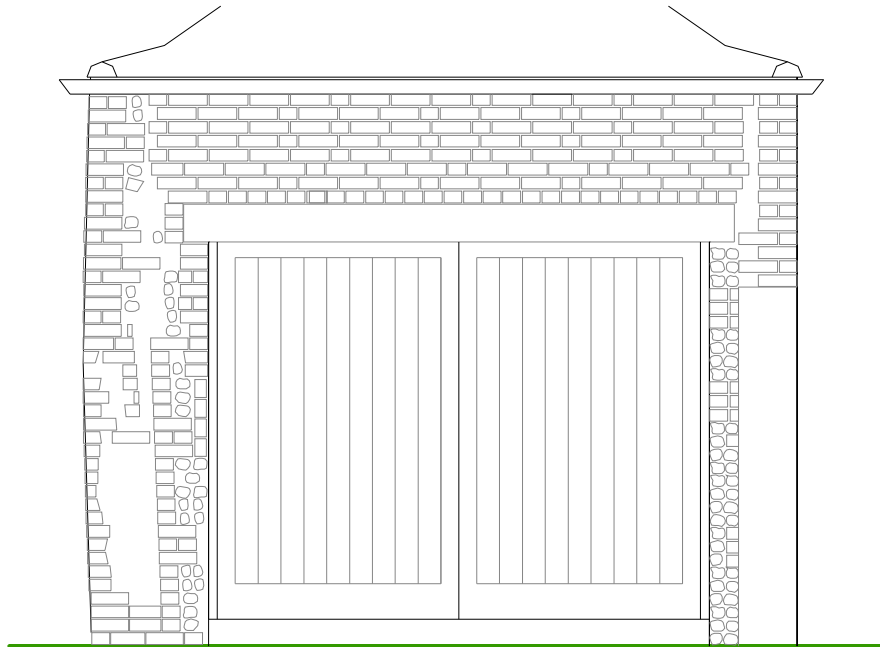
PARTIAL EXISTING NORTHERN ELEVATION

- 1.6 The engineer has stated *“The pre-existing movement to the existing brick quoin to the north east corner is such that it will not be possible to bond new brickwork to it whilst maintaining the correct lines and levels for the north elevation masonry. In addition, from our recent inspection, it is not considered possible to bond any new brickwork to the already deformed existing masonry on the north elevation and which includes the infill brick and flintwork. Any attempt at doing so will destabilise the wall and corner of the building further. In addition, the masonry over the garage door has moved and is unlikely to be able to be safely supported in the temporary condition without risk of partial or total collapse.”*

- 1.7 He further states that *“In order to safeguard the longer term stability of the garage structure and to extend its longevity for the foreseeable future we strongly recommend that the existing brick quoin to the north*

*east corner of the garage structure is rebuilt in its entirety, returning this along the north elevation and replacing poorly formed and structurally unsound flint and brick infill. The masonry over the garage doors should also be rebuilt in order to provide a robust and stable structural arrangement. The existing flint and brick elements cannot be retained as to do so will leave the structure in an inadequate structural condition and at risk of potential further movement or collapse. The rebuilding and remedial work could be achieved by reusing some existing materials or similar reclaimed materials."*

The replacement wall is to be built with the same bow and lean as existing to be able to tie in the flint walling to the flank wall.
