**RE: 2-4 Waterloo Square, Bognor Regis PO21 1SU**

#### BRIEF

On 17<sup>th</sup> May 2018, H J Concepts Ltd were contacted and instructed by Mr R Brooks of B5 Ltd for the purpose attending site to review the structural condition of the buildings (where access is available) and more specifically the exposed structural steel support beams at 2-4 Waterloo Square, Bognor Regis PO21 1SU

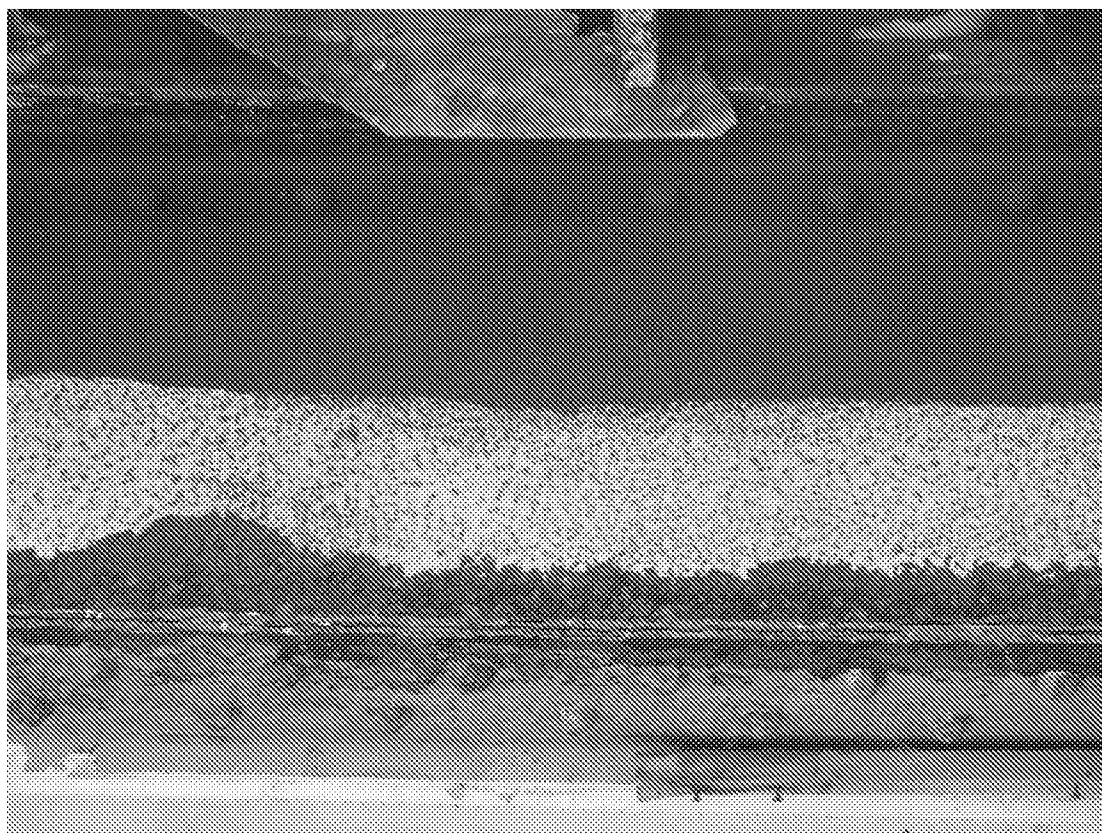
The following images show the clear and extensive damage that has taken place within the primary structure, especially the structural steelwork, which is showing signs of extensive and serious corrosion. The primary cause of this is water ingress from the aggressive coastal environment, with much of the damage associated with salt water ingress and entrapment. The buildings have been neglected for many years and as such the exterior of the building has been unable to protect the inner structure.

Primary Support Beam, supporting the floor and structure to the Boxing Facility (Viewed from Ground Floor) Note the lamination of the top and bottom metal plates and the extensive corrosion of the main beams web at the base of the beam.

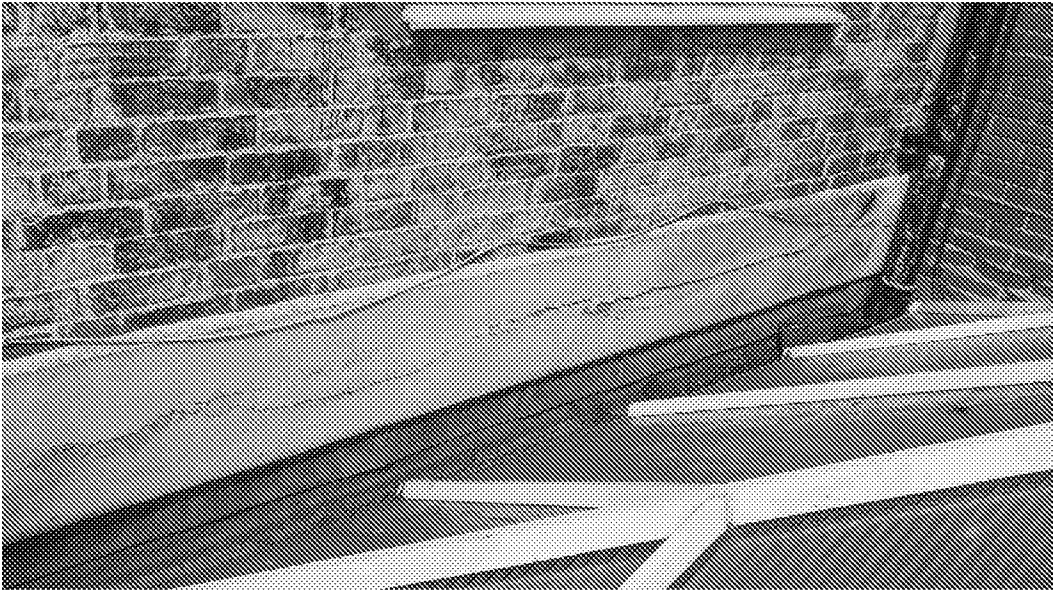
Severe cracking to render over support beams at First Floor (no safe access to investigate further)

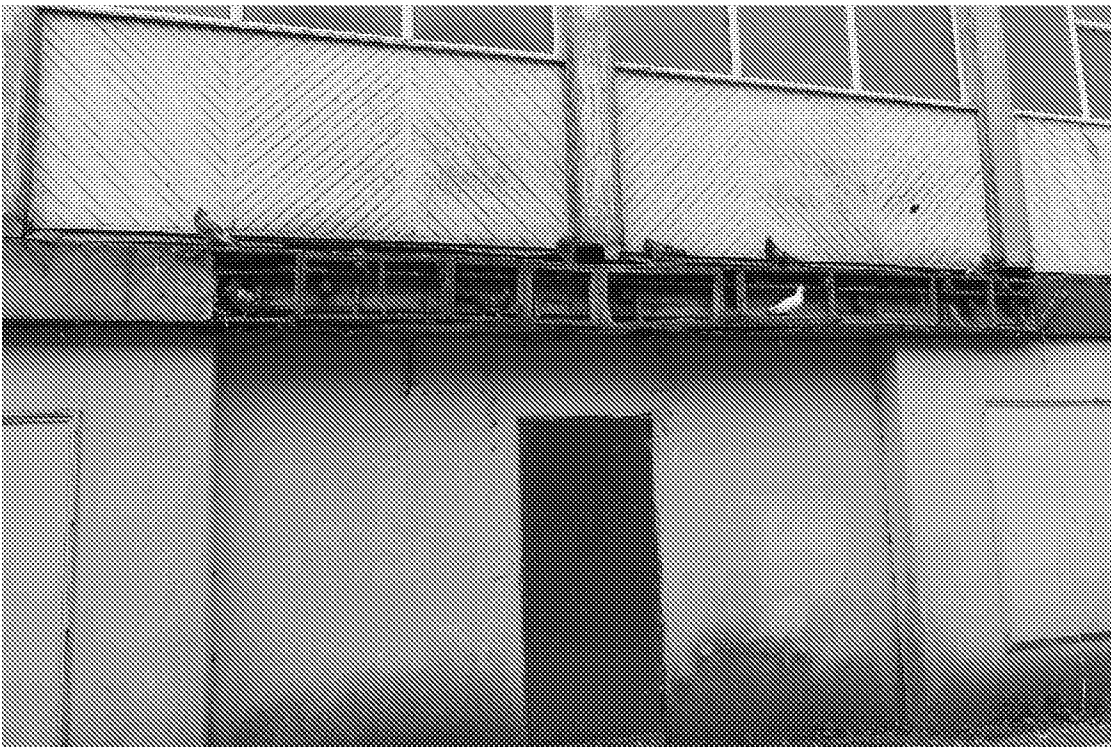
Beam in Norfolk Street at ground Floor (Badly decayed timber boxing hiding a Steel Riveted beam)

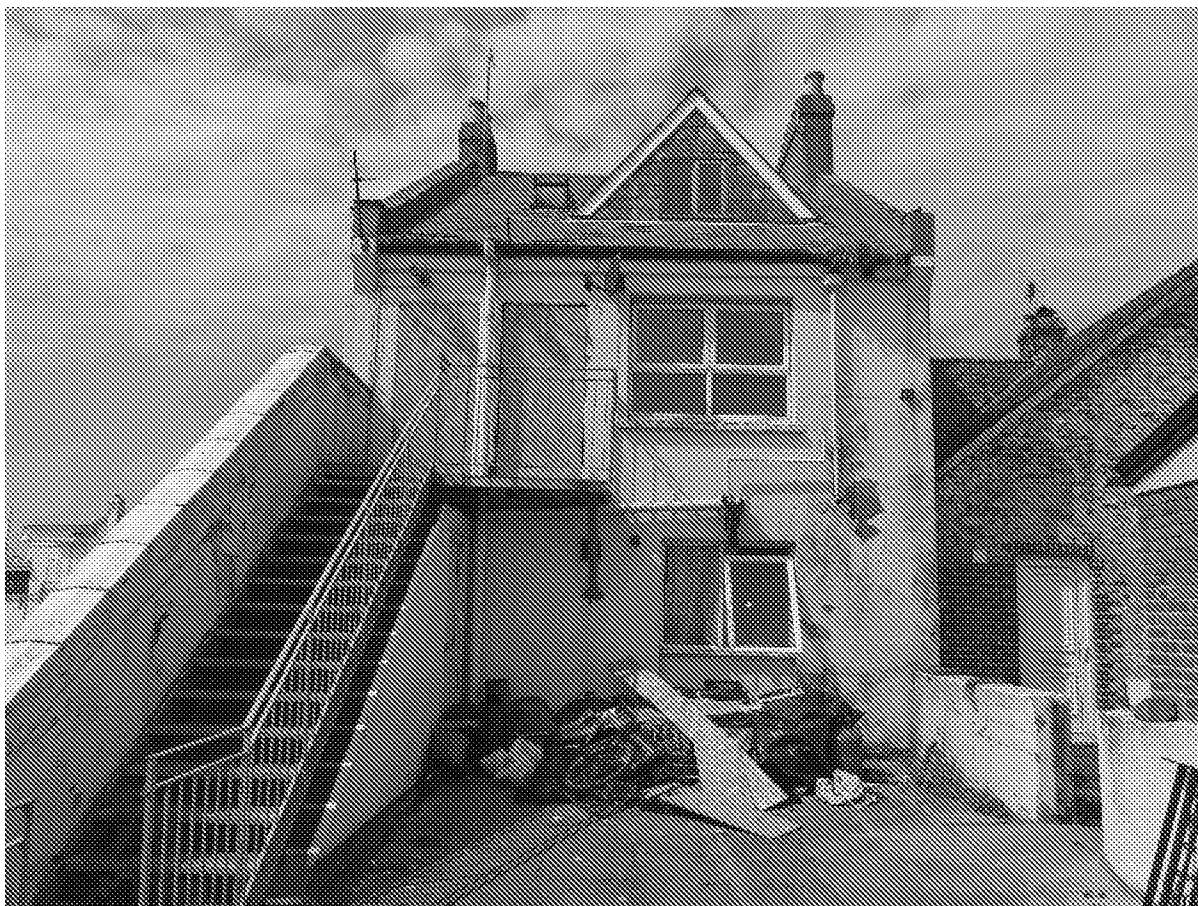
Rear view of floors at first and second level (facing Norfolk Street)

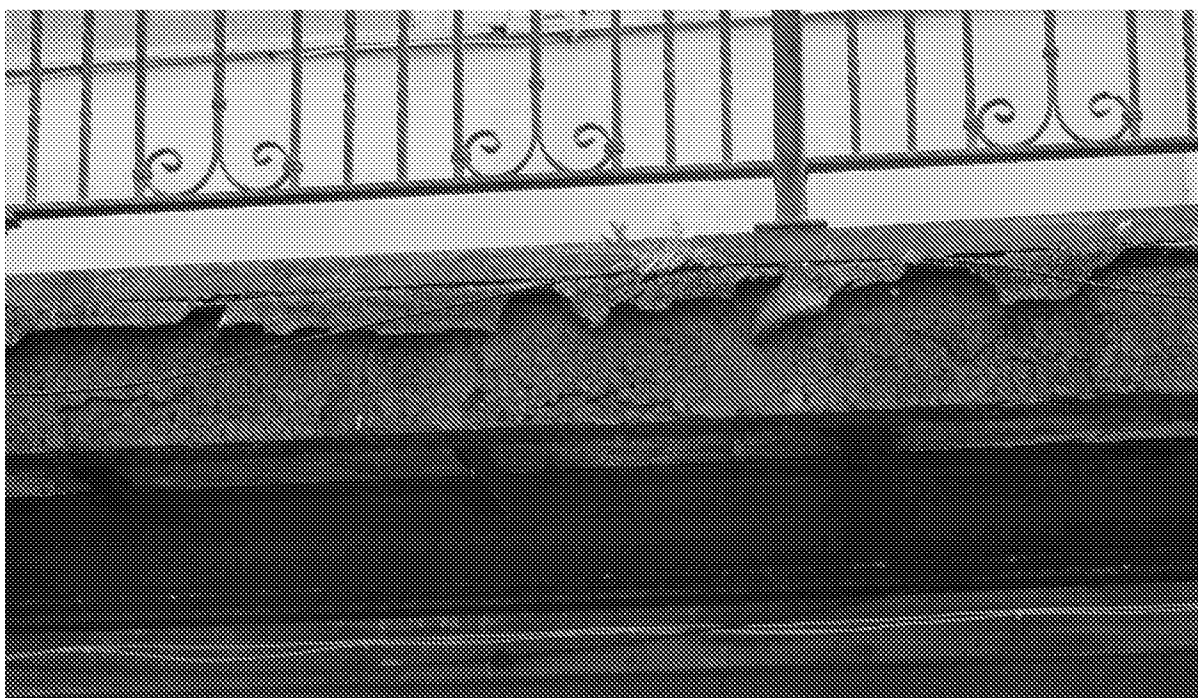
Waterloo Square Elevation – Severely laminated balcony steelwork at First Floor
